PORT KEMBLA GAS TERMINAL Construction Water Quality Management Plan

Document Number SCSB-AIE-PKGT-ENV-PRO-003

CONSTRUCTION WATER QUALITY MANAGEMENT PLAN

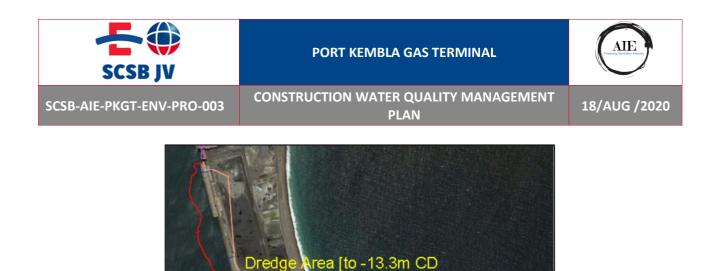
Figure 2 Inner Harbour Dredging Footprint and OHDSCA Footprint

OHDSC

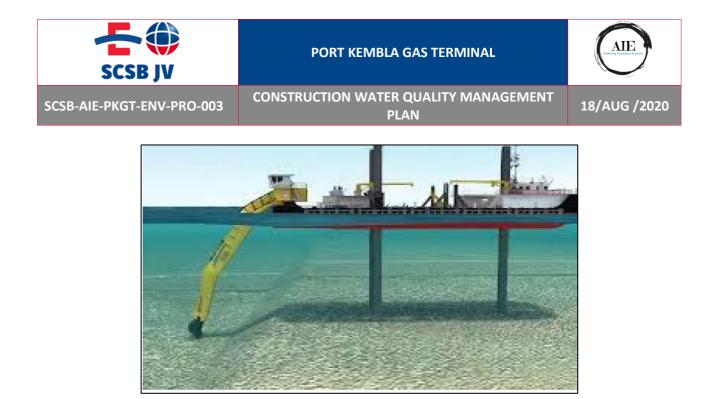
Figure 3 Backacter Dredge and spud configuration in disposal works areas

The Dredging Contractor, Hall, will use a Backacter dredge for the project. The Backacter dredge is based on a conventional excavator platform, mounted to a barge. The dedicated dredging machine is mounted to a fabricated pedestal located at one end of a spud-rigged pontoon. The spud location of the pontoon is necessary to provide positive reaction to the hydraulic digging action, particularly when dredging in difficult ground. The dredge is picture below in **Error! Reference source not found.**

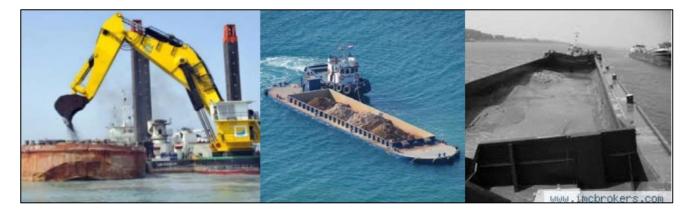
Figure 4 Backacter dredge transport and discharge configuration

The Backacter dredge will side cast spoil directly into a barge, side hipped to a tugboat. The barge will transport the spoil directly to the emplacement cell. Bottom dump barges (Split Hopper Barges) will be used at early stages, depositing spoil either to construct the lower sections of the bund wall or inside the emplacement cell. A flat top barge will be used for subsequent transport, unloaded at the emplacement cell by conventional earthwork equipment. The approach minimises changes in density of the spoil material. The transport and discharge configuration are presented in **Error! Reference source not found.** below.

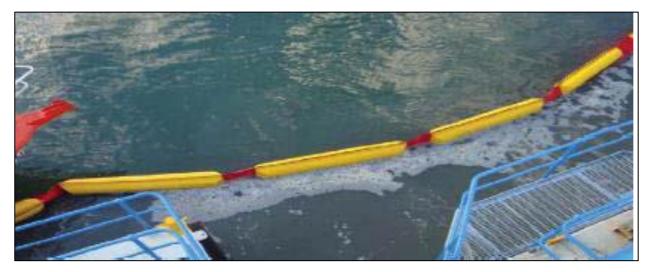
Figure 5 Silt Curtain to deployed around dredging and disposal works areas

- Setting anchors along the curtain run and really focussing on the corners, using 2 x 300KG dump weights stacked up on the corners to mitigate movement, more if required
- Use land point anchors by either using a mass of weight or a structure that's available. If nothing is available then either cement a post, place a dump weight
- 300kg dump weights at 60m intervals will be used and some extra in load area this is going to be where/when the body of water turns and longer runs of curtains now facing more of the tide adding load.

Appropriately-sized silt curtains will also be used during the storm water construction in the Outer Harbour, during demolition of the deck on pile in the Inner Harbour and while land dredging from +5 m PKHD to 1+ m PKHD in the Inner Harbour. Those appropriately-sized silt curtain will not need to be of the same Category nor as deep as the one that will be installed for dredging. They will be appropriate for the type of work they are being used for.

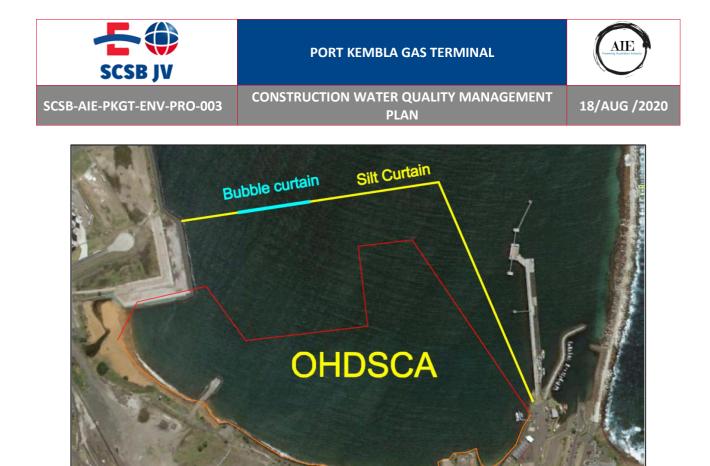
Figure 6 Approximate Silt and Bubble Curtain alignment in Outer Harbour

The final location of the silt curtain and bubble curtains for the OHDSCA is under discussion with NSW Ports. Approximate alignments are outlined in Figure 6

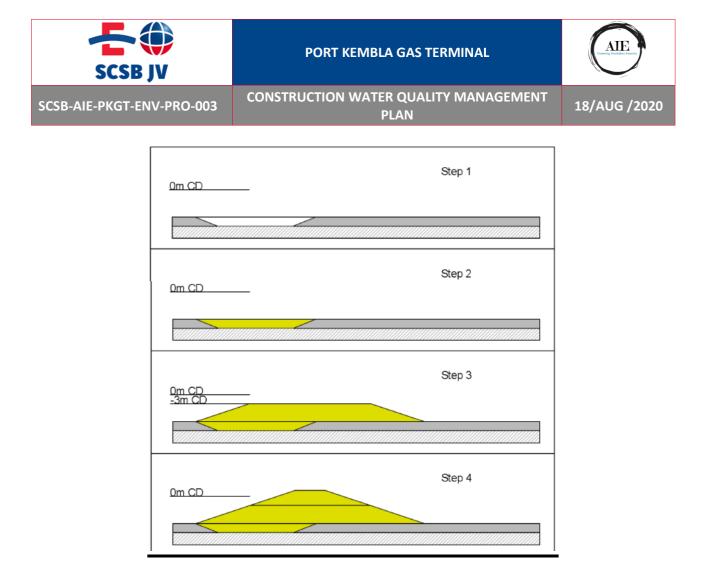
Figure 7 Sequencing of perimeter bund construction

The perimeter bund is to be constructed using the material of Berth 101 categorised as type 1A/1B sandy material and uncontaminated fill material (Yellow areas in Figure 7). Soil investigation has shown that these layers extend to approximately - 8 m PKHD / - 9 m PKHD. The dredging plan includes sequencing to ensure potentially and known contaminated materials are placed behind the bund, and non-contaminated materials are used to create the perimeter bund.

The dredged material will be loaded onto a Split Hopper Barge (SHB). Once loaded the tugboat, hipped up to the SHB, will bring the SHB to the perimeter bund. Dumping operations are to be controlled using a dump grid system.

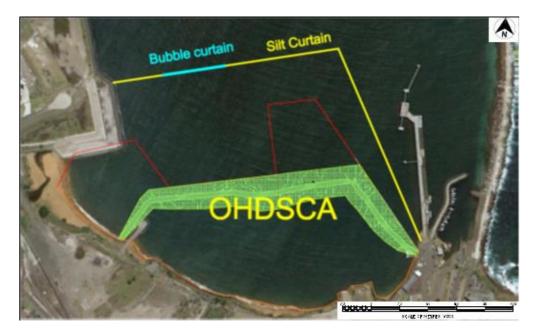
Figure 8 Outer Harbour Perimeter Bund

Once established the Outer Harbour Perimeter bund will serve as the primary sediment control measure, with the Silt curtains and Bubble curtains providing a secondary layer of protection. Indicative Location and footprint of the Perimeter Bund is shown below in Figure 8.

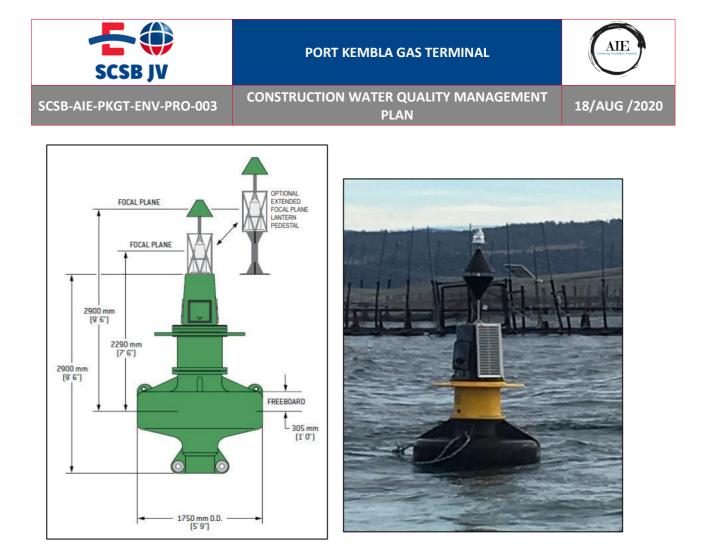
Figure 9 Automated Water Quality Monitoring Buoy dimensions

The average value of the 3 buoys will be compared to the background value. In other words, the average value of WQM 1,2,3 will be compared against WQM 4. If there is an exceedance, a comparison of each individual value will provide direction on where is the exceedance coming from.

Real time data will be displayed in the dredging project superintendent's site office.

Once deployed, an initial calibration of the AMBs will be done in accordance with manufacturer's specification and a maintenance program will be established. The Environmental Representative and Team will inspect each AMB twice weekly, or in response to any observed 'drift' in results. Inspection will also be undertaken as part of an investigation into a triggered alarm level, or anomalous reading. Additional maintenance measures are included in Appendix C.

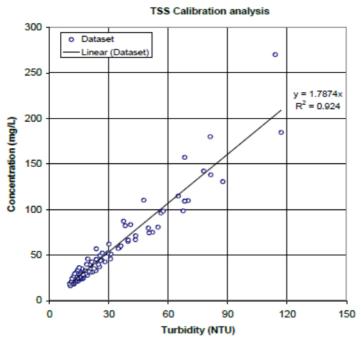
Figure 10 Example of a TSS (mg/L) and Turbidity (NTU) Correlation analysis

Total Suspended Solids (TSS) is the primary parameter for the measurement for Turbidity at Water Quality Monitoring Points until the EPA has been provided, and subsequently approves, onsite statistical correlation and assessment methodology and results. Previous EPL's issued at Port Kembla indicate that 50mg/l of suspended sediment is equal to 25 NTU. An example of Turbidity and TSS correlation graph is seen below in **Figure 10**. Following establishment of NTU values, weekly testing of TSS will be undertaken concurrently with COC Grab sampling. The results of which will be compared and correlated monthly to enable refinement and accuracy of the real-time TSS data relayed by the AMB.

TSS and turbidity samples will be taken at three depths; 1.5m below surface, half depth and 2 m above the sea bed. All these samples will be taken at the same location as the buoys for the sake of comparison. If the reading 2 m above the sea bed is high, the contractor will redo one to confirm that the sea bed was not disturbed by the sampling causing high value. The average value between the three depth readings will be compared to the automatic monitoring in order to validate the manual sampling values.

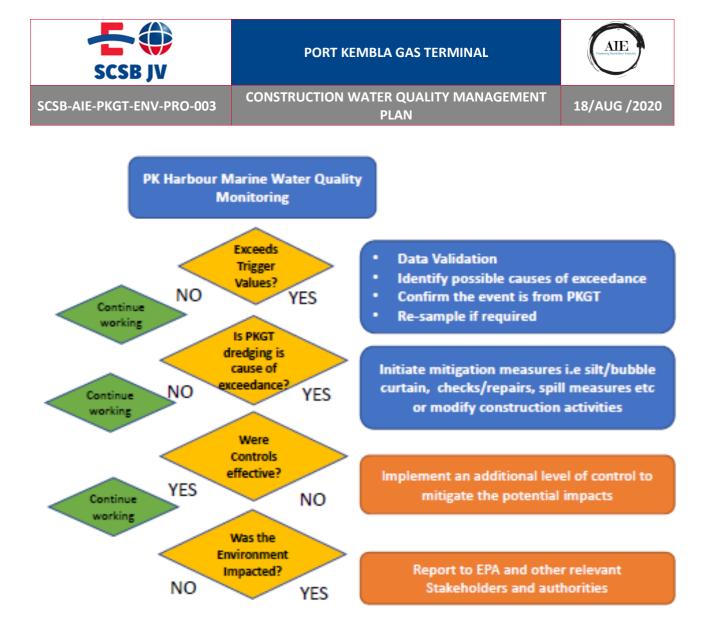
Figure 11 Triggered event process flow chart

A flow diagram illustrating the water quality assessment and management processes is depicted below.

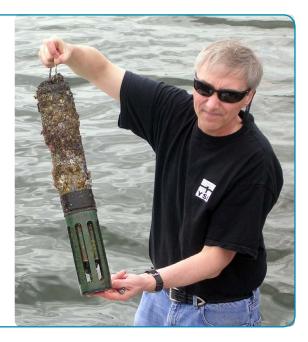
Copper Tape

Many water quality probes have either plastic or metal housings. While copper-alloy housings offer some measure of biofouling protection, plastic and metal (non-copper) housings do not. You can apply excellent anti-fouling protection to these probes by wrapping the housings in copper tape in a two-step treatment.

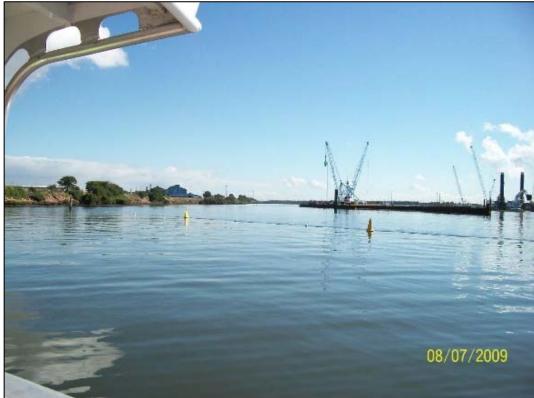
Photograph 3. Silt Curtain in place

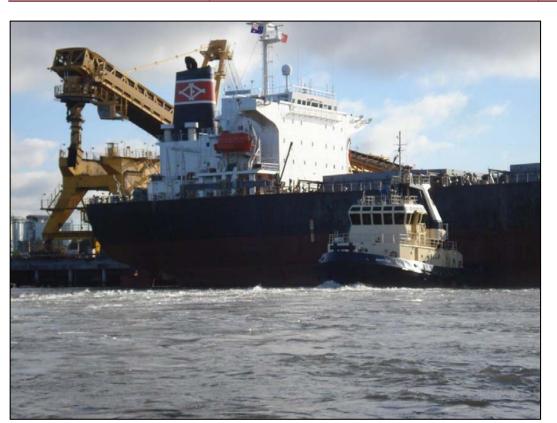
Photograph 4. Tugs moving coal ship into other berth in Harbour, contributing to plume observations **NOT** attributed to PKGT contruction works
