## SOILS AND LAND ASSESSMENT

# Soil and Land Assessment

Snowy 2.0 Main Works

Prepared for Snowy Hydro Limited  
September 2019

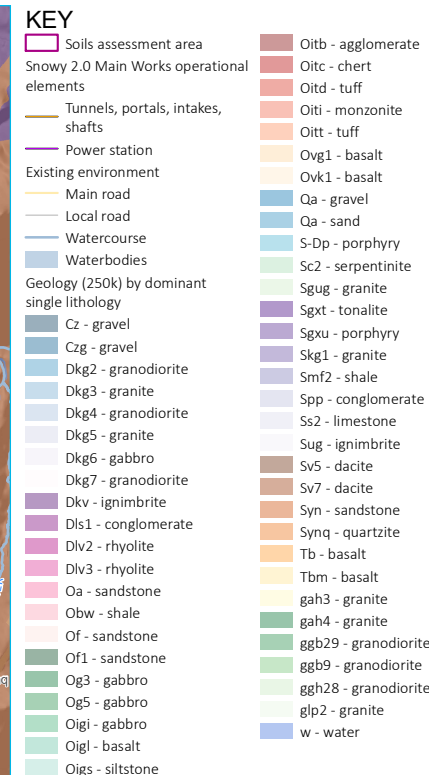
Snowy 2.0  
Soil and land assessment report  
Main Works  
Figure 4.5

Geology of the soils assessment area

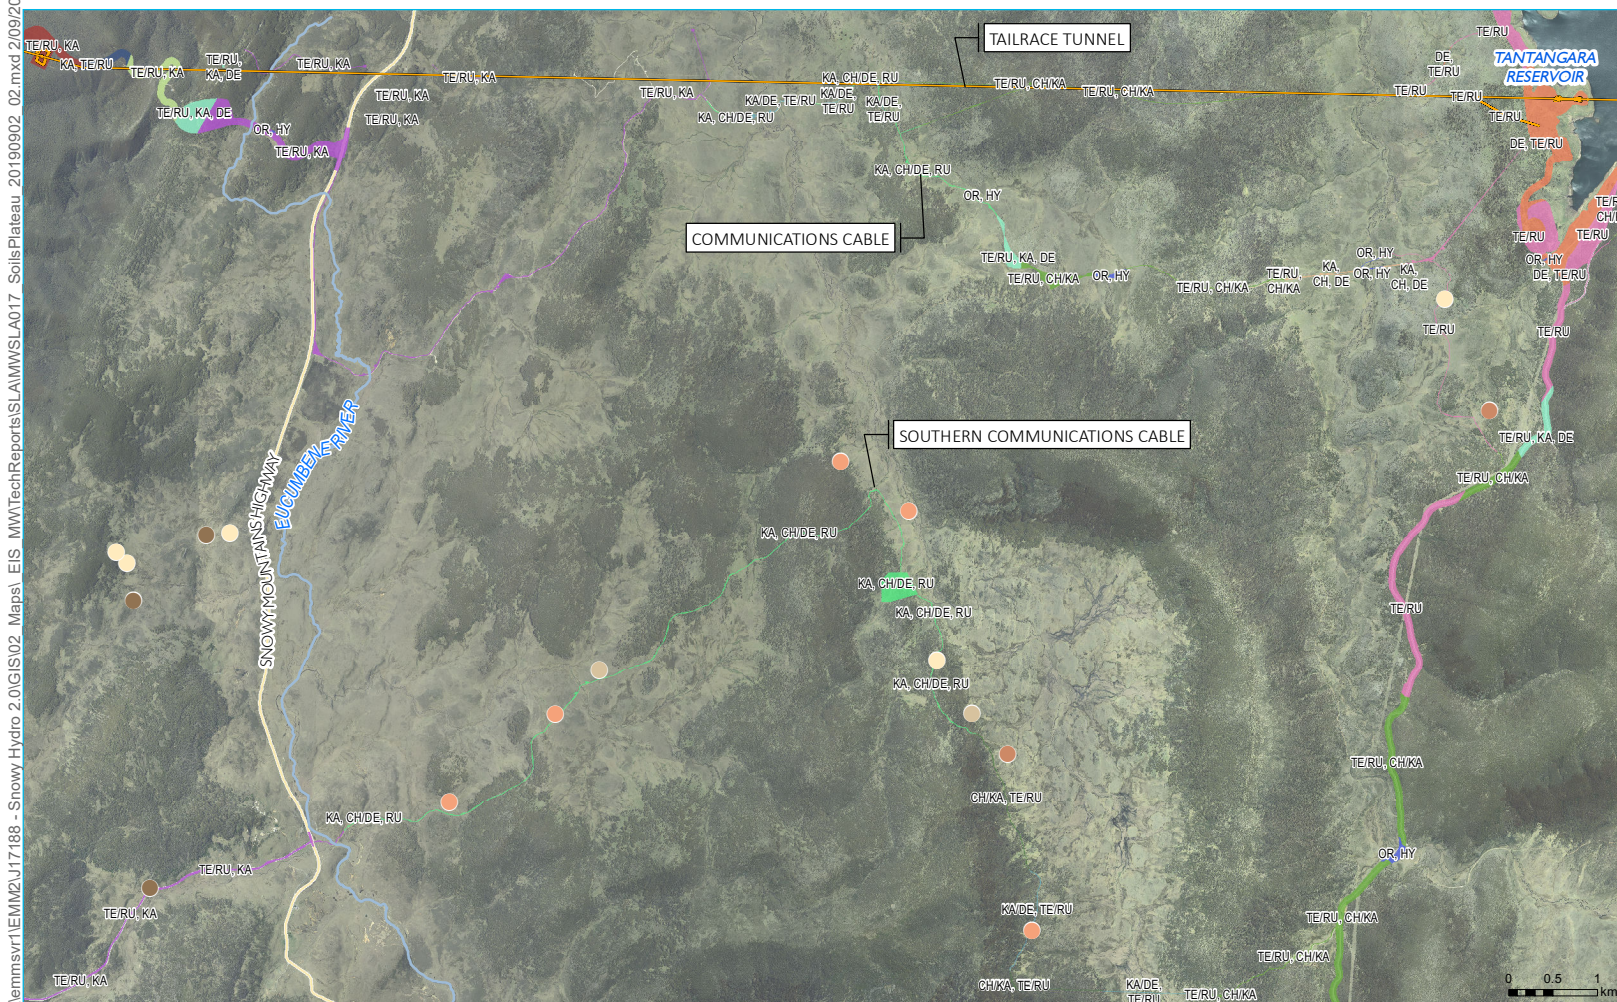
## Plateau - soils

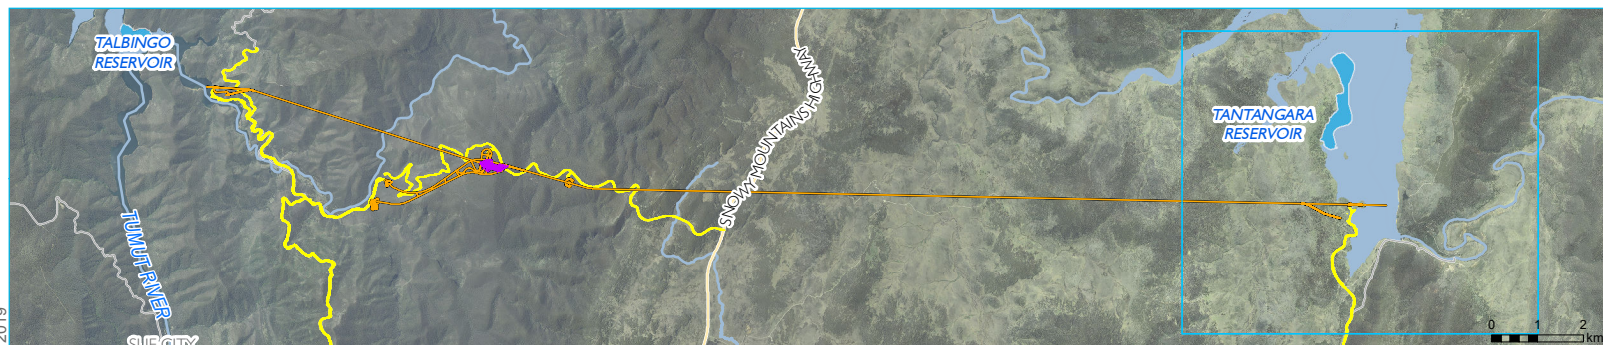
## Tantangara Reservoir and Rock Forest - soils

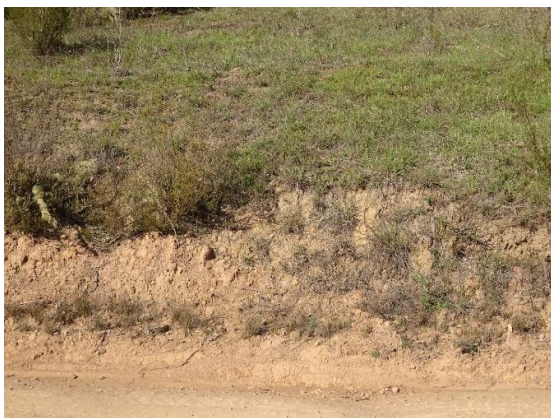
**Plate 4.1** Cutting on Tantangara Road

Road cuttings appear quite stable with no significant erosion including the absence of rilling and gullies. A few examples of road cuttings are shown in Plate 4-1 to Plate 4-4.

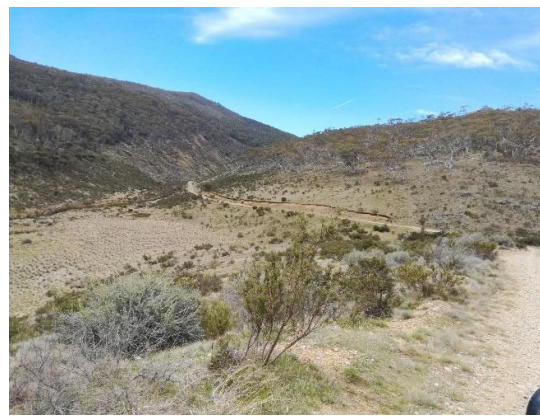
**Plate 4.2** Schofields Trail

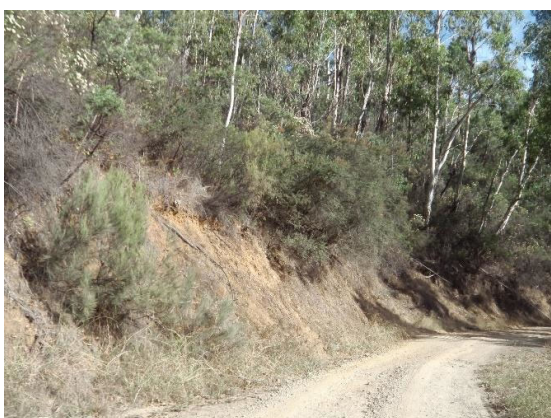
**Plate 4.3** Cutting on Ravine Road

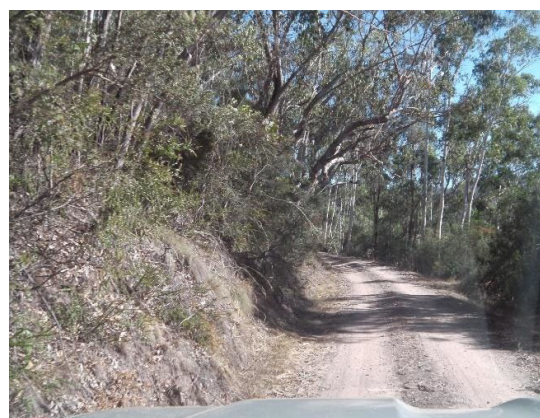
**Plate 4.4** Cutting on Ravine Road
