# Snowy 2.0 – BH4201 & 4202 Rehabilitation Plan

Version: S2-SHL-ENV-PLN-0008 - Rev 4

Date: 24/09/2024

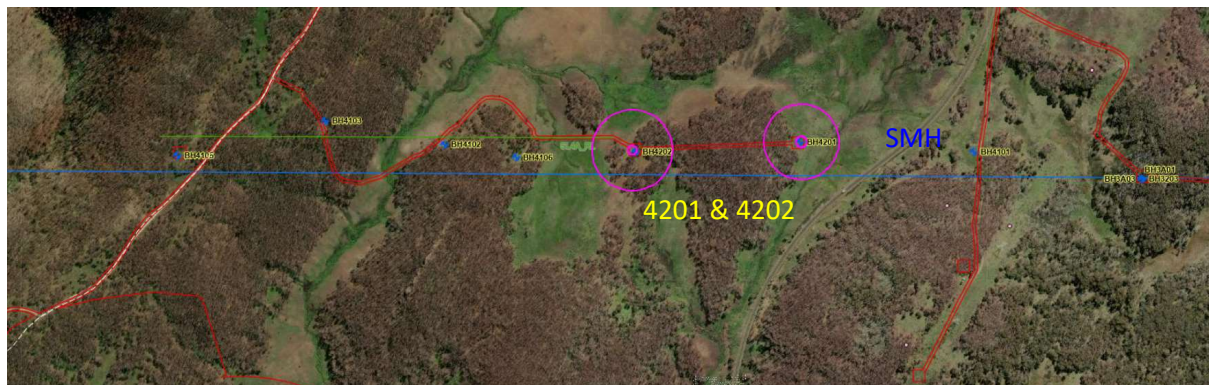
### Figure 2: BH4201 & 4202 Layout

The area to be rehabilitated is approximately 0.8 Ha of disturbance. Figure 2 details the BH4201 & 4202 layout (purple circles signifying the bore hole locations).

**Note – Coppermine Trail (red and white), Temporary access track (red)**

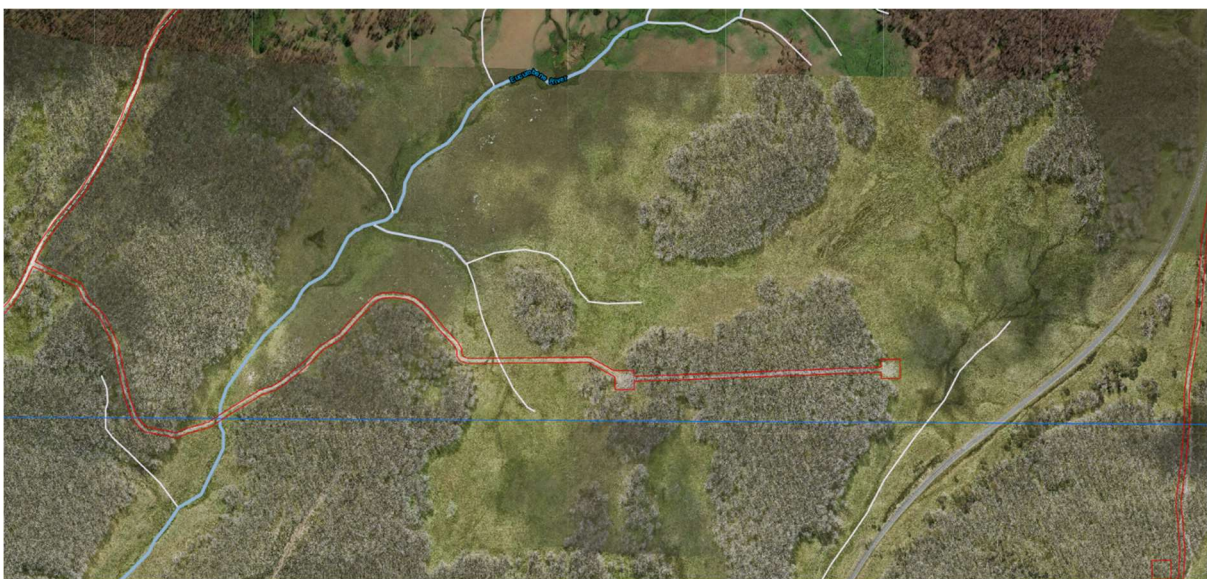
**Figure 3: Waterways**

There are two tributaries that intersect the access track between Coppermine Trail and the first borehole (B4201) as shown below in Figure 3. Both waterways are stable however some additional plantings to prevent erosion in the riparian zone will be undertaken. Species to be planted in the riparian zones are outlined in Section 4.2. See Appendix A for current imagery of Eucumbene and the unnamed waterway.

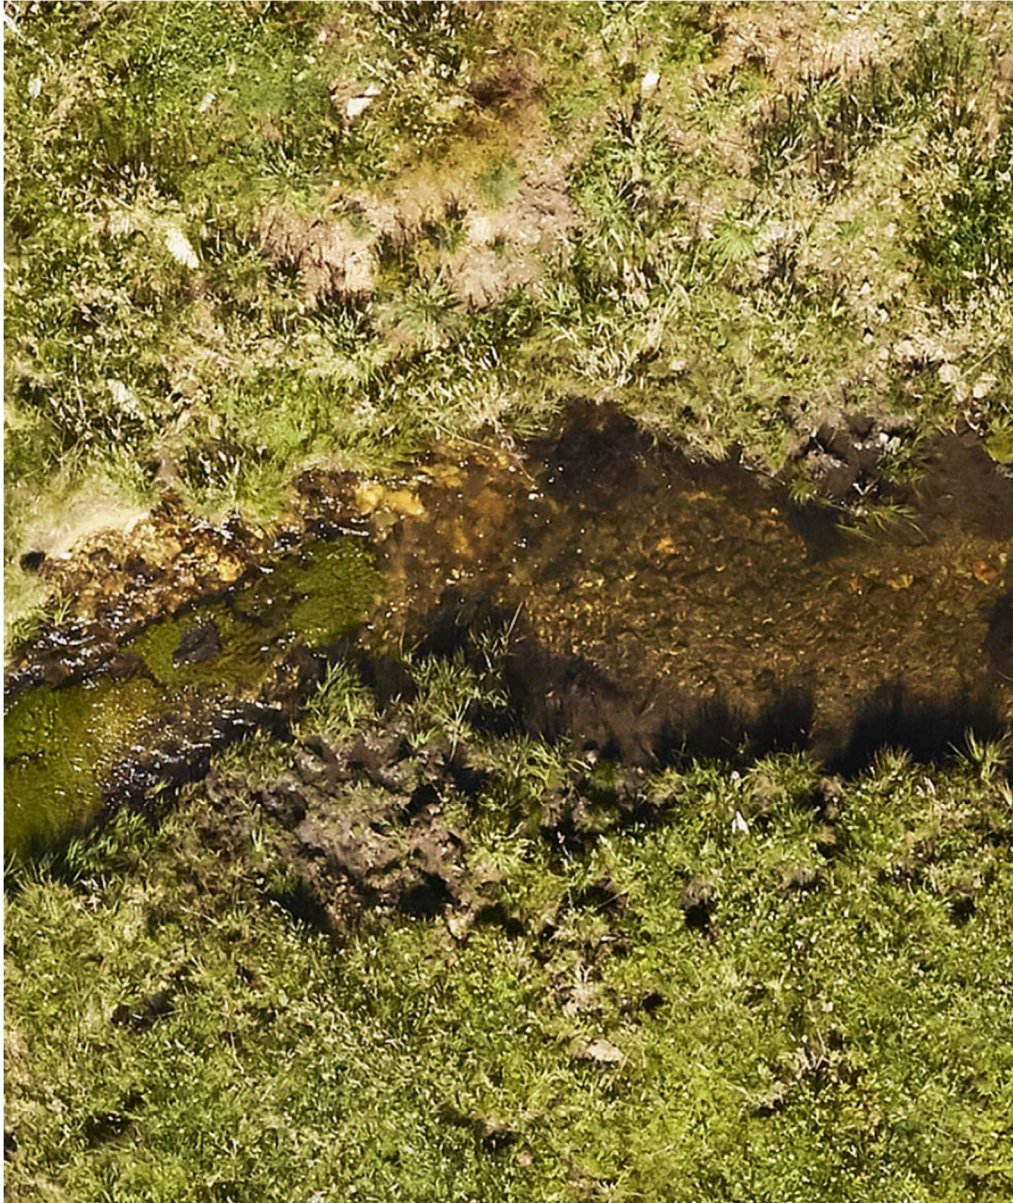
Eucumbene River - January 2024

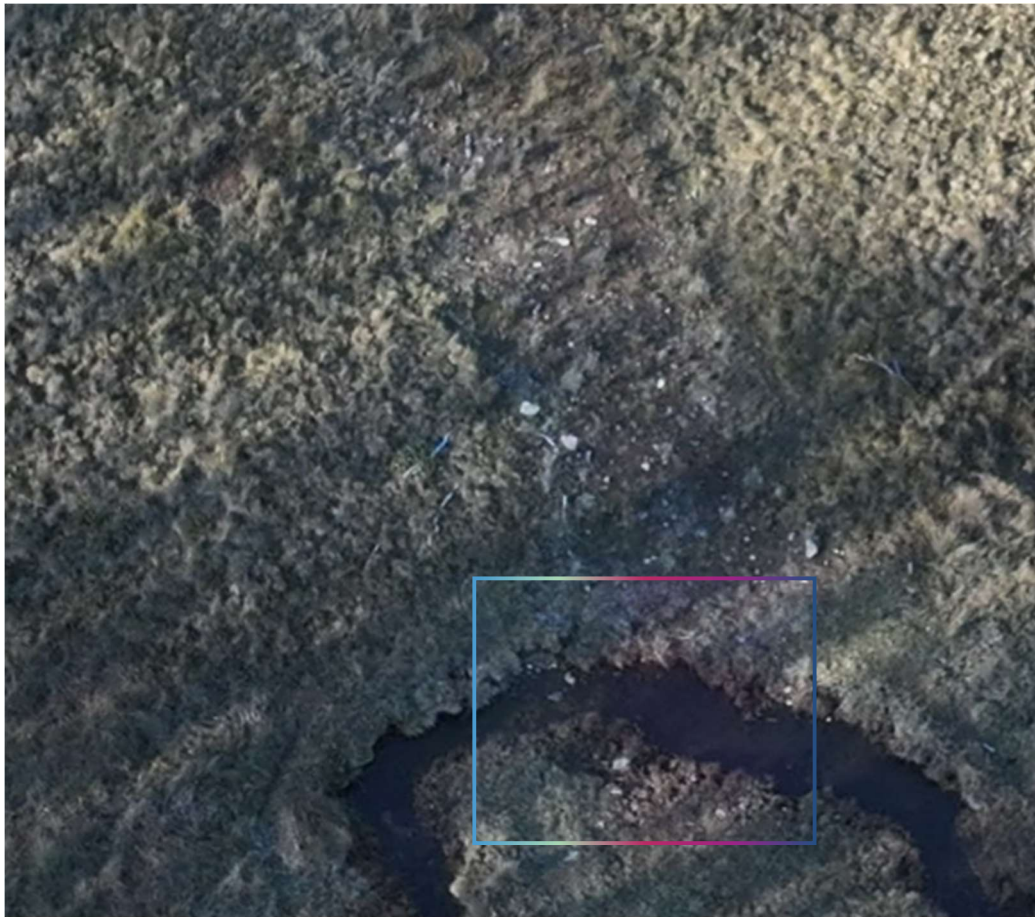
Eucumbene River - May 2024 (greater context)

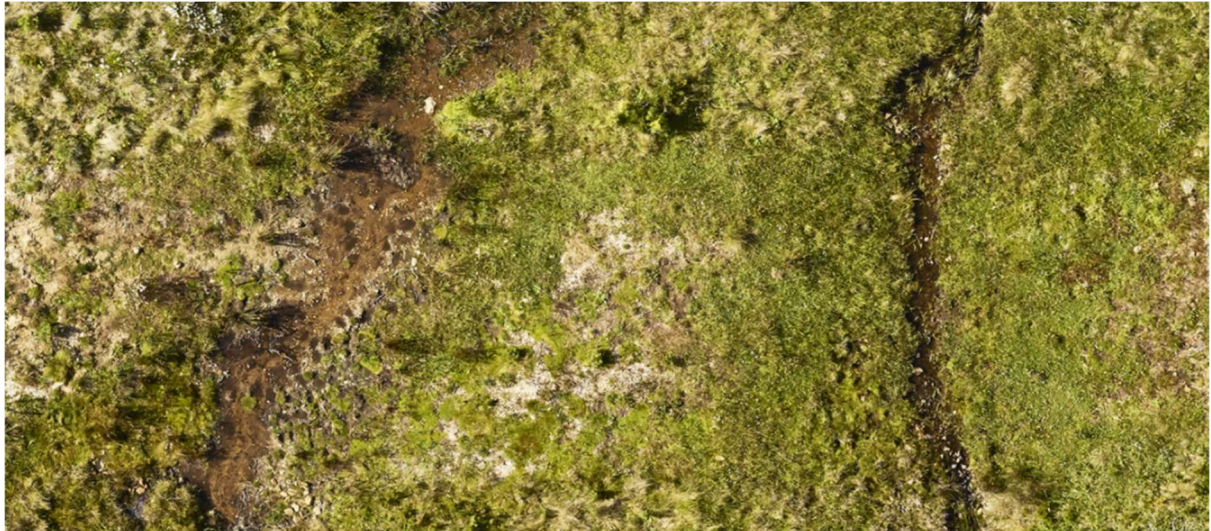
Unnamed Tributary – January 2024

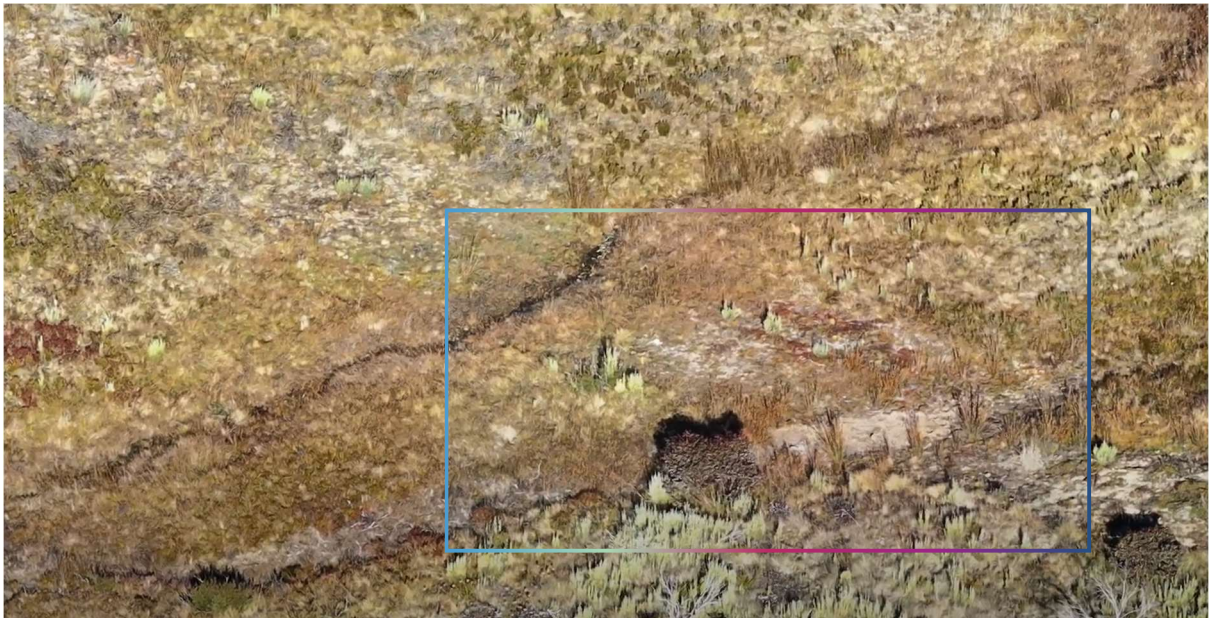
Unnamed Tributary – May 2024 (greater context)

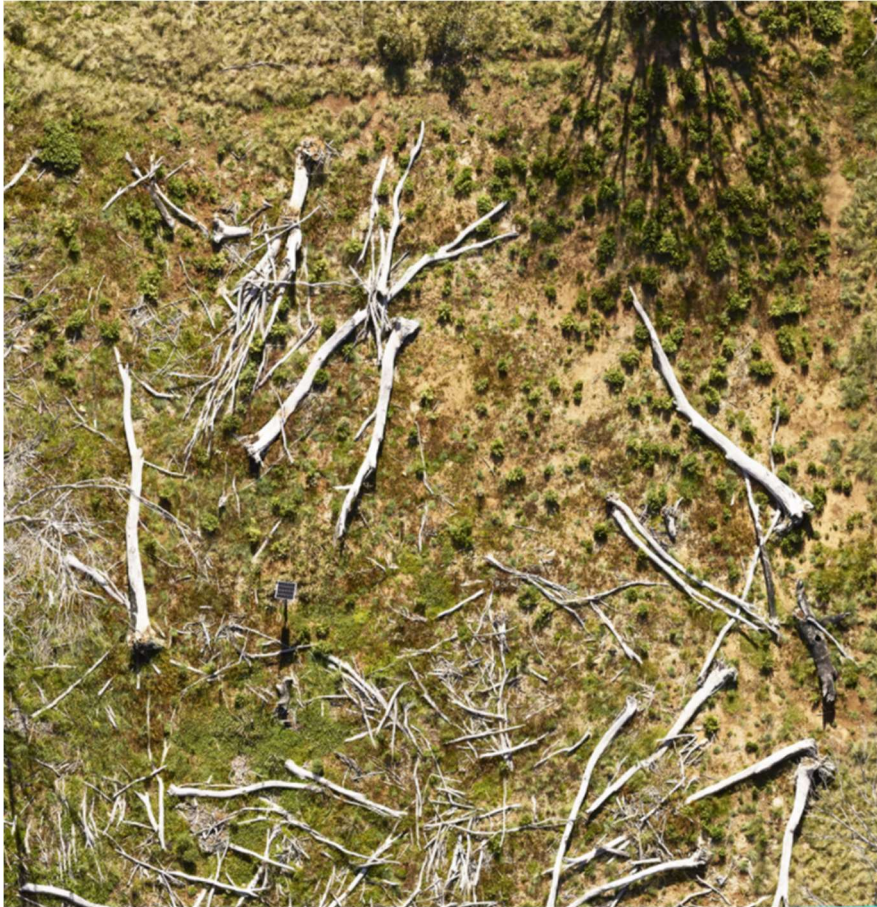
BH4201 – January 2024

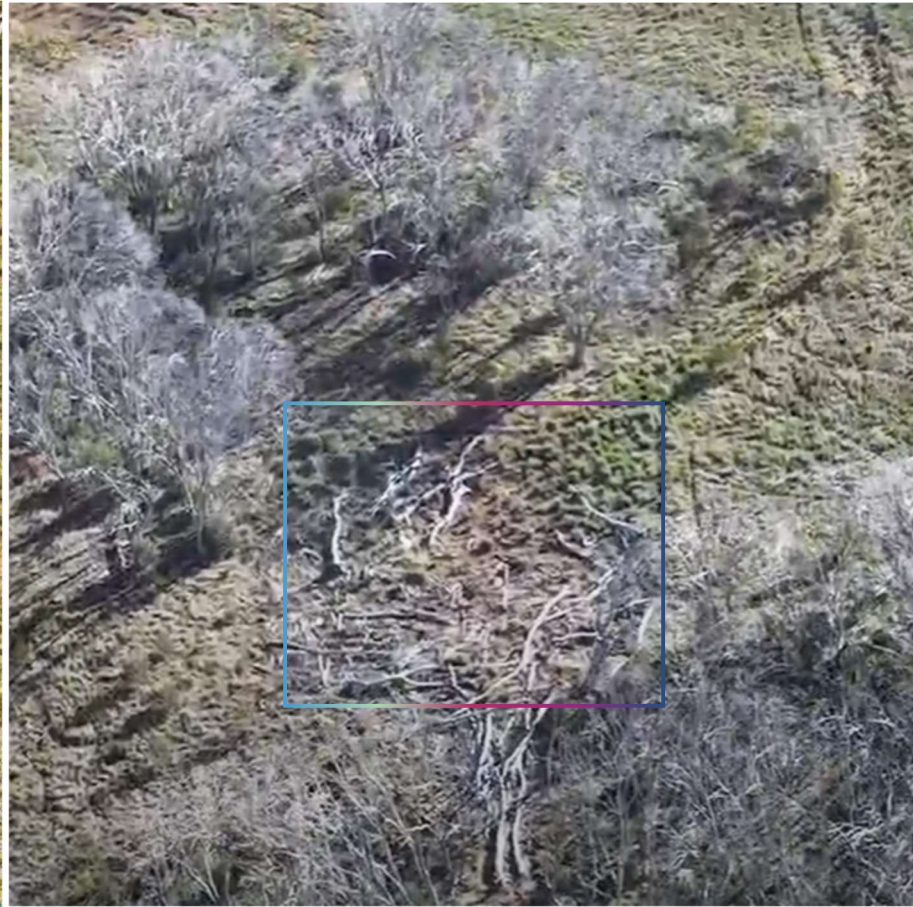
BH4201 – May 2024 (additional context)

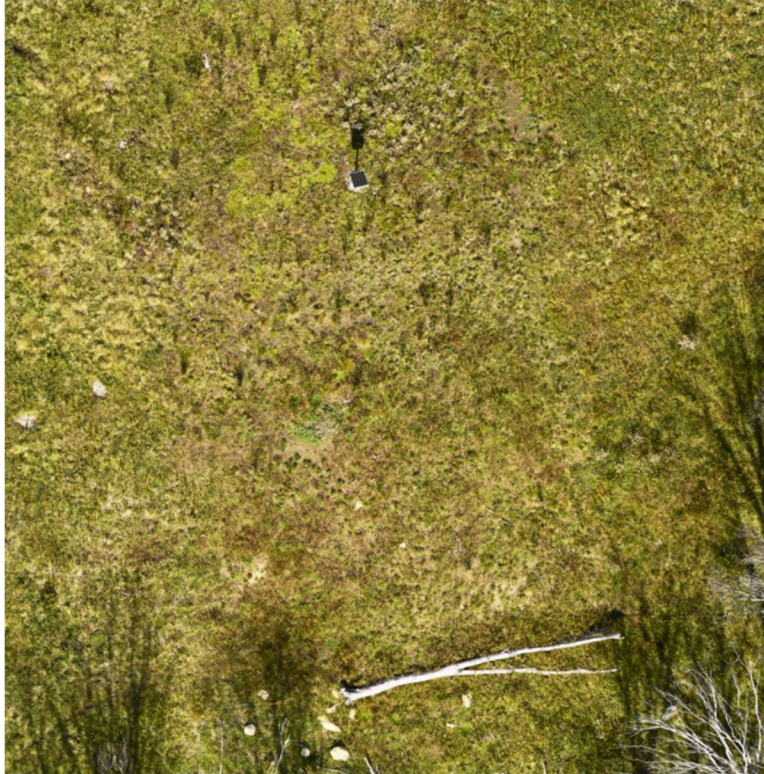
BH4202 – January 2024
