Snowy 2.0 Transmission Connection Project
Environmental Impact Assessment

Snowy 2.0 Transmission Connection Project
Landscape Character and Visual Impact Assessment

Rev 04
December 2020

TransGrid

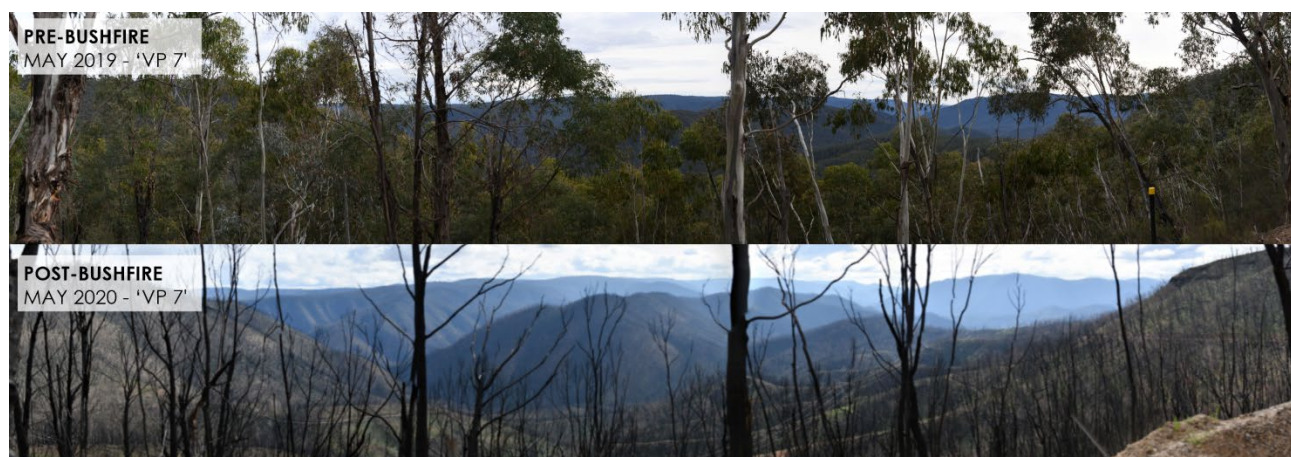
Photo 5-1: Bushfire impact to landscape character, located along Lobs Hole Ravine Road

The visual change to the landscape as observed upon revisiting the site is predominantly the change in vegetation cover and colour as shown in **Photo 5-1**, which is located along Lobs Hole Ravine Road, and discussed further at **Section 6.2**.

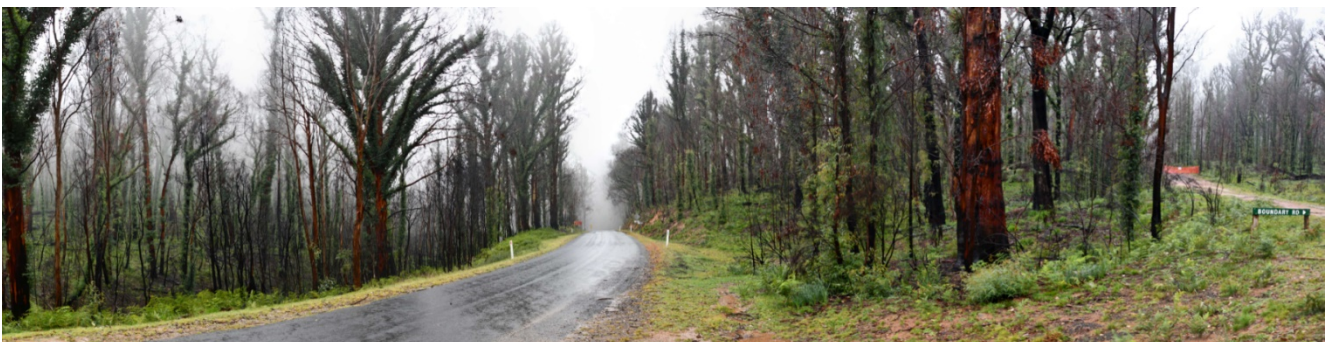
Photo 6-6: VP 2 – Elliott Way / Boundary Road looking east – post bushfire

Following the 2019/2020 bushfires, vegetation in this area has been similarly damaged and begun to re-emerge as seen at VP 1. The density of the remaining vegetation at this location allows filtered views through the trees. Within this context, lattice-tower structures, if visible, would not be an obvious or stark feature in views from this location. As the emerging vegetation develops, it would provide for the filtering and screening of views towards the transmission structures from this VP.

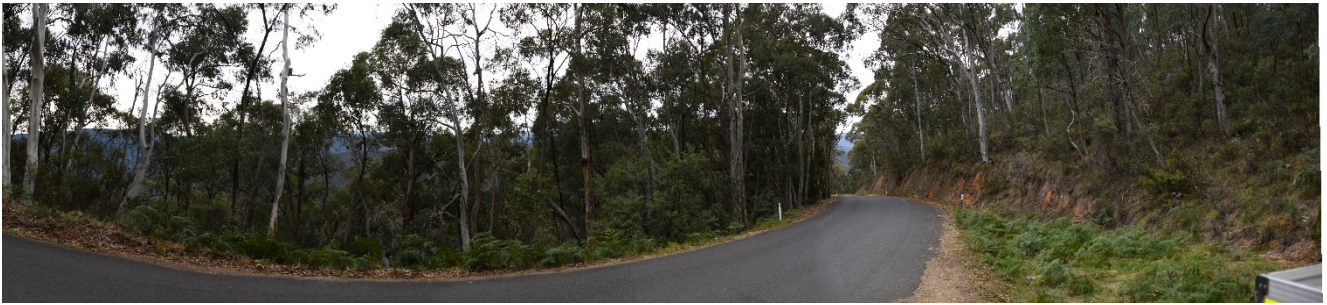
Photo 6-8: VP 3 – Elliott Way, looking east to south – prior to 2019 bushfire

The existing view is one that is currently confined to the road due to existing vegetation which screens or filters views to the surrounding landscape, including the Talbingo Reservoir and ranges to the east. It is expected that following the bushfires, these views have temporarily opened up to reveal broader views across the reservoir and beyond as vegetation has been damaged or felled. It is unknown whether these trees remain or have been felled due to landslides.

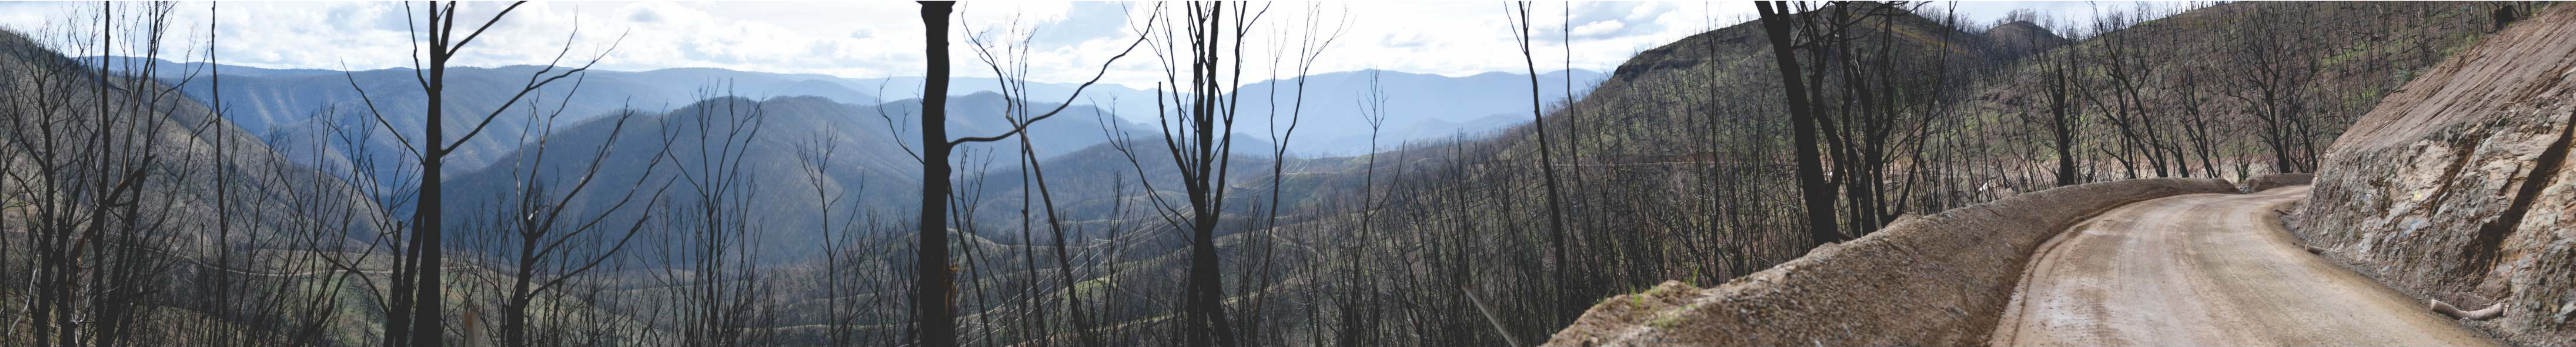
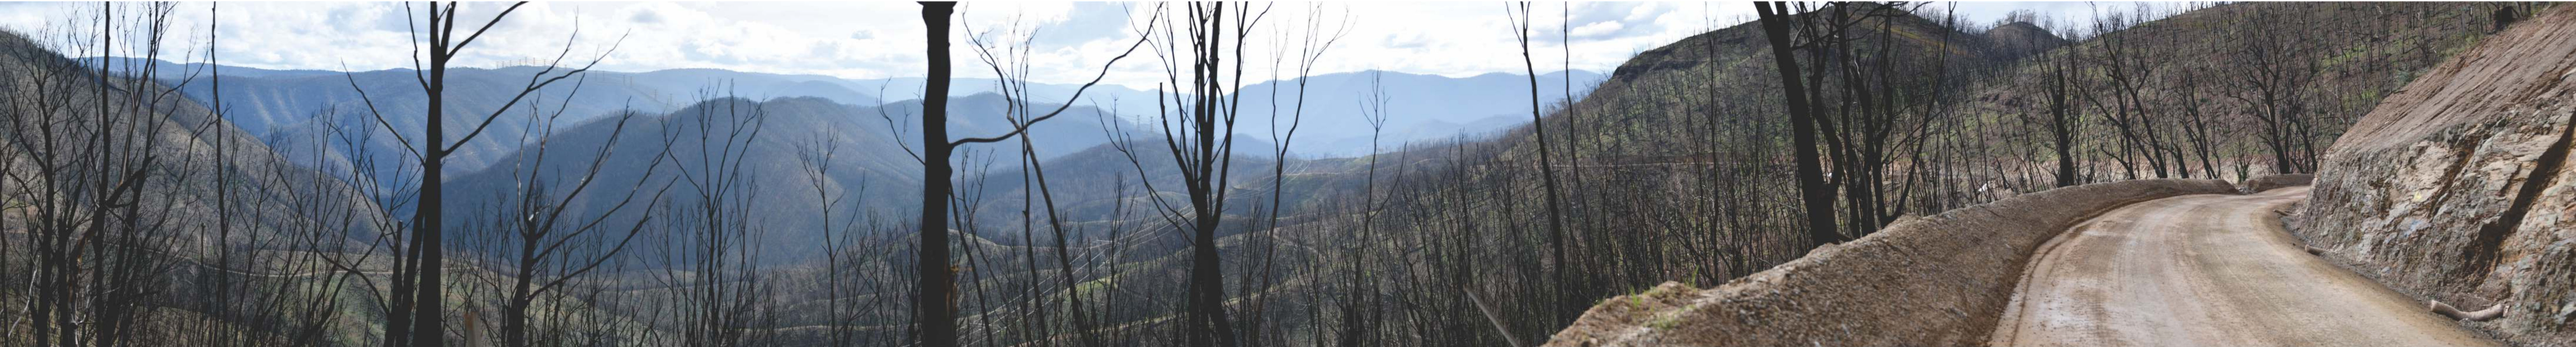
Existing view

Photomontage

Distance to Project: Approximately 3.0km

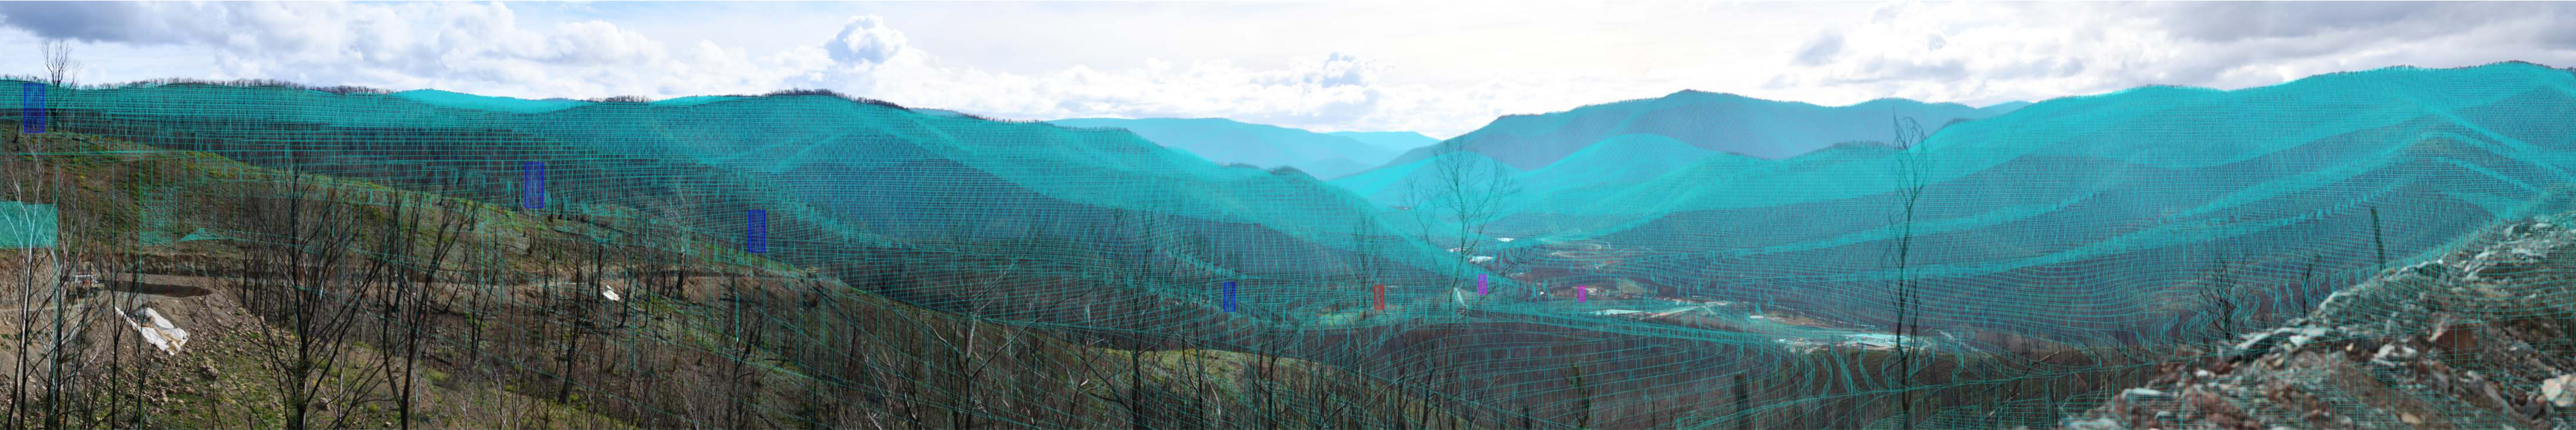
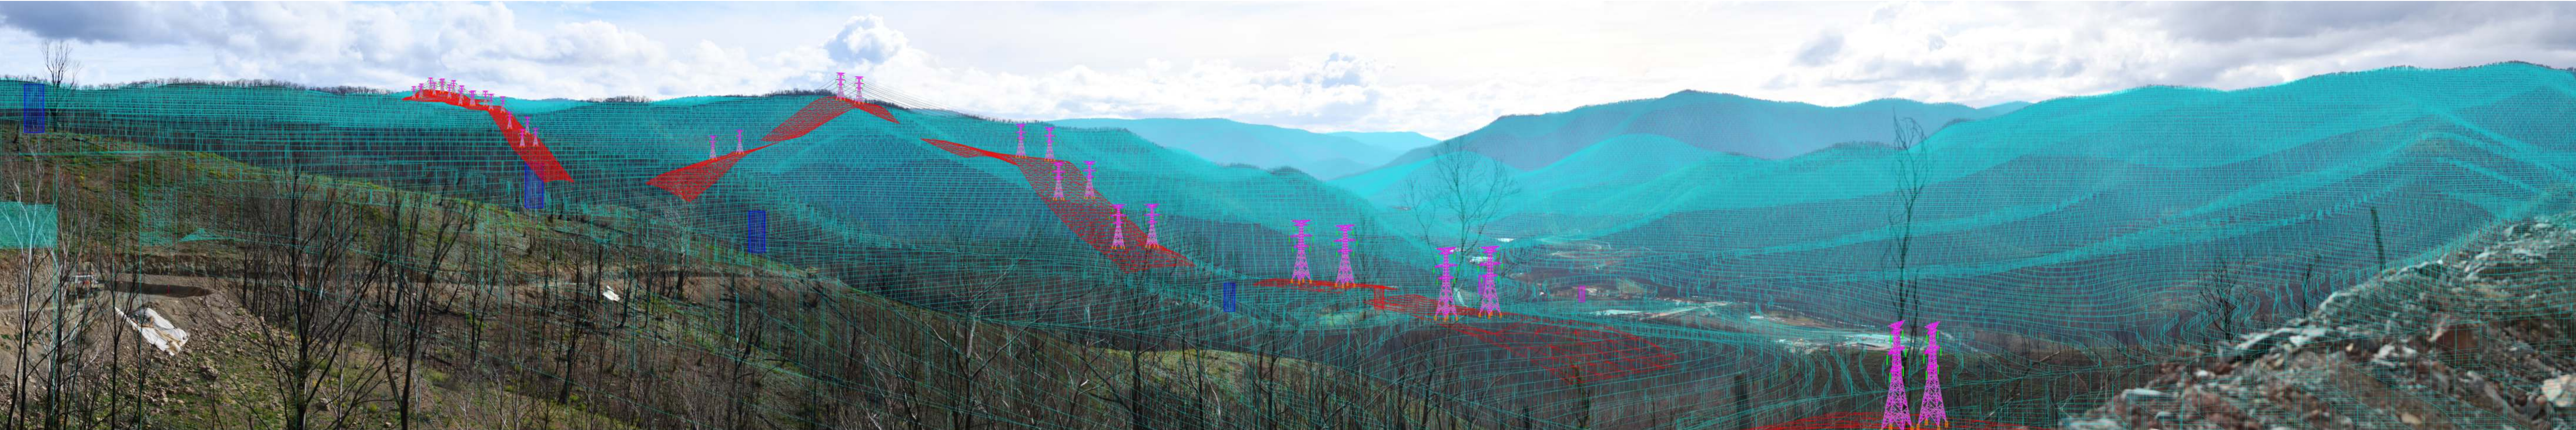
Wireframe view - Existing

Wireframe view - Project

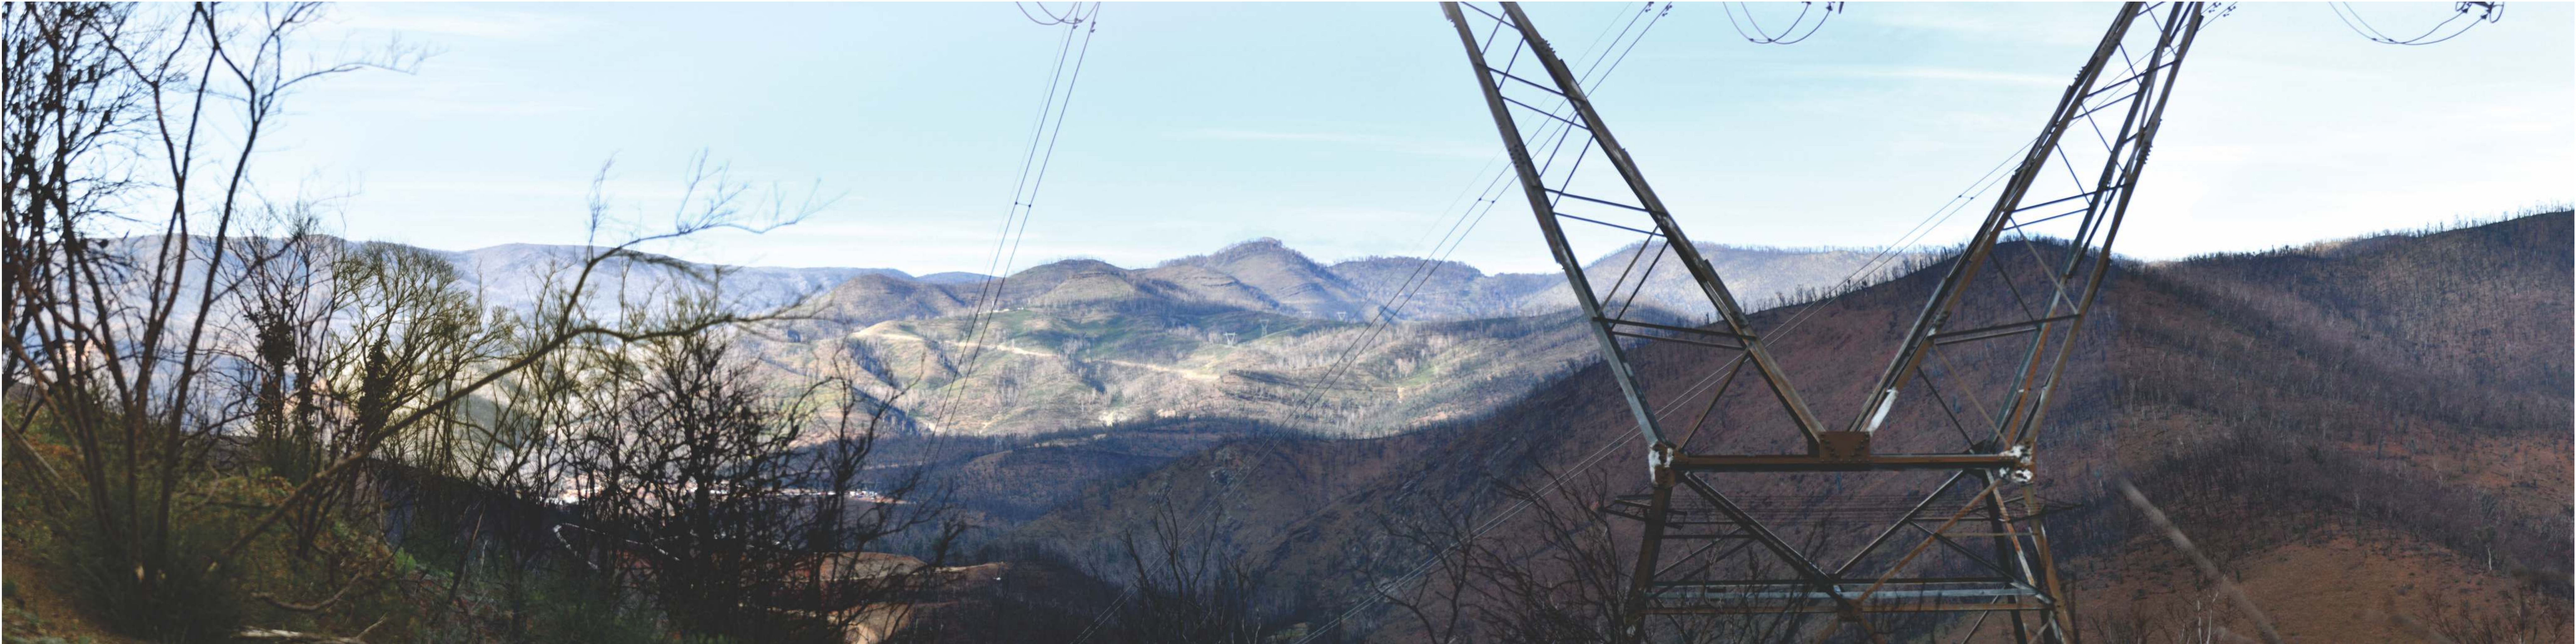
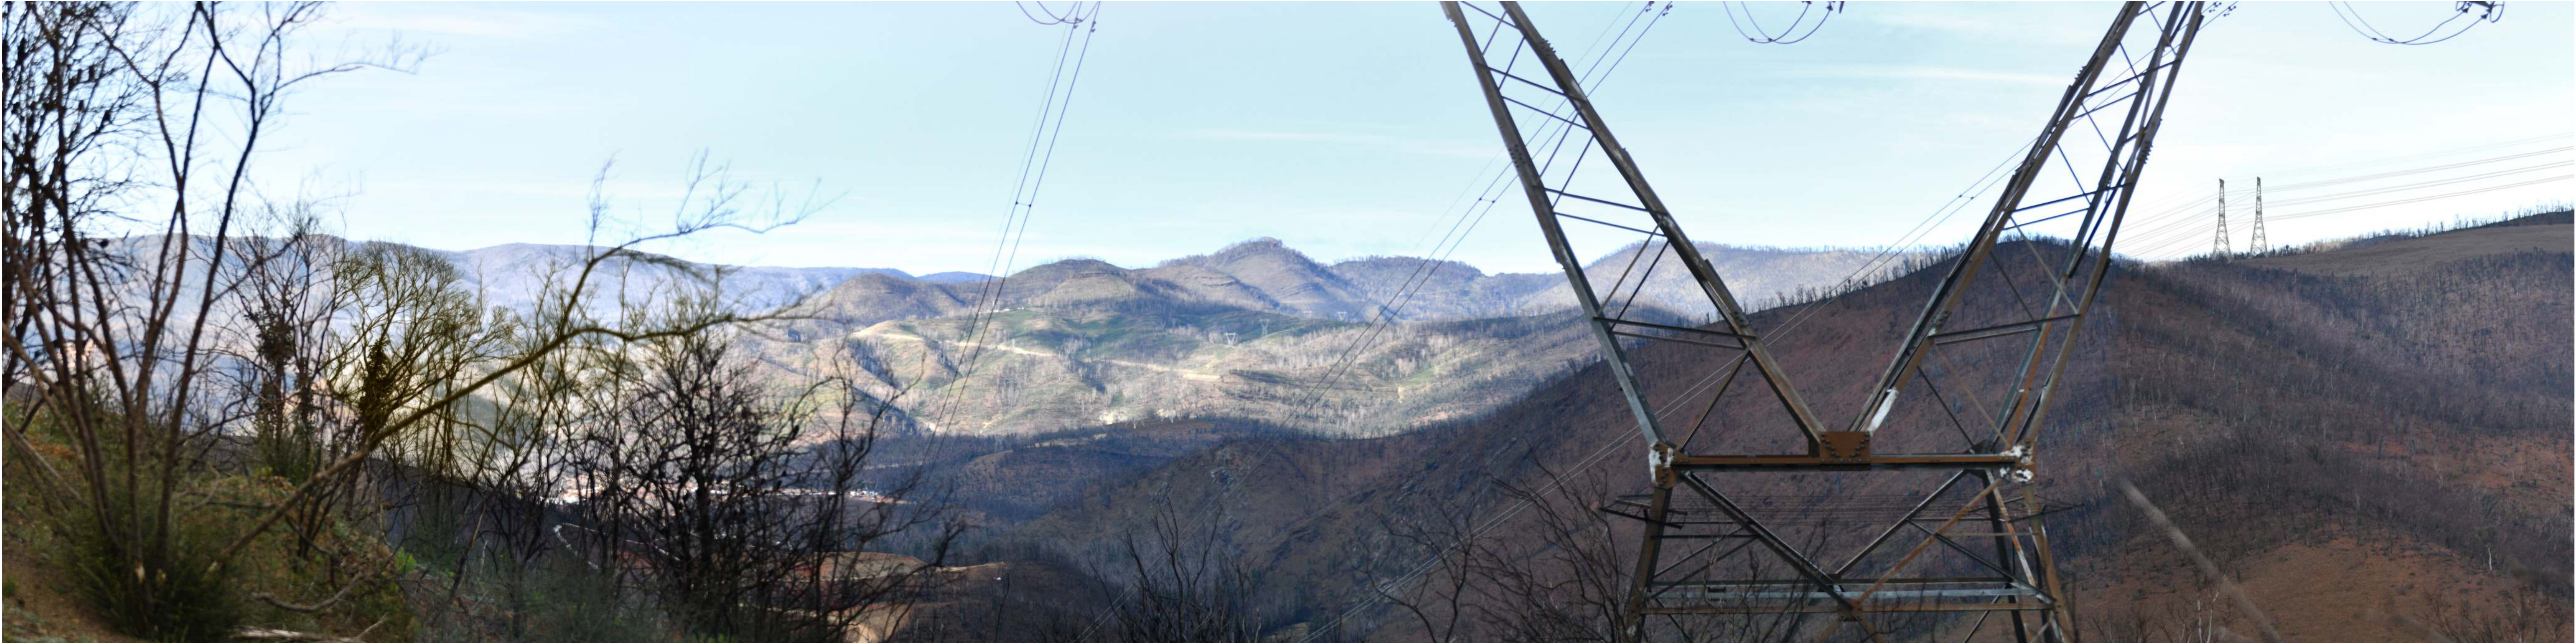
60 degree view looking south east to south

Existing view

Photomontage

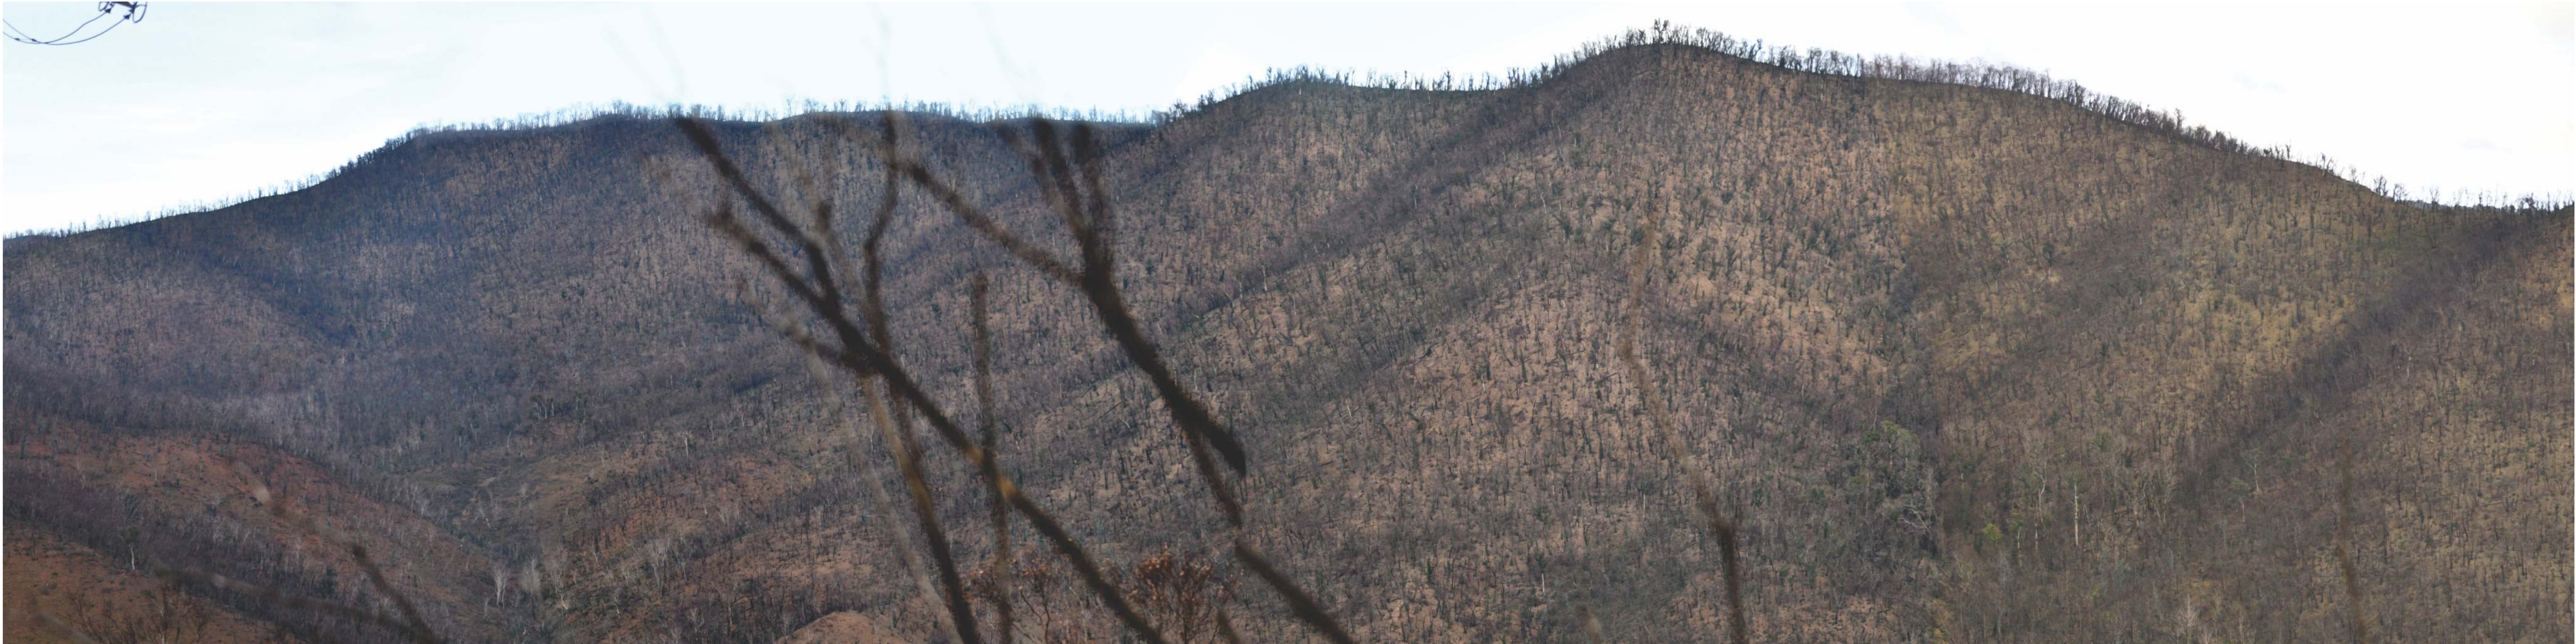
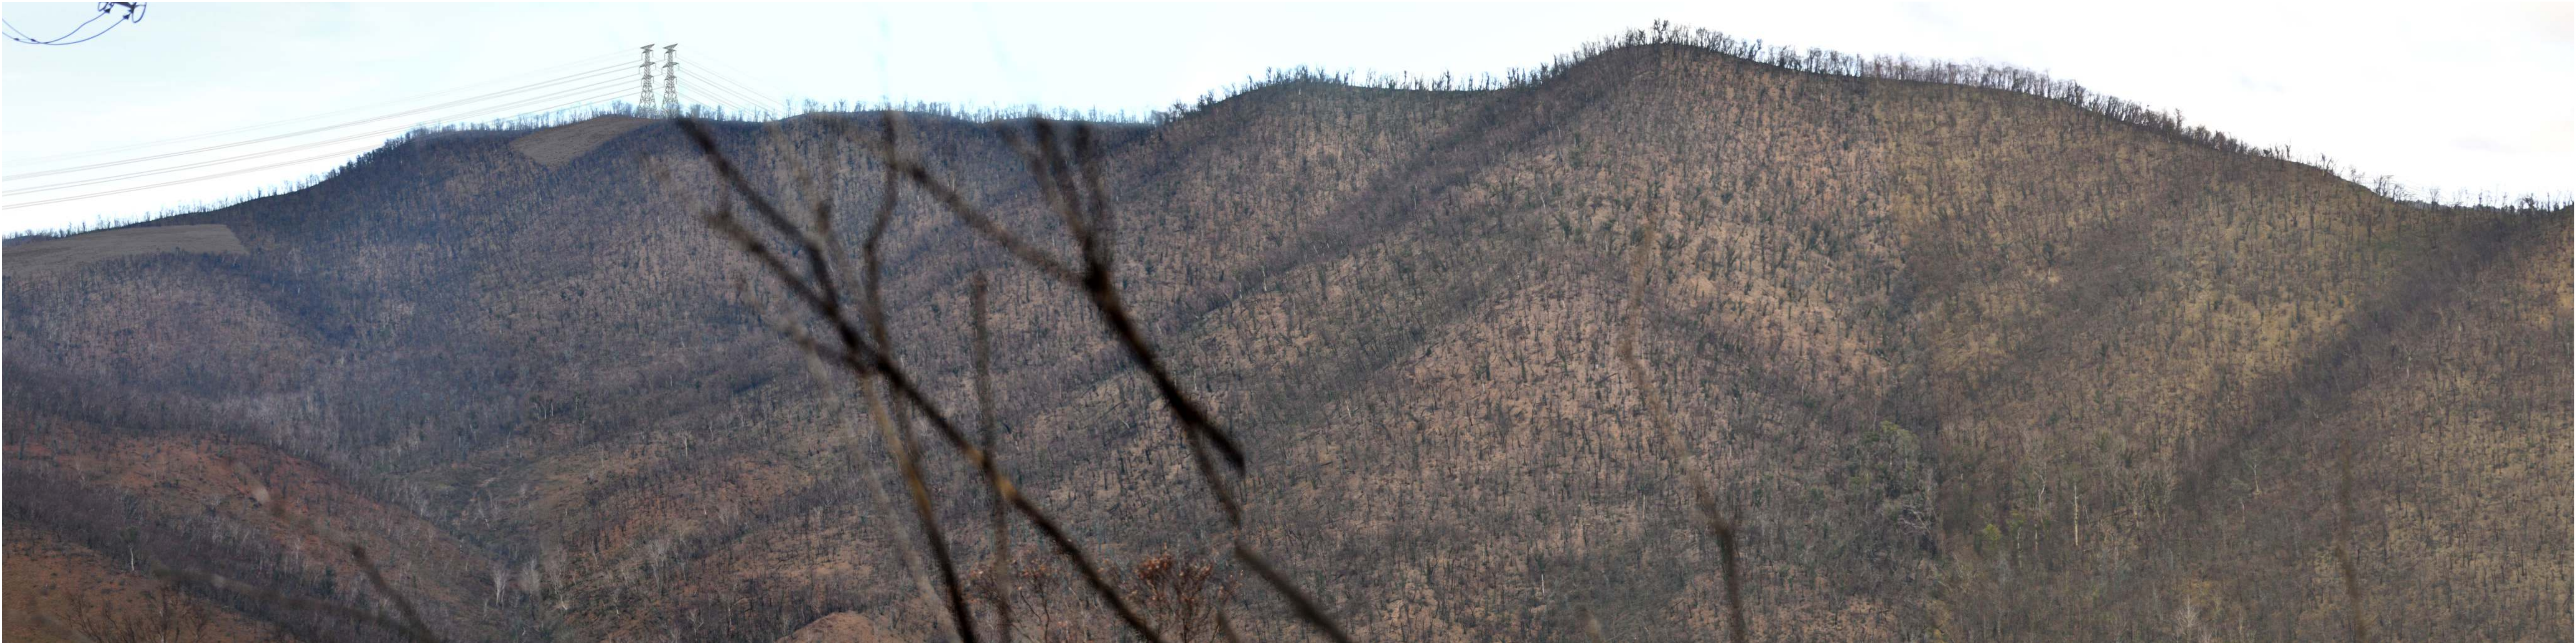
60 degree view looking south to south west

Existing view

Photomontage

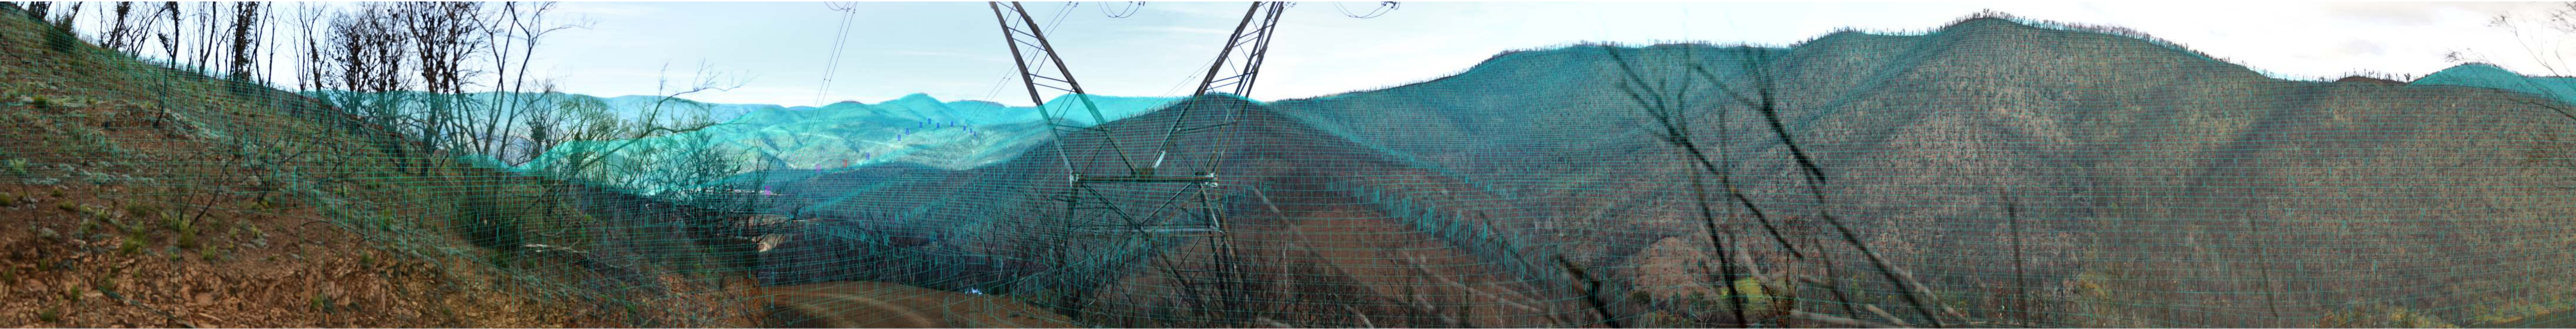
Existing view - wireframe

Wireframe view
