Appendix E Water Quality Monitoring Program

Snowy 2.0 Transmission Connection Project
(December 2021)

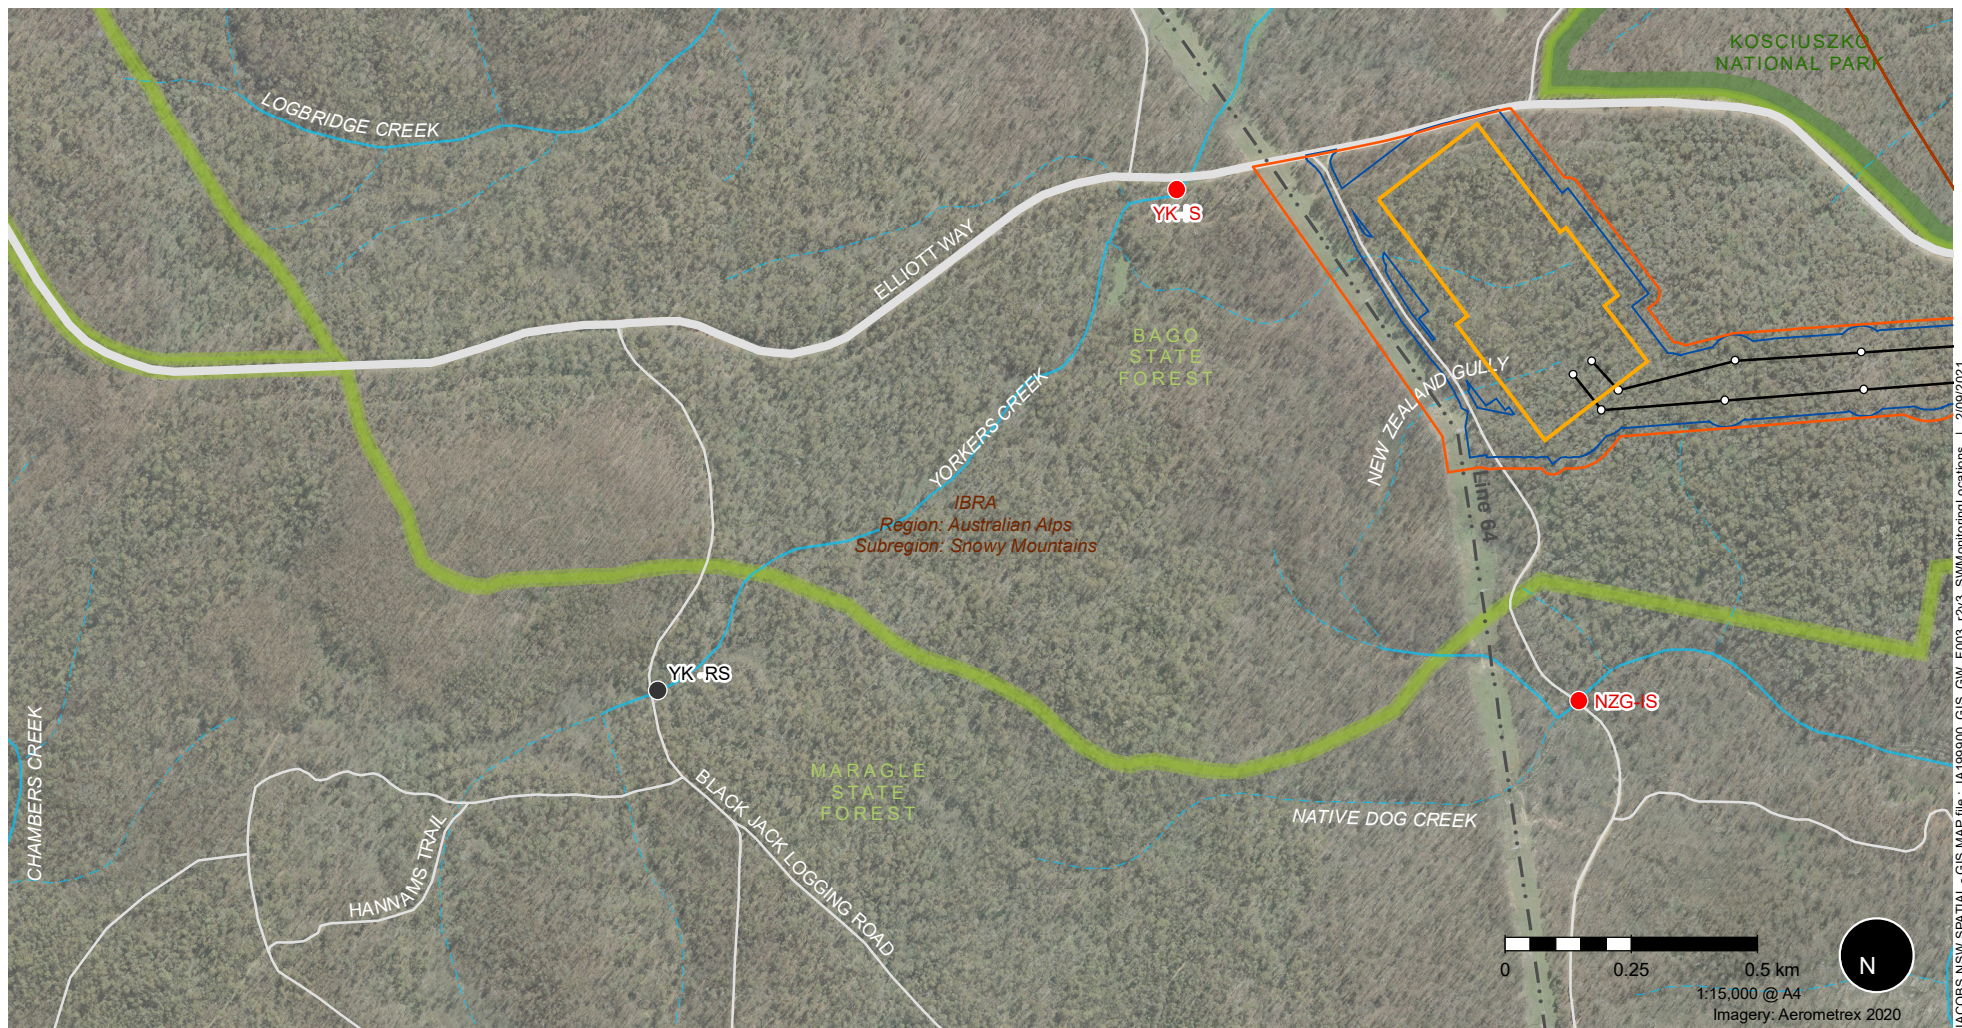
Figure A | Monitoring sites **Page 1 of 6**

Monitoring locations for surface water quality during pre-construction (baseline), construction and operation are shown in Table 3.2 and Figure A.

Sampling locations will be named according to Table 3-2 and it is proposed to sample a select number of reference sites (where possible) located upstream of project works as well as impact sites, being those that are downstream of the project works. Monitoring locations may be refined during initial investigations subject to site access and availability of water. In addition to the proposed sites in Table 3.2, monitoring sites (and data) sampled under the Snowy 2.0 Main Works will be utilised where relevant, particularly where they can act as a TARP site for the proposed monitoring sites.

Monitoring Site [^]	Site type	Monitoring nomenclature	Latitude	Longitude	Description and location details
Yorkers Creek upstream (u/s)	Reference	YK-RS	35°48'4.97"S	148°17'52.41"E	Reference site for Yorkers Creek and tributaries that have potential to be impacted by works downstream. Access via Black Jack Logging Road, off Elliott Way.
Yorkers Creek at Western end of alignment	Impact	YK-IS	35°47'32.34"	148°18'32.89"E	Access via Elliott Way.
Yorkers Creek downstream (d/s)	Impact	YK-IS (d/s)	35°46'57.41"S	148°19'12.47"E	Access via Brown Fire Trail (off Elliott Way) downstream of disturbance area and YK-IS
New Zealand Gully	Impact	NZG-IS	35°48'4.84"S	148°19'5.21"E	Access via unnamed road off Elliott Way
Tumut River u/s O'Hares Creek	Reference	TR-RS	35°49'58.49"S	148°21'41.10"E	Reference site for water quality downstream. Access via Goat Ridge Road
Lick Hole Gully u/s alignment	Reference	LHG-RS	35°48'4.43"S	148°23'40.44"E	Reference site of for Lick Hole Gully downstream of disturbance areas. Access via Lobs Hole Ravine Road.

Lick Hole Gully d/s alignment	Impact	LHG-IS	35°47'34.17"S	148°24'2.61"E	Downstream of disturbance area and proposed access track (option A). Access via Mine Trail
Sheep Station Creek	Impact	SSC-IS	35°47'14.32"S	148°23'27.46"E	Within disturbance area and proposed access track. Access via unnamed road of Lobs Hole Ravine Road.
Cave Gully	Impact	CG-IS	35°47'43.68"S	148°24'24.43"E	Within disturbance area and proposed access track. Access via Mine Trail.
Yarrangobilly River at alignment	Impact	YR1-IS	35°47'34.57"S	148°24'34.03"E	Adjacent to disturbance area and proposed access Road (option A). Access via Mine Trail.
Yarrangobilly River d/s alignment	Impact	YR2-IS	35°47'5.80"S	148°23'33.76"E	Downstream of disturbance area and proposed access Road (option A). Access via Lobs Hole Ravine Road.
Wallaces Creek	Impact	WC-IS	35°47'33.74"S	148°24'46.39"E	Within disturbance area. Access via Mine Trail
[^] Additional water quality monitoring points may be implemented in consultation with NWPS and BCS that are downhill of the construction footprint and upstream of the Booroolong Frog habitat.
