16 December 2025

Reference: 251075.01FA

**LETTER OF ADVICE RELATED TO THE  
WALKING DISTANCE ASSESSMENT  
AT 11 - 23 RANGERS AVENUE, MOSMAN**

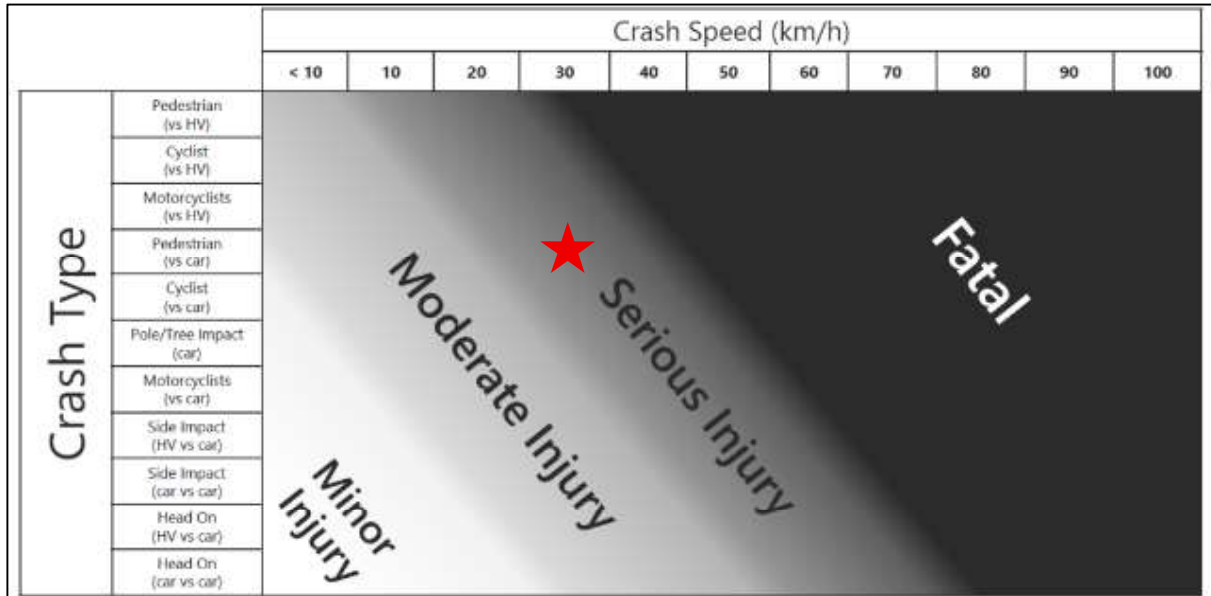
**FIGURE 2: SEVERITY GUIDANCE SHEET – AUSTRROADS**

Safe System crash outcome threshold

A vehicle would likely decelerate in anticipation of a pedestrian strike. It is reasonable to assume that at the point of impact, a vehicle would be traveling approximately 30km/h. As shown, in **Figure 3** an incident involving a pedestrian and a car at speeds between 30km/h can cause serious injuries. Although the incident may be rare, serious injuries indicate a **medium** risk level and exceeds the Safe System crash outcome threshold. Safety conscious planning is the term generally applied in the minds of accredited road safety auditors who are listed on the following website <https://www.roadsafetyregister.com.au>.

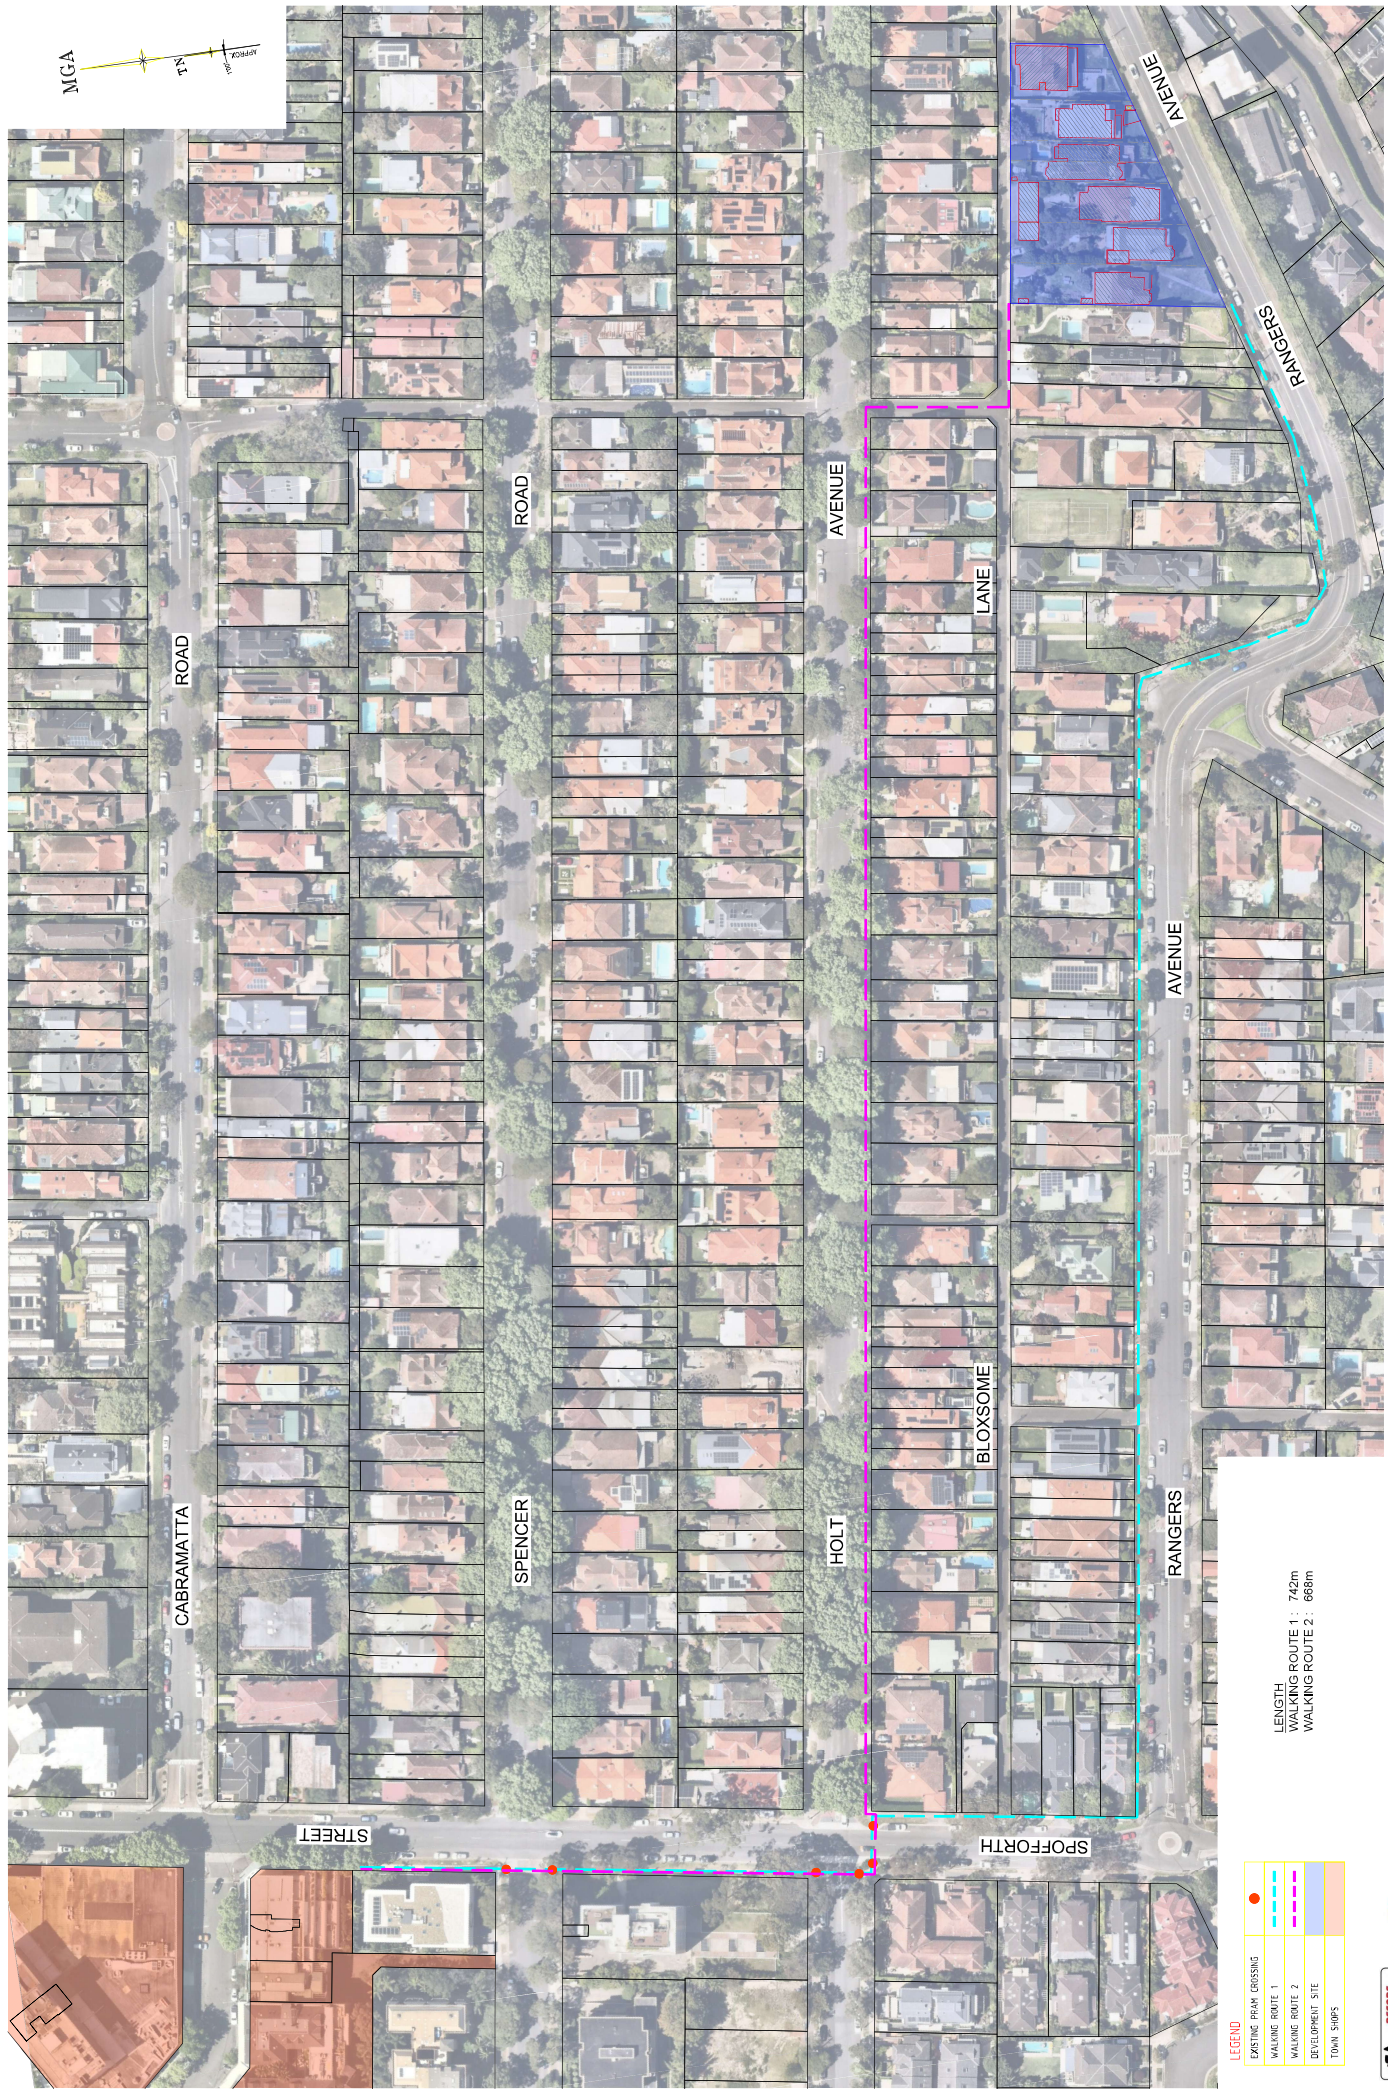
**ANNEXURE A: WALKING ROUTES  
(1 SHEET)**

LENGTH  
WALKING ROUTE 1 : 742m  
WALKING ROUTE 2 : 668m

LTS Surveyors undertook a survey on 11 November 2025 using high-accuracy GPS surveying equipment and physically verified on foot two (2) walking routes to determine the walking distance between the site and the Cremorne Town Centre (provided in **Annexure A**). The definition of “walking distance” under the SEPP Housing 2021 is below.

Both survey routes require pedestrians to cross Spofforth Street at the intersection of Holt Avenue, which the letter accompanying the survey describes as *residential streets with adequate pedestrian safety*. The Walking Route 1 is a distance of 742m, whilst the Walking Route 2 is 668m, which does not use footpaths for the entire length.

In accordance with the definition under the SEPP Housing 2021, Walking Route 2 does not use public footpaths as Bloxsome Lane and Bardwell Lane do not have adequate public footpaths and require pedestrians to walk with the carriageway of Bloxsome Lane and Bardwell Lane.

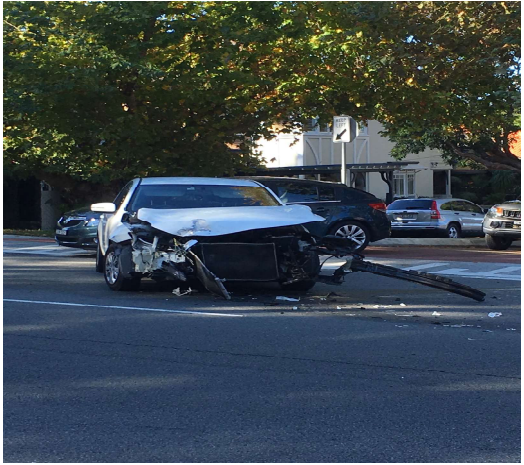
<b>2018</b>		
March 17, 2018 1pm	2 car crash	Ambulance, police, tow trucks
June 12, 2018 9pm	2 car crash	Car and van
June 24, 2018 2pm	2 car crash	Tow truck in attendance
July 2, 2018 4:40pm	2 car crash	
September 13, 2018 3:45pm	2 car crash	
September 14, 2018 4pm	2 car crash	
December 3, 2018 3pm	2 car crash	Car attempting right turn into Holt eastbound. Panel damage - no polic
<b>2019</b>		
February 2, 2019 8:50pm	2 car crash	
May 6, 2019 2pm	2 car crash	Head on collision

May 8, 2019 4pm	2 car crash	No police involved.
May 11, 2019 4pm	2 car crash	Car was attempting to traverse across Spofforth from Holt when it was hit by a vehicle heading northbound on Spofforth.
July 11, 2019 10am	2 car crash	Car was attempting to traverse Spofforth from Holt Ave. Tow away.

The intersection of Holt Avenue & Spofforth street is a location with frequent vehicle accidents. This is a record of **accidents witnessed and reported by residents to Harrison Precinct** but there may be many more which were not observed particularly during weekdays.

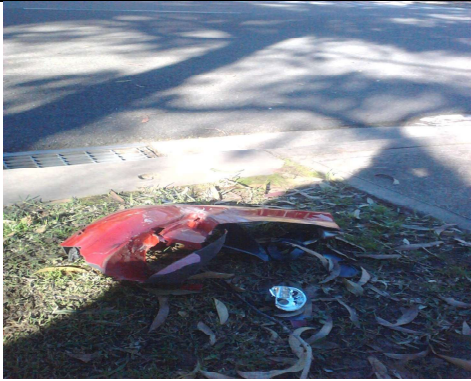
October 5, 2019 7:30am	2 car crash	Corner of Holt Ave and Spofforth St.

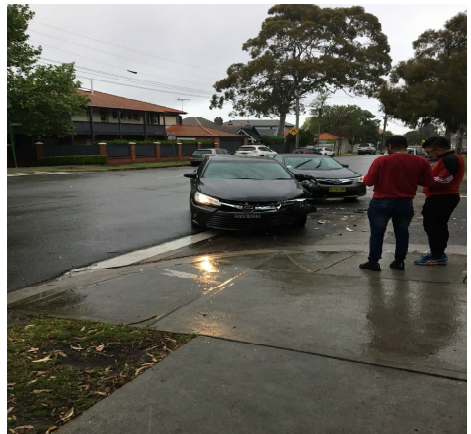
October 17, 2019 12pm	2 car crash	Subaru Foster and white Barina – ambulance arrived. No photo.	
October 18, 2019 1:30pm	2 car crash	T-bone accident on Spofforth – vehicle traversing from Holt Ave.	
October 19, 2019 5:30pm	2 car crash	Corner of Holt and Spofforth – Police and Fire brigade.

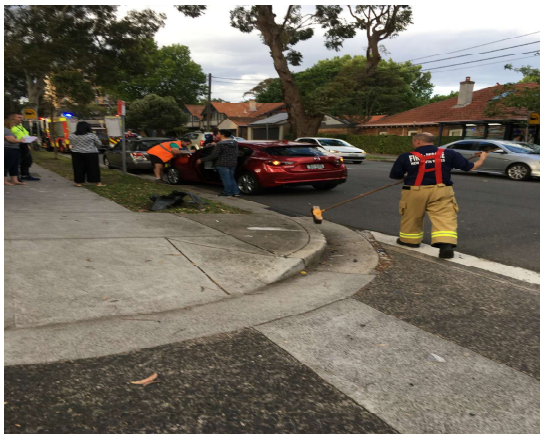
October 24, 2019	Cyclist + car	Cyclist traveling inside of stationary traffic south on Spofforth clipped by taxi turning right onto Spofforth from Holt	
November 15, 2019	2 car crash	T-bone accident. No photo.	
November 16, 2019	2 car crash	T-bone accident.

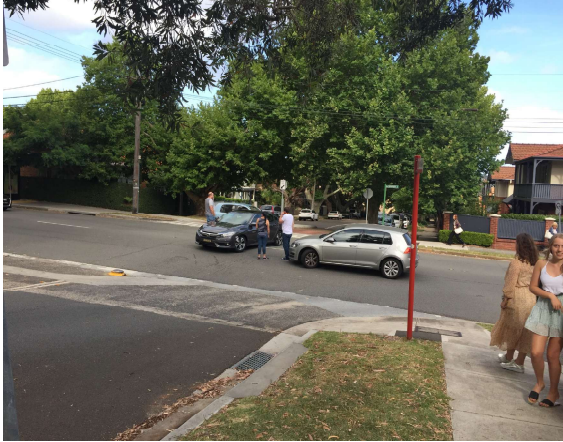
<p><b>2020</b></p>		
<p>January 23, 2020</p>	<p>Single car</p>	<p>Taxi with flat tyres - caused by hitting "silent cop" (now removed) at center of Holt Ave.</p>

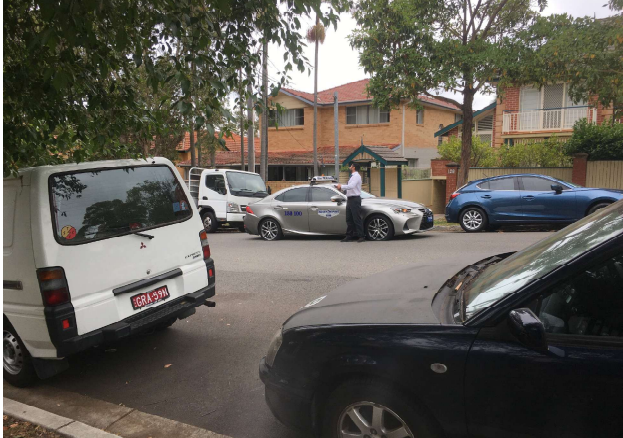
<p>February 27, 2020</p>	<p>Single car</p>	<p>Accident corner of Cabramatta Road &amp; Spofforth - vehicle lost control, mounted footpath, hit a pole and tree at the corner of Cabramatta Road.</p>

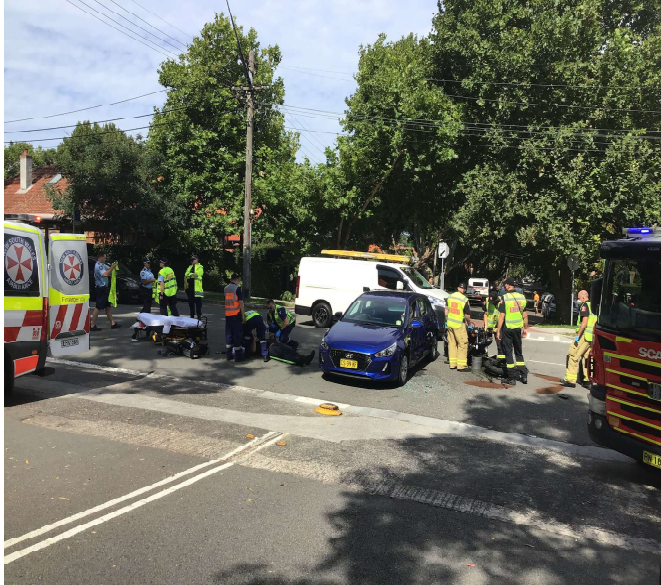
January 22, 2021	Single car	<p>Car crash on Holt Ave - outside 140 Holt Ave            Residents reported vehicle being driven at high speed northbound towards Military Road            Car extensively damaged.</p>
<b>2022</b>		
July 24, 2022	2 car crash	<p>T-bone crash. Extensive damage to both vehicles.</p>

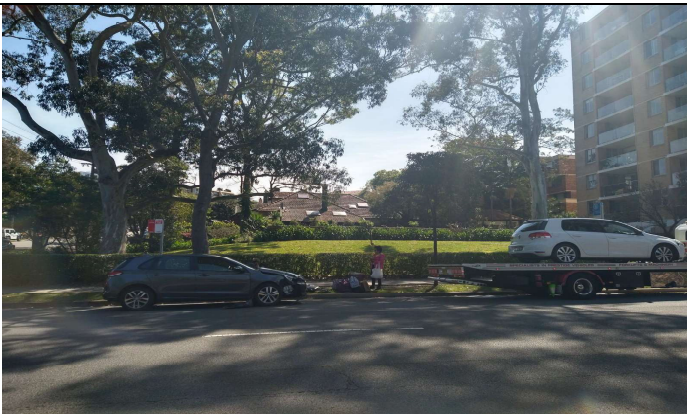
<p>September 10, 2022 1:30pm</p>	<p>3 car crash</p>	  <p>The first photograph shows a blue hatchback car parked on a street. The rear left side of the car is heavily damaged, with significant crumpling and paint loss. Three people are standing behind the car, looking at the damage. The second photograph shows the same blue hatchback car from a front-three-quarter view. The front end is severely damaged, with the hood crumpled and the front bumper missing. The driver's side door is open. The car is parked on the side of a street with other vehicles and buildings in the background.</p>
<p>October 3, 2022 2:33pm</p>	<p>2 car crash</p>

<p>A photograph showing a dark-colored car being towed by a white tow truck on a residential street. The car is positioned on the tow truck's bed. The street is lined with large trees and a multi-story apartment building is visible in the background.</p>

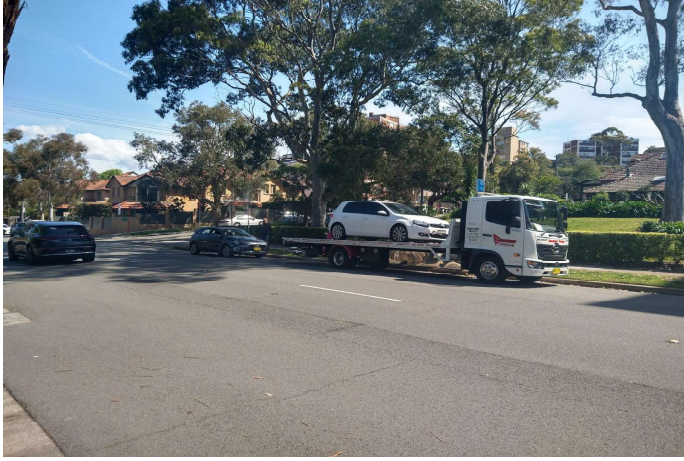
<b>2023</b>		
<p>November 28, 2023 10:57</p>	<p>2 car crash</p>	<p>Reported by Cathy to to mayor, r.bendall, p.friedrich, s.hughes, s.menzies, l.moline, m.randall</p> <p>Police and ambulance in attendance.</p>
<b>2024</b>		
<p>February 6, 2024 9am</p>	<p>3 car crash</p>	<p>Holt ave intersection of Spofforth. Victim stated she was hit whilst turning right out of Holt on the Mosman side - the car was seriously damaged. Police in attendance.</p>

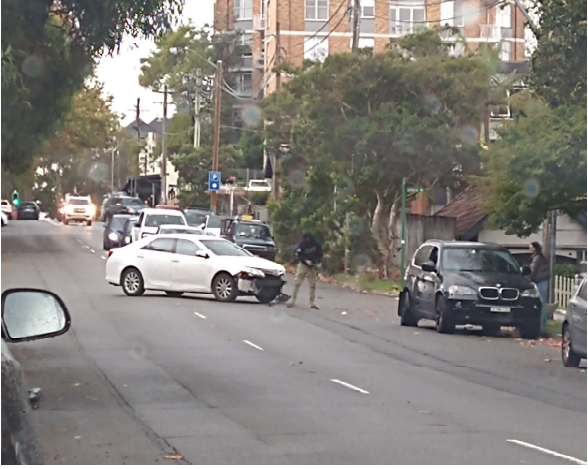
<p>September 2, 2024 9am</p>	<p>2 car crash</p>	<p>Resident reported: I just heard on the ABC traffic report about a big crash this morning causing traffic delays on Military Rd. I didn't see/hear anything although when I went outside to put my garbage out at 9am I saw a tow truck with a smashed up black BMW 4-wheel drive on it.</p>
<p>November 9, 2024 4:30pm</p>		<p>Serious accident at the intersection of Holt Ave and Spofforth St. Ambulance, Fire Brigade and Police were in attendance.</p>

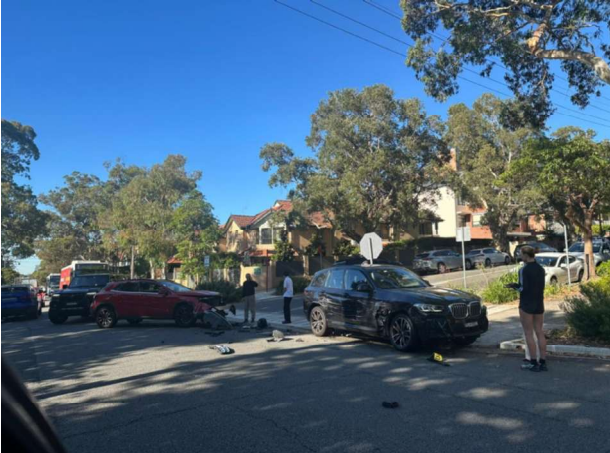
2025		
<p>October 27, 2025 9:45pm</p>	<p>3 car crash</p>	<p>T-bone collision. Main damage was to a late model sports Mercedes which was undriveable due to damage to the front and passenger side. No police were in attendance and no one was physically injured.</p>
<p>November 19, 2025 Approximately 8am</p>	<p>2 car crash</p>	<p>Intersection of Holt Avenue and Spofforth St.</p>
