Submission on behalf of:

Moree Gun Club 157 Back Pally Rd Moree

Narrabri to North Star Phase 2 EIS

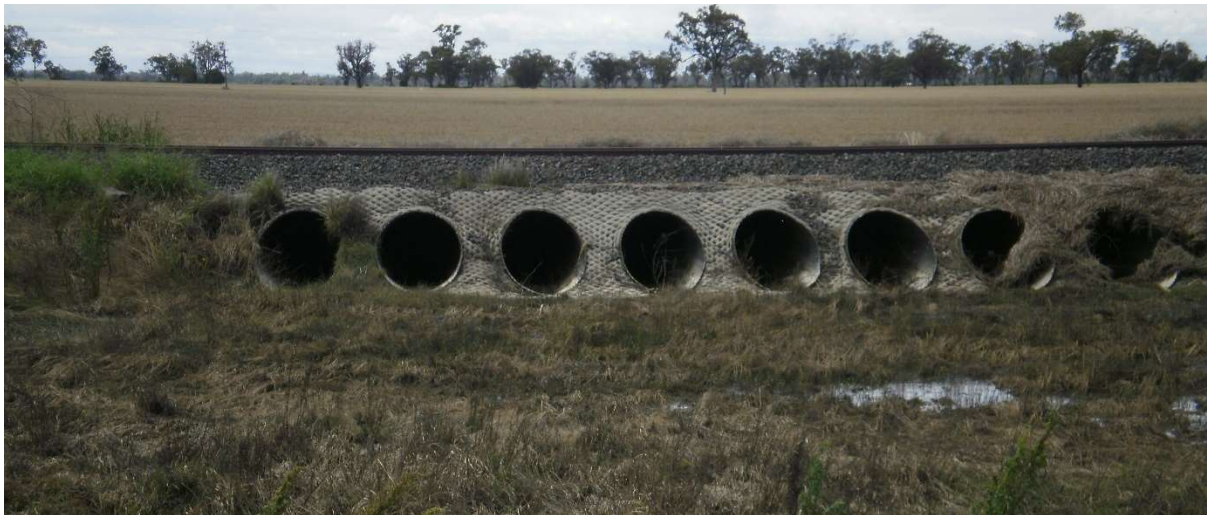
P1

During the seventies, a number of developments occurred, including several floods 1971, 1974 and 1976 a major event. Irrigation also came to the valley and with it the construction of two supply channels to our west. The wooden culverts on the rail line were replaced with corrugated steel pipe culverts, see P1* below, during an upgrade which also included elevating the line to its current height. The capacity of these structures is in no way matched to what preceded them.

- *Example of a culvert of similar design. This structure is blocked and north of town on the southern side of the Gwydir river (Nov 22)*

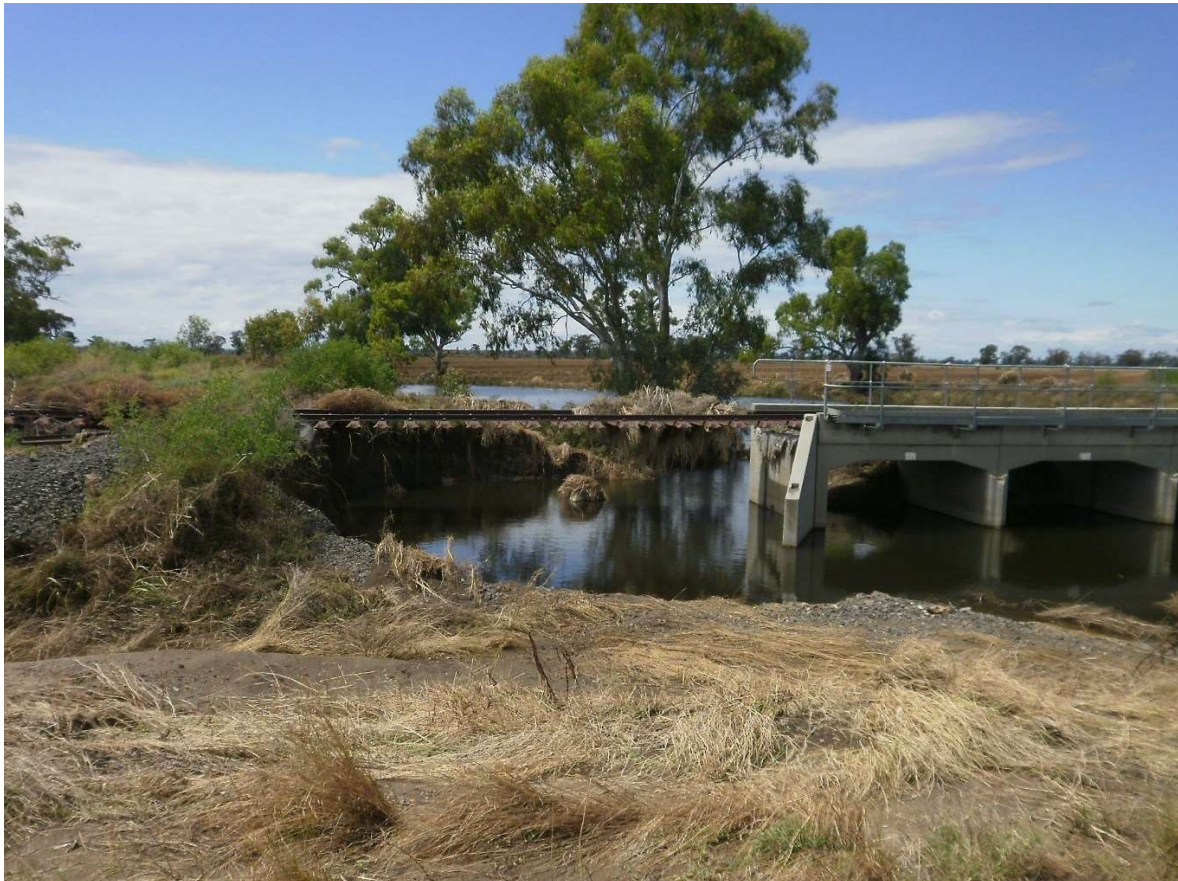
On the southern side of the river the railway line has sustained massive damage as shown in the following sequence of photo's P2 – P5. I have included them to show what happens to a bank of any construction which is suddenly subjected to substantial hydraulic head and then overtopped. Despite the culvert system on this side of the river also currently inadequate to handle more recent events, this event was exacerbated by a windrowed canola crop floating into and blocking the structures.

Culvert north of P1 “A more recent upgrade and current design”

Like P1 this culvert also became substantially blocked prior to this failure. The following three photos are of line sections between these two structures and represent but a small sample of the damage sustained in this location.
