# ANALYSIS: SUMMARY

# PARK SPACES: EAST PLAN: CYCLEWAY - OPTION A

## PARK SPACES: EAST PLAN: CYCLEWAY - OPTION B

# PARK SPACES: EAST

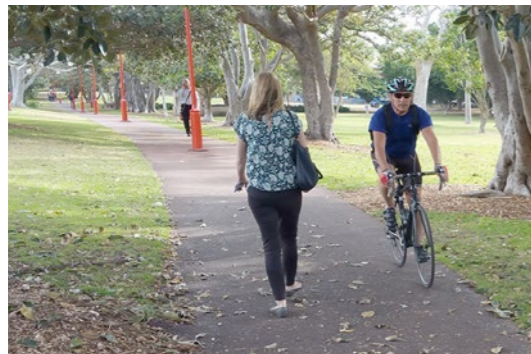
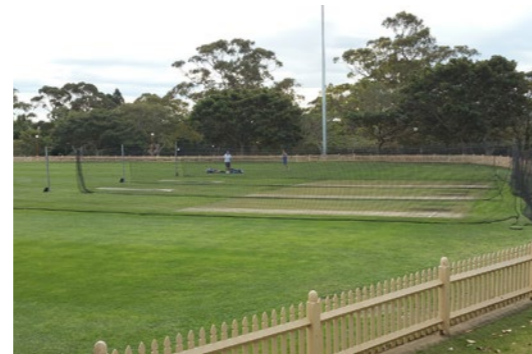
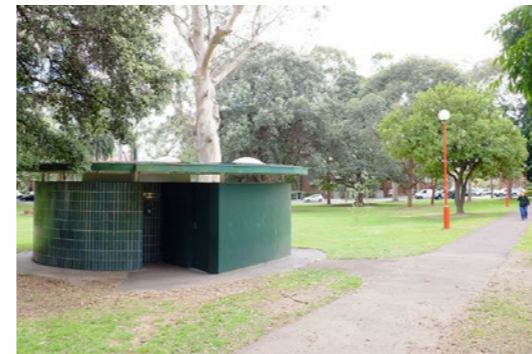
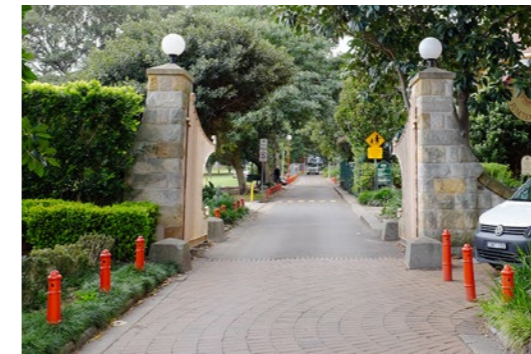
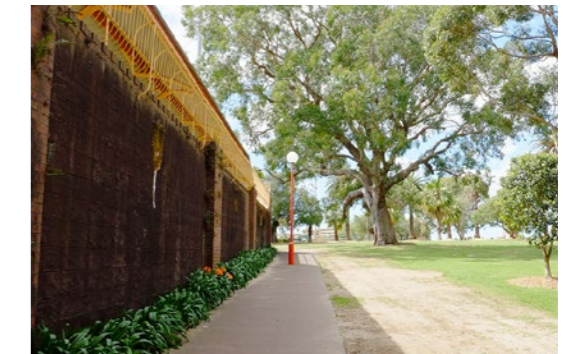
## ISSUES

- Lamp posts are hindering circulation due to their central placement on some pathways
- Conflict between vehicles, pedestrians and cyclists on Fig Tree Lane
- Conflict on internal pathways between pedestrians and commuter cyclists

- Very high usage
- Conflict between certain users
- Commuter cyclists using the park as a thoroughfare
- Practice wicket is not currently of a 1st grade standard
- Children's playground caters to a limited age-range
- Restricted use of Music Shell lawn, particularly for events due to stormwater drainage issues in that location

- Public toilets in the west of the park are dilapidated and are in need of an upgrade
- Seating is dated and not frequently located
- Lack of seating choice
- Lighting is located in the middle of already narrow pathways and are visually obtrusive
- Noise and visual impact of traffic, particularly on the Falcon St edge
- Lawn maintenance issues with the lawn under the figs in the south western corner of the park due to the dense canopies and low light levels
- Ponding of water in the north-western corner and regular flooding of the Music Shell during high rainfall events

- Items from the 1980's upgrade of the park often clash with the heritage character of the park
- Clutter is having a negative visual impact
- Materiality is worn out and in need of repair in many locations. e.g. Asphalt pathways throughout the park is worn along the edges, park furniture is dated.

- The North Sydney Oval complex is hindering movement and visual connections throughout the park
- Wall surrounding the North Sydney Oval complex is visually undesirable
