Documentation Supporting an Application for a Site Verification Certificate

Bowdens Silver Project

August 2017

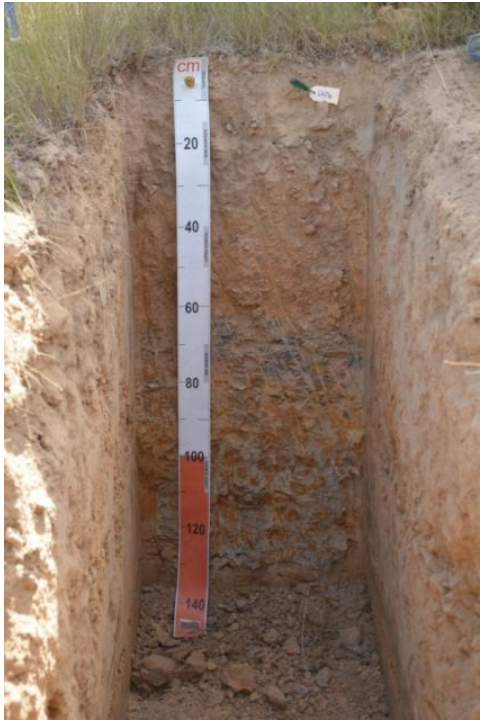
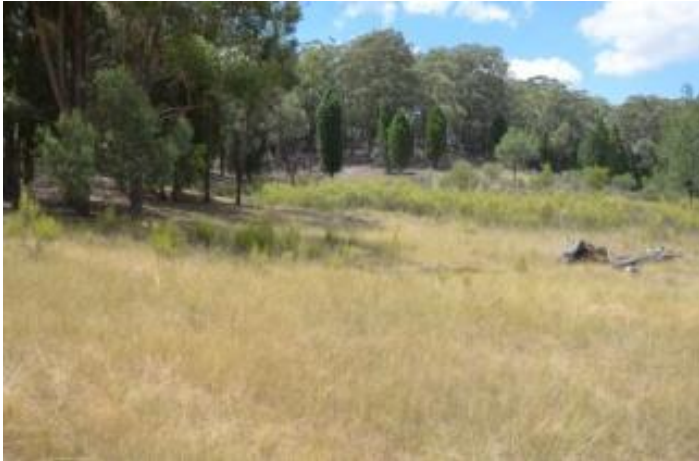
Soil Test Pit 47B	Landscape view, soil test pit 47B
Australian Soil Classification	Kurosol
Representative Soil Test Pits	47B, 49, 54
Dominant Slope Association	>10%
Land Use	Grazing
Soil Fertility	Low to moderately low
BSAL	No

Site Description - Kurosol

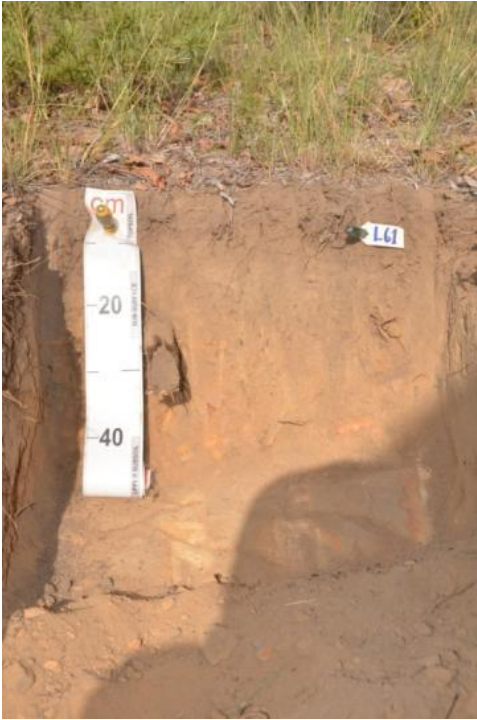
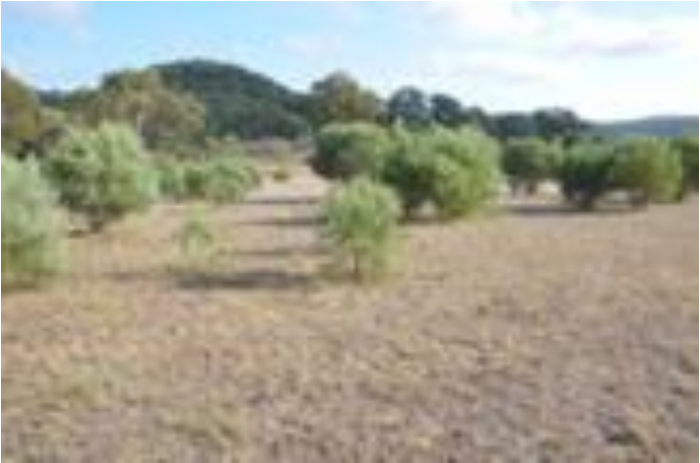
Soil Test Pit 61	Landscape view, soil test pit 61
Australian Soil Classification	Tenosol
Representative Soil Test Pits	60A, 61
Dominant Slope Association	<10%
Land Use	Grazing
Soil Fertility	Low
BSAL	No

Site Description - Tenosol

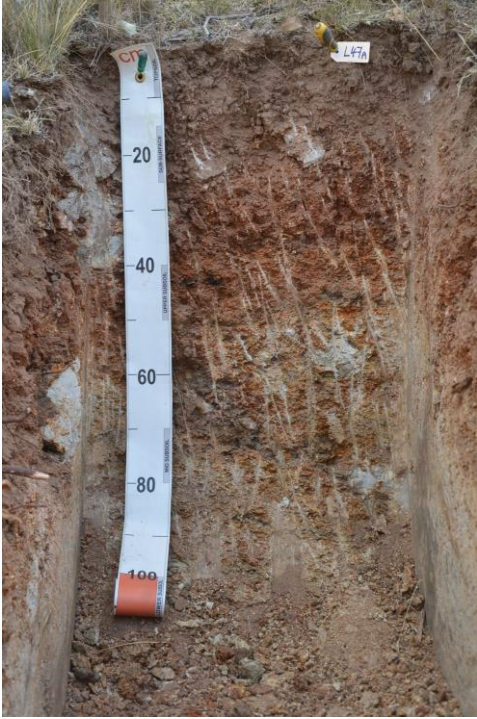
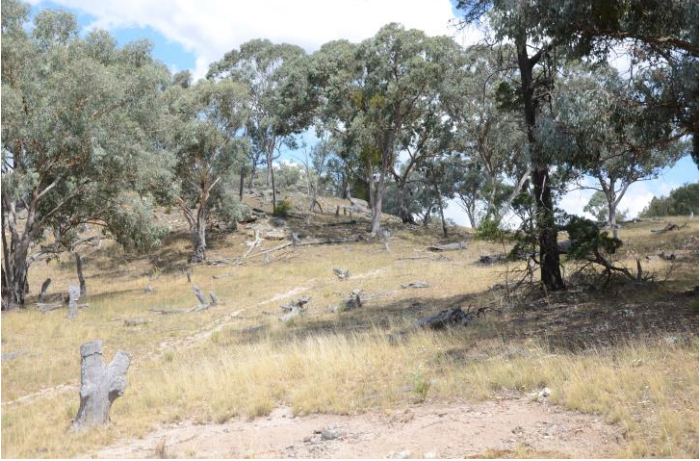
Soil Test Pit 47A	Landscape view, soil test pit 47A
Australian Soil Classification	Chromosol
Representative Soil Test Pits	47A, 59, 64, 67
Dominant Slope Association	>10%
Land Use	Grazing
Soil Fertility	Moderately high - low
BSAL	No

Site Description - Chromosol

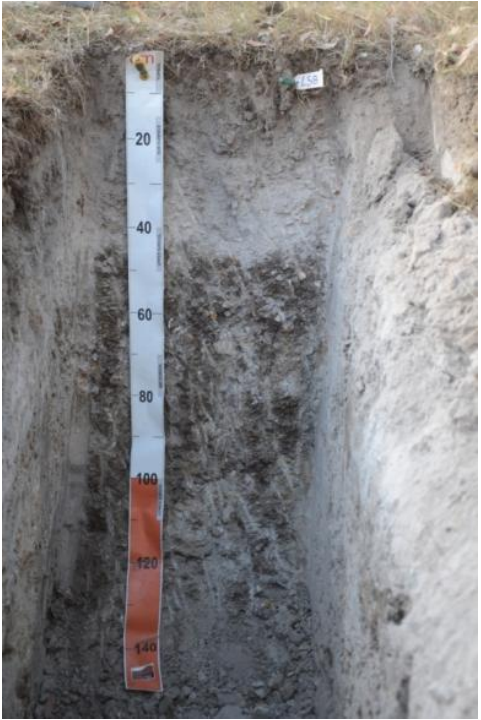
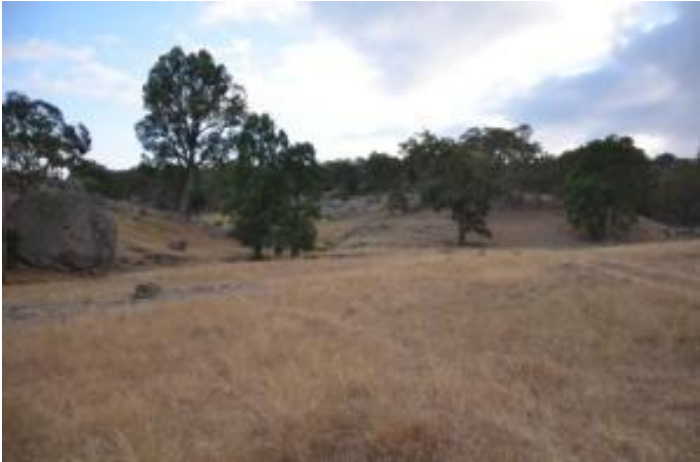
Soil Test Pit 58	Landscape view, soil test pit 58
Australian Soil Classification	Kurosol
Representative Soil Test Pits	52, 53, 56, 57, 58, 65, 66, 71, 72, 73, 74, 78, 79, 82, 86
Dominant Slope Association	<10%
Land Use	Grazing
Soil Fertility	Moderately high - low
BSAL	No

Site Description - Kurosol

- Sites 52 and 82 were the only soil test pits from ‘Acid volcanic-gentle slope’ Soil Landscape Unit that could be classified as BSAL however the remaining 10 soil test pits of this Soil Landscape Unit did not meet BSAL criteria.

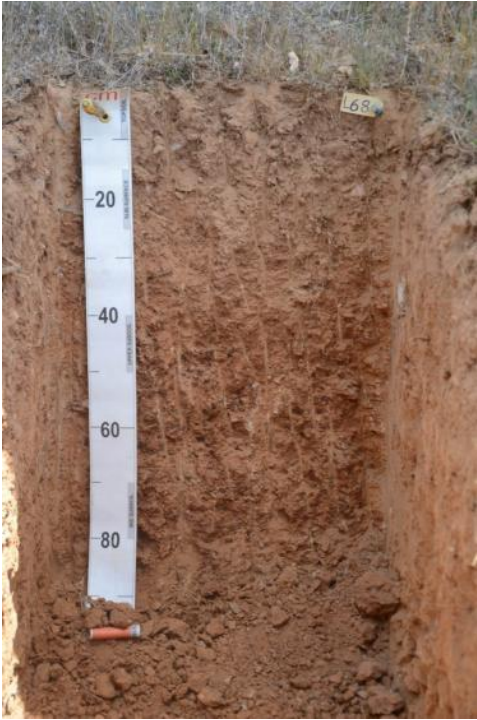
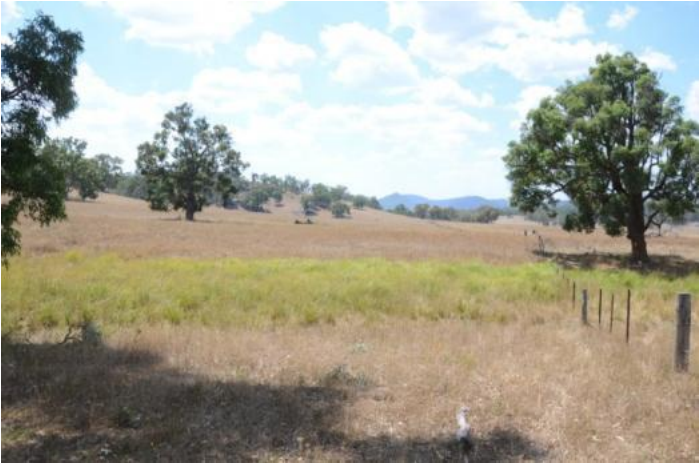
Soil Test Pit 68	Landscape view, soil test pit 68
Australian Soil Classification	Dermosol
Representative Soil Test Pits	68, 76 and 81
Dominant Slope Association	<10%
Land Use	Grazing
Soil Fertility	Moderately high
BSAL	No

Site Description - Dermosol

- Site 68, was the only soil test pit from the ‘Ordovician shale’ Soil Landscape Unit which met the BSAL criteria, however, this Soil Landscape Unit is not classified as BSAL as two of the three soil test pits were non-BSAL due to the presence of rock at depths less than 75cm.

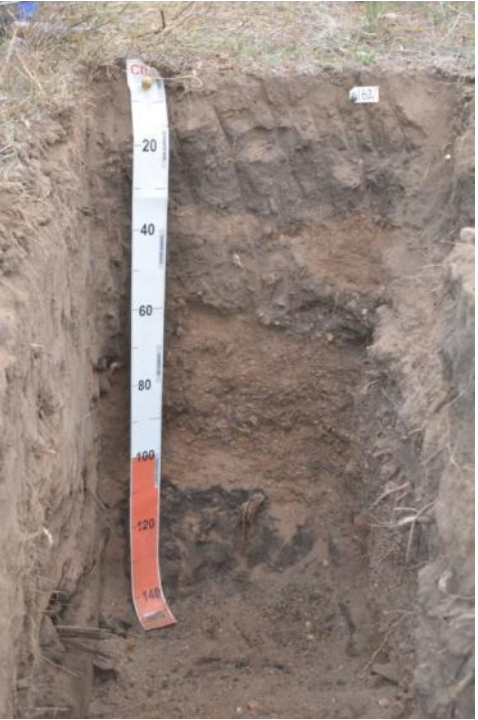
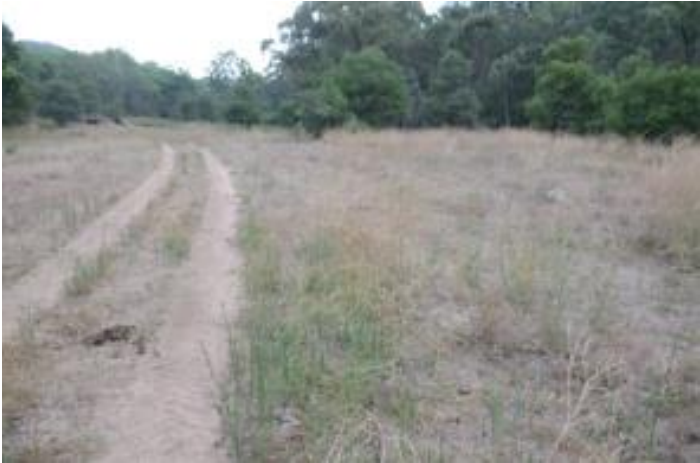
Soil Test Pit 62	Landscape view, soil test pit 62
Australian Soil Classification	Stratic Rudosol
Representative Soil Test Pits	51, 55 and 62
Dominant Slope Association	<10%
Land Use	Grazing
Soil Fertility	Moderately low
BSAL	No

Site Description – Stratic Rudosol

- Soil test pits 51, 55 and 62 of the ‘Alluvium-high quality’ Soil Landscape Unit were classified as non-BSAL as this unit was identified as being a “Stratic Rudosol” under the Australian Soil Classification. The Interim Protocol considers “Stratic Rudosols” as being non-BSAL however, should this soil type ever be considered “moderate or higher” fertility” under the Interim Protocol (**Appendix 2**) interpretation of the Australian Soil Classification, this Soil Landscape Unit would remain classified as non-BSAL as it covers an area which fails to meet the minimum 20ha BSAL threshold.

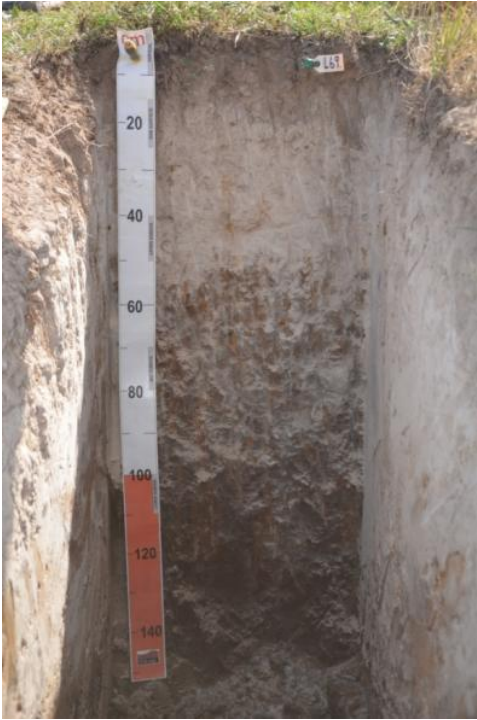
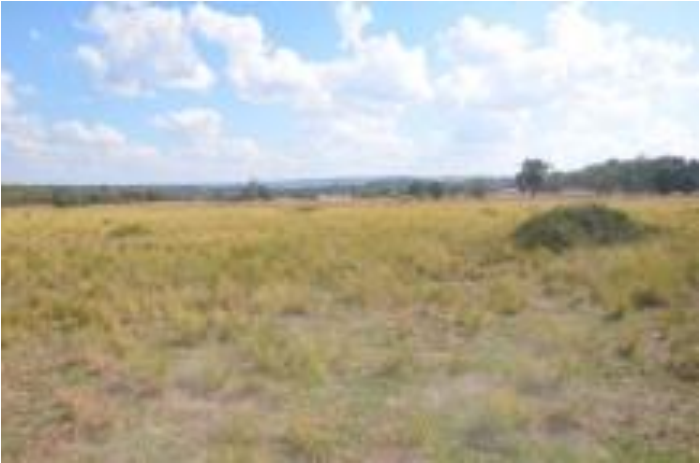
Soil Test Pit 69	Landscape view, soil test pit 69
Australian Soil Classification	Chromosol
Representative Soil Test Pits	69, 80
Dominant Slope Association	<10%
Land Use	Grazing
Soil Fertility	Moderately high
BSAL	No

Site Description - Chromosol

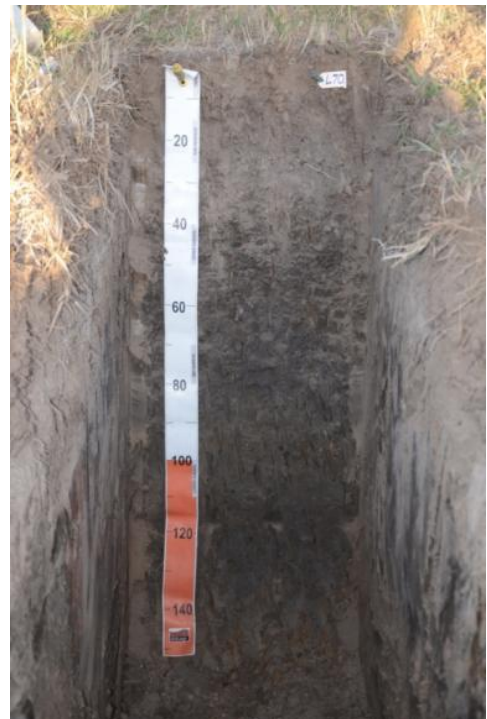
Soil Test Pit 70	Landscape view, soil test pit 70
Australian Soil Classification	Sodosol
Representative Soil Test Pits	70, 77
Dominant Slope Association	<10%
Land Use	Grazing
Soil Fertility	Moderately low
BSAL	No

Site Description - Sodosol
