Sydney Water Modifications to the Picton Sewerage Scheme

Aboriginal Heritage Due Diligence Assessment

April 2011

**Report prepared for Parsons Brinckerhoff on behalf of
Sydney Water Corporation**

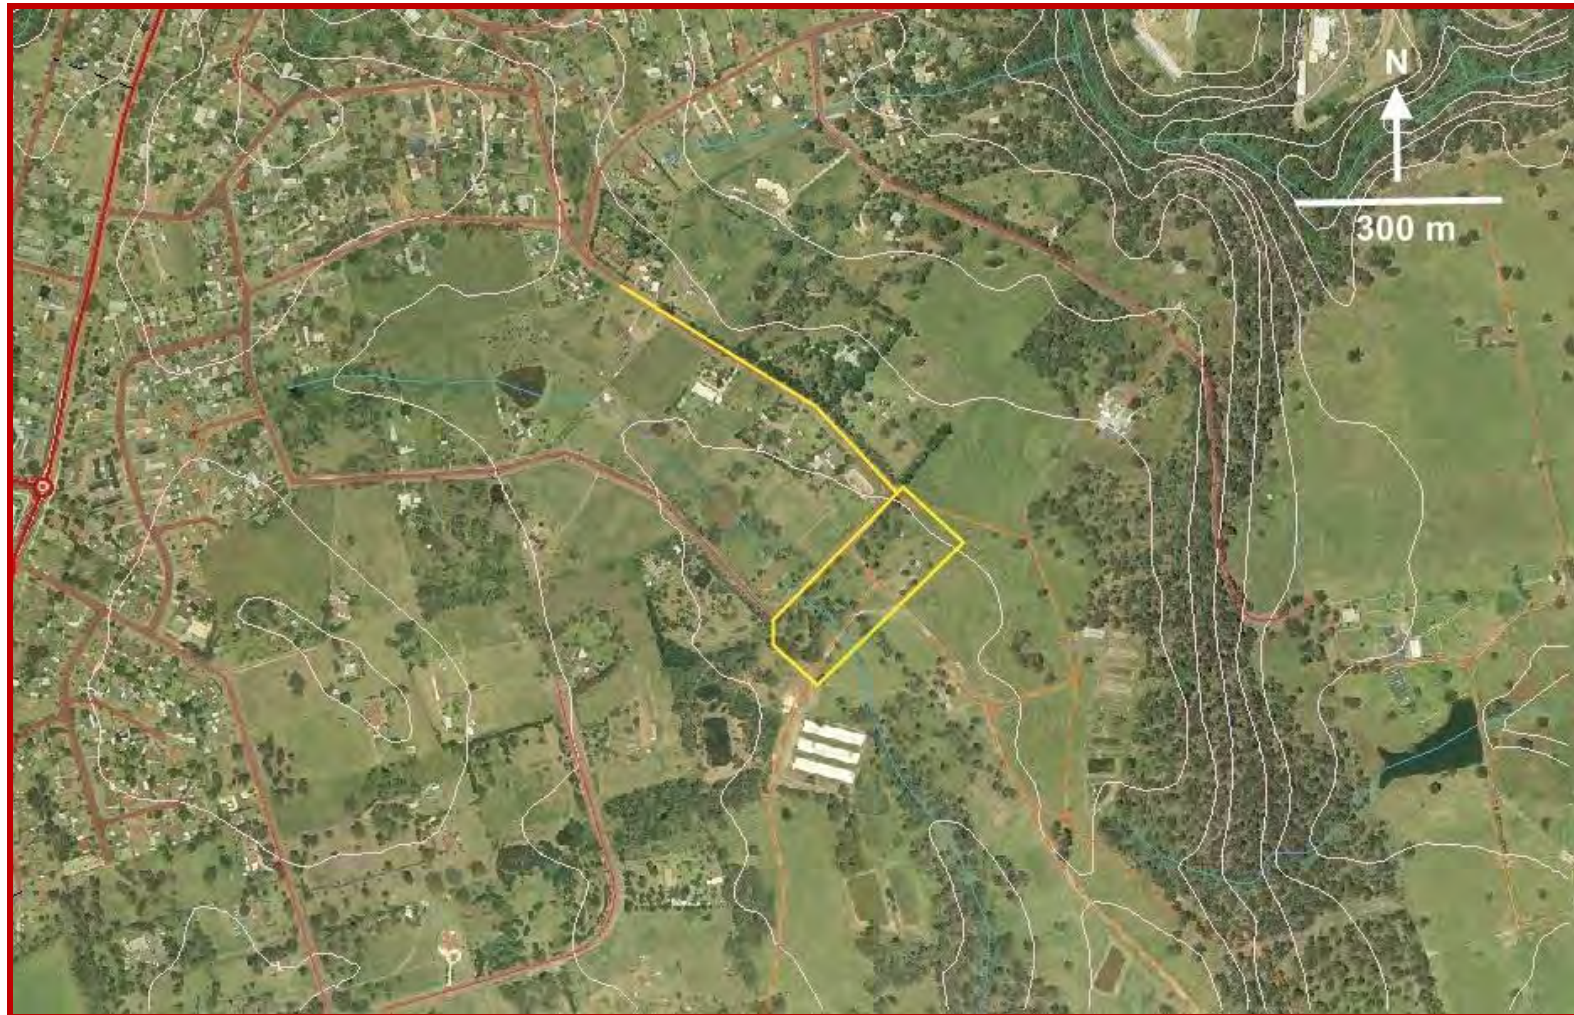
Study Area A encompasses a swamp flat and lower to mid-slope (Figure 3-2, Appendix 3). It slopes upwards from a swampy area in the southwest to northeast at a gradient of

Figure 3-2. Topographic map showing landform in Area A (outlined in yellow).

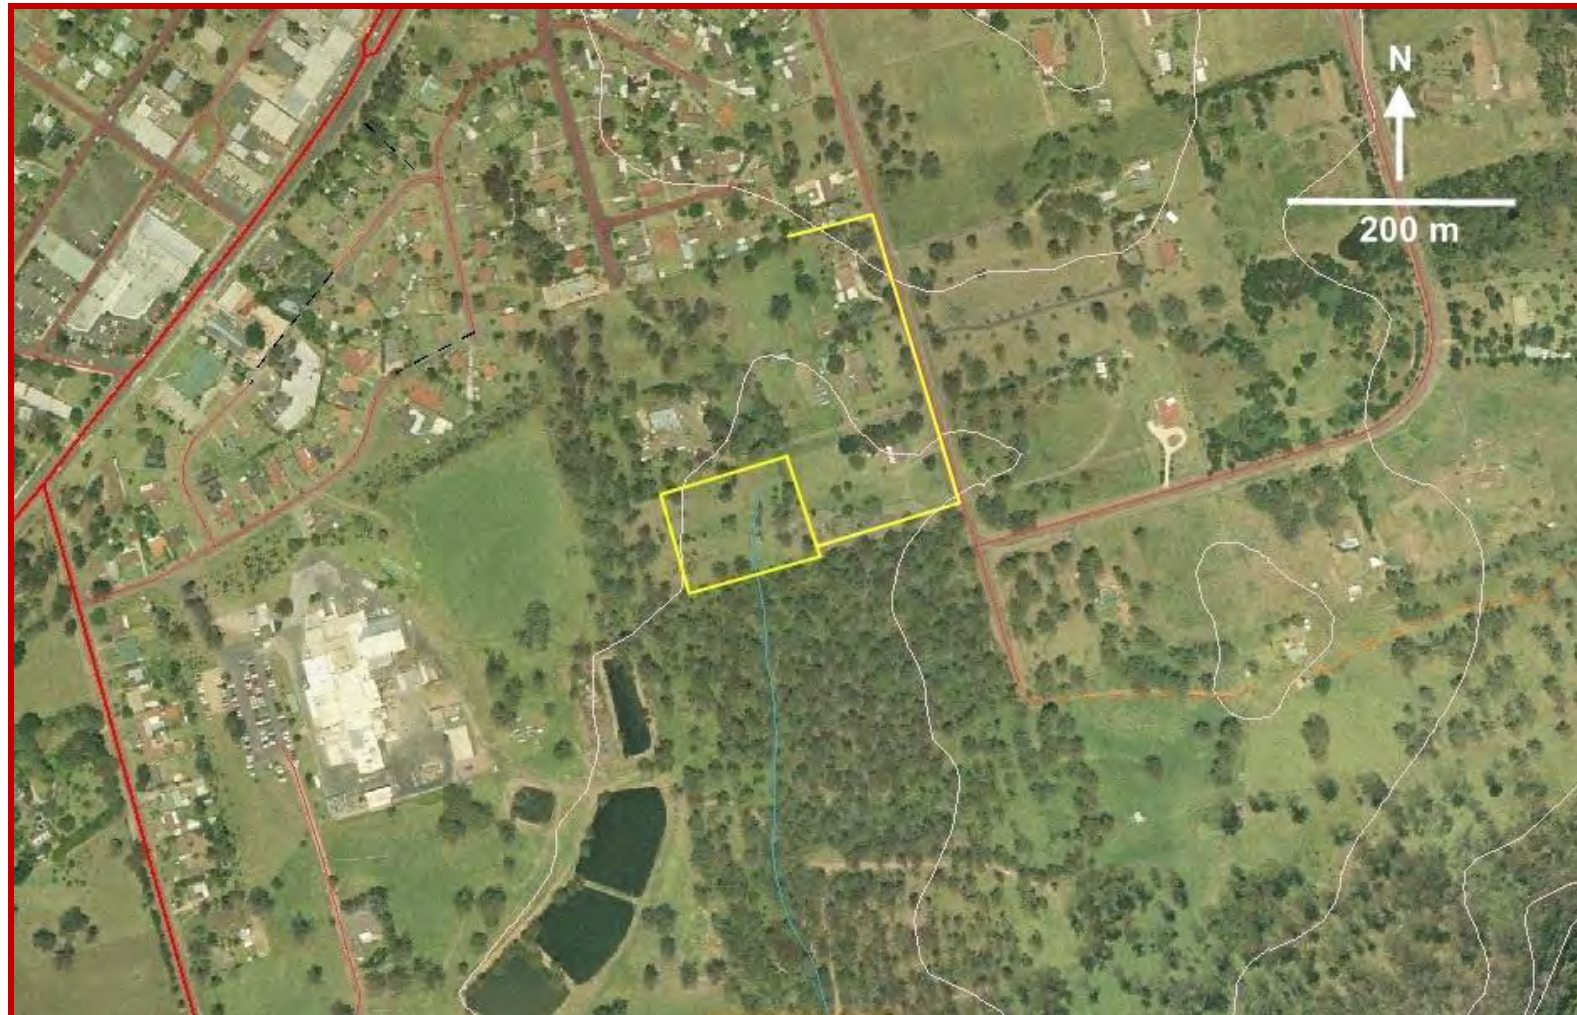
Study Area B consists of a gentle lower slope bisected by a small (<1 m across) ephemeral creek-line (**Figure 3-3, Appendix 3**). The site slopes upwards away from the creek-line in both directions at a gradient of no more than 5 degrees. The nearest permanent water source is a tributary of the Nepean River some 770 m to the southeast.

Figure 3-3. Topographic map showing landform in Area B (outlined in yellow).

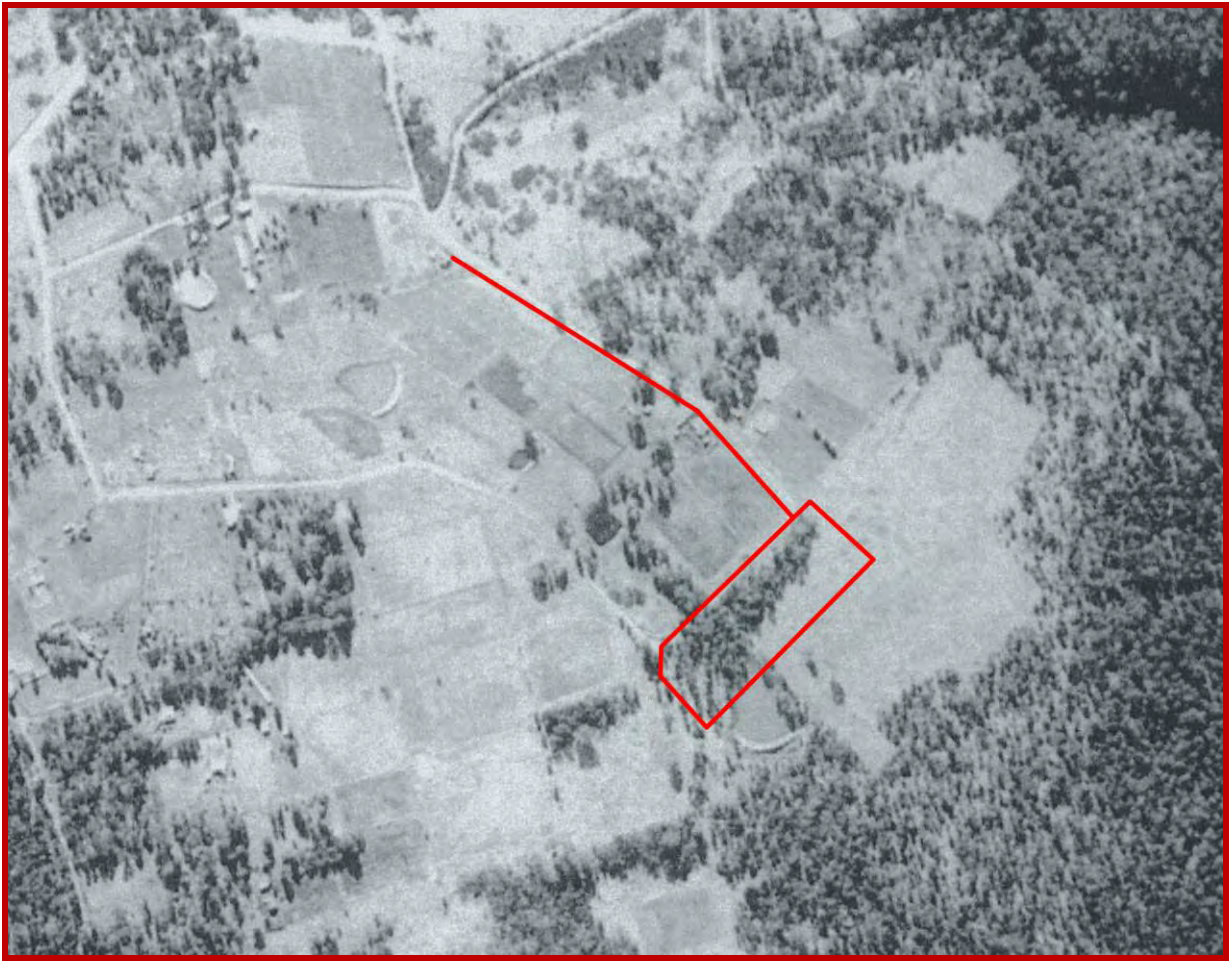
The aerial photographs show that, in 1955, a dam appeared to be located in the south corner of Study Area A, which is the lowest lying point of the site (**Figure 3-5, Appendix 3**). By 1990, there is no sign of the dam (**Figure 3-6, Appendix 3**). The 1990 aerial photograph also shows that by that year several roads had been built across the study area. One road, oriented northeast to southwest had been built up through the low lying swampy area in the south of the study area. Another road, running adjacent to this bisected the middle of the study area. Neither road appeared to be sealed. The 1955 photograph of Study Area A does not show any buildings on this site. By 1990 the extant structures on the site had been built. It appears from the photographs that Study Area A had largely been cleared of vegetation by 1955, with only a strip of trees along the northwest border remaining.

Figure 3-5. Study Area A in 1955 (outlined in red).⁷

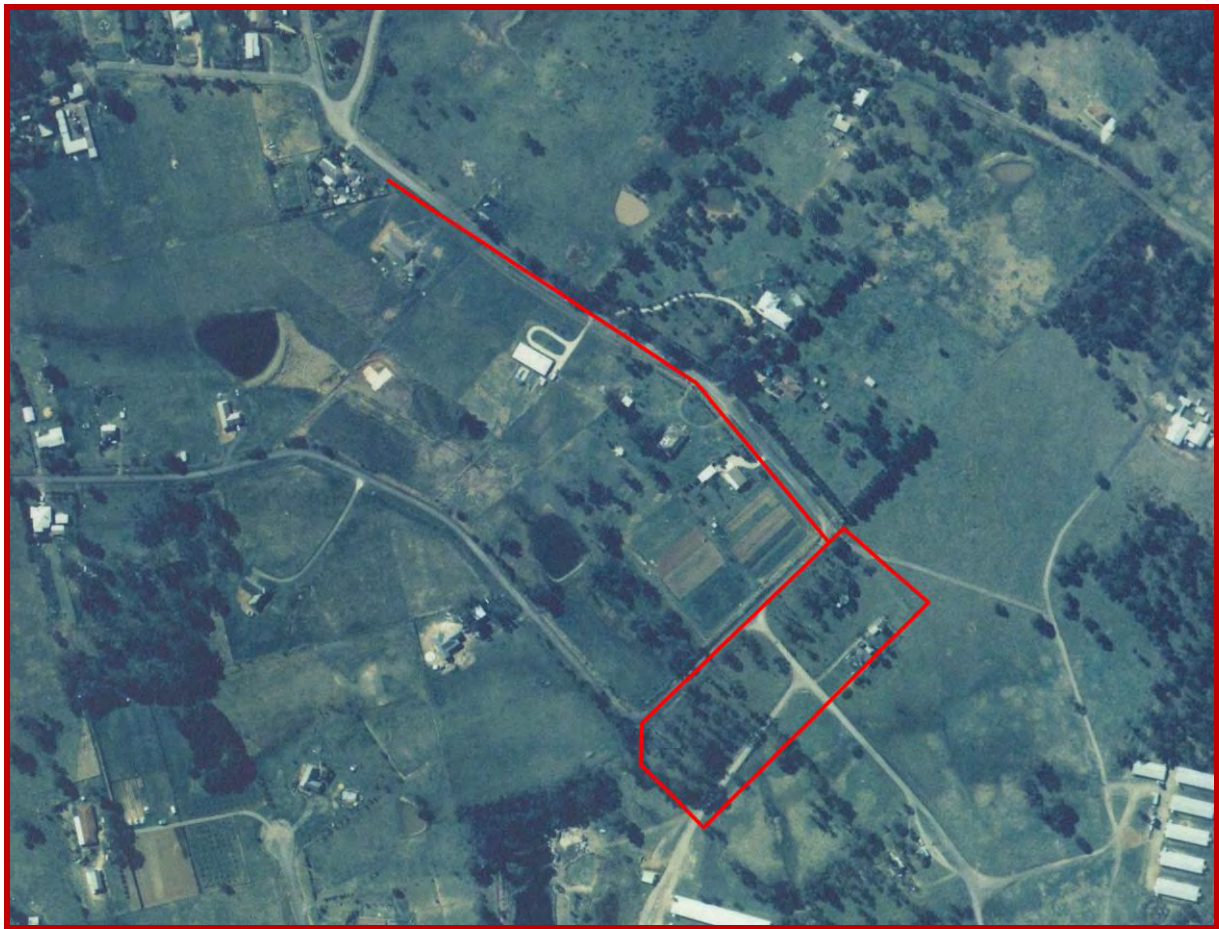
Figure 3-6. Study Area A in 1990 (outlined in red).⁸

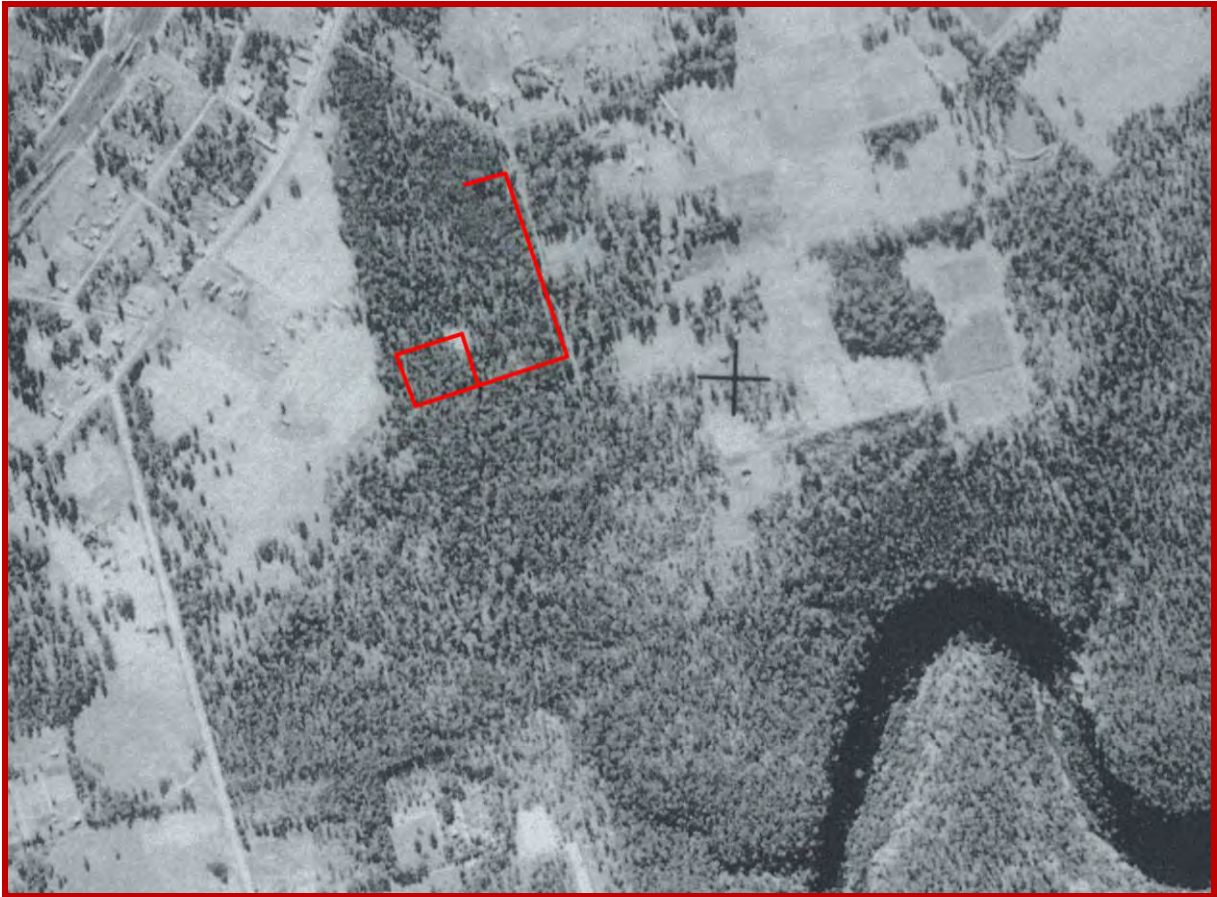
The 1955 photograph of Study Area B shows a site largely covered in trees (**Figure 3-7, Appendix 3**). No buildings are apparent. An ephemeral waterway enters the site from the south east. By 1990 Study Area B had been largely cleared (**Figure 3-8, Appendix 3**). The waterway appears to have been artificially rerouted. Several structures have been built in the vicinity of the site, with one located in the southeast. A track is apparent running east to west across the site. Google Earth shows some revegetation since 1990. The area for the proposed rising mains, along the road verge and the northernmost part of the site had been cleared of vegetation by 1990, and appears disturbed due to the building of the road, and installation of several power poles.

Figure 3-7. Study Area B in 1955 (outlined in red).⁹

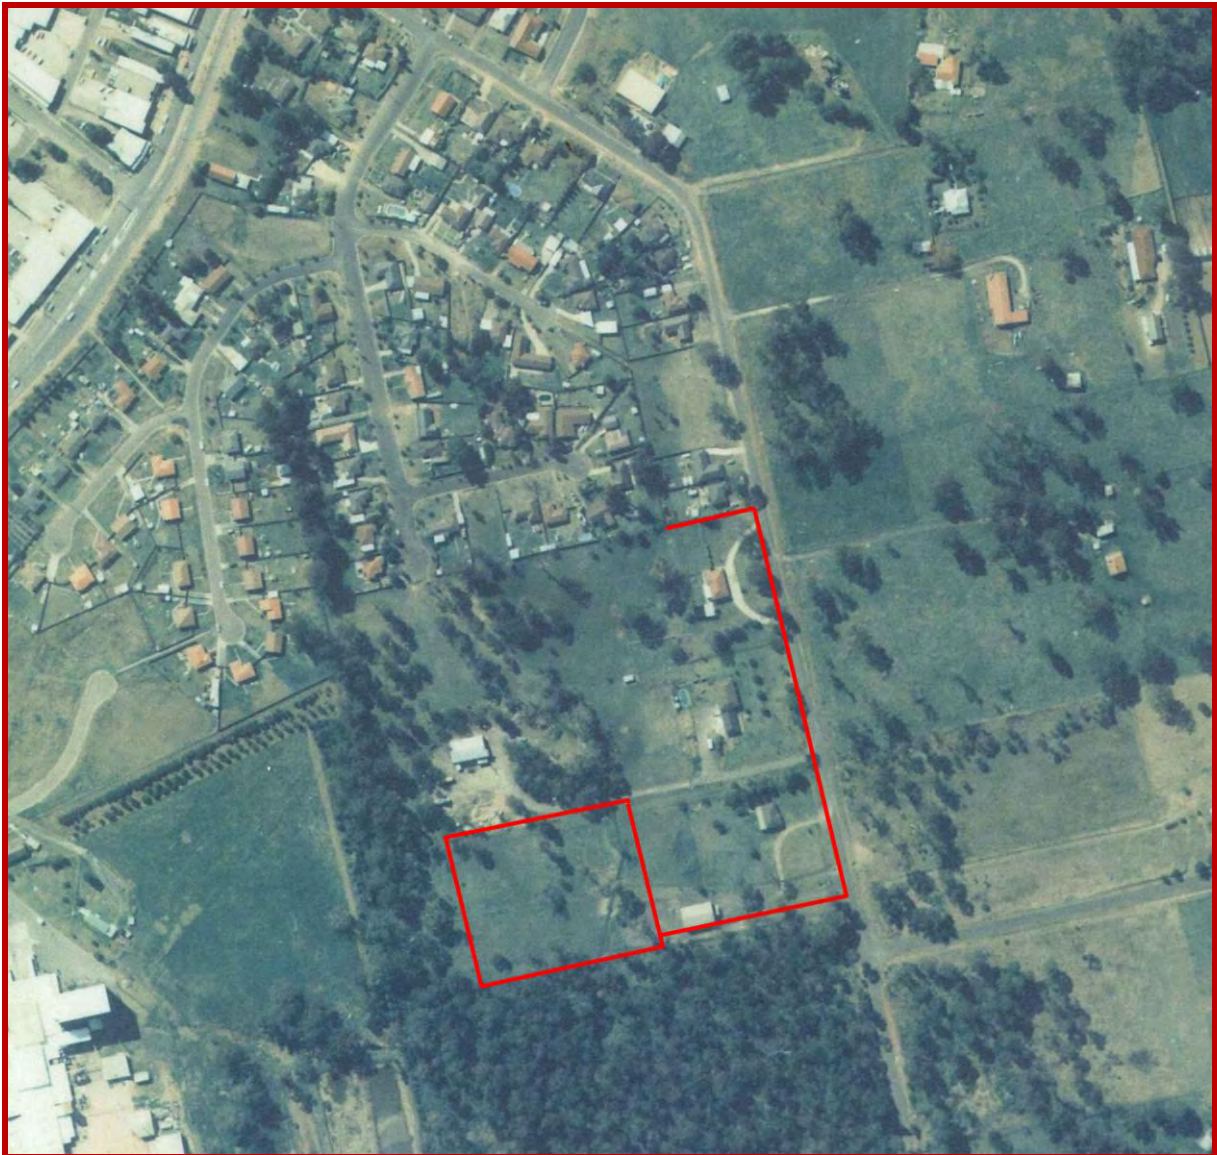
Figure 3-8. Study Area B in 1990 (outlined in red).¹⁰

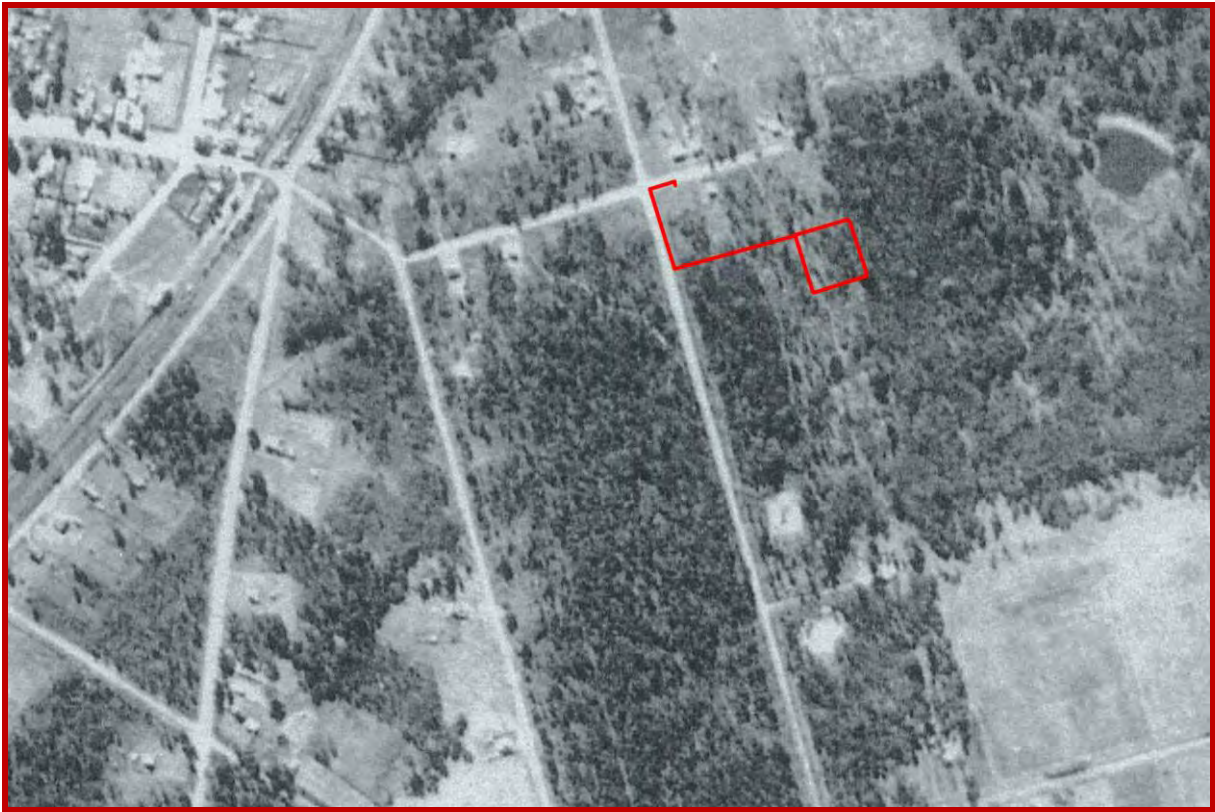
The 1955 aerial photograph of Study Area C (**Figure 3-9, Appendix 3**) shows what appear to be erosion scours across a site which is extensively vegetated with trees. No buildings are visible. By 1966 (**Figure 3-10, Appendix 3**) the site is largely cleared of vegetation, and platforms of previous buildings are visible. One building still stands on the site. The 1969, 1972 and 1979 (**Figures 3-11 to 3-13, Appendix 3**) photographs show the same building, however, the building platforms are no longer visible. By 1990 the site has been completely cleared of vegetation (**Figure 3-14, Appendix 3**). The building has been removed, and houses had been built on lots to the north and west. Moreover, the topographical map shows the area as being located on an upper slope (**Figure 3-4, Appendix 3**). Therefore, it seems likely that

Figure 3-9. Study Area C (outlined in red) in 1955 (outlined in red).¹¹

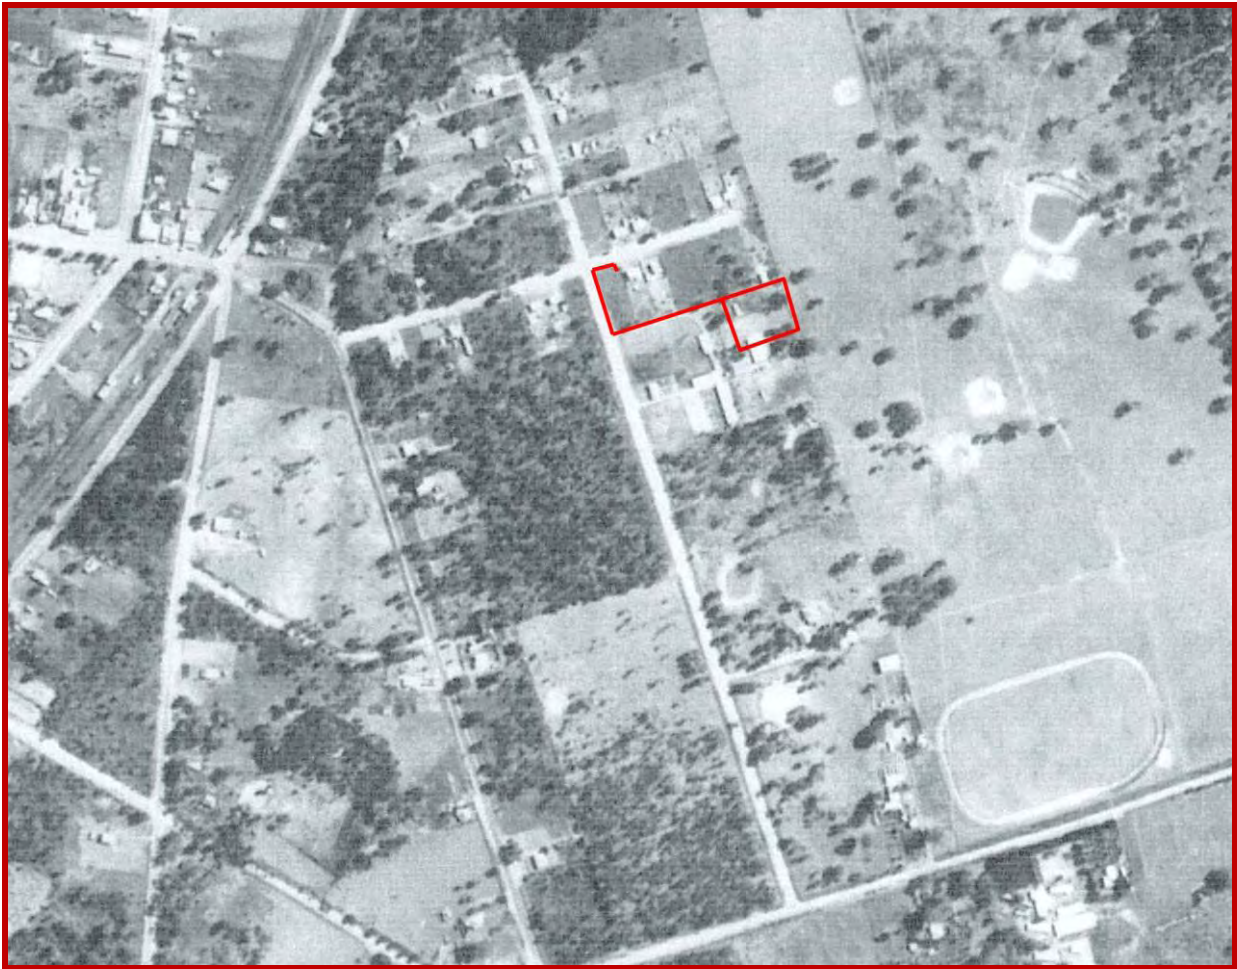
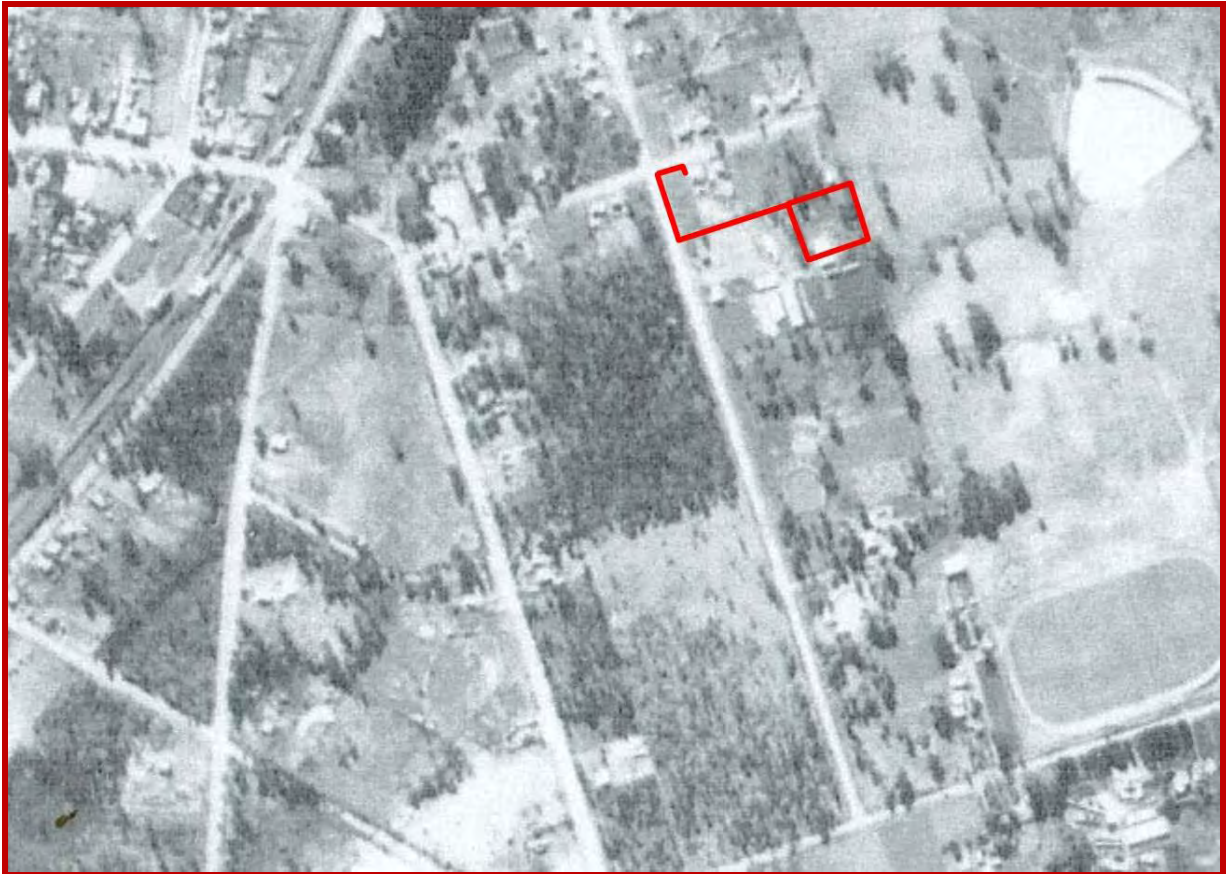
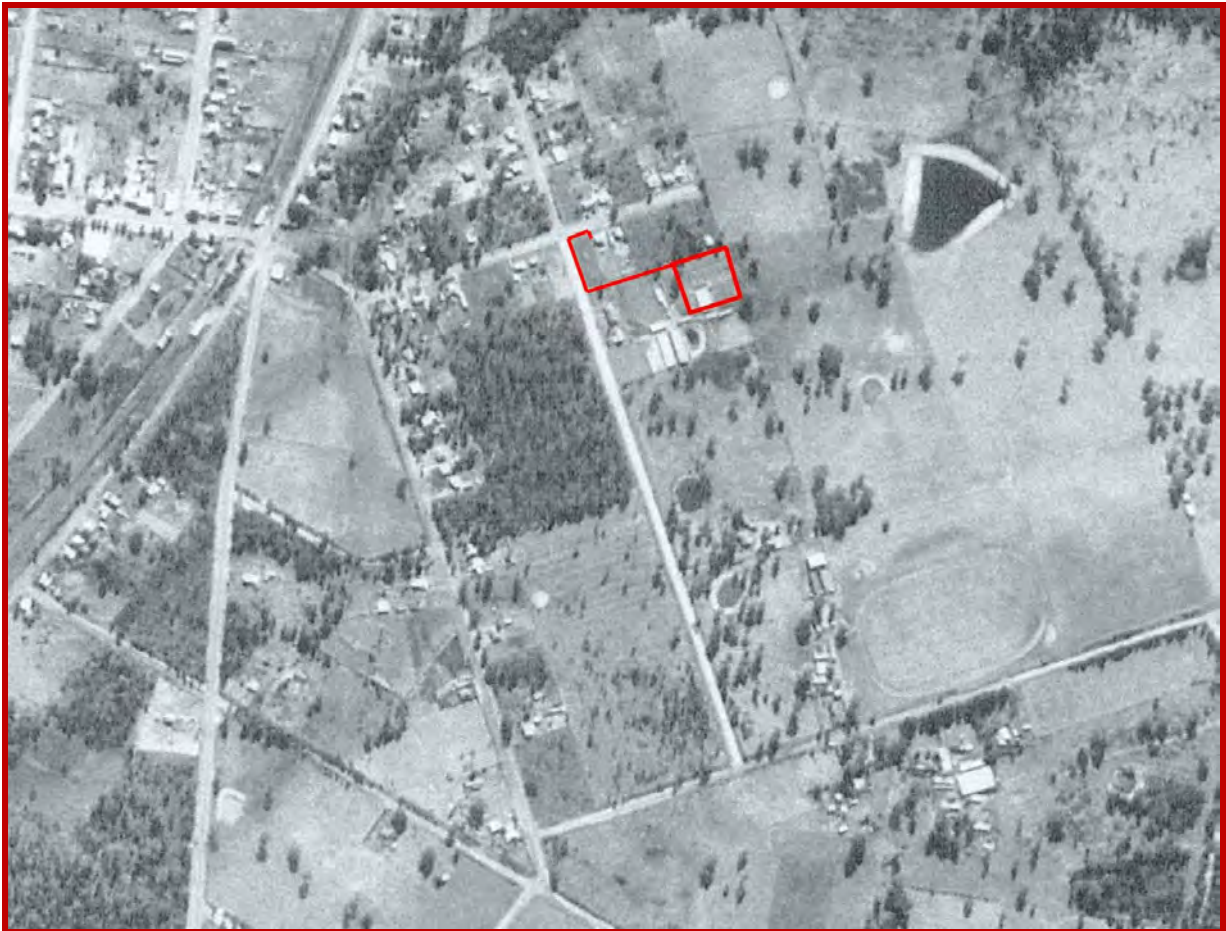
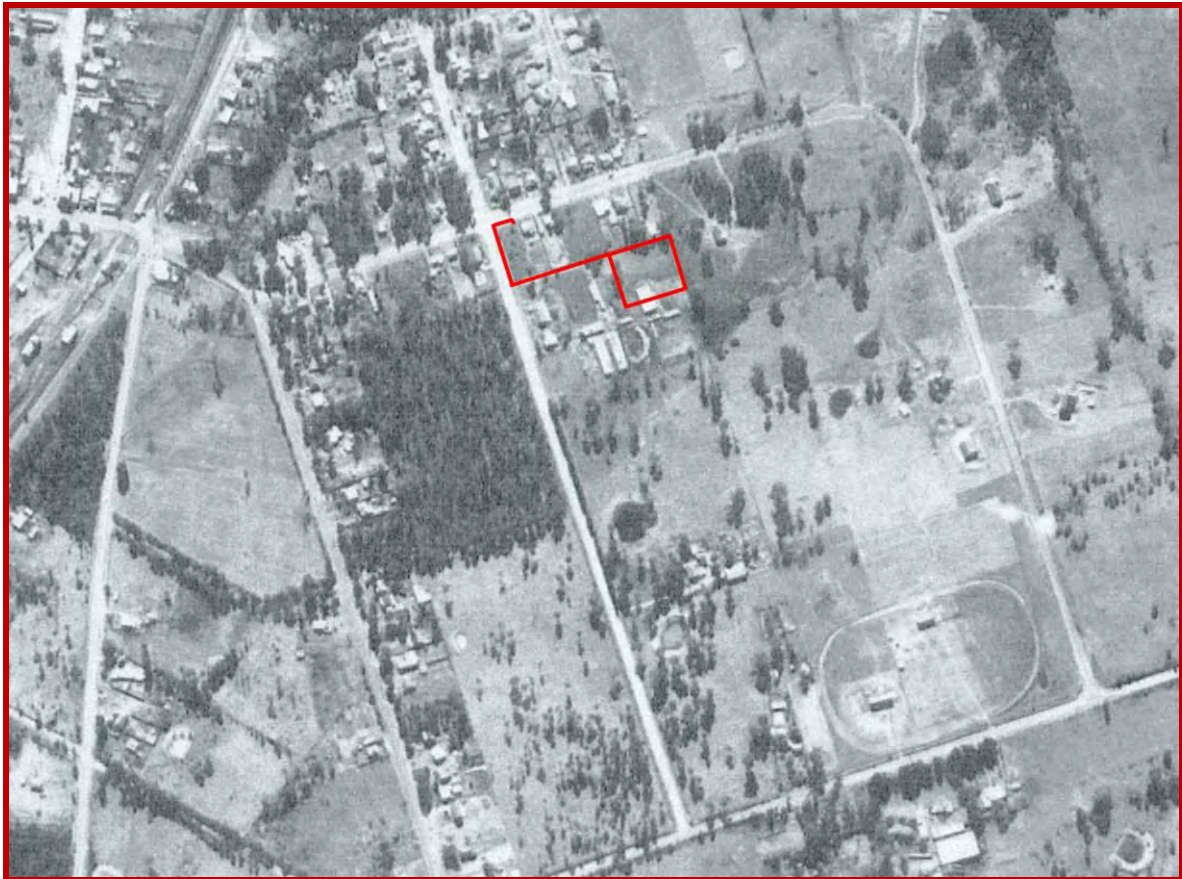
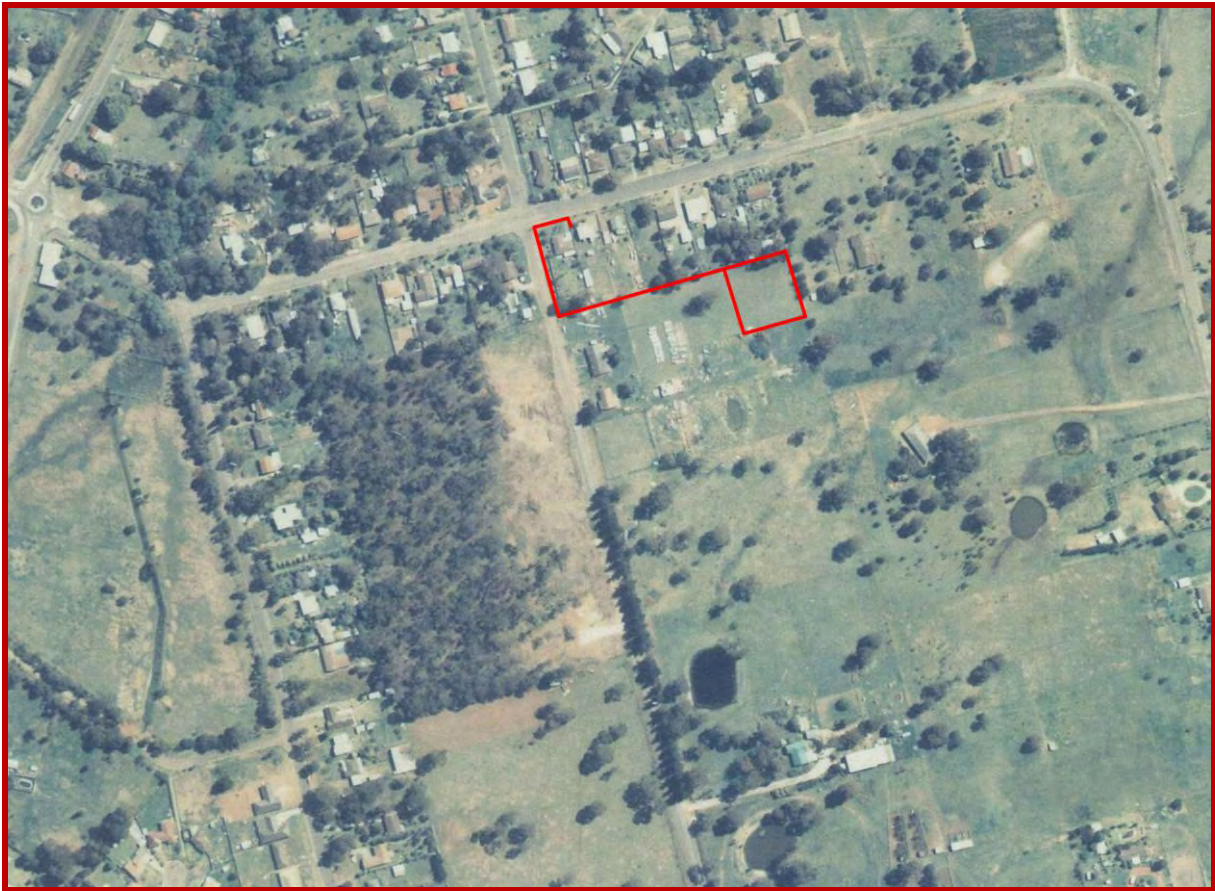
Although Study Area C was considered initially to be a landform of interest due to its proximity to creeks, subsequent historic aerial photographs showed significant disturbance to the site. Due to extremely low visibility during the visual inspection, additional photographs were inspected for Area C. These were taken in 1966, 1969, 1972 and 1979 (**Figures 3-10 to 3-1, Appendix 3**).

Figure 3-10. Study Area C (outlined in red) in 1966 (outlined in red).¹²

Figure 3-11. Study Area C (outlined in red) in 1969 (outlined in red).¹³

Figure 3-12. Study Area C (outlined in red) in 1972 (outlined in red).¹⁴

Figure 3-13. Study Area C (outlined in red) in 1979 (outlined in red).¹⁵

Figure 3-14. Study Area C (outlined in red) in 1990(outlined in red).¹⁶

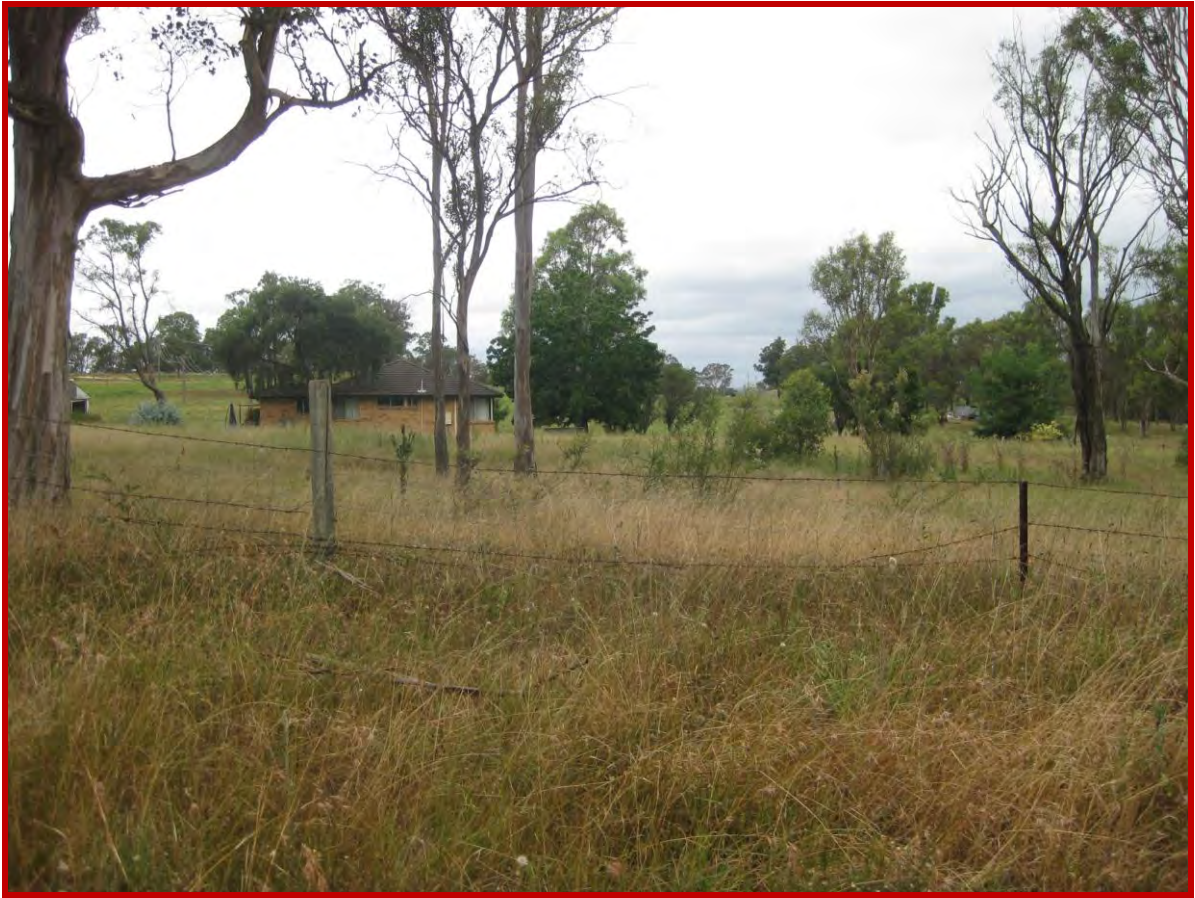
Inspection found that tall thick grass obscured ground surface visibility which was estimated to be low to nil over the majority of the site. The site appeared to be largely disturbed due to various structures built on it (**Figure 3-15, Appendix 3**), a 50 cm deep road cut (**Figure 3-16, Appendix 3**), and several roads built up through the swampy area to the southwest of the site (**Figure 3-17, Appendix 3**). Glenda Chalker indicated that there were more sheds on the site in the past 20 years than are now extant. Several stepped areas were observed that may

Figure 3-15. Area A from Cross Street, facing northeast. Note building in mid-ground.

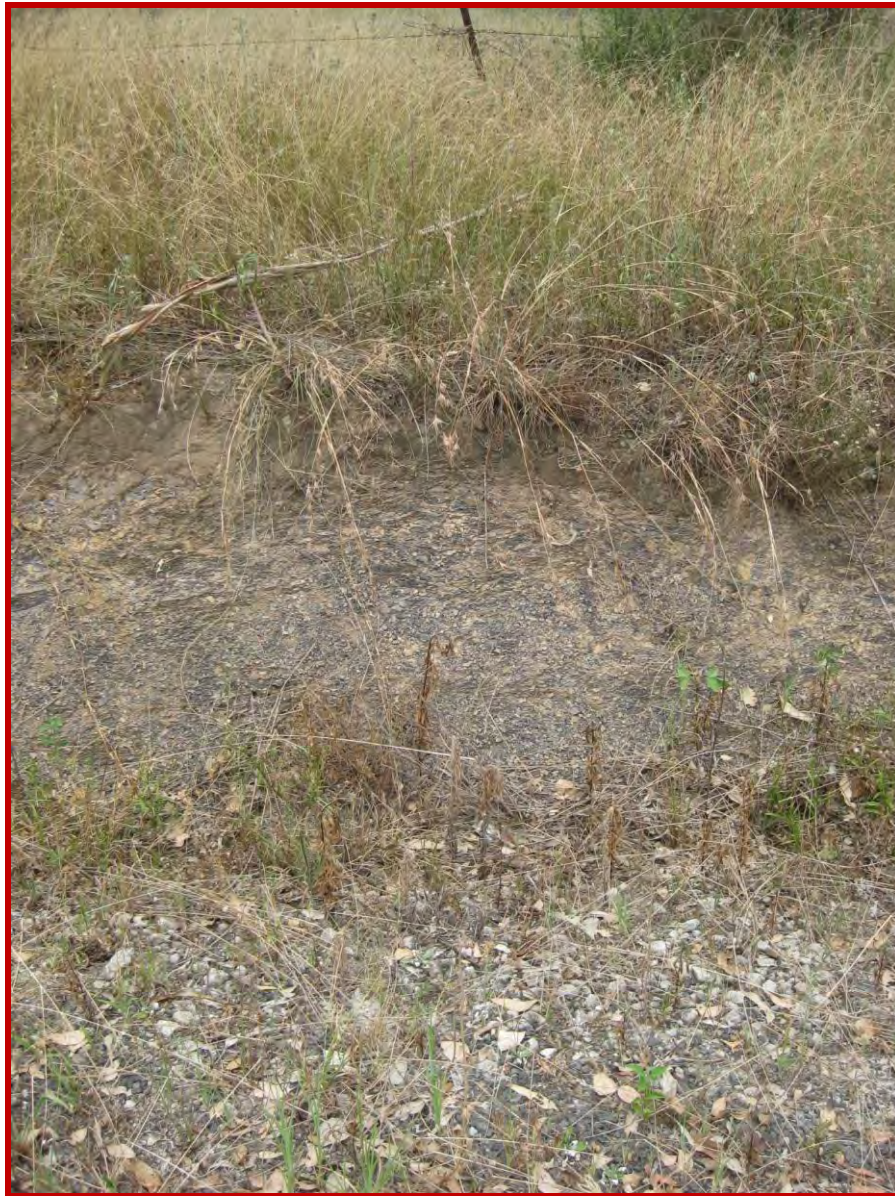
Figure 3-16. Road cut in Area A, facing northeast. Depth is 50 cm.

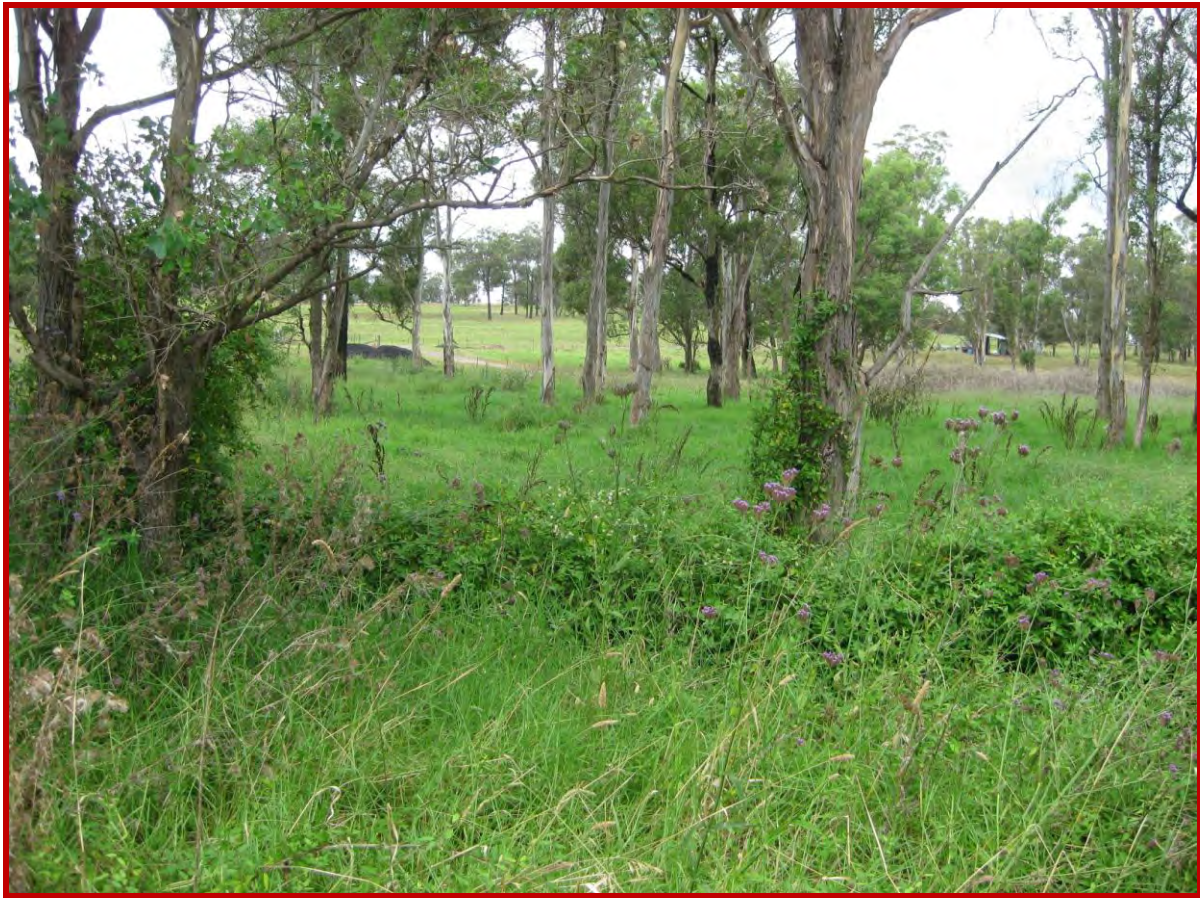
Figure 3-17. Road across swamp in Area A (mid-ground), facing southeast.

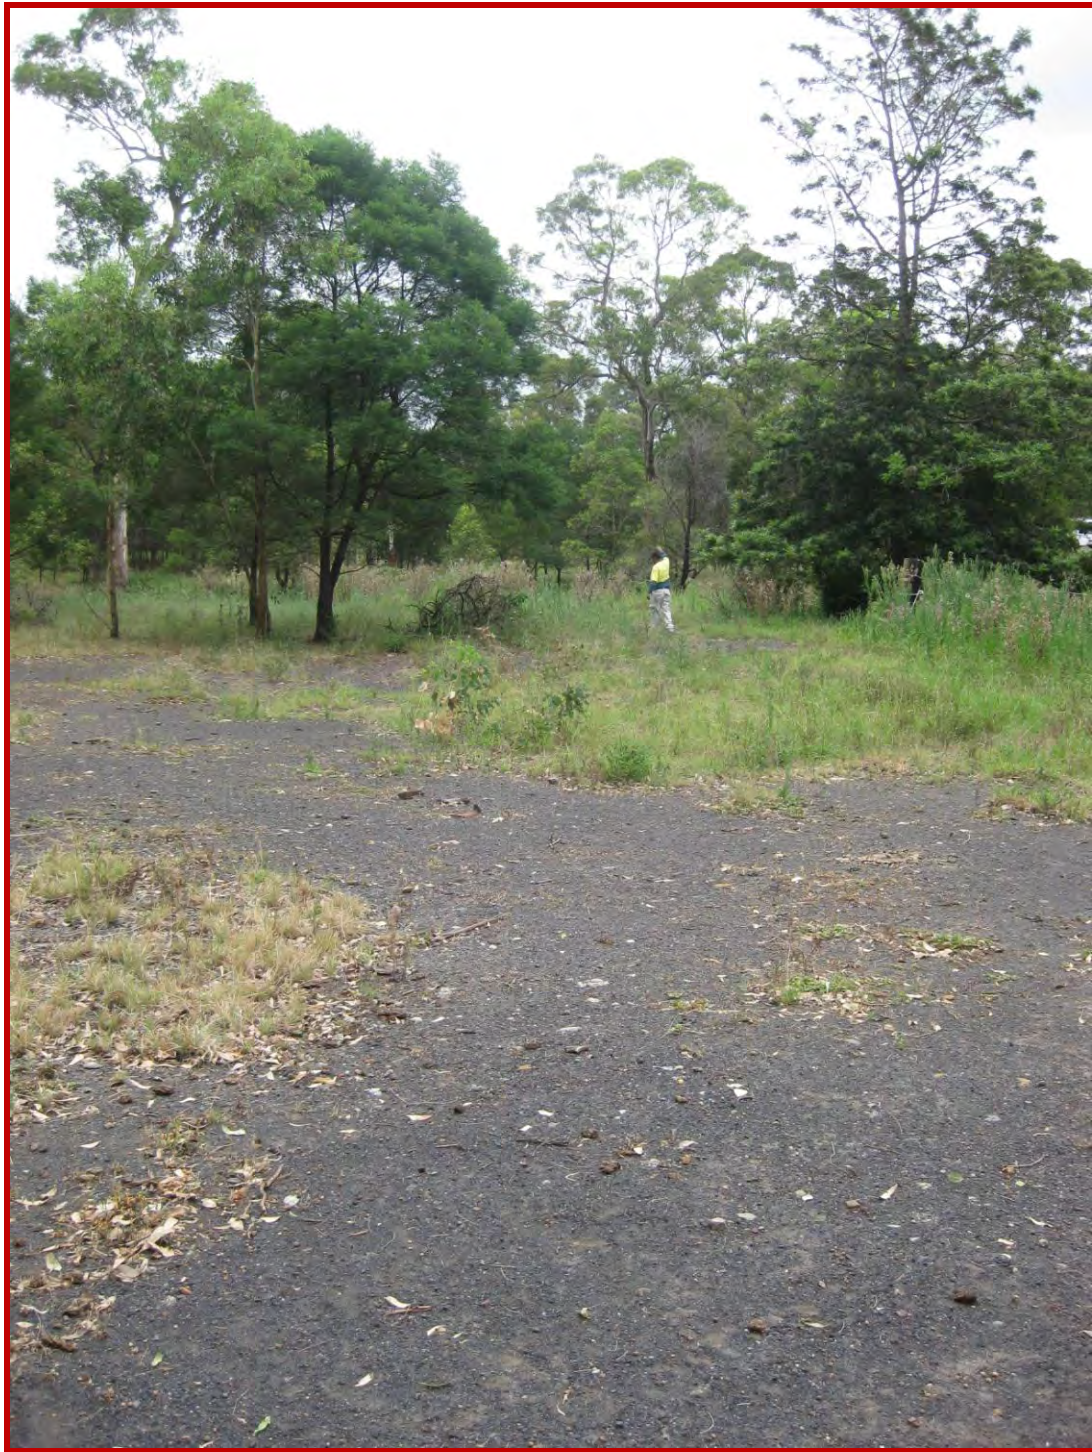
Study Area B was being used to graze cattle, and had been moderately disturbed by trampling. There were also patches of introduced gravel apparent (**Figure 3-18, Appendix 3**). It appeared that the ephemeral creek that runs through the site had been rerouted (**Figure 3-19, Appendix 3**).

Figure 3-18. Introduced gravel in Area B, facing west.

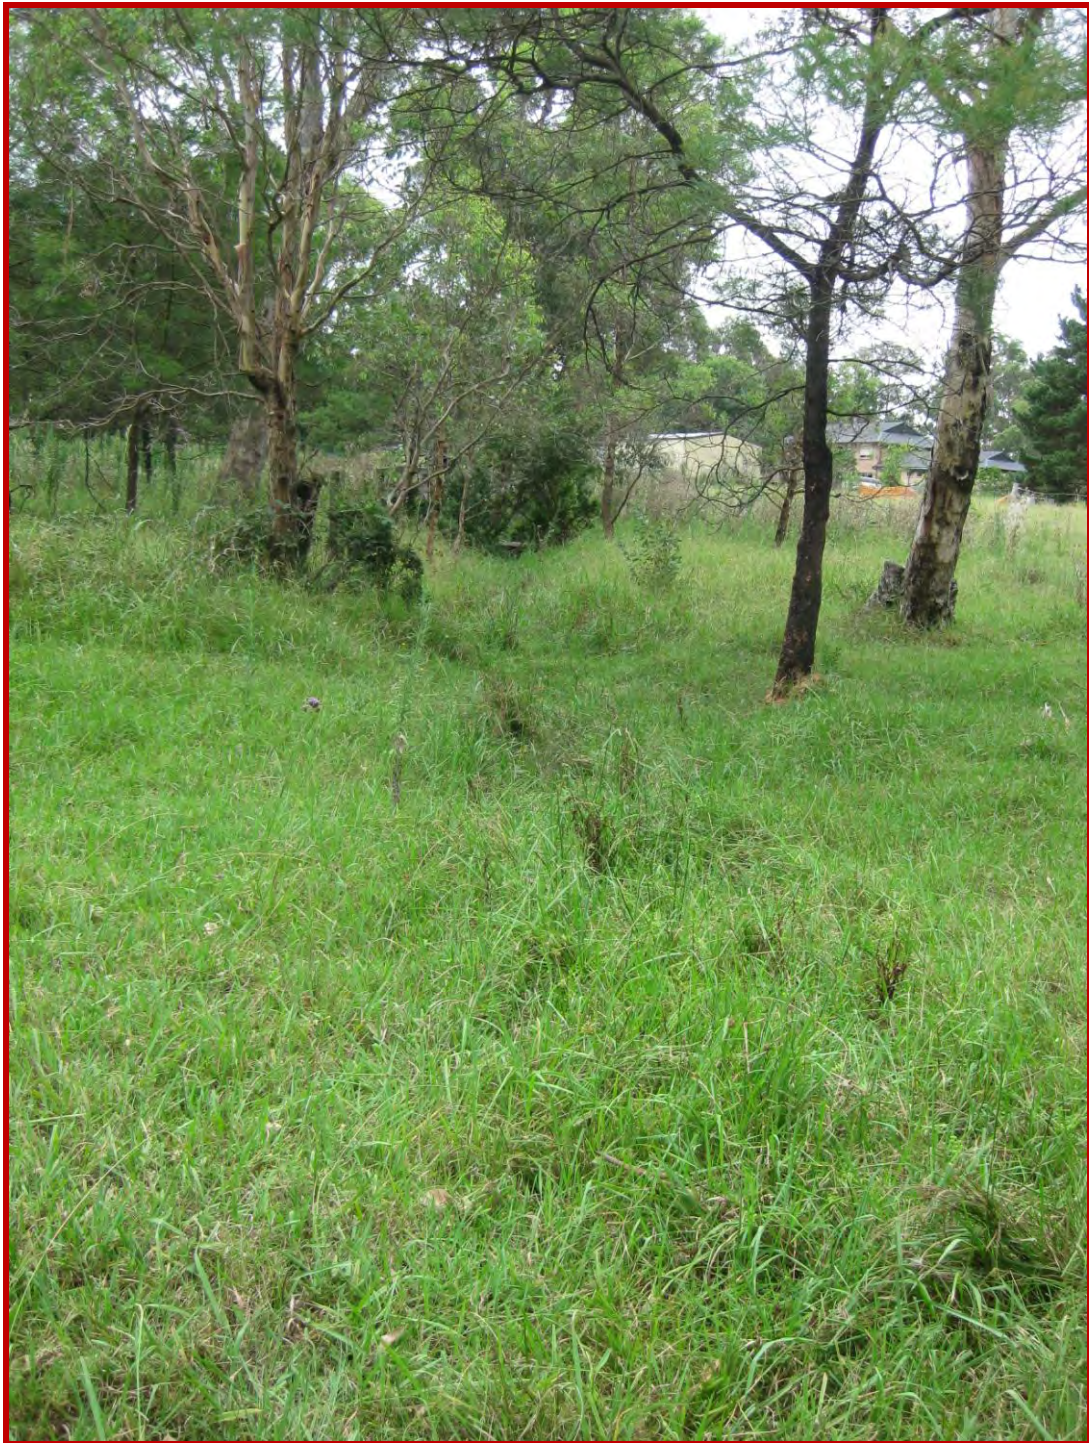
Figure 3-19. Creekline across Area B, facing north.
