Sydney Water Modifications to the Picton Sewerage Scheme

Aboriginal Heritage Due Diligence Assessment

April 2011

**Report prepared for Parsons Brinckerhoff on behalf of
Sydney Water Corporation**

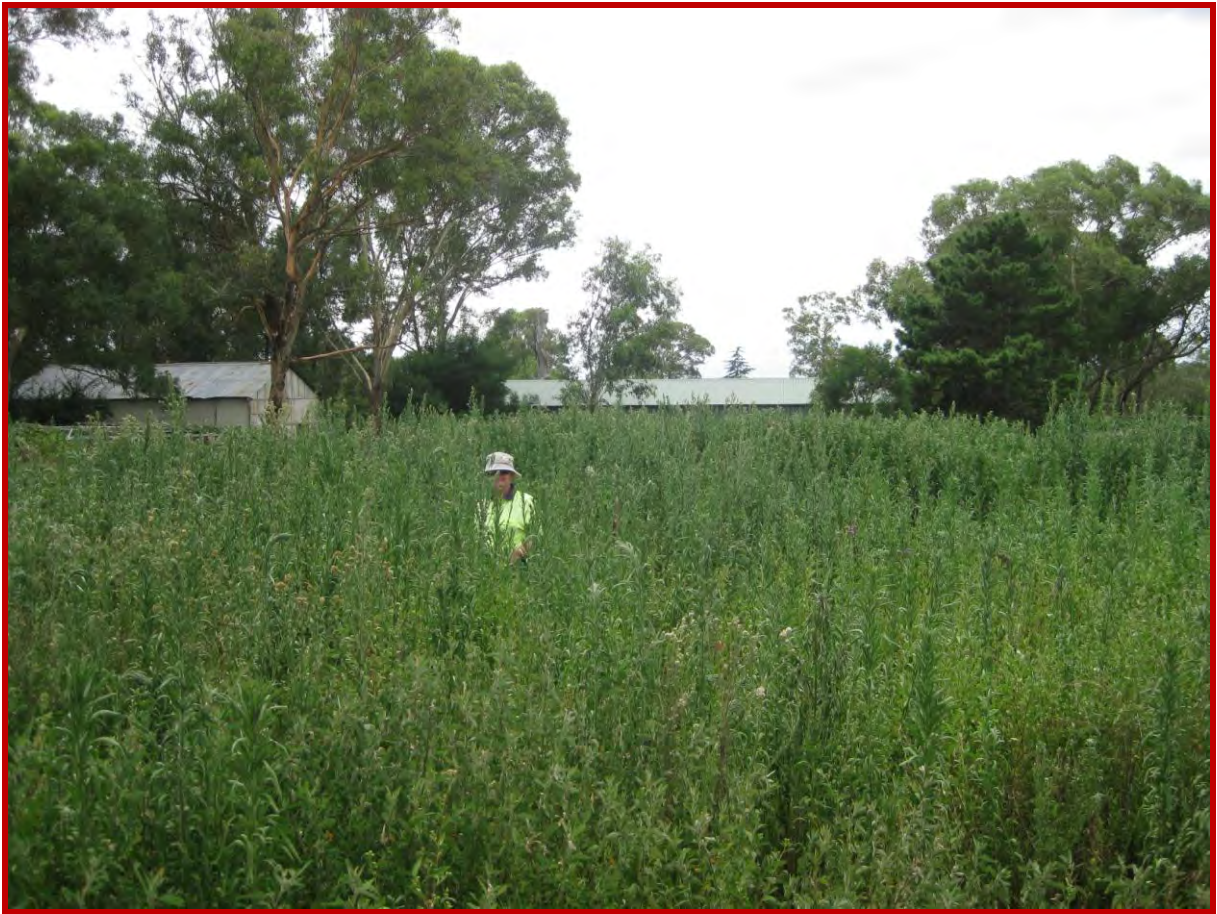
During the visual inspection, Study Area C appeared to be almost completely flat. A creek-line to the southeast has been dammed and was dry. It is possible that it may have been a permanent water course in the past. Due to thick vegetation cover, it was not possible to examine the ground surface in this study area during the visual inspection (**Figure 3-20, Appendix 3**). Visibility was nil, therefore no sites were identified in this study area. However, it should be noted that the weed, fleabane (*Conyza spp.*), growing within the study area thrives in clay, and is generally indicative of significant ground surface disturbance.

Figure 3-20. Area C facing east. Note the weed growth across the whole site.
