COWAL GOLD OPERATIONS

2019 ANNUAL REVIEW

COWAL GOLD OPERATIONS 2019 Annual Review

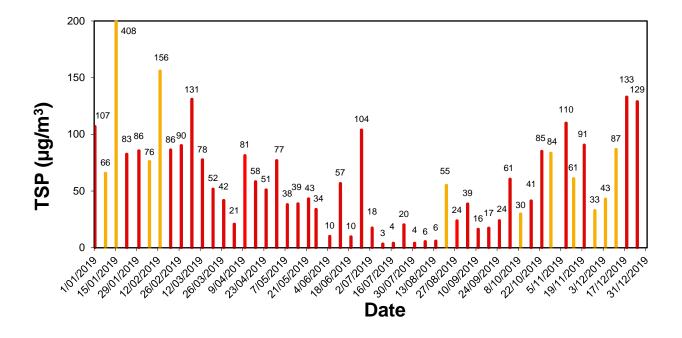
Graph 1: TSP masses measured at the Coniston Homestead during 2019. (Orange-coloured columns represent those sampling periods with strong regional dust activity or large dust storms observed at the CGO.)

The seasonality of the TSP data in 2019 was strong, and closely reflected the temporal variation in rates of deposited dust. During the summer and early autumn months of January to March, inclusive, the mean TSP value was 112 μ g/m³, whereas between the cooler months of April and September, inclusive, the mean TSP value was only 33 \Box g/m³. In the late spring and early summer months of October to December, inclusive, the mean TSP value jumped to 76 \Box g/m³. Notably, there were observed high levels of district-wide dust activity and/or dust storms at CGO in mid-January, early February, late August, October, November and early December. The two largest TSP values occurred in the weeks ending on January 15th and February 13th; for the month of January, the DustWatch report indicated "widespread dust activity recorded every week of the month (across NSW)" (DustWatch, 2019a),

According to the AWS records of wind direction for 2019, southerly winds were prominent during a number of the monthly sampling periods, including January, June, August and September. Specifically January, TSP values were high to very high, it is possible that there was at least some fine-grained particulates from the ML, transported on southerly winds to the HVAS site. South-south easterlies were only prominent in July, when TSP values were generally very low, so it is very unlikely that these winds transported an appreciable amount of fine-grained particulates from the ML to the HVAS site.

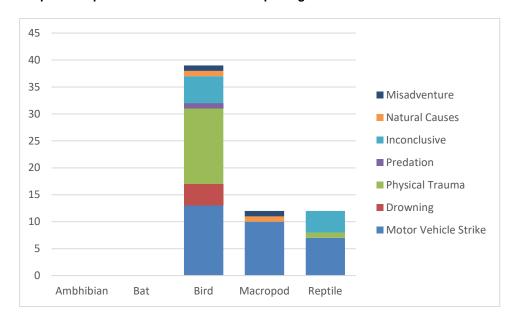
Graph 1: Graph of Fauna Deaths for the Reporting Period

There were a total of 61 fauna incidents on ML 1535 during the reporting period. All injured or deceased fauna were taken to the local vet for examination as required (i.e. in instances where cause of death cannot be immediately determined). Motor vehicle strike was the most prominent cause of death during the reporting period (Graph 1). There were no cyanide related fauna incidents or deaths.

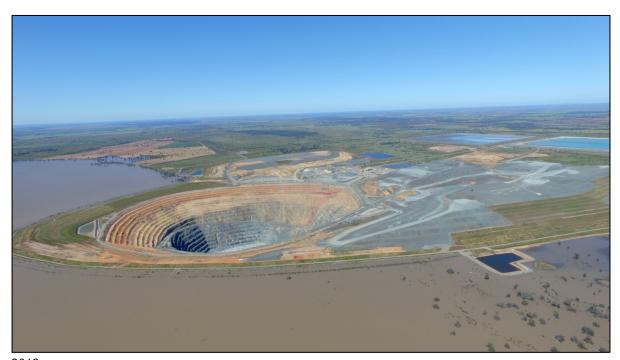
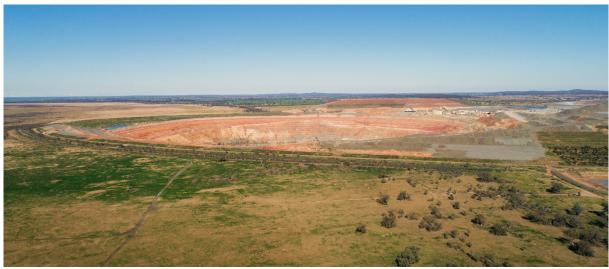
Plate 2: Aerial Photograph of the Lake Protection Bund

During the reporting period, Lake Cowal was predominantly dry with the lake receding to by dry by mid-February, no samples were taken during this period as a result.

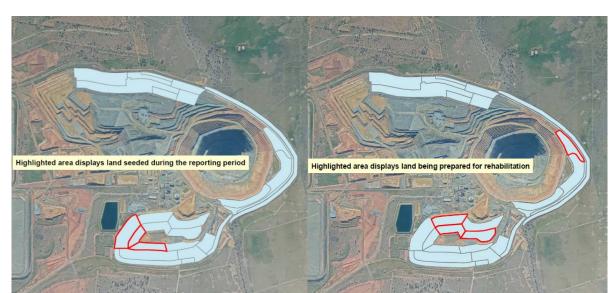
Plate 3: Conceptual View of Rehabilitated Areas During the Reporting Period

Table 26 provides details of the nature of disturbance and the rehabilitation status for areas that have been disturbed up to and including the reporting period. Plate 3 shows the areas rehabilitated during the reporting period.

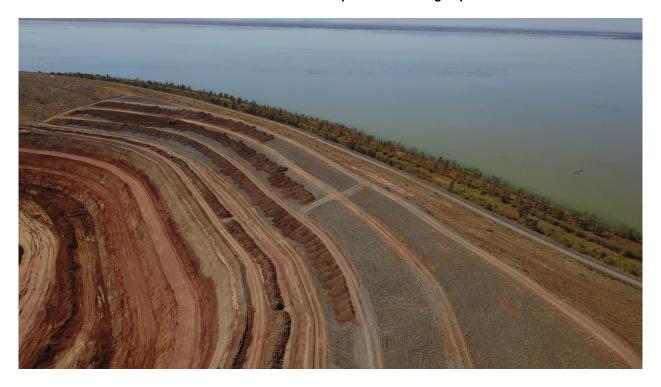
Plate 4: South Eastern Side of Perimeter Waste Rock Emplacement during Topsoil Movement 2018

Approximately 7.8ha of the inner perimeter wall was re-ripped in the reporting period due to lack of covers from prolonged dry periods and wind/splash erosion was corrected (Plate 4).

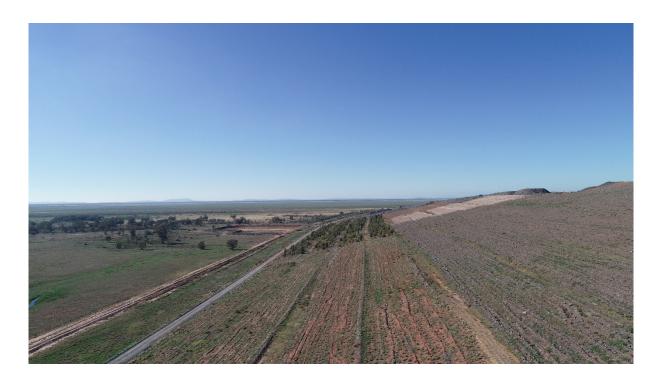
Plate 5: North Side of Northern Waste Rock Emplacement (May 2019)

The NWRE is approved to be constructed to approximately 308 m AHD and will occupy an area of approximately 269 ha northwest of the pit (Plate 5).

Tube stock planted in previous years on the NWRE was monitored during the reporting period.

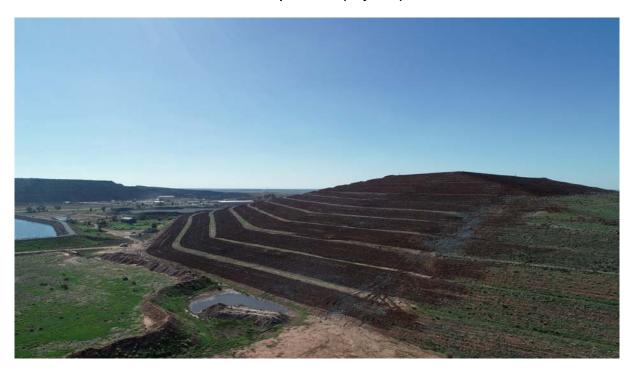
Plate 6: West End of Southern Waste Rock Emplacement (May 2019)

Area of approximately 5ha on the south side of the SWRE upper batters and areas of 3.7ha and 9.5ha on the west side of the SWRE lower, mid and upper batters were rock armoured, topsoiled, gypsum spread and were direct seeded via aerial application during the reporting period.

Approximately 37.5ha was also re ripped and direct seeded with native species in the previous reporting period and continued to be monitored during this reporting period.

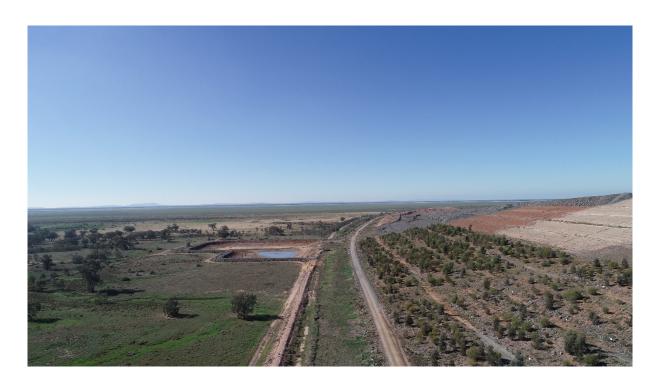
Plate 7: NWRE - Pond D1 North Trial Tubestock (May 2019)

These trials will continue during the next reporting period.
