# BORAL CEMENT WORKS, TAYLOR AVENUE, NEW BERRIMA, NEW SOUTH WALES

## ABORIGINAL CULTURAL HERITAGE DUE DILIGENCE ASSESSMENT

FINAL REPORT

24 November 2021

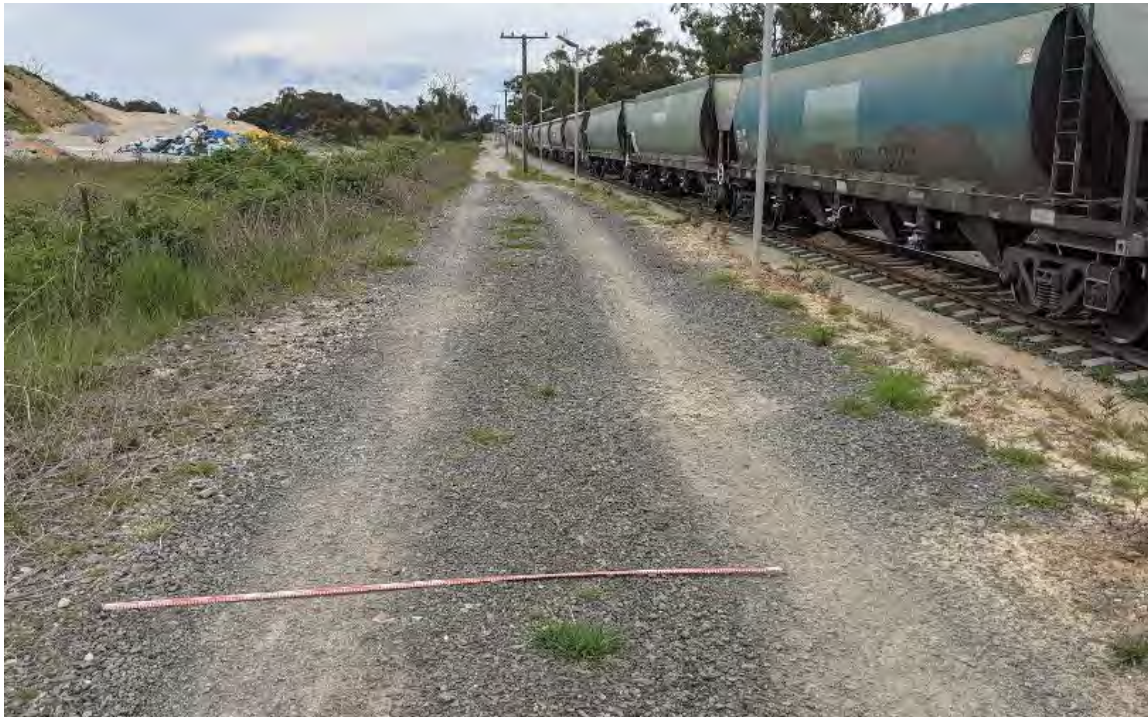
Overall, it was noted that the site was extensively disturbed and had low surface visibility due to vegetation coverage and imported fill materials. In particular, the portions of the study area such as the existing siding, roads and buildings associated with the Berrima Cement Works were noted to be entirely overlaid with surfaces consisting of consolidated fill, concrete and bitumen (Figure 2.5 and Figure 2.6).

**Figure 2.5** Northeast facing photo of existing siding with imported fill.

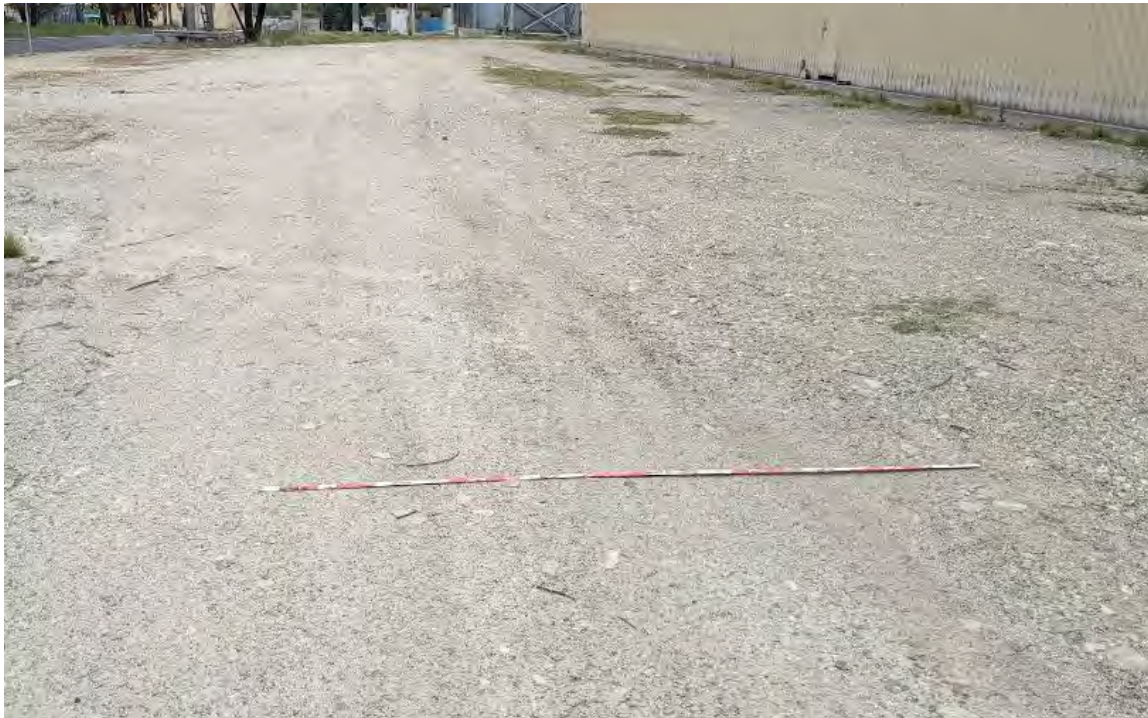
**Figure 2.6** East facing photo of disturbed terrain within existing Cement Works.

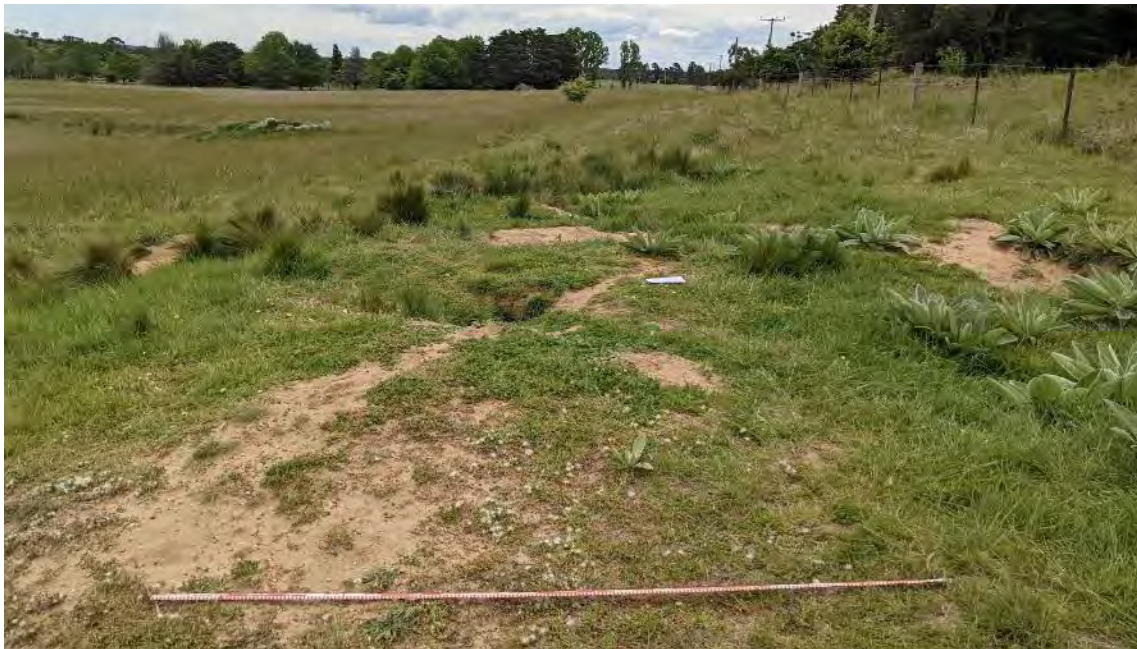
Where the new road is to be installed, there is dense grassland, with areas of exposure limited to isolated areas of erosion and cattle grazing. These portions of the study area were characterised by steep to moderately inclined mid-slopes associated with a ridgeline to the north of the study area (Figure 2.7 and Figure 2.8).

**Figure 2.7** Northwest facing photo of moderate slope with animal disturbance.

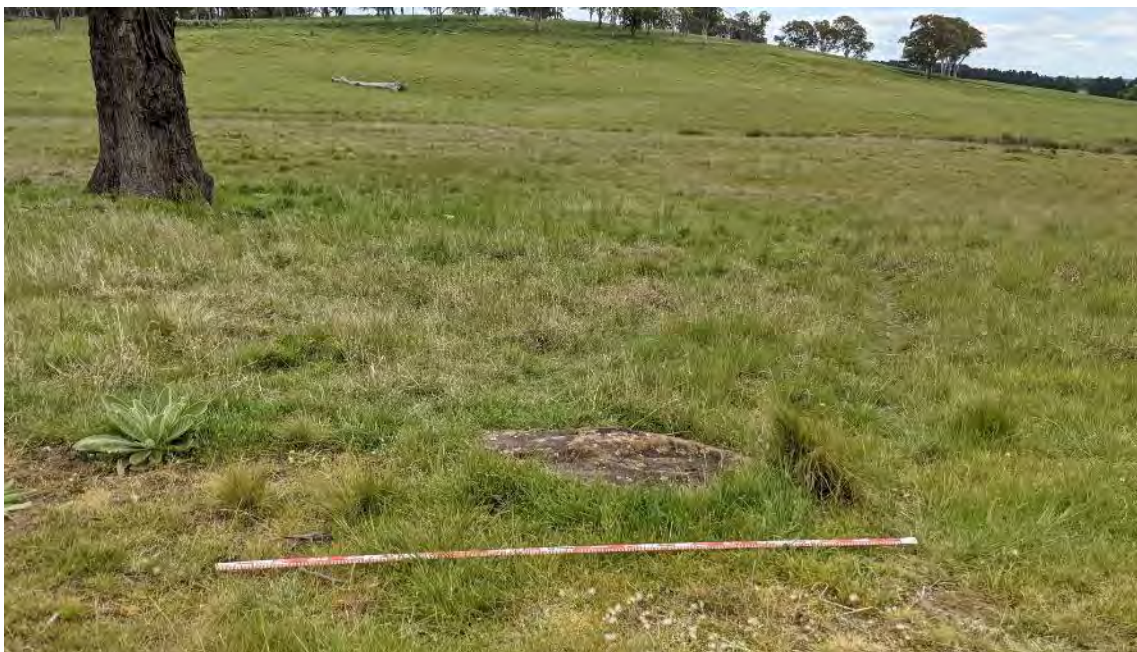
**Figure 2.8** Southwest facing photo of rock outcrop overlooking 2<sup>nd</sup> order creek.

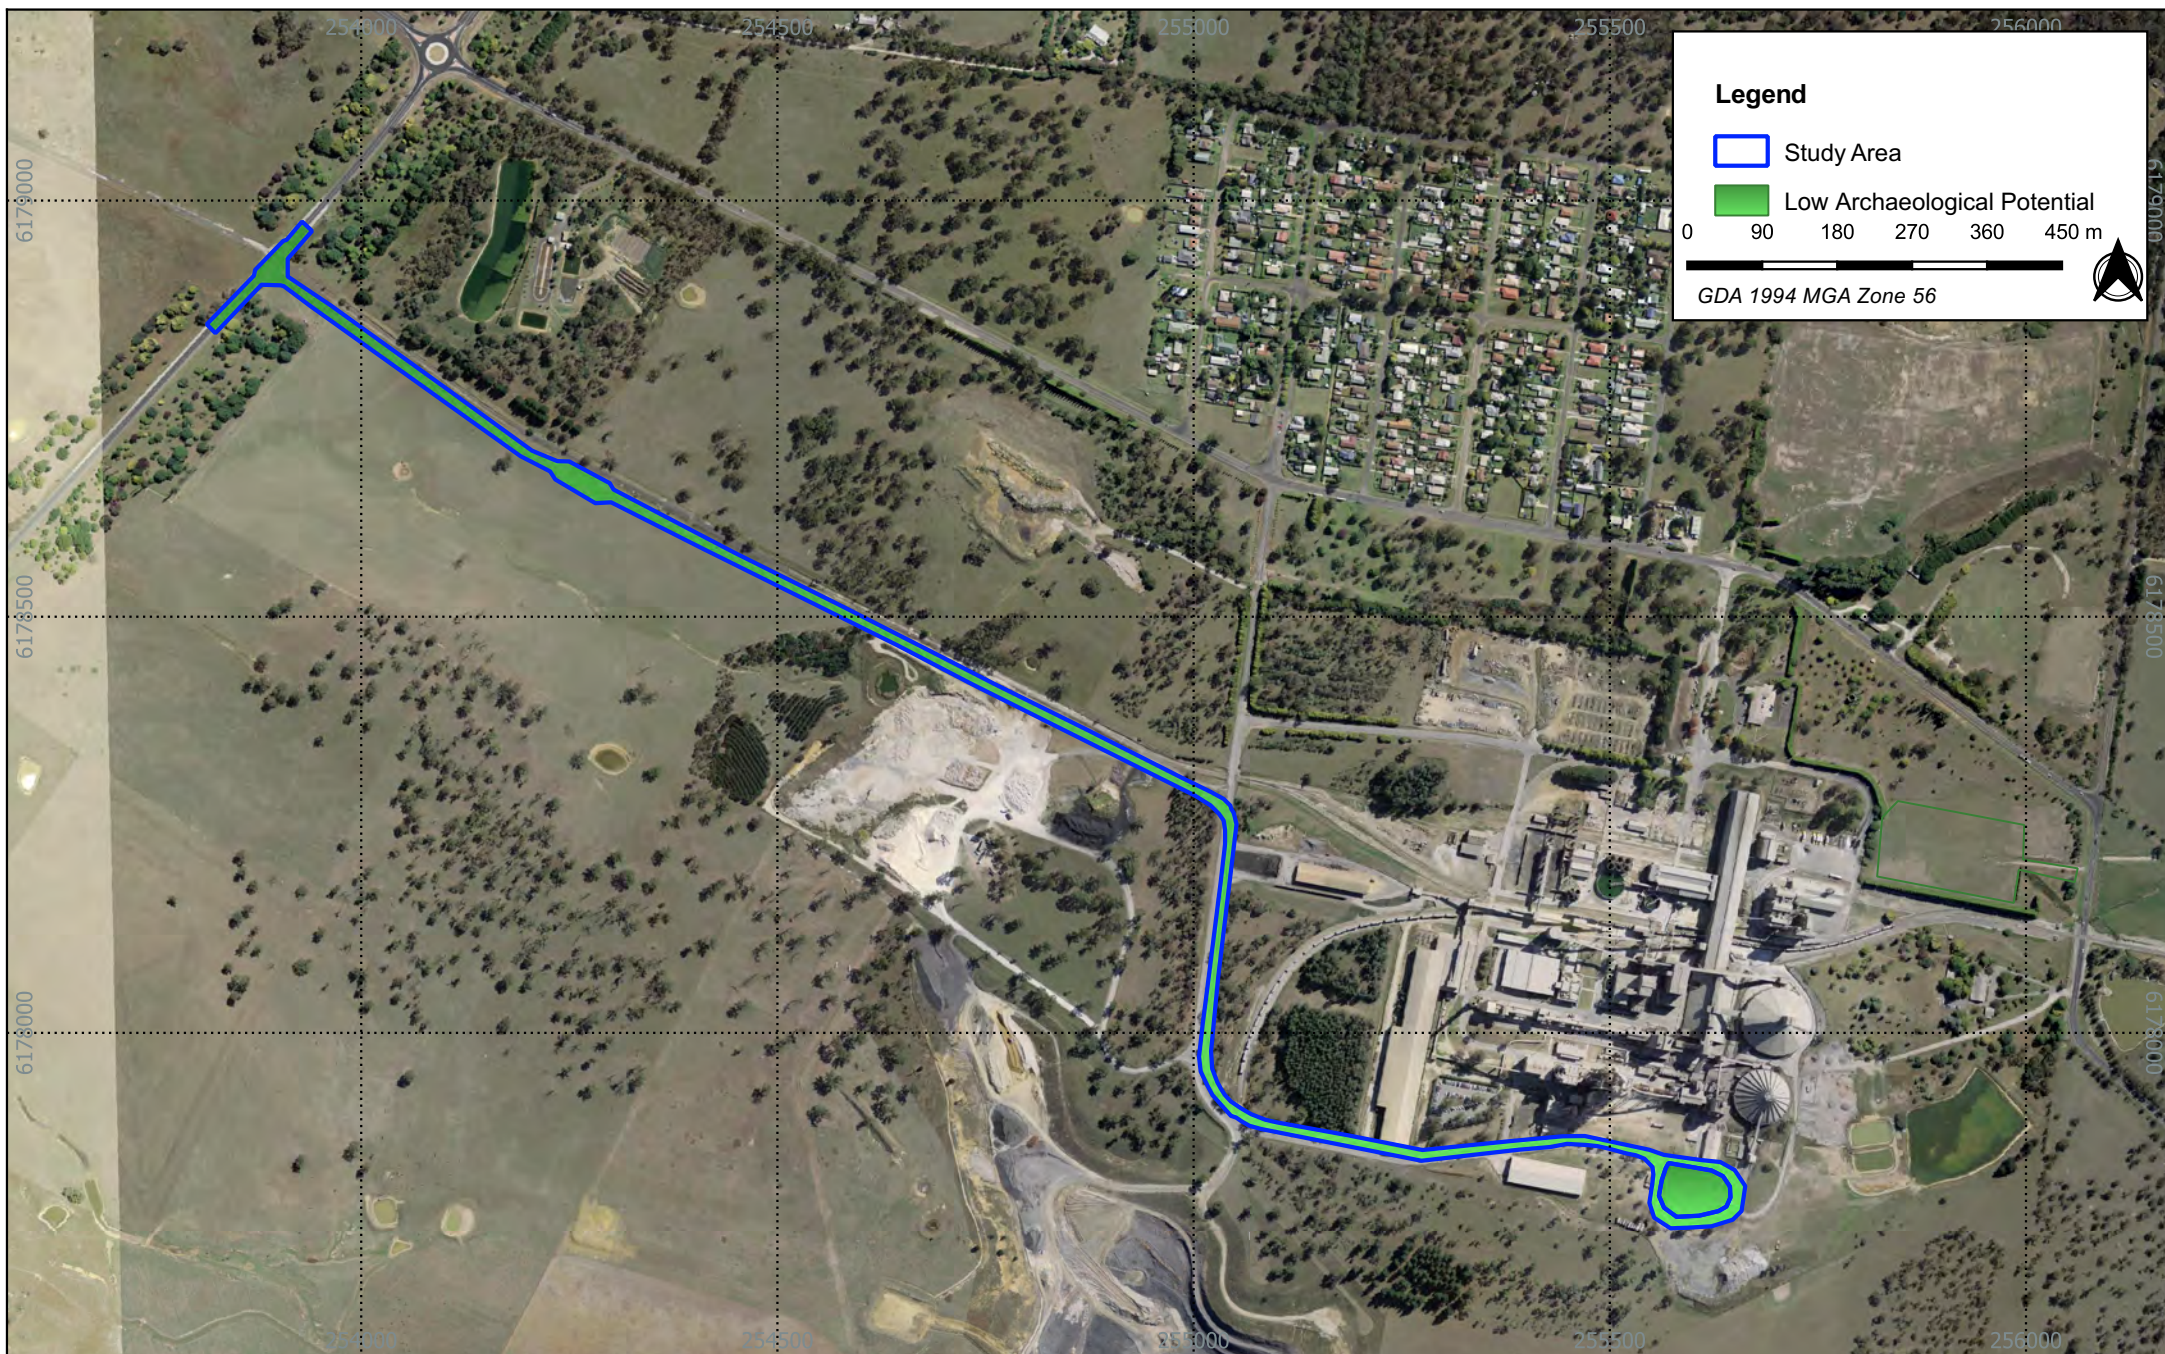
**Figure 2.9 Archaeological potential of the study area**

Given the nature of the terrain and likely levels of disturbance associated with the former rail line, this portion of the study area is considered to have a low potential to contain Aboriginal objects. The archaeological potential of the study area is outlined in Figure 2.9.
