Sydney Grammar School
c/-Jattca Property Solutions
Acid Sulfate Soil Management Plan
Proposed SGS Weigall Sports Complex
Neild Avenue, Paddington NSW

22 February 2021
58554/135442 (Rev 0)
JBS&G Australia Pty Ltd

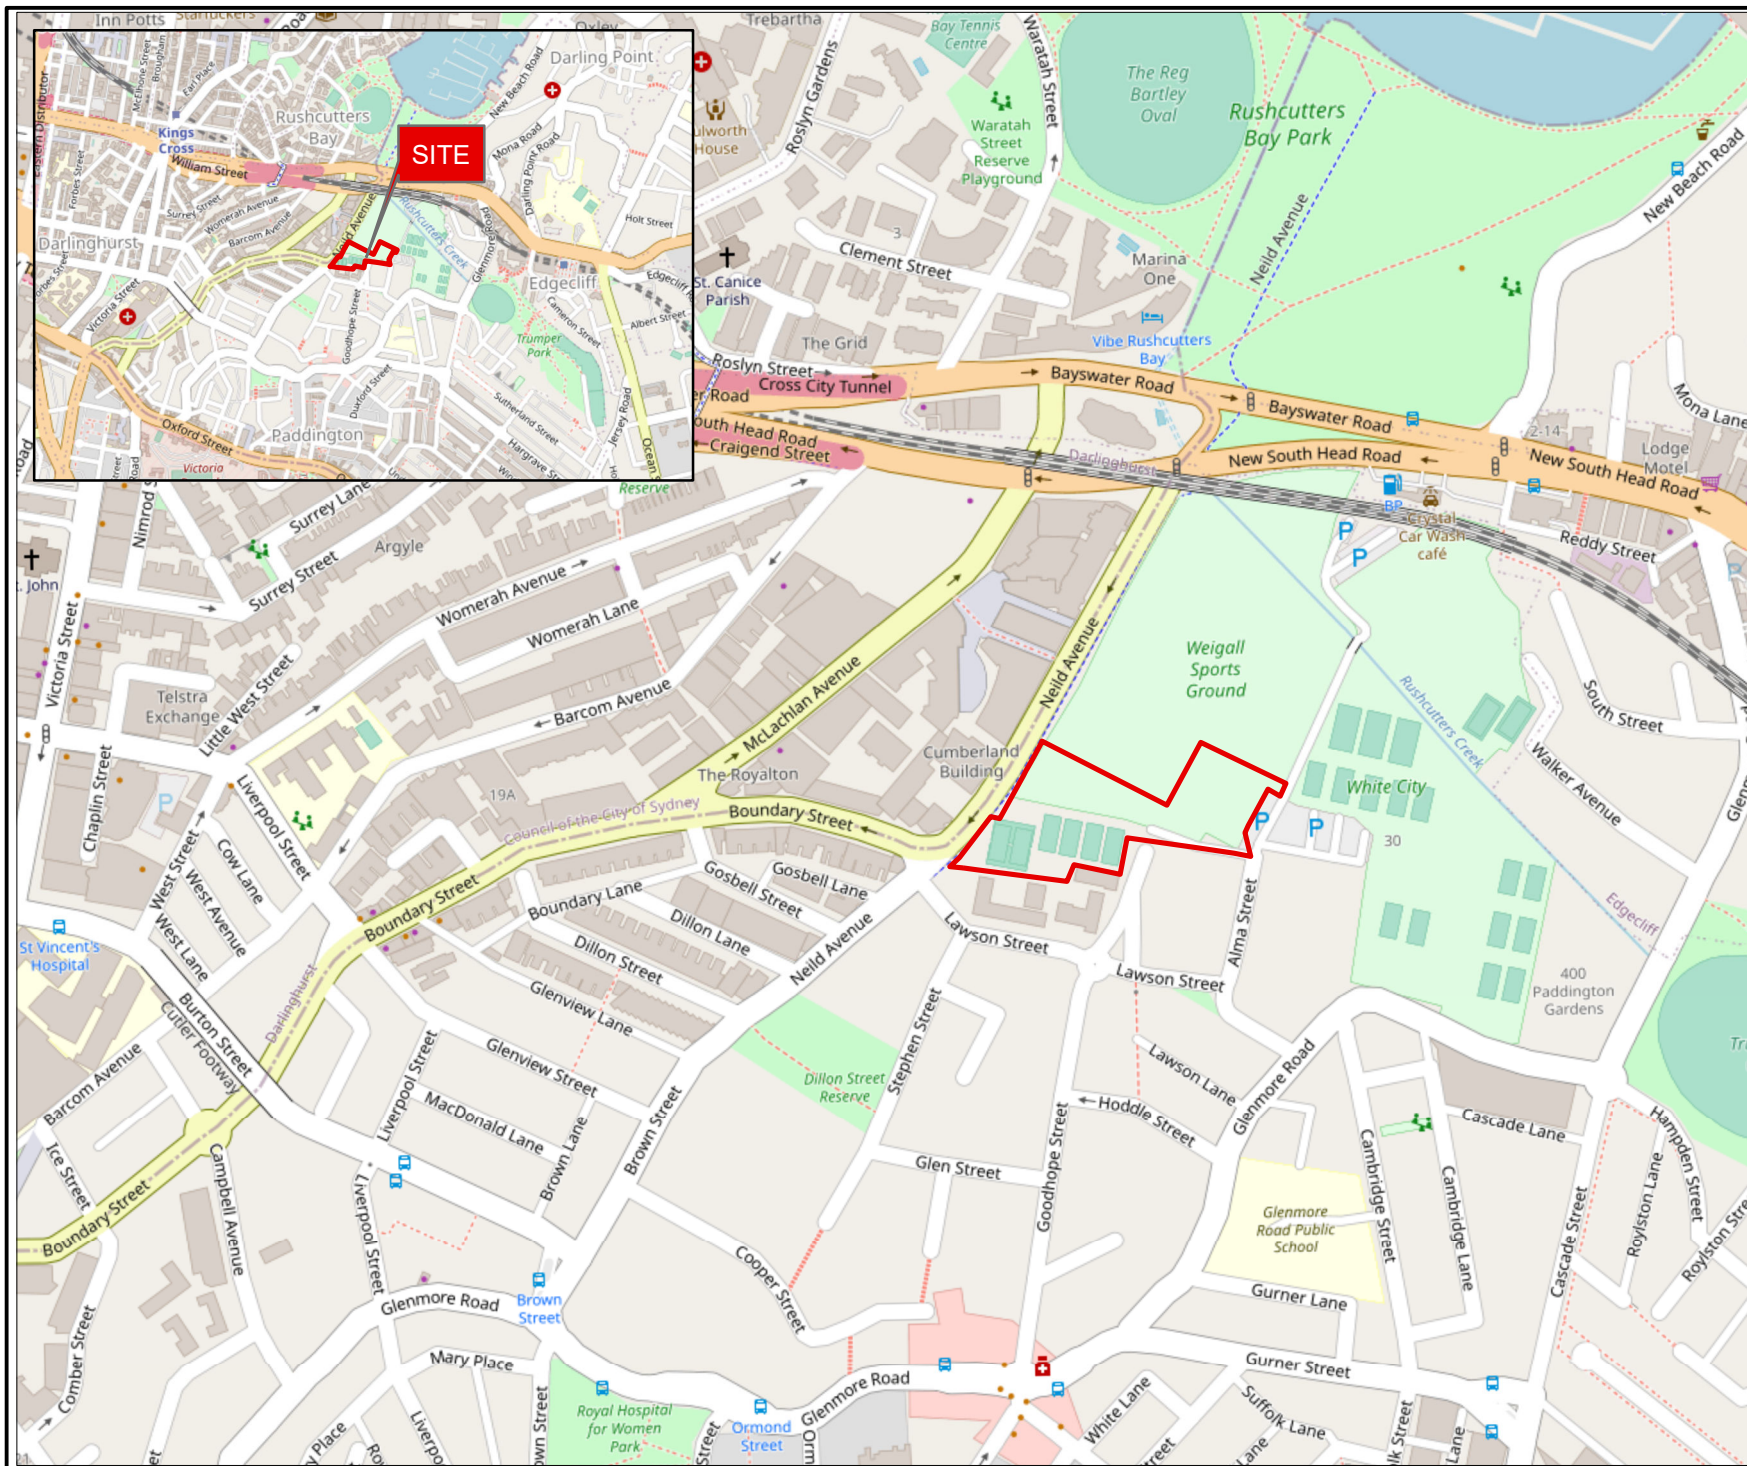
Legend:
 Approximate Site Boundary

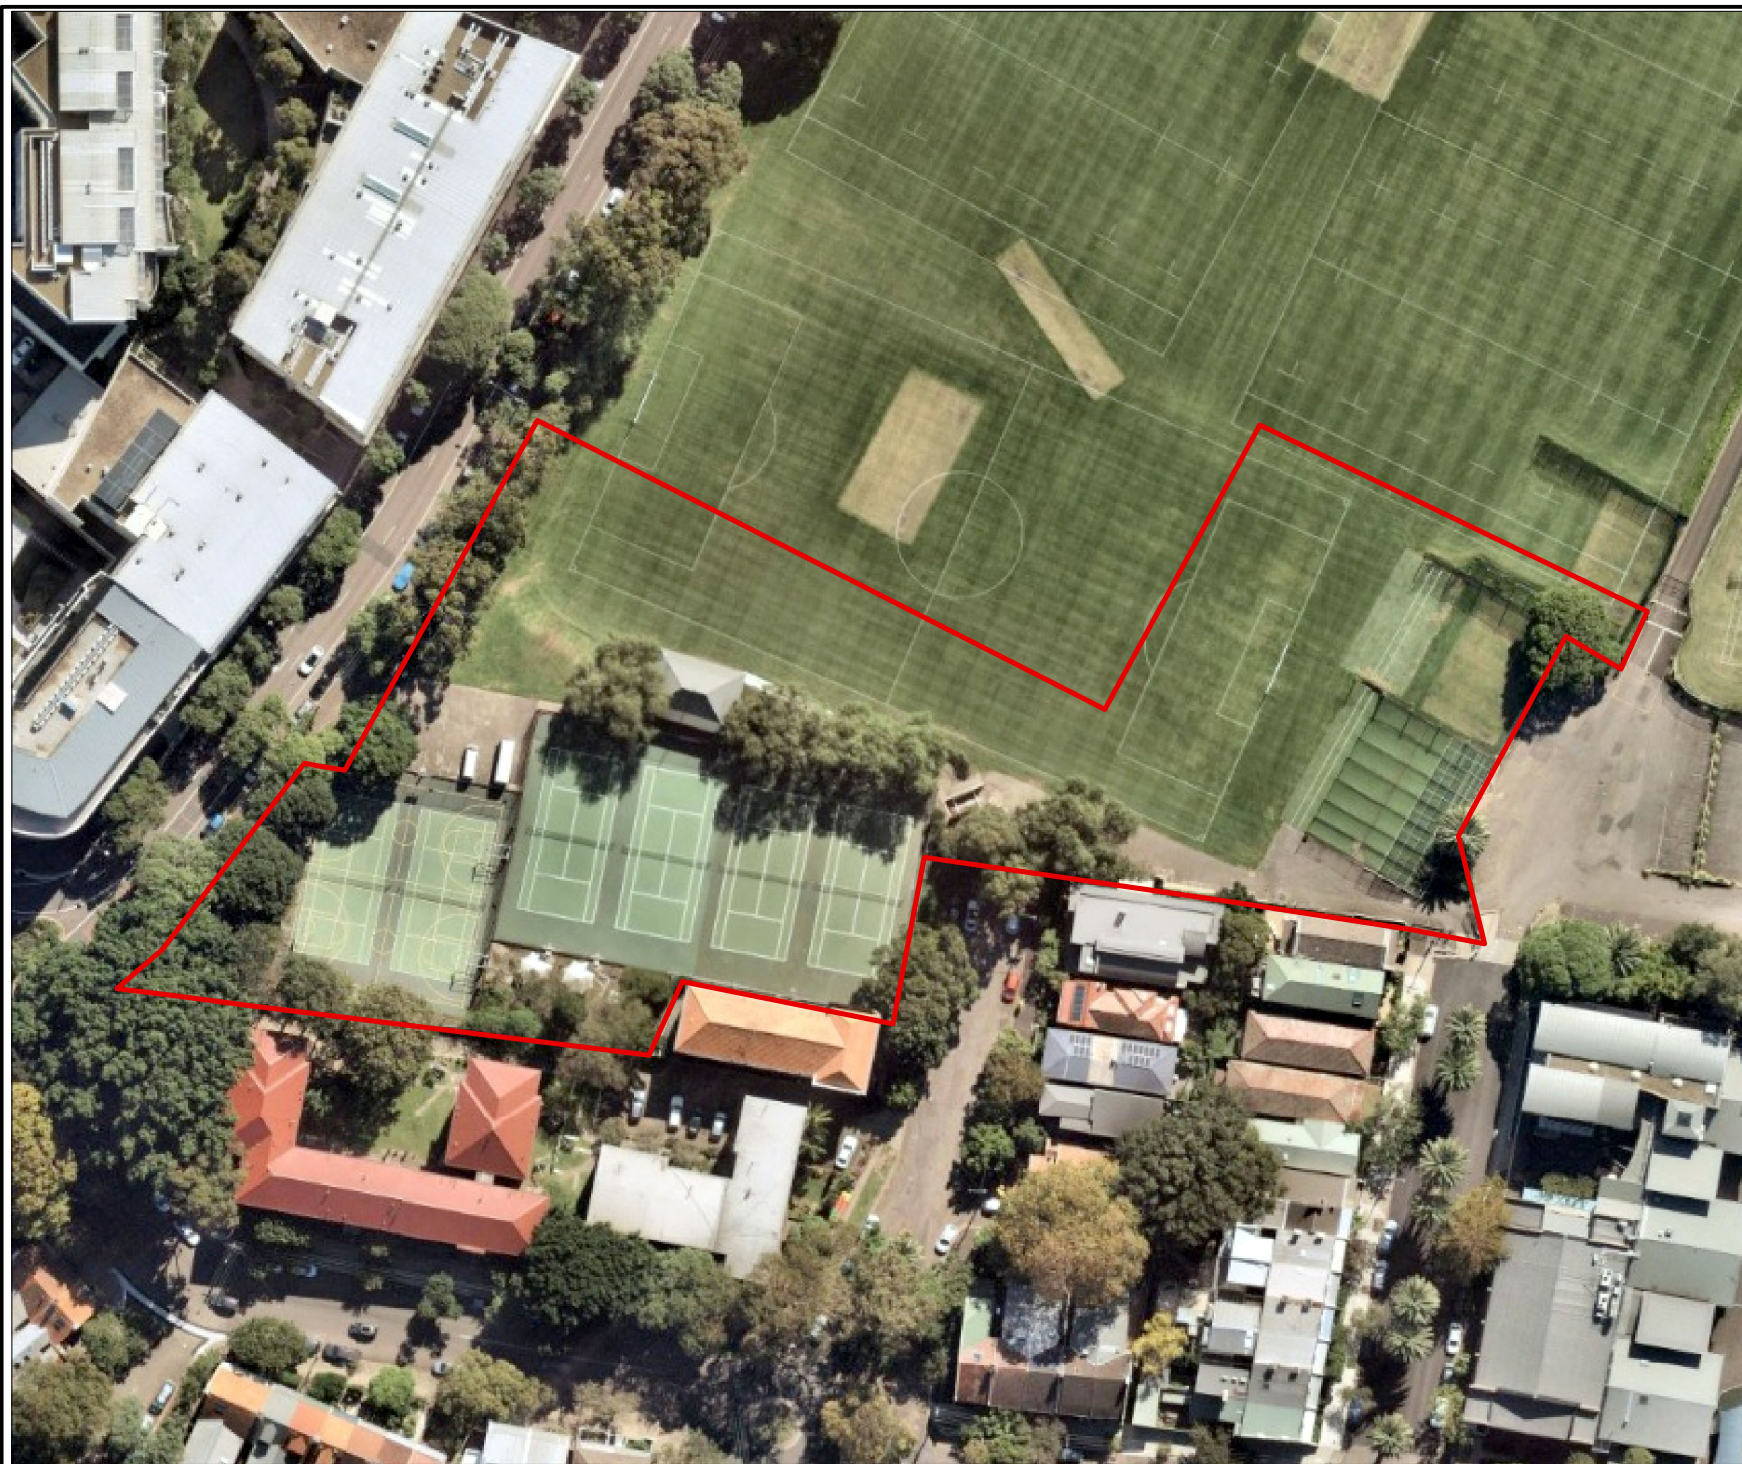
FIGURE 2

SITE LAYOUT

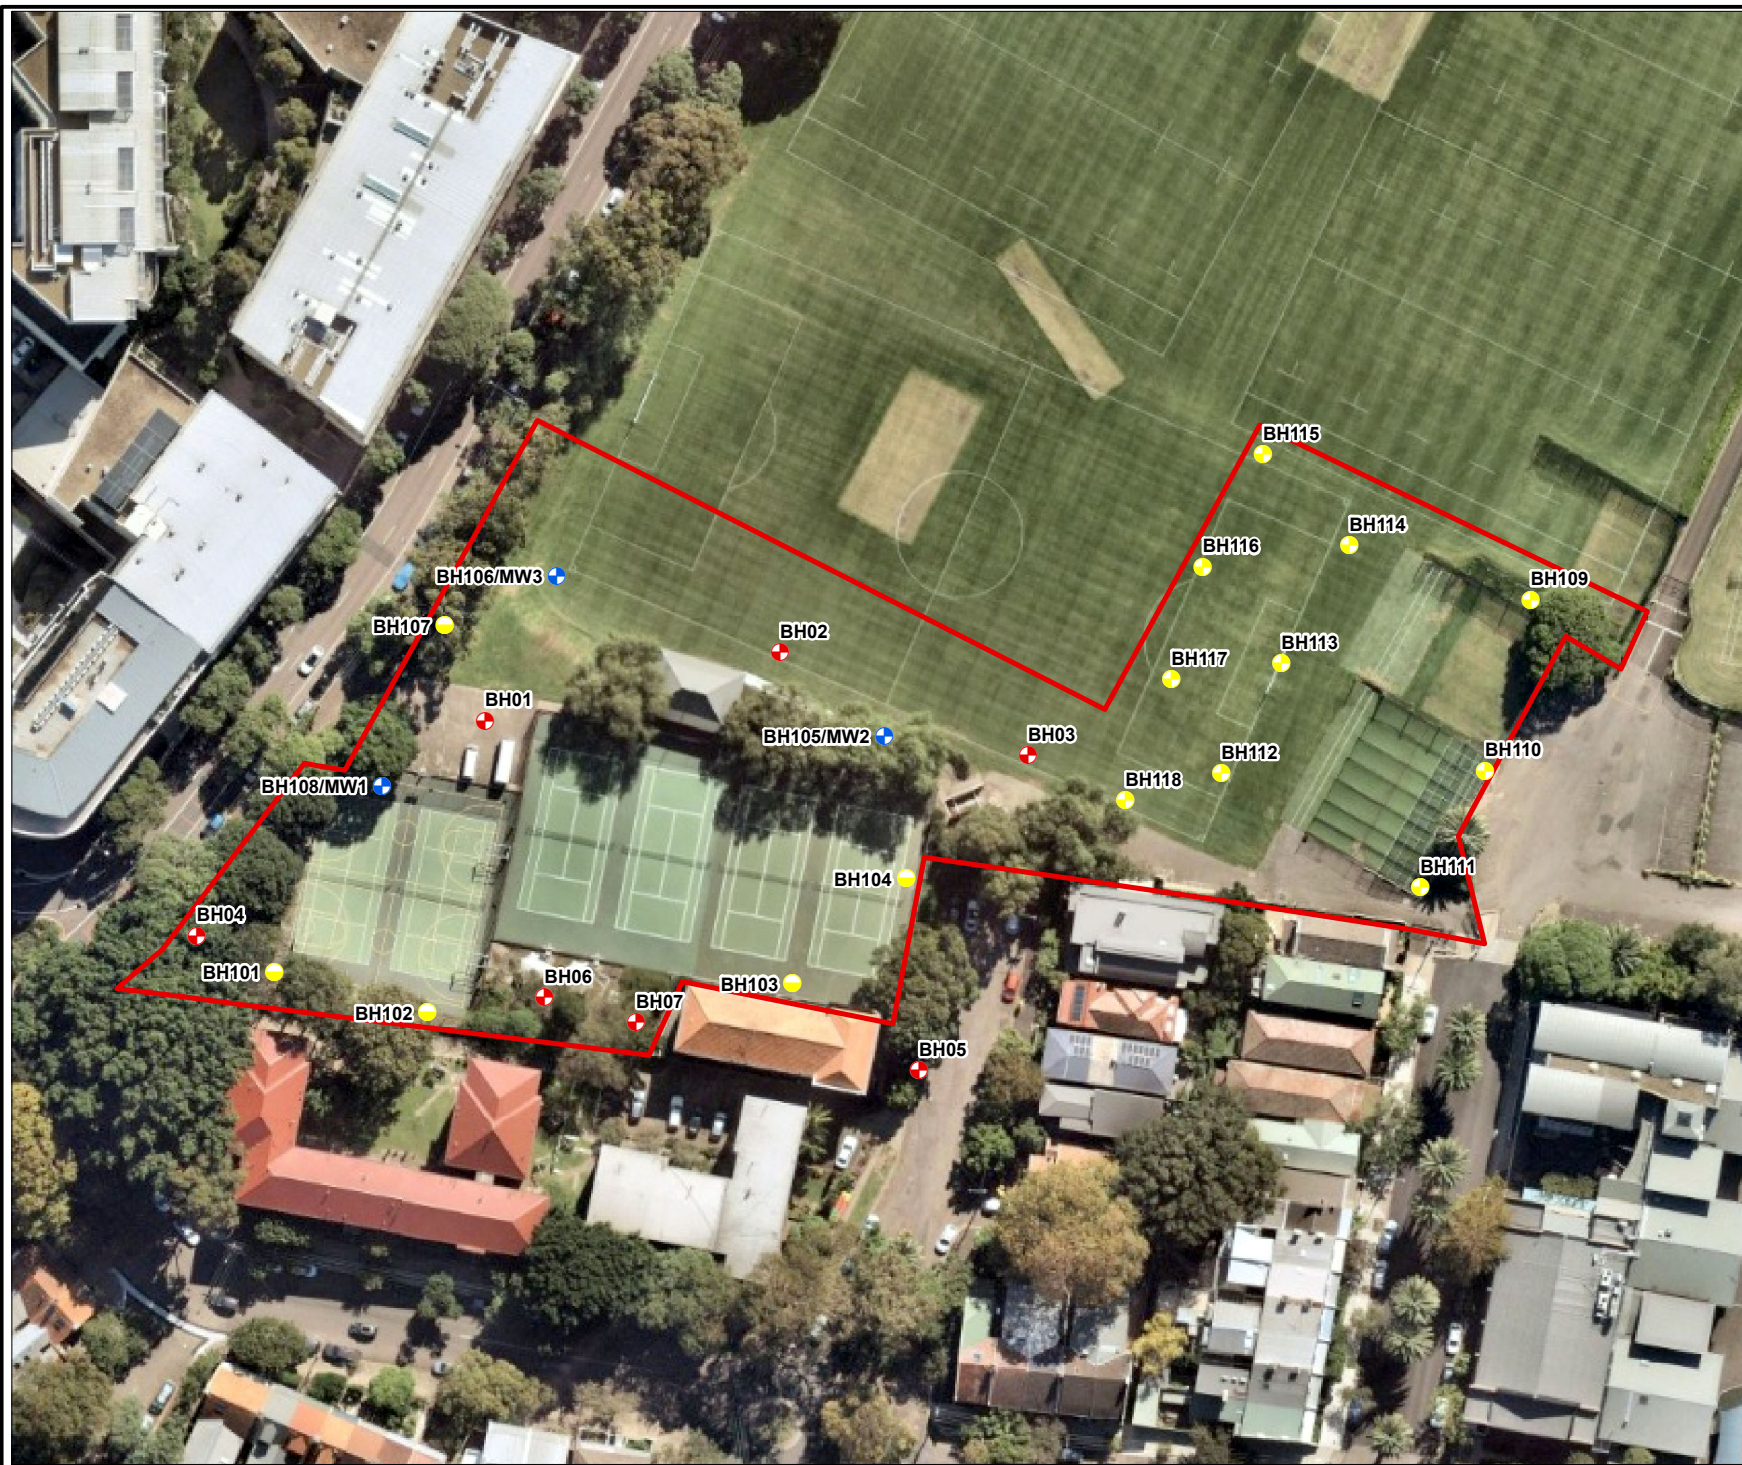
FIGURE 3

DP (2020) indicated that the northern portion of the investigation area is potentially underlain by ASS, in particular the wet, dark grey clayey sand fill containing organic matter encountered in the vicinity of BH01, BH02 and BH03 (**Figure 3**) from depths of 2.5 m bgs. Given the limited testing, DP (2020) reported that soils beneath this layer should be considered to present an elevated risk of ASS. DP (2020) further stated that, based on the preliminary field-testing results there is the potential for ASS to be present in the southern portion of the site and also noted that given the site lies in an area of disturbed terrain there exists the additional possibility for ASS to have been used as backfill at the site. Additional sampling undertaken during the DSI (JBS&G 2020) identified the presence of PASS/ASS in grey clayey sand and grey sand encountered at borehole locations MW1, MW2 and MW3.

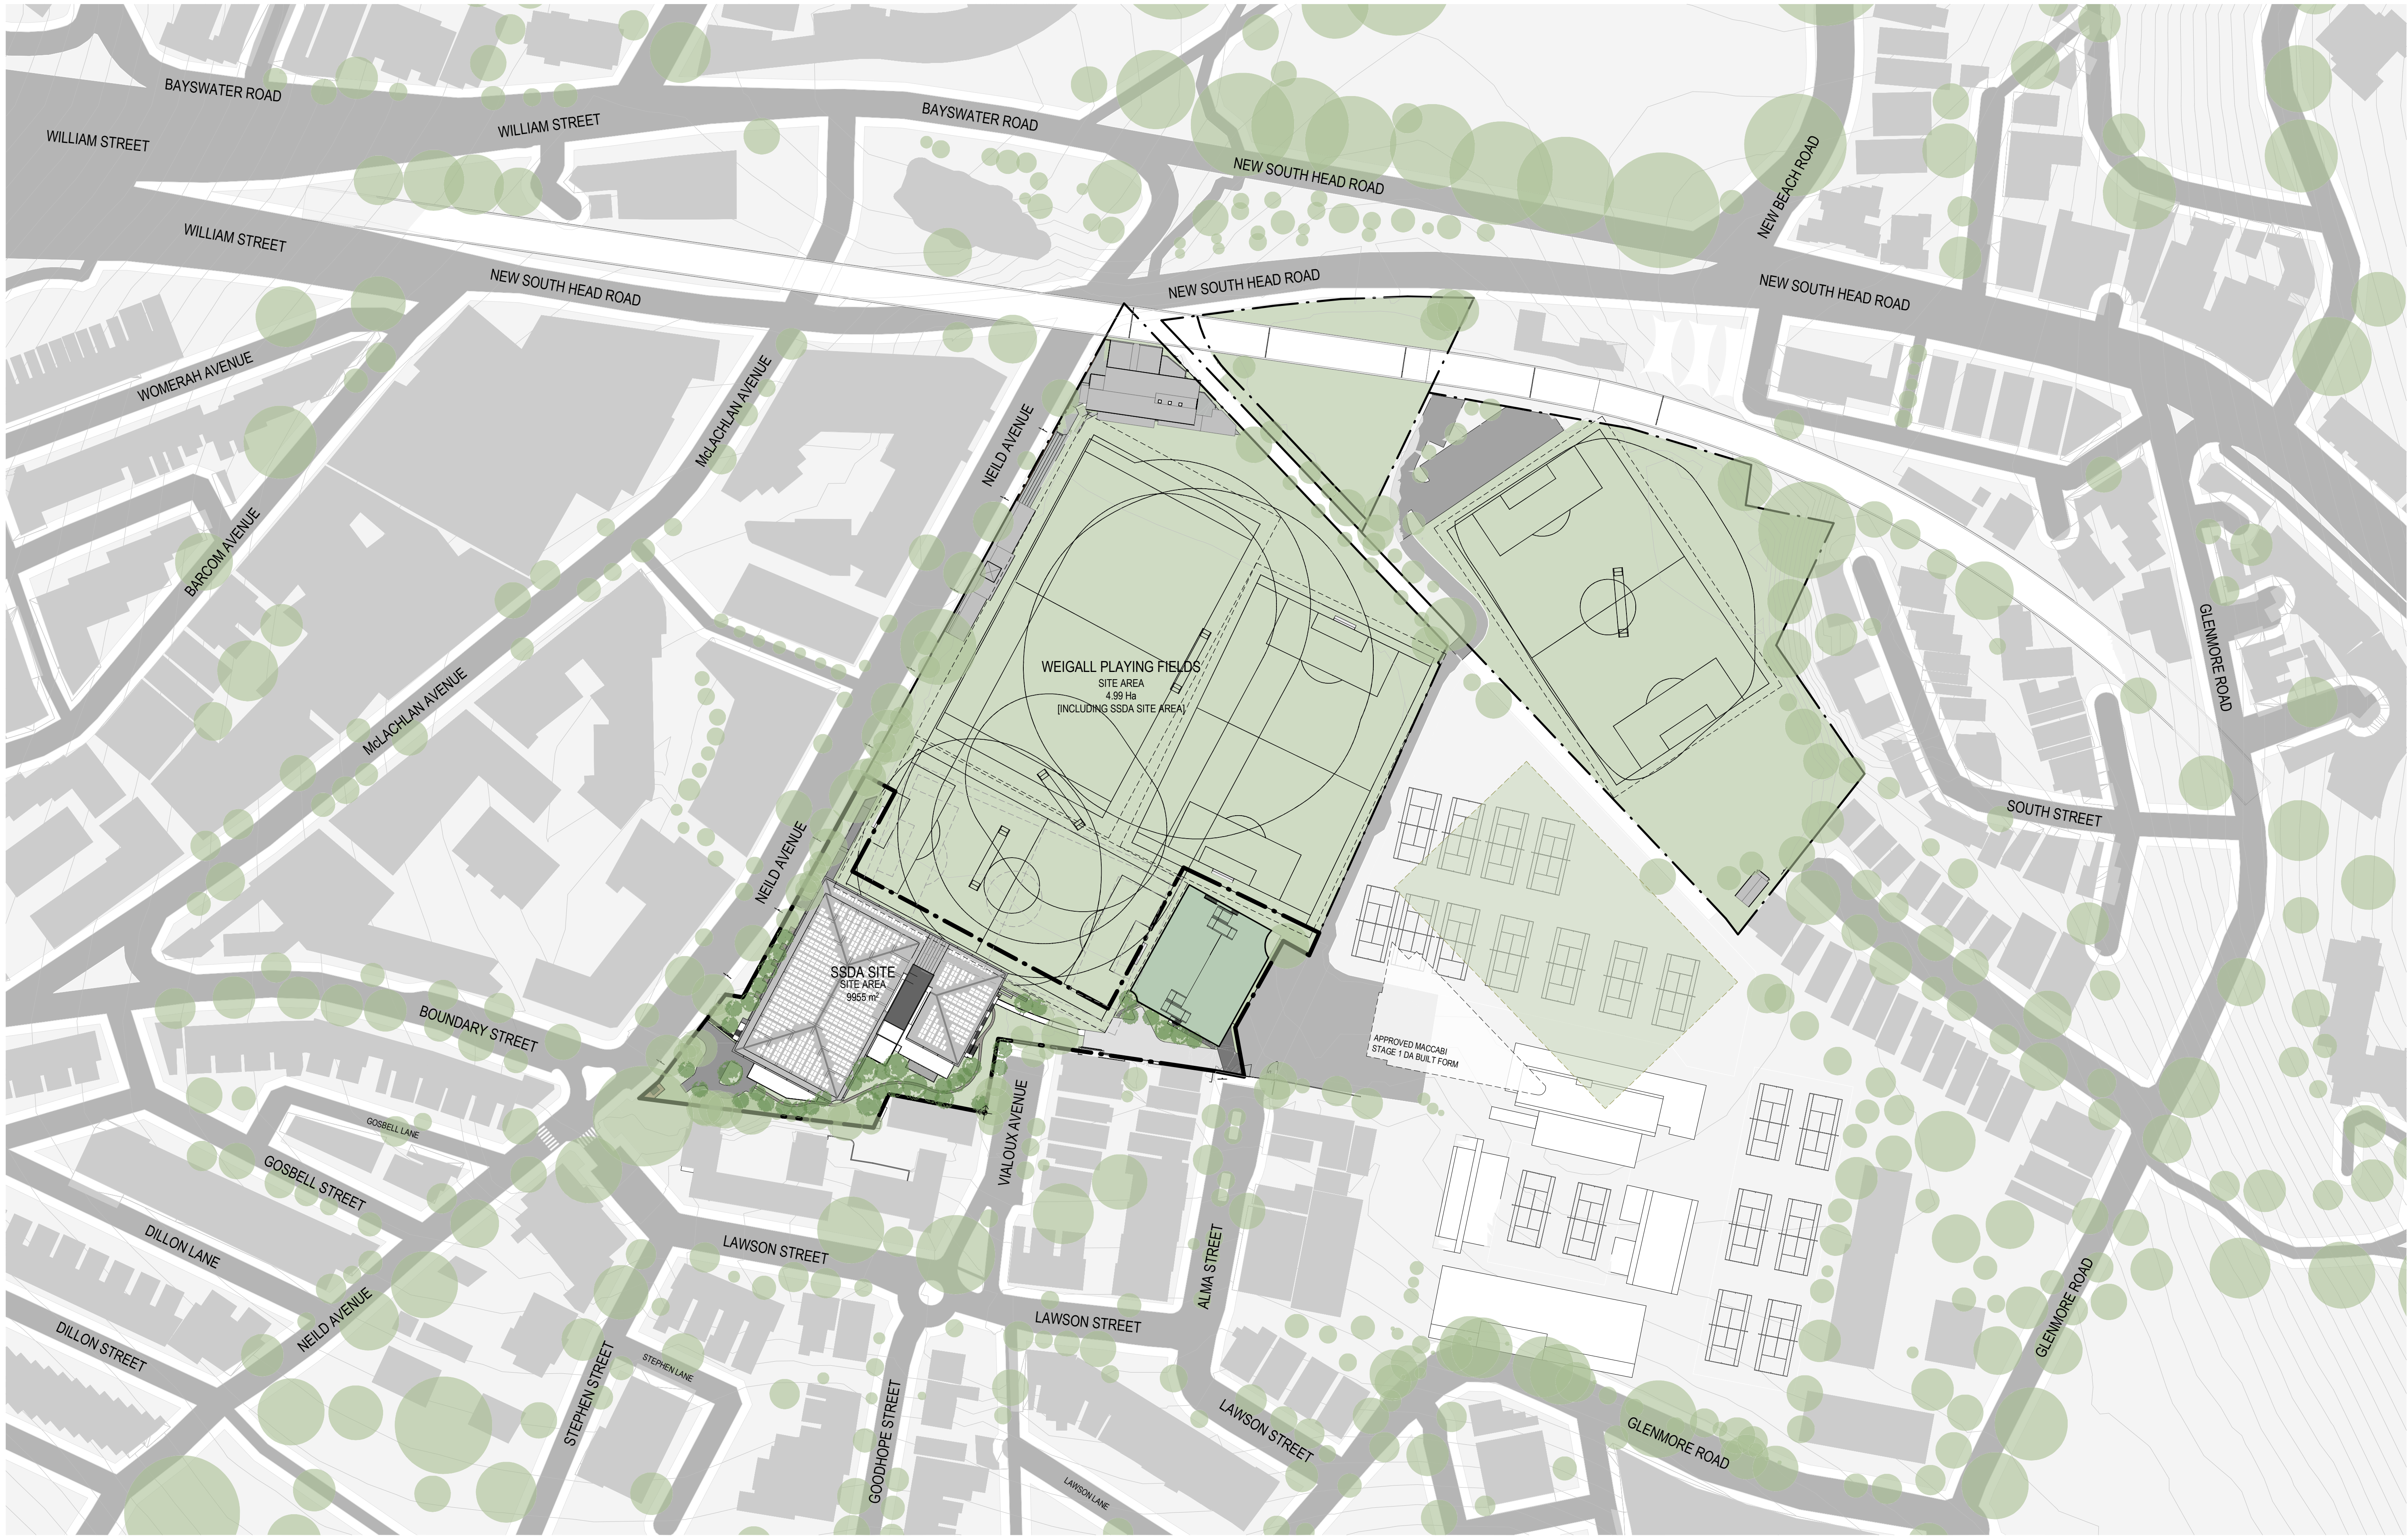
Scale
1 : 1000
@A1
Drawing No.
A1000
Issue
A

Drawing Title
**WEIGALL SPORTS COMPLEX
BUILDING 01 AND BUILDING 02
LOCALITY PLAN**
Sheet Status
NOT FOR CONSTRUCTION
