Report on  
Geotechnical Investigation

Student Housing Development  
90-102 Regent Street, Redfern

Prepared for  
The Trust Company (Australia) Limited ATF WH  
Regent Trust

Project 86852.00  
September 2020

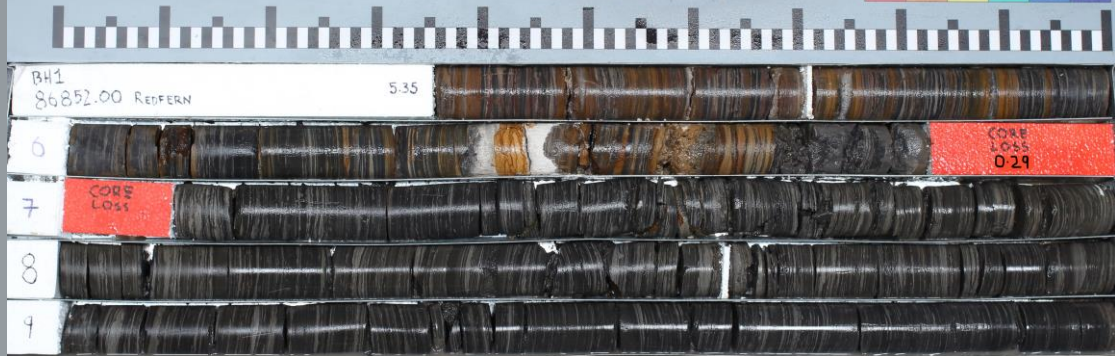
Project No: 86852.00  
BH ID: BH1  
Depth: 5.35-10  
Core Box No.: Box 1 of 1

5.35-10.0m

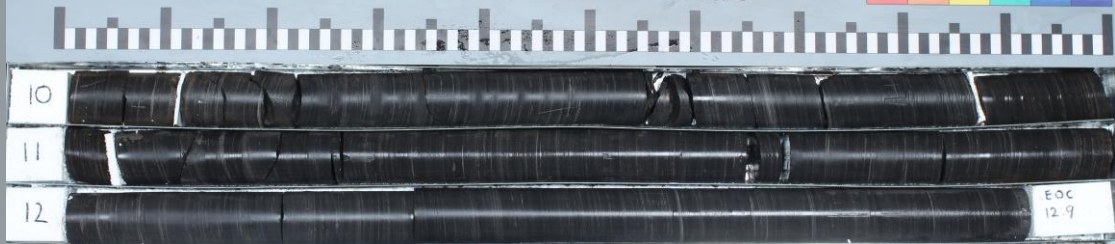
Project No: 86852.00  
BH ID: BH1  
Depth: 10-12.9  
Core Box No.: Box 2 of 2

10.0-12.9m

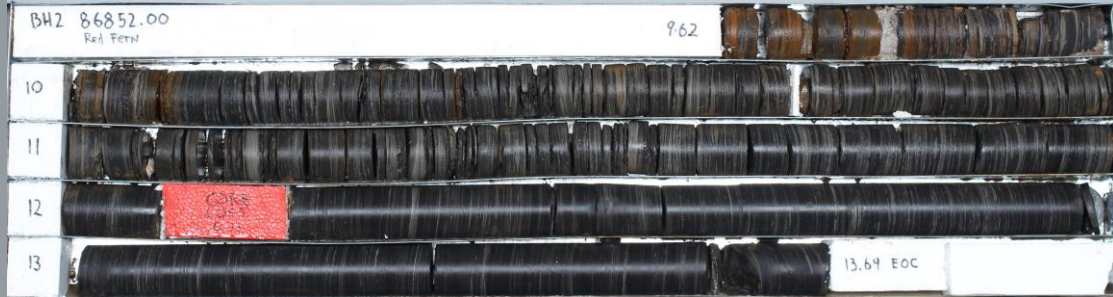
Project No: 86851.00  
BH ID: BH2  
Depth: 9.62-13.69m  
Core Box No.: 1 of 1

**9.62-13.69m**

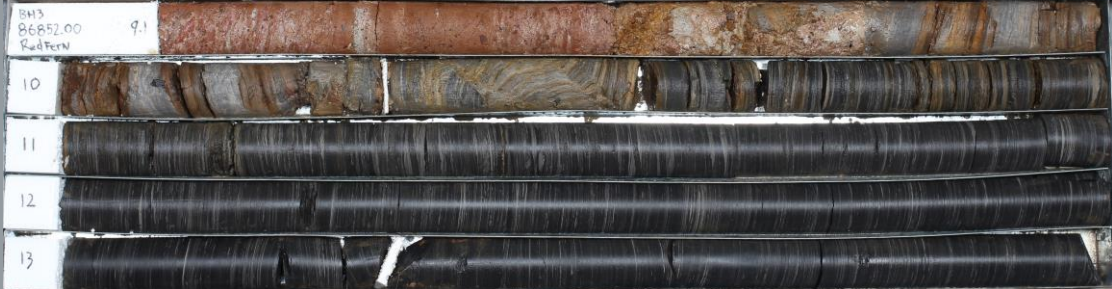
Core Box No.: Box 1 of 3

9.1-14.0m

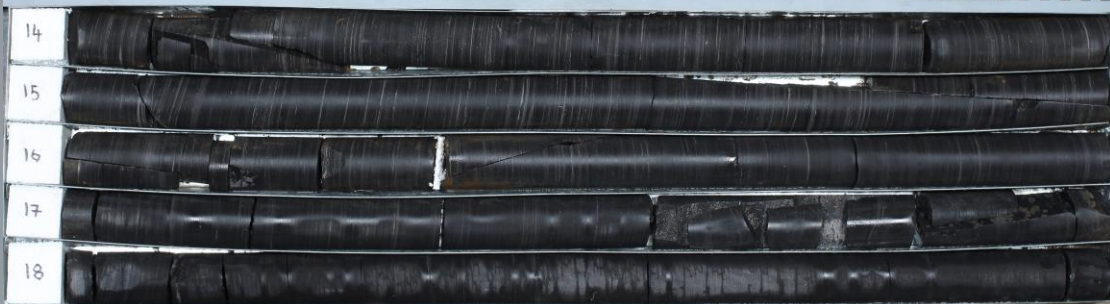
Core Box No.: 2 of 3

14.0-19.0m

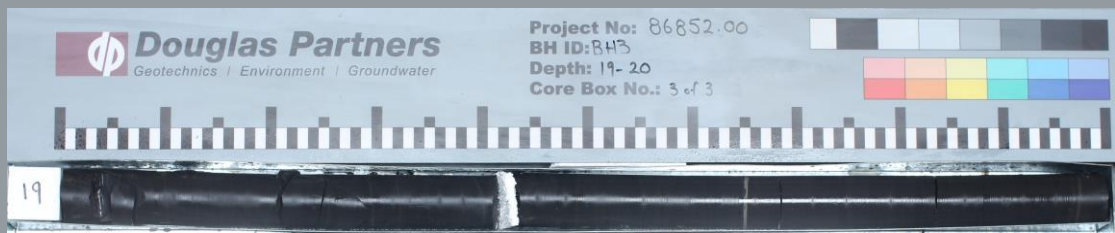
**BORE: 3    PROJECT: REDFERN SEPTEMBER 2019**

**19.0-20.0m**
