# Conceptual Remediation Action Plan

9 Church Street, Newcastle NSW  
2300

81019007

28 May 2019

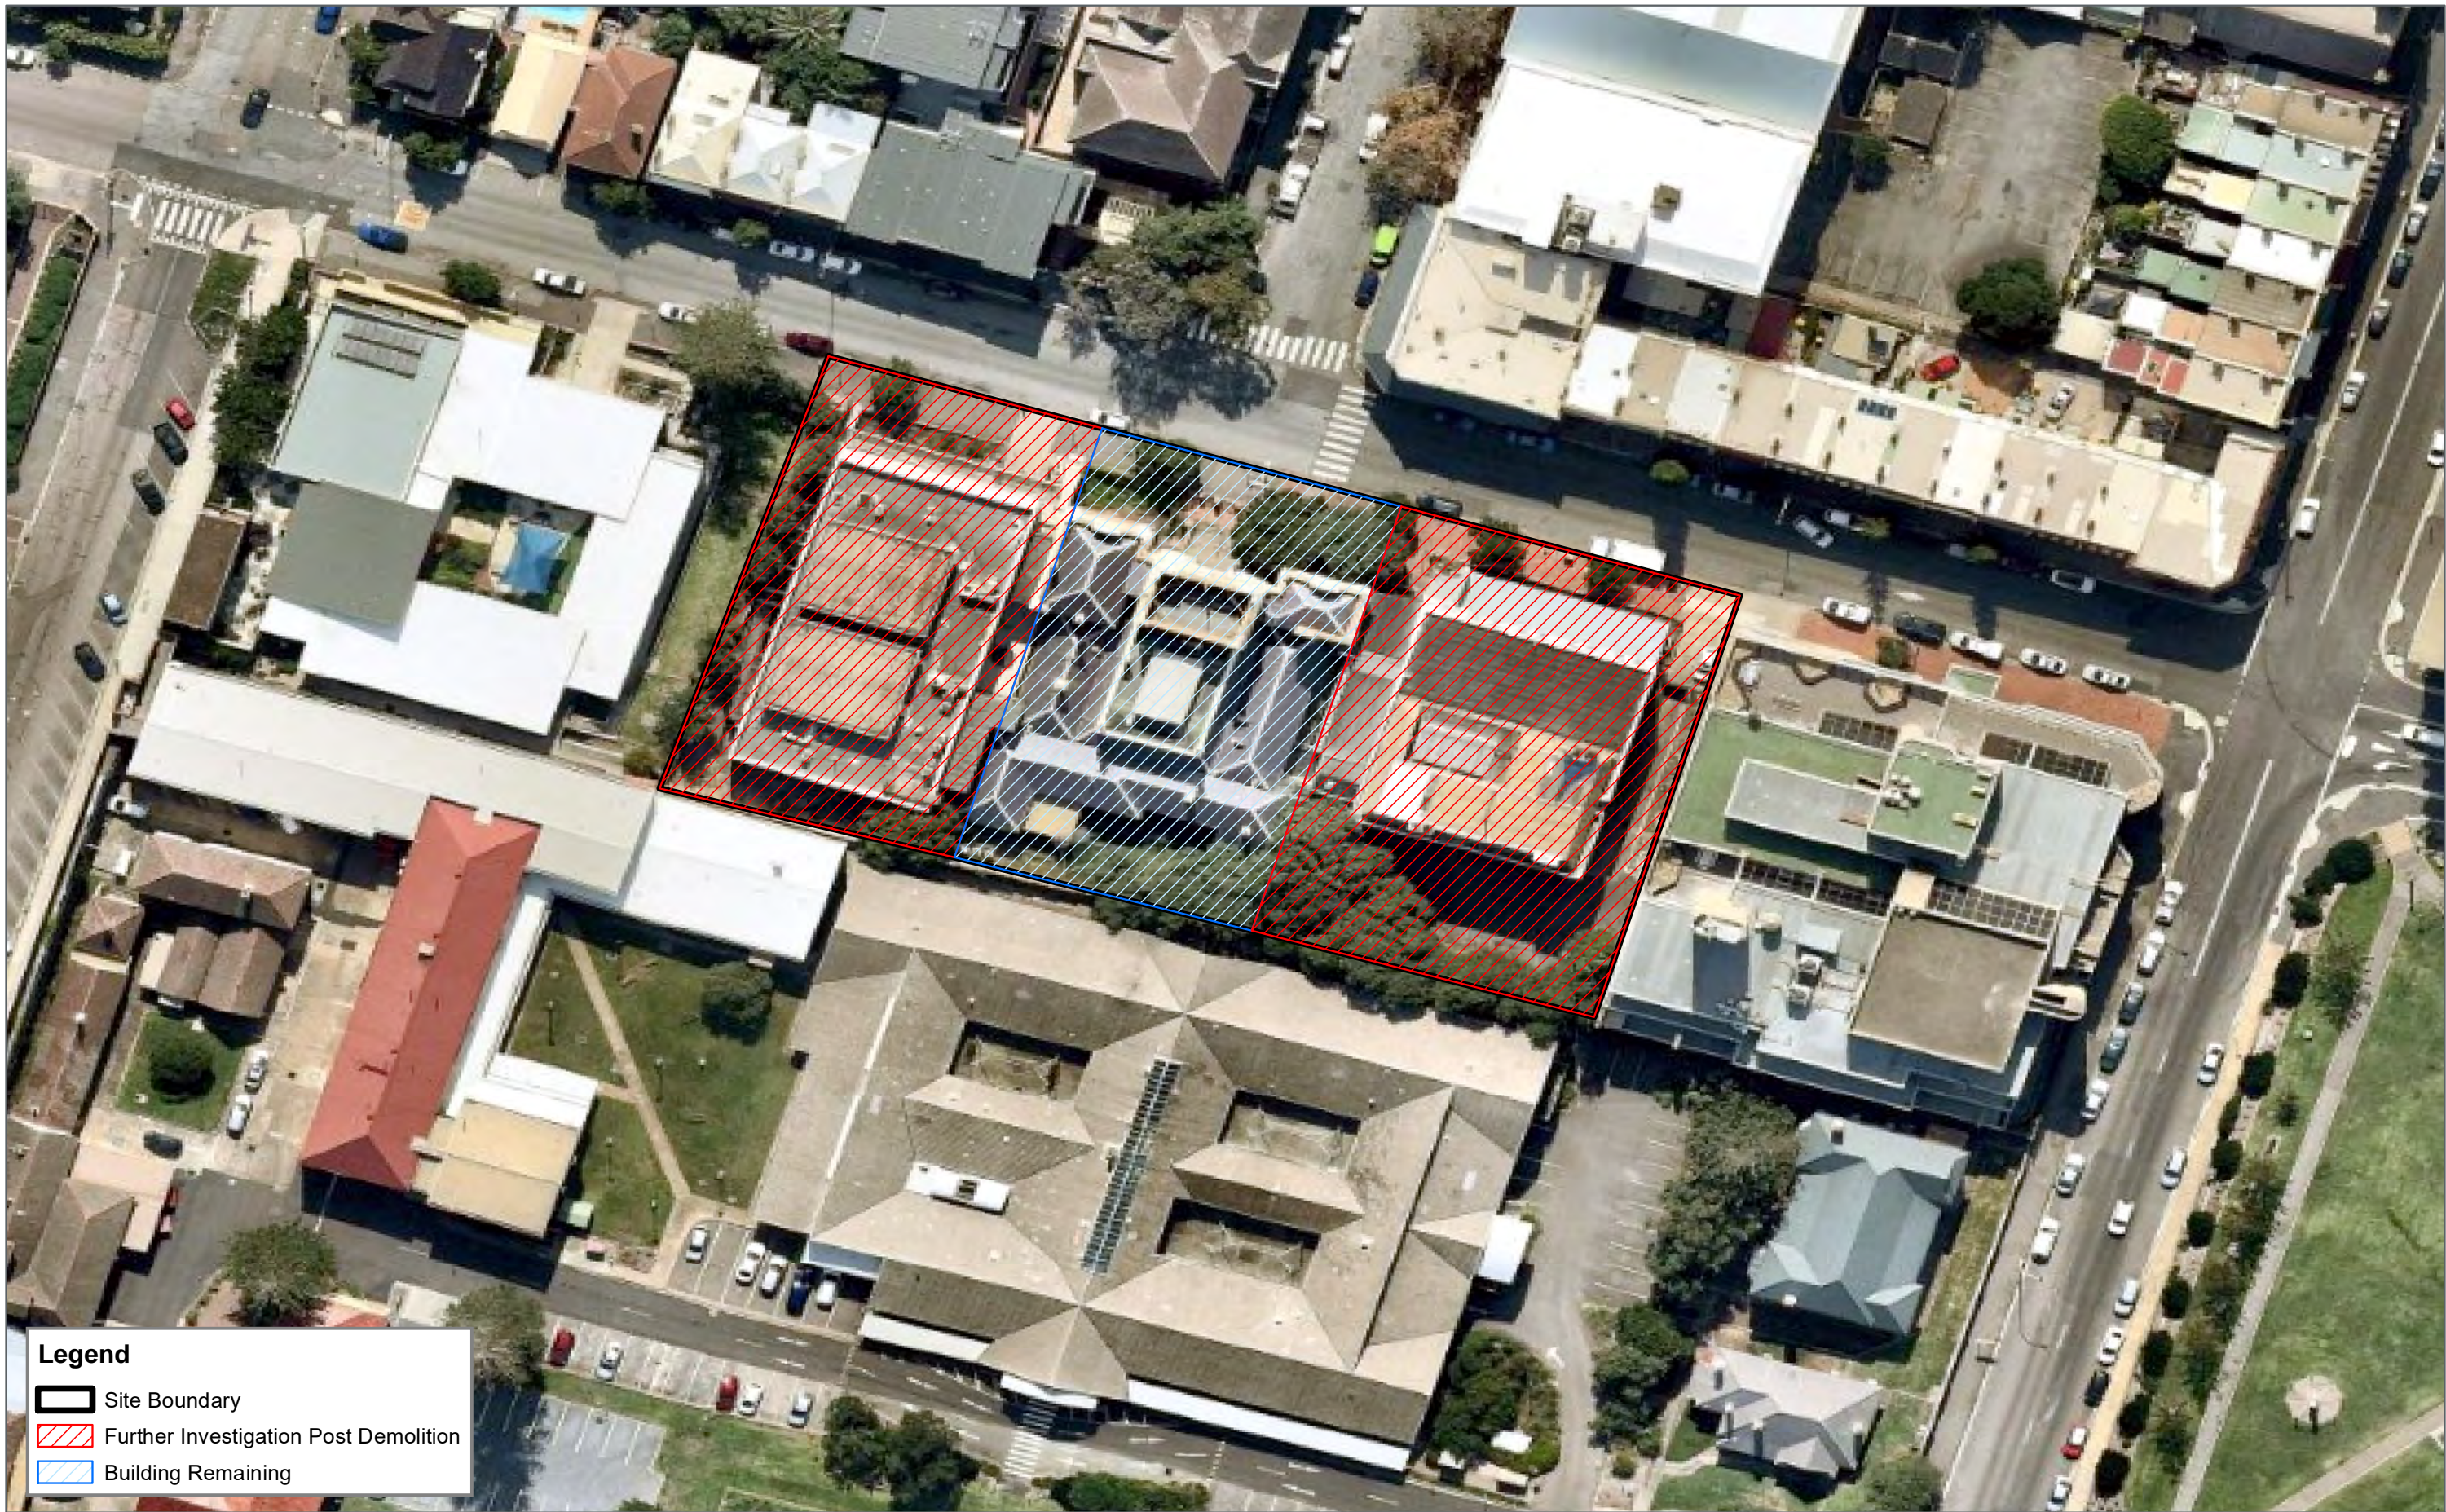
- Site Boundary
- Further Investigation Post Demolition
- Building Remaining

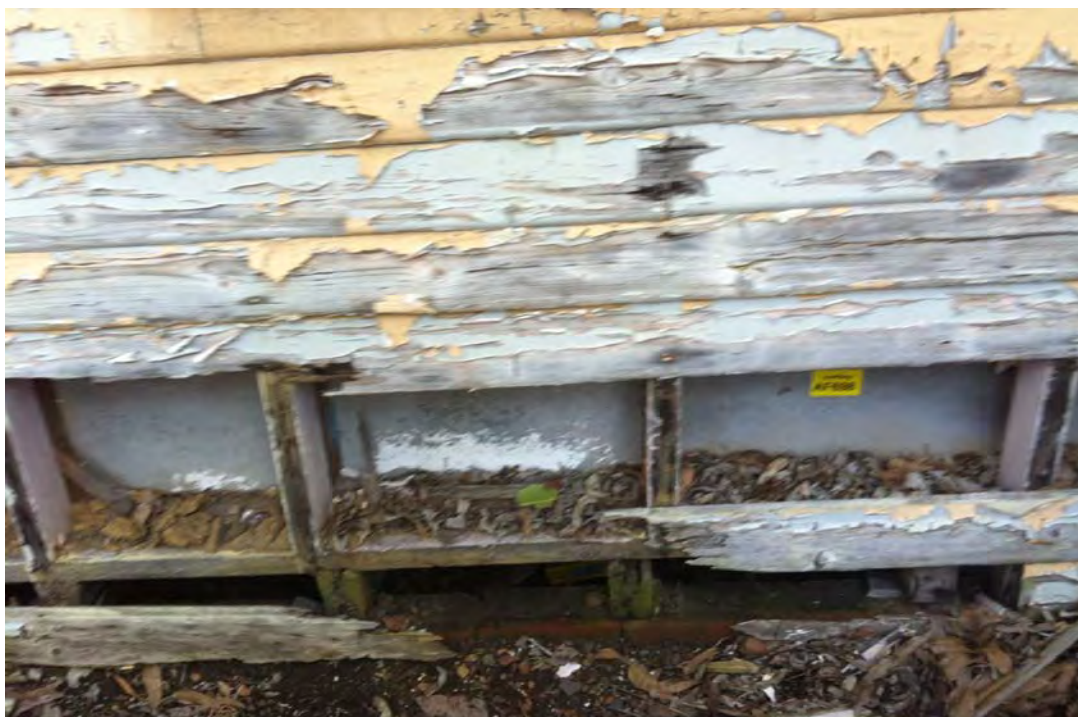
Photograph 5: Deteriorated weatherboards on southern building in site 2. Flaking lead paint

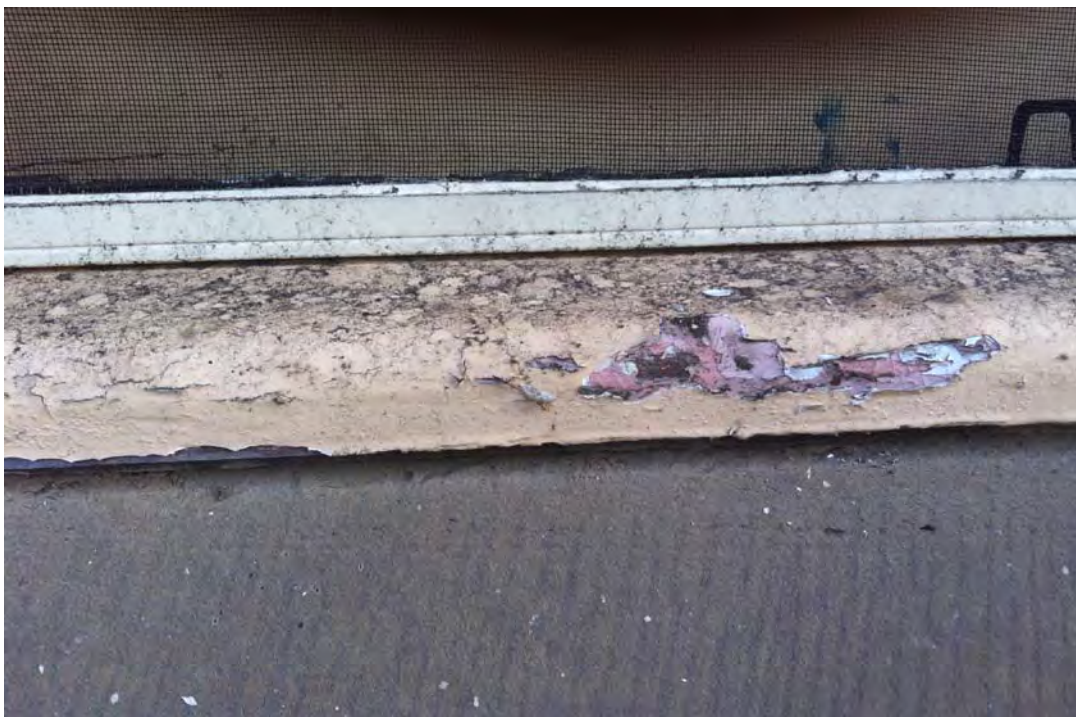
Photograph 6: Flaking lead paint on the window sill of former school building.

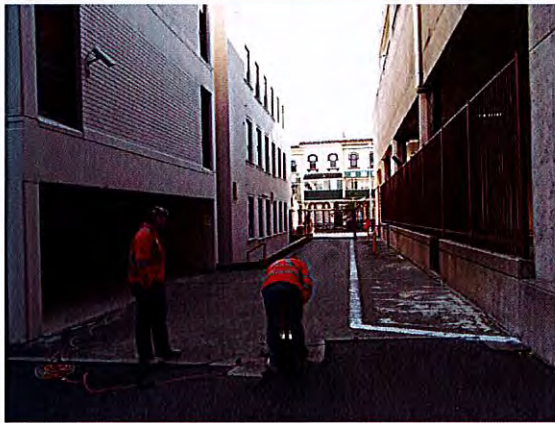
**Photo 1.** Concrete coring conducted at BH6.

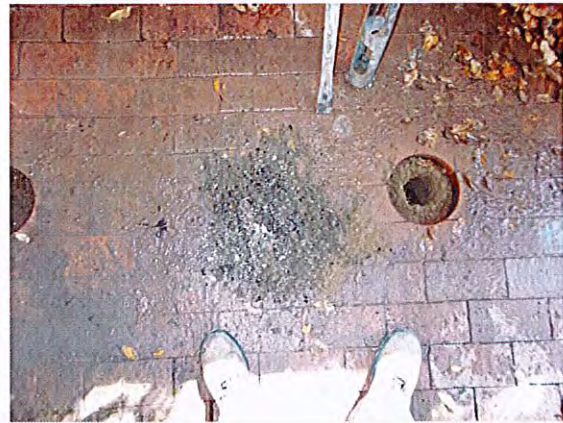
**Photo 2.** Bitumen present within fill material at BH1.

Prensa states that the identified benzo(a)pyrene concentrations were likely associated with asphalt in fill material, and that the elevated lead was likely due to degradation of lead based paint adjacent to the sample location. Risks to ecological receptors such as soil biota and terrestrial vertebrates and invertebrates were considered to be low due to the urbanised nature of the land use and zoning. However, the report concludes that should the site be used for high density residential purposes, additional investigation, remediation of management of fill material across the site and beneath slabs should be undertaken.

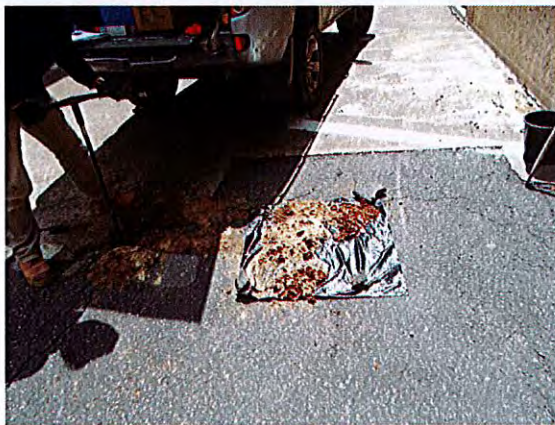
**Photo 3.** Fill material at BH6.

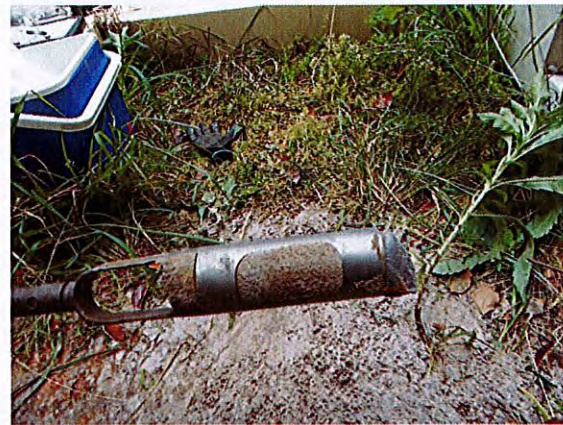
**Photo 4.** Fine to medium grained grey sand at BH10.

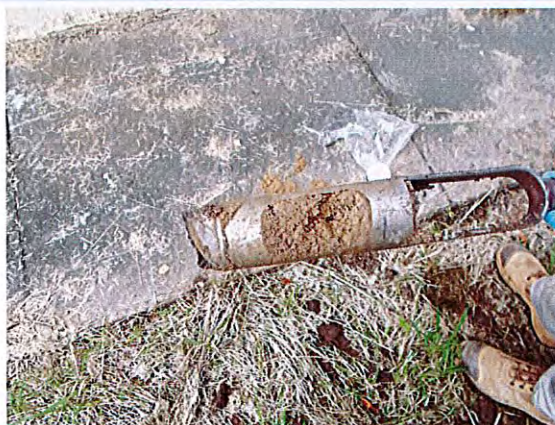
**Photo 5.** Fill material at BH9.

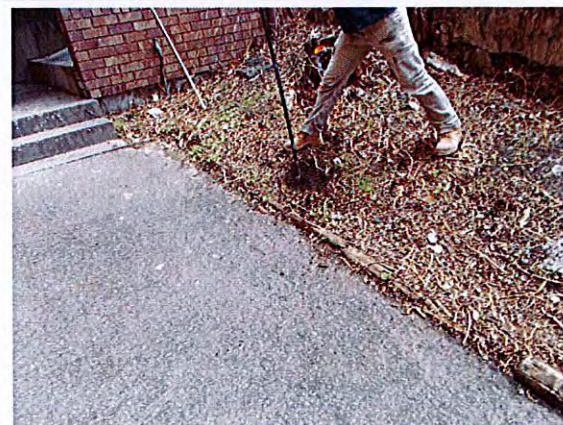
**Photo 6.** Hand auger progressing BH5. Lead impact reported at 0.1 m BGL.

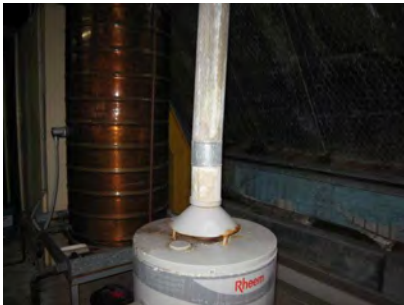
Item ref	6.1	Location
Level	Four	Connected to top of hot water heater
Type	NT	Description of material
Matrix	Hard	Presumed asbestos cement flue pipe
Condition	Sound	
Risk	R4	Comments / recommendations
Sample ref	NT	Flue pipe is sound and represents a minimal health risk if left undisturbed. Apply warning labels and avoid any abrasion by cutting or drilling. Suggest that flue be sealed with a suitable paint.
Date removed

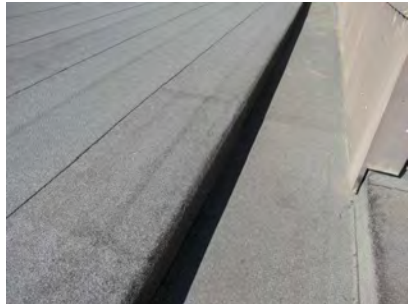
Item ref	6.1	Location
Level	Level 4	Exterior roof areas
Type	NT	Description of material
Matrix	Not sighted	Presumed asbestos based membrane material under waterproofing membranes added more recently.
Condition	Not sighted	
Risk	R4	Comments / recommendations
Sample ref	NT	Any asbestos membranes present are encapsulated by the newer membranes and would offer a minimal health risk if left undisturbed. Take the appropriate precautions during any renovations or demolition.
Date removed

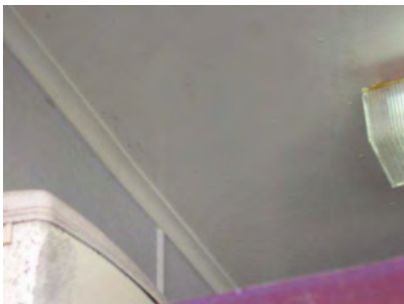
Item ref	6.2	Location
Level	Level 2	Jury Toilets at rear of building
Type	NT	Description of material
Matrix	Hard	Presumed asbestos cement wall and ceiling linings and possible toilet partitions
Condition	Not fully sighted	
Risk	R4	Comments / recommendations
Sample ref	NT	Toilets could not be accessed and photo was taken through rear window. Asbestos cement sheet represents a minimal health risk if left undisturbed and is kept sealed with paint. Apply warning labels and avoid any abrasion by cutting or drilling.
Date removed

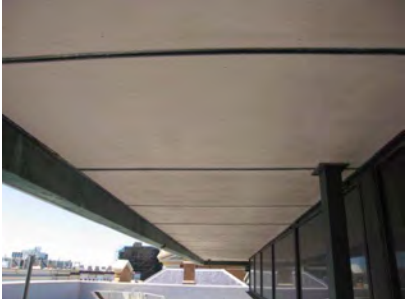
Level	Roof	Roofs over Courts 1 and 2	
Type	NT	Description of material	
Matrix	Hard	Presumed asbestos cement eaves linings	
Condition	Sound		
Risk	R4	Comments / recommendations	
Sample ref	NT	Asbestos cement sheet represents a minimal health risk if left undisturbed and is kept sealed with paint. Apply warning labels and avoid any abrasion by cutting or drilling.	
Date removed

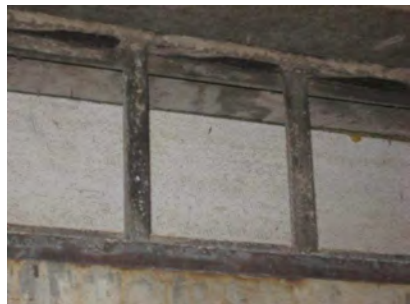
Level	Level 1	Rear air vent to car park	
Type	NT	Description of material	
Matrix	Hard	Presumed asbestos cement linings over sections of vent	
Condition	Sound		
Risk	R4	Comments / recommendations	
Sample ref	NT	Asbestos cement sheet represents a minimal health risk if left undisturbed and is kept sealed with paint. These linings are not sealed. Seal with paint, apply warning labels, and avoid any abrasion by cutting or drilling.	
Date removed

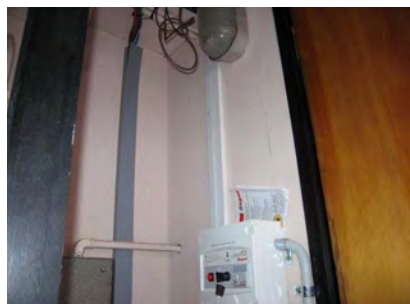
Level	Levels 2 and 3	Service cupboards off public spaces outside Courts 1 and 2	
Type	NT	Description of material	
Matrix	Hard	Presumed asbestos cement linings inside cupboards	
Condition	Sound		
Risk	R4	Comments / recommendations	
Sample ref	NT	Asbestos cement sheet represents a minimal health risk if left undisturbed and is kept sealed with paint. Apply warning labels and avoid any abrasion by cutting or drilling.	
Date removed

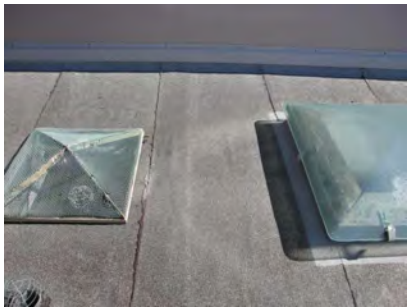
Level	Level 4	Exterior flat roof areas	
Type	NT	Description of material	
Matrix	Not sighted	Presumed asbestos based membrane material under waterproofing membranes added more recently.	
Condition	Not sighted		
Risk	R4	Comments / recommendations	
Sample ref	NT	Any asbestos membranes present are encapsulated by the newer membranes and would offer a minimal health risk if left undisturbed. Take the appropriate precautions during any renovations or demolition.	
Date removed

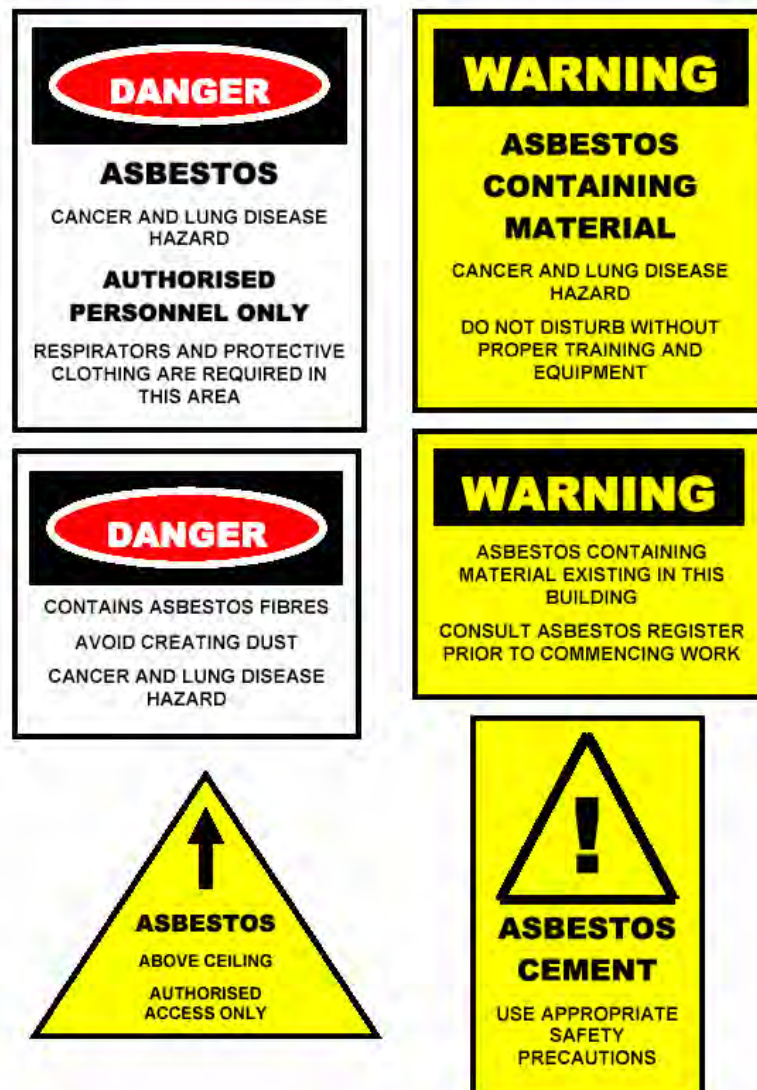
**Figure 2 – Examples of warning signs and labels**

**Note:** The examples of warning signs and labels in **Figure 2** provide only an indication of the words that may be used to alert persons to the presence of ACM and asbestos hazards. *The wording is not mandatory.* Other warning signs and labels may be used, provided they meet the requirements of AS 1319.
