# **HISTORIC ARCHAEOLOGICAL ASSESSMENT**

**SIRIUS SITE, 2-60  
CUMBERLAND STREET,  
THE ROCKS.**

16 FEBRUARY 2021  
P0019042  
FINAL  
PREPARED FOR SIRIUS DEVELOPMENTS PTY LTD

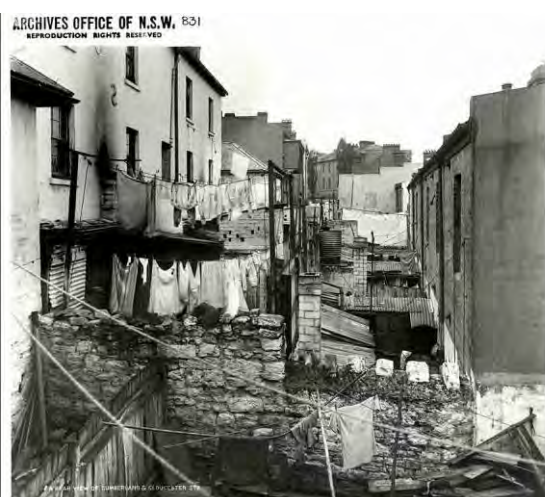
Figure 10 – Rear of terraces on Gloucester and Cumberland Streets, Rocks Resumption Photographic Survey, 1901. Note the difference between site level is visible at this time, with Cumberland Street higher than Gloucester Street.

In the early 1800s, while settlement and development took place around it, the land upon which the Sirius Building currently resides remained primarily vacant, with only a few structures present to the south (see Figure 12). As The Rocks continued to develop and grow, the subject area was subdivided and developed. By 1880, the subject area was heavily subdivided and included a number of terrace houses and buildings (see Figure 13). Terrace houses in this area generally fronted onto Cumberland Street with rear entrances to Gloucester Street. Evidence along the ridgeline suggests that, from as early as 1820, sandstone was quarried along the ridgeline, with properties fronting Gloucester Street (on its former alignment) and Cumberland Street divided (comment from Place Management NSW, 2021). This is evidenced in Figure 10 above, where the gardens of Cumberland Street and Gloucester Street properties are not aligned.

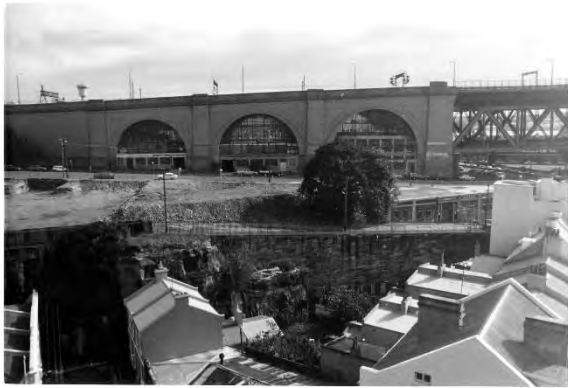
Figure 19 – Photograph, 1977. The site upon which Sirius is constructed has been cleared, with Gloucester Walk visible in the foreground. The site is cleared with some footings of previous structures visible along Cumberland Street.

The construction of the Sirius Building saw the demolition of the existing buildings within the subject area, including the Rowan’s Bond Store and the Mercantile Shipping Office. The site was cleared by 1977, with photographs showing the cleared Sirius site (see Figure 19 and Figure 20). In clearing the site, photographs demonstrate that the existing structures were almost entirely demolished, and the site level was considerably lower at the time than Cumberland Street, with footings visible where the Cumberland Street pavement is now present. Following the clearing of the site, it was then bulk excavated for the existing carpark, and now the site steps up above Cumberland Street with the basement levels below.

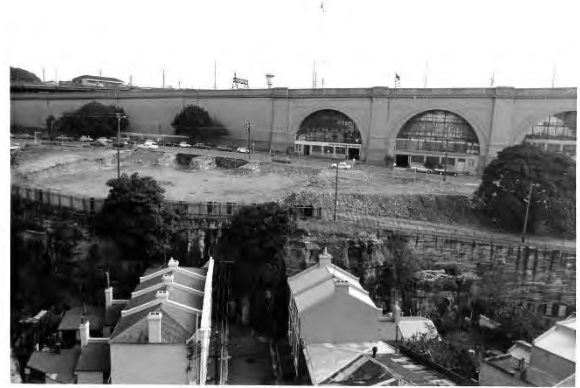
Figure 20– Photograph, 1977. The site upon which Sirius is constructed has been cleared, with Gloucester Walk visible in the foreground. The site is cleared with some footings of previous structures visible along Cumberland Street and there is a visible difference between the level of the site and the level of Cumberland Street.

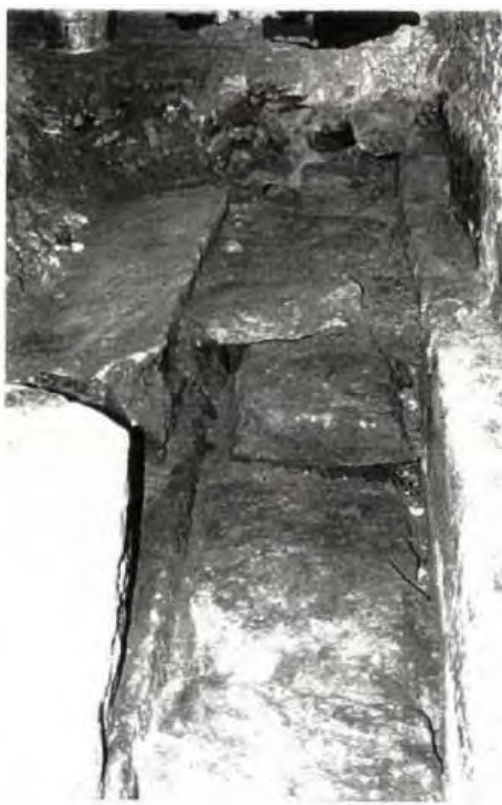
Figure 24 – Box drain associated with south wall of Cleland Bond Store, Johnson 1996.

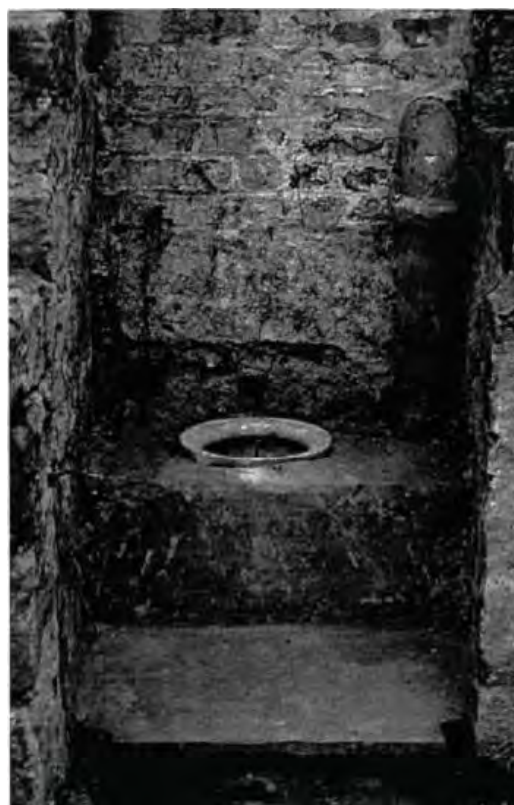
Figure 25 – excavated toilet and stair from rear of No 6 Gloucester St, Johnson 1996.

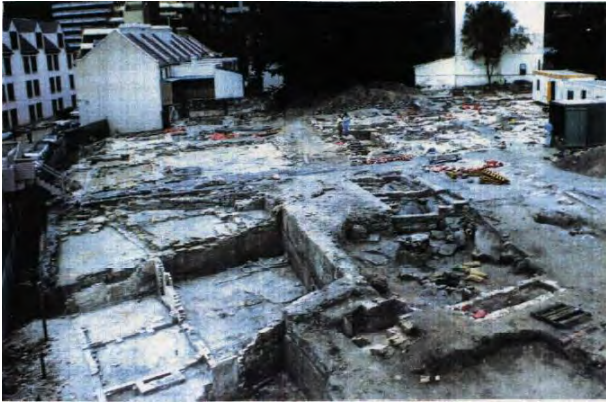
Figure 26 – subject area looking south during excavation, Godden Mackay 1994.

The Gloucester/Cumberland Street excavations were undertaken over 20 weeks with over 400 volunteers in 1994 and aimed to investigate the archaeological resources associated with early colonial life in the rocks. This archaeological investigation was undertaken approximately 160m south of the current subject area. The assessment identified that this area had been home to a number of commercial and domestic properties as well as narrow laneways and paths, revealing a totally different view of the Rocks to the one currently extant. The resulting assemblage included ceramics, pipes, glass, structural foundations, bone and abundant other material (see Figure 26-Figure 28). This assessment is one of the largest archaeological programs undertaken within Sydney, with the area (and buildings above) now known as the Big Dig Centre and used as a resource not only to teach future generations of archaeologists about Sydney's colonial past, but also to demonstrate to members of the wider public the significance and interest inherent in archaeology (see *Figure 29*).

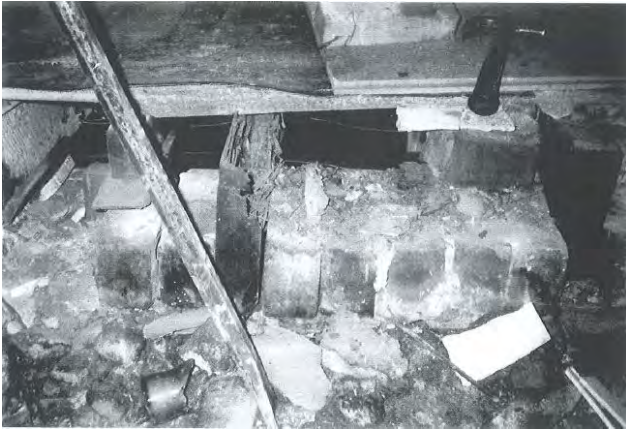
Figure 30 – image from monitoring program showing exposed subfloor area

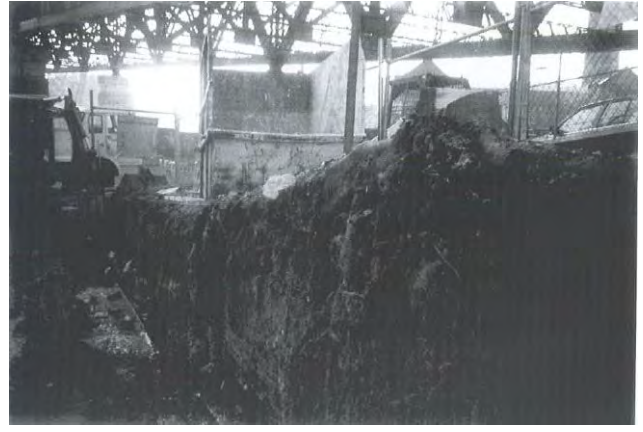
Figure 31 – exposed soils behind eastern boundary wall

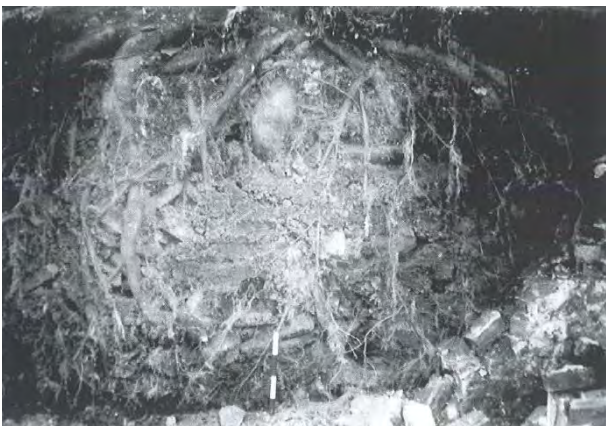
Figure 32 – Root system containing artefacts

In the southern section the removal of a tree resulted in the identification of a number of artefacts from a refuse dump which the root system had grown through. This included the following: bottles dating to 1928-1929, a Pascals sweet jar base, glass fragments, potentially of gin bottles, slate, and unidentified metals. Below the root system sandstone bedrock was encountered.

Austral identified that these artefacts were primarily related to the construction and occupation of the Harbour View Hotel and that due to post depositional disturbance the chronological integrity of these materials was poor. Austral posited that the artefactual material entangled in the roots was likely the result of a dump outside the hotel dating to the 1920s, and further that there was potential that these materials were associated with the frequenting of the pub by construction workers working on the Harbour Bridge. Austral asserted that the disturbed nature of the materials removes the capacity to make this claim with any certainty, however. No materials associated with earlier occupation were identified by Austral.

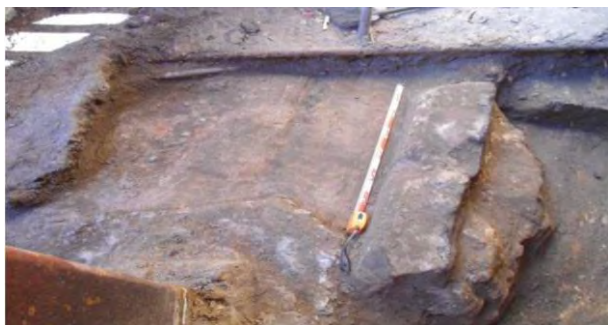
Figure 34 – Sandstone road fabric below basement  
Source: DSCA, 2012

The works included the removal of the basement slab and subsurface works below. Through the removal of the slab, an intact sandstone road and kerbside remains were exposed, and retained in situ. The road represents the remains of the old alignment of Gloucester Street. Following the alignment of the street as identified by the monitoring at the Glenmore Hotel, the remains of Gloucester Street would also run under the current subject area, beneath the Sirius building. However, the substantial disturbance resulting from the construction of Sirius and the basement level below the Sirius Building will likely have removed any *in situ* remains of the Gloucester Street road surface. This assessment found that any previously accumulated occupational deposits or structural remains were likely removed during the resumption period (c.1901) and/or during the hotel construction.

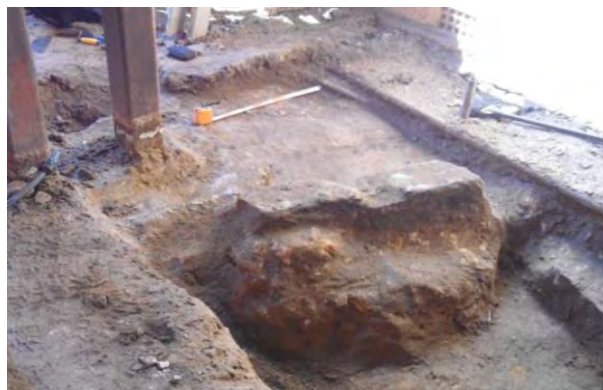
Figure 35 – Sandstone road fabric below basement with sandstone retaining wall.  
Source: DSCA, 2012

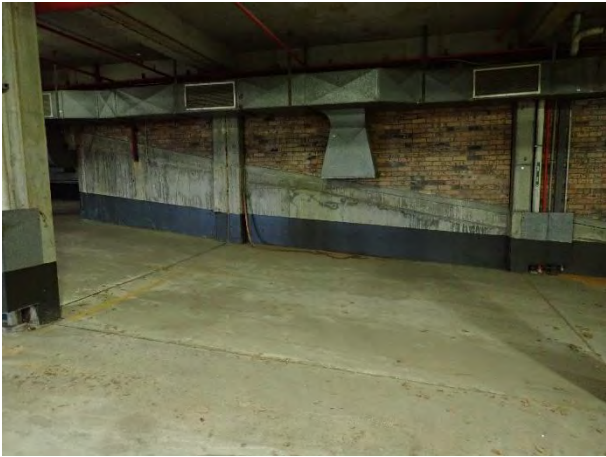
Figure 48 – basement parking level with brick wall.

The site inspection identified that the construction of the Sirius building has resulted in considerable disturbance across the site, through the presence of basements levels, in some areas cut into the natural sandstone bedrock (see Figure 48-Figure 52). Sandstone blocks with degraded mortar were identified about the natural sandstone bedrock in the boiler room, the origins of which are unknown. While these blocks may represent structural remains from earlier developments, they are more likely to be functional in nature, representing a retaining wall at the edge of the Sirius development.

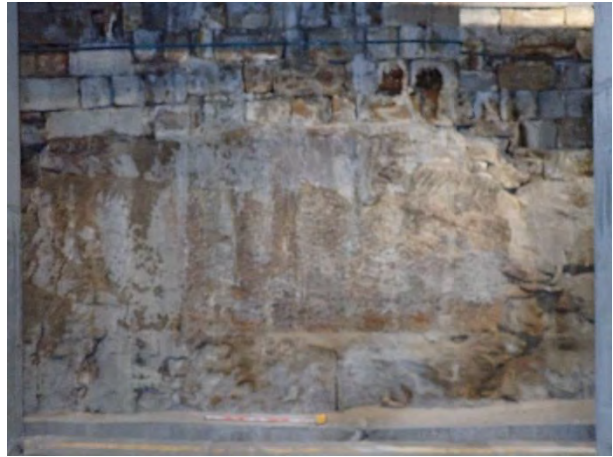
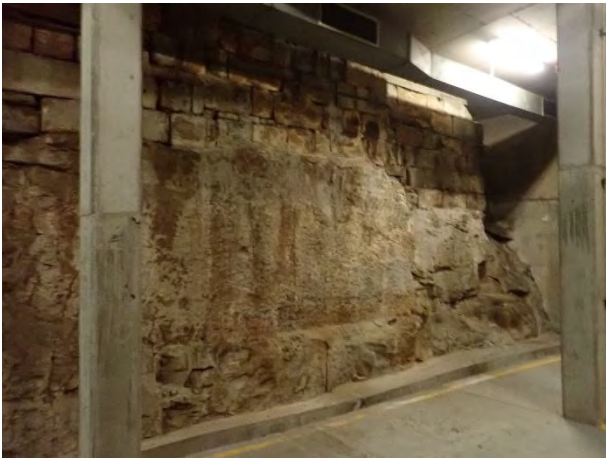
Figure 49 – sandstone bedrock cut for the boiler room basement, with sandstone blocks present on top of the bedrock.

Figure 50 – sandstone bedrock cut for the boiler room basement, with sandstone blocks present on top of the bedrock.

Sandstone blocks with degraded mortar were identified about the natural sandstone bedrock in the boiler room, the origins of which are unknown. While these blocks may represent structural remains from earlier developments, they are more likely to be functional in nature, representing a retaining wall at the edge of the Sirius development.

The site inspection did not identify any areas of archaeological potential or archaeological materials, excluding the sandstone blocks potentially the remnants of previous structures, which are under investigation.

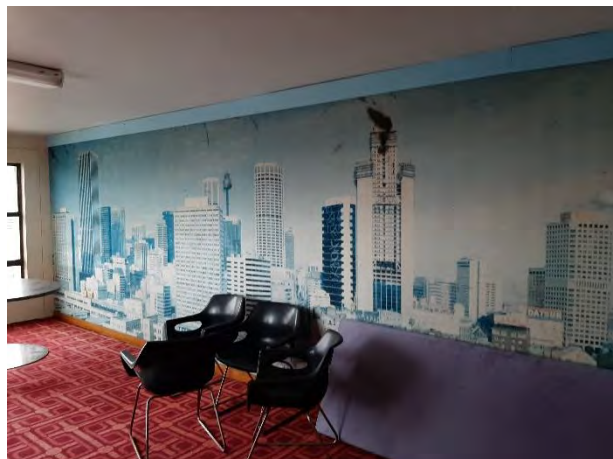
Figure 53 – example of an interior room, with the flooring not suitable for the presence of underfloor deposits.
