Urbanco Group Pty Limited
PO Box 546
PYRMONT NSW 2009Project 94525.04
27 June 2019
R.001.Rev0
GAR

Email: guy.evans@urbancogroup.com.au**Further Asbestos Investigation
Proposed St Marys Intermodal Freight Terminal
Lot 2, Forrester Road, St Marys, NSW****1. Introduction**

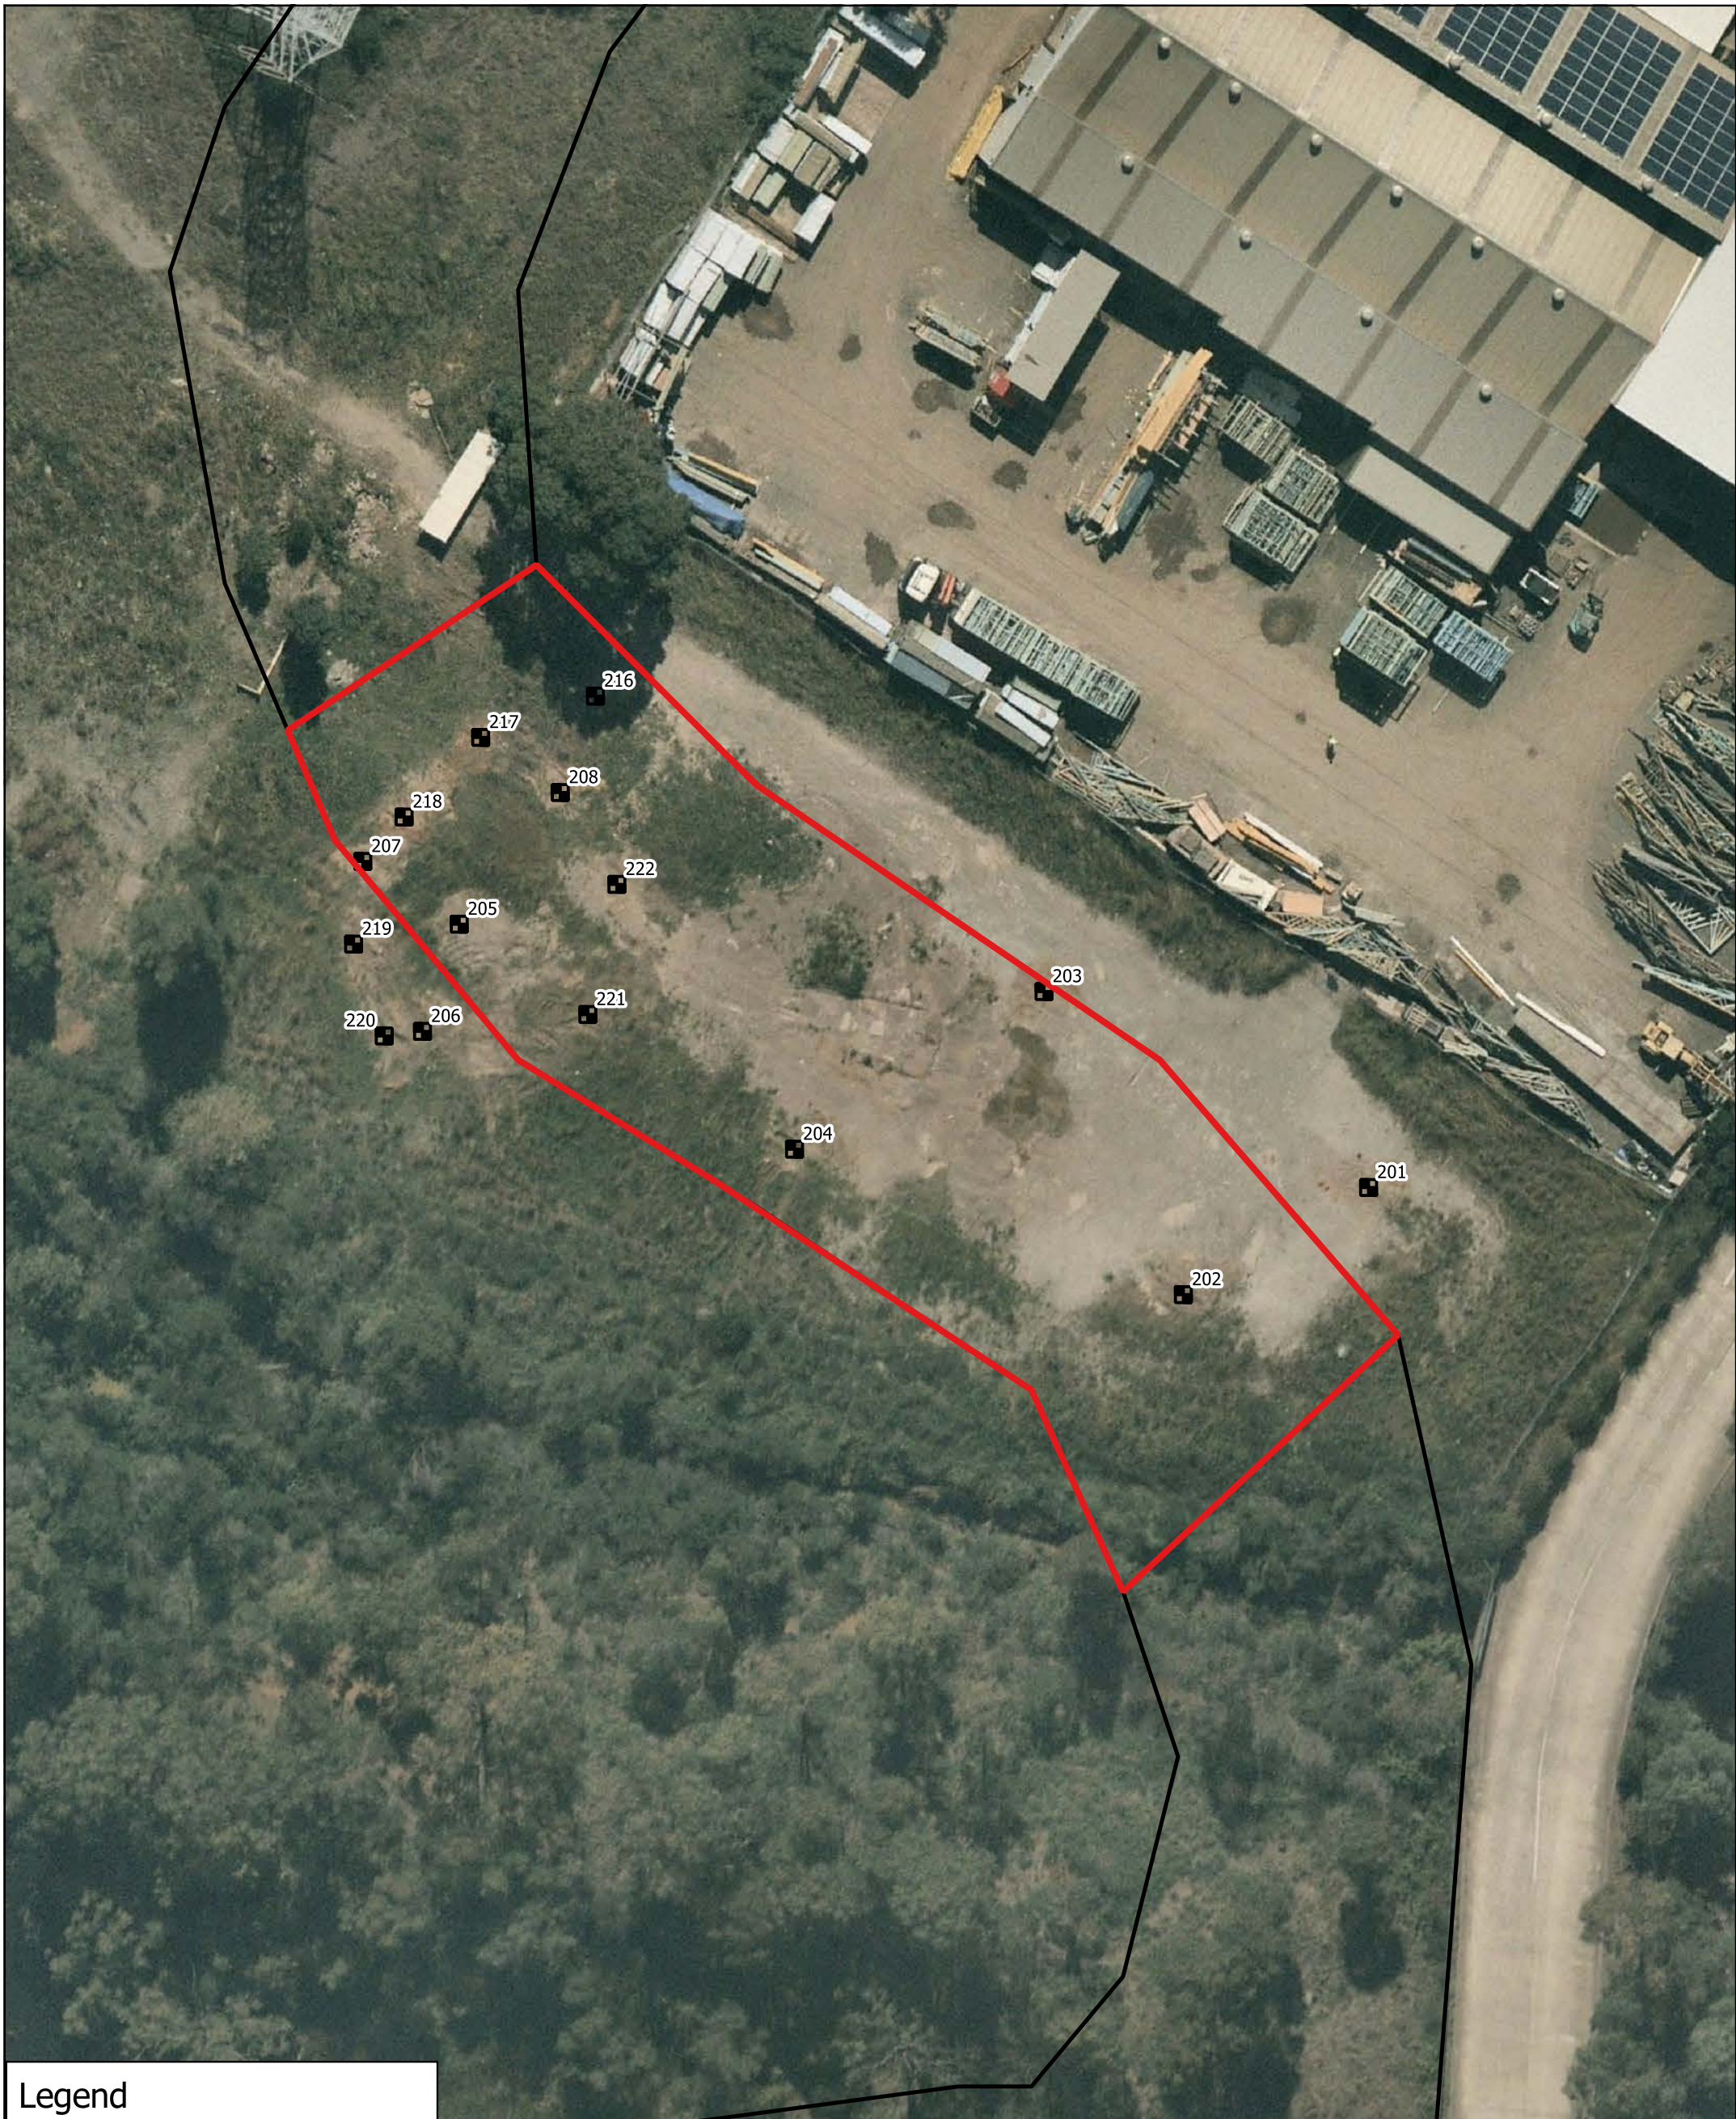
CLIENT: PROJ. 94525.04 DRAWING No: 2 REVISION: 0

A supplementary contamination assessment (SCA, DP ref. 94525.02.R.002.Rev1) of the larger site completed in April 2019 identified bonded asbestos containing material (ACM) impacted fill within two test pits (TP205 and TP208) completed within the site (referred to as PAEC1 in the SCA) at concentrations exceeding commercial / industrial land use health screening levels. The SCA test pit locations within the site are shown on Drawing 2, Appendix A.

TITLE: **SCA Test Pit Locations**
Further Asbestos Delineation Investigation
Lot 2 Forrester Road, St Marys NSW

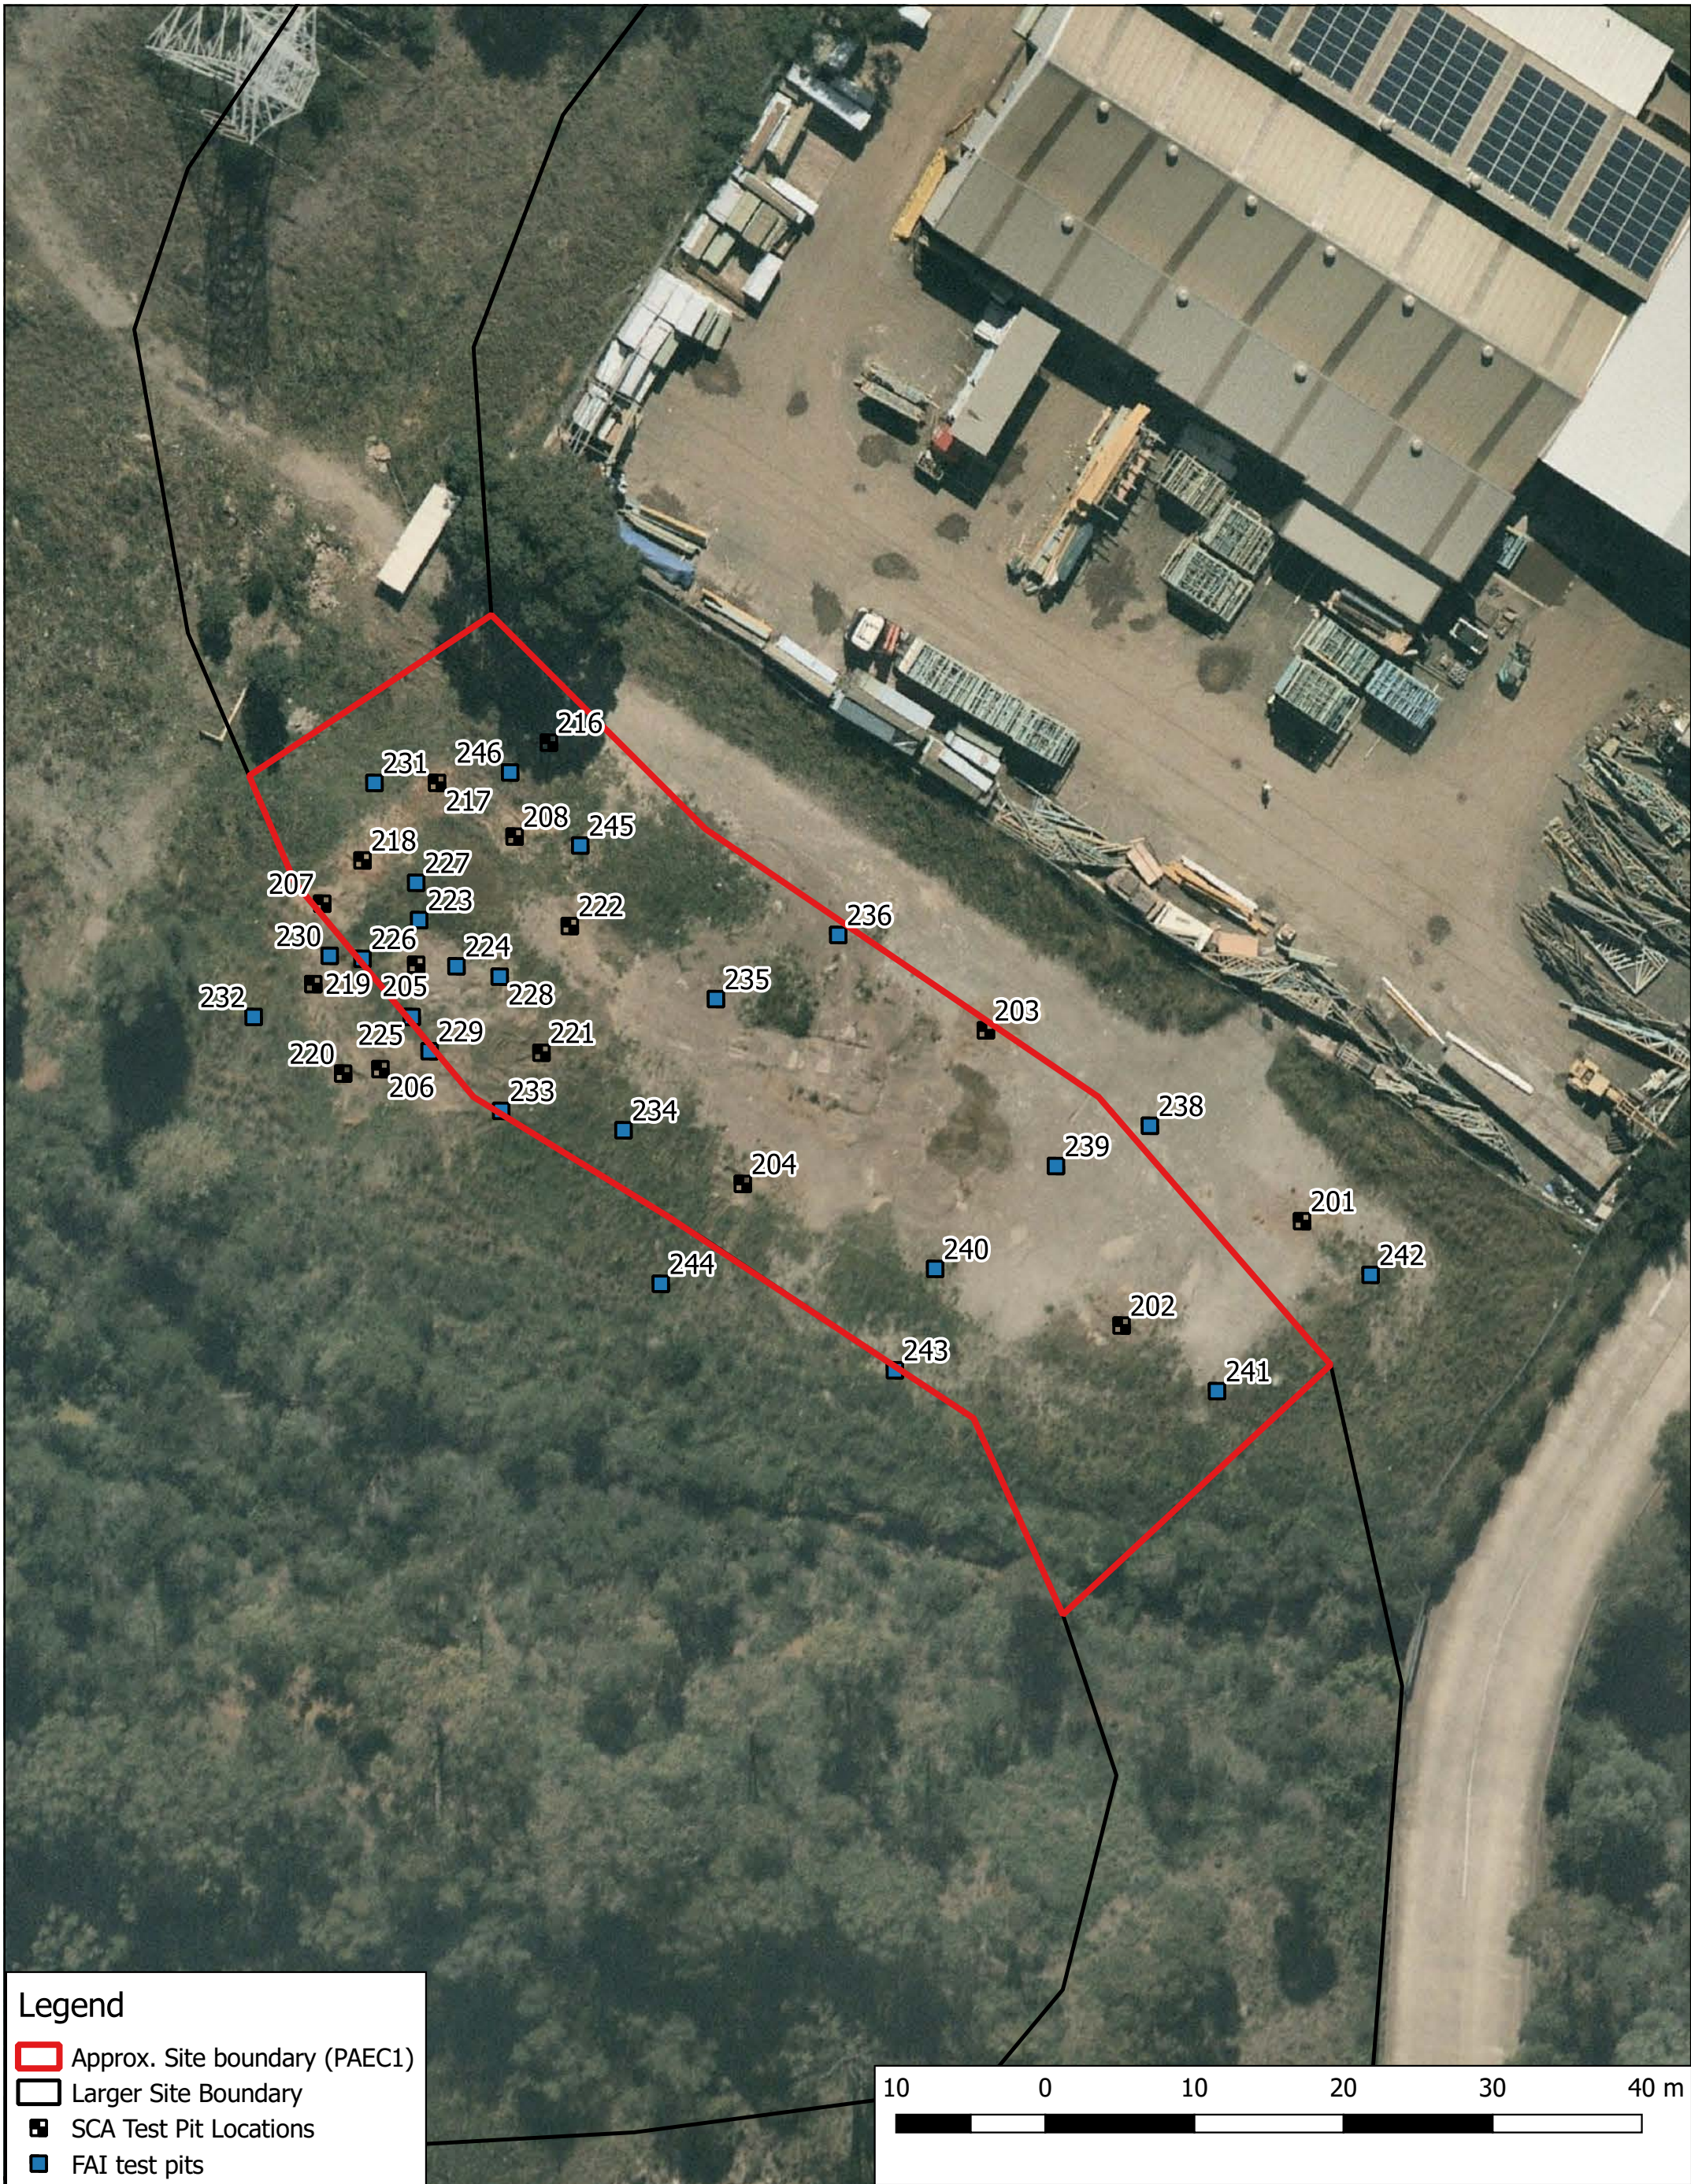
CLIENT:	PROJ. 94525.04	DRAWING No: 3	REVISION: 0	
---------	----------------	---------------	-------------	--

The SCA and FAD test pit sample locations are presented on Drawing 3, attached.

TITLE: **FAD Test Pit Locations**
Further Asbestos Investigation
Lot 2 Forrester Road, St Marys NSW

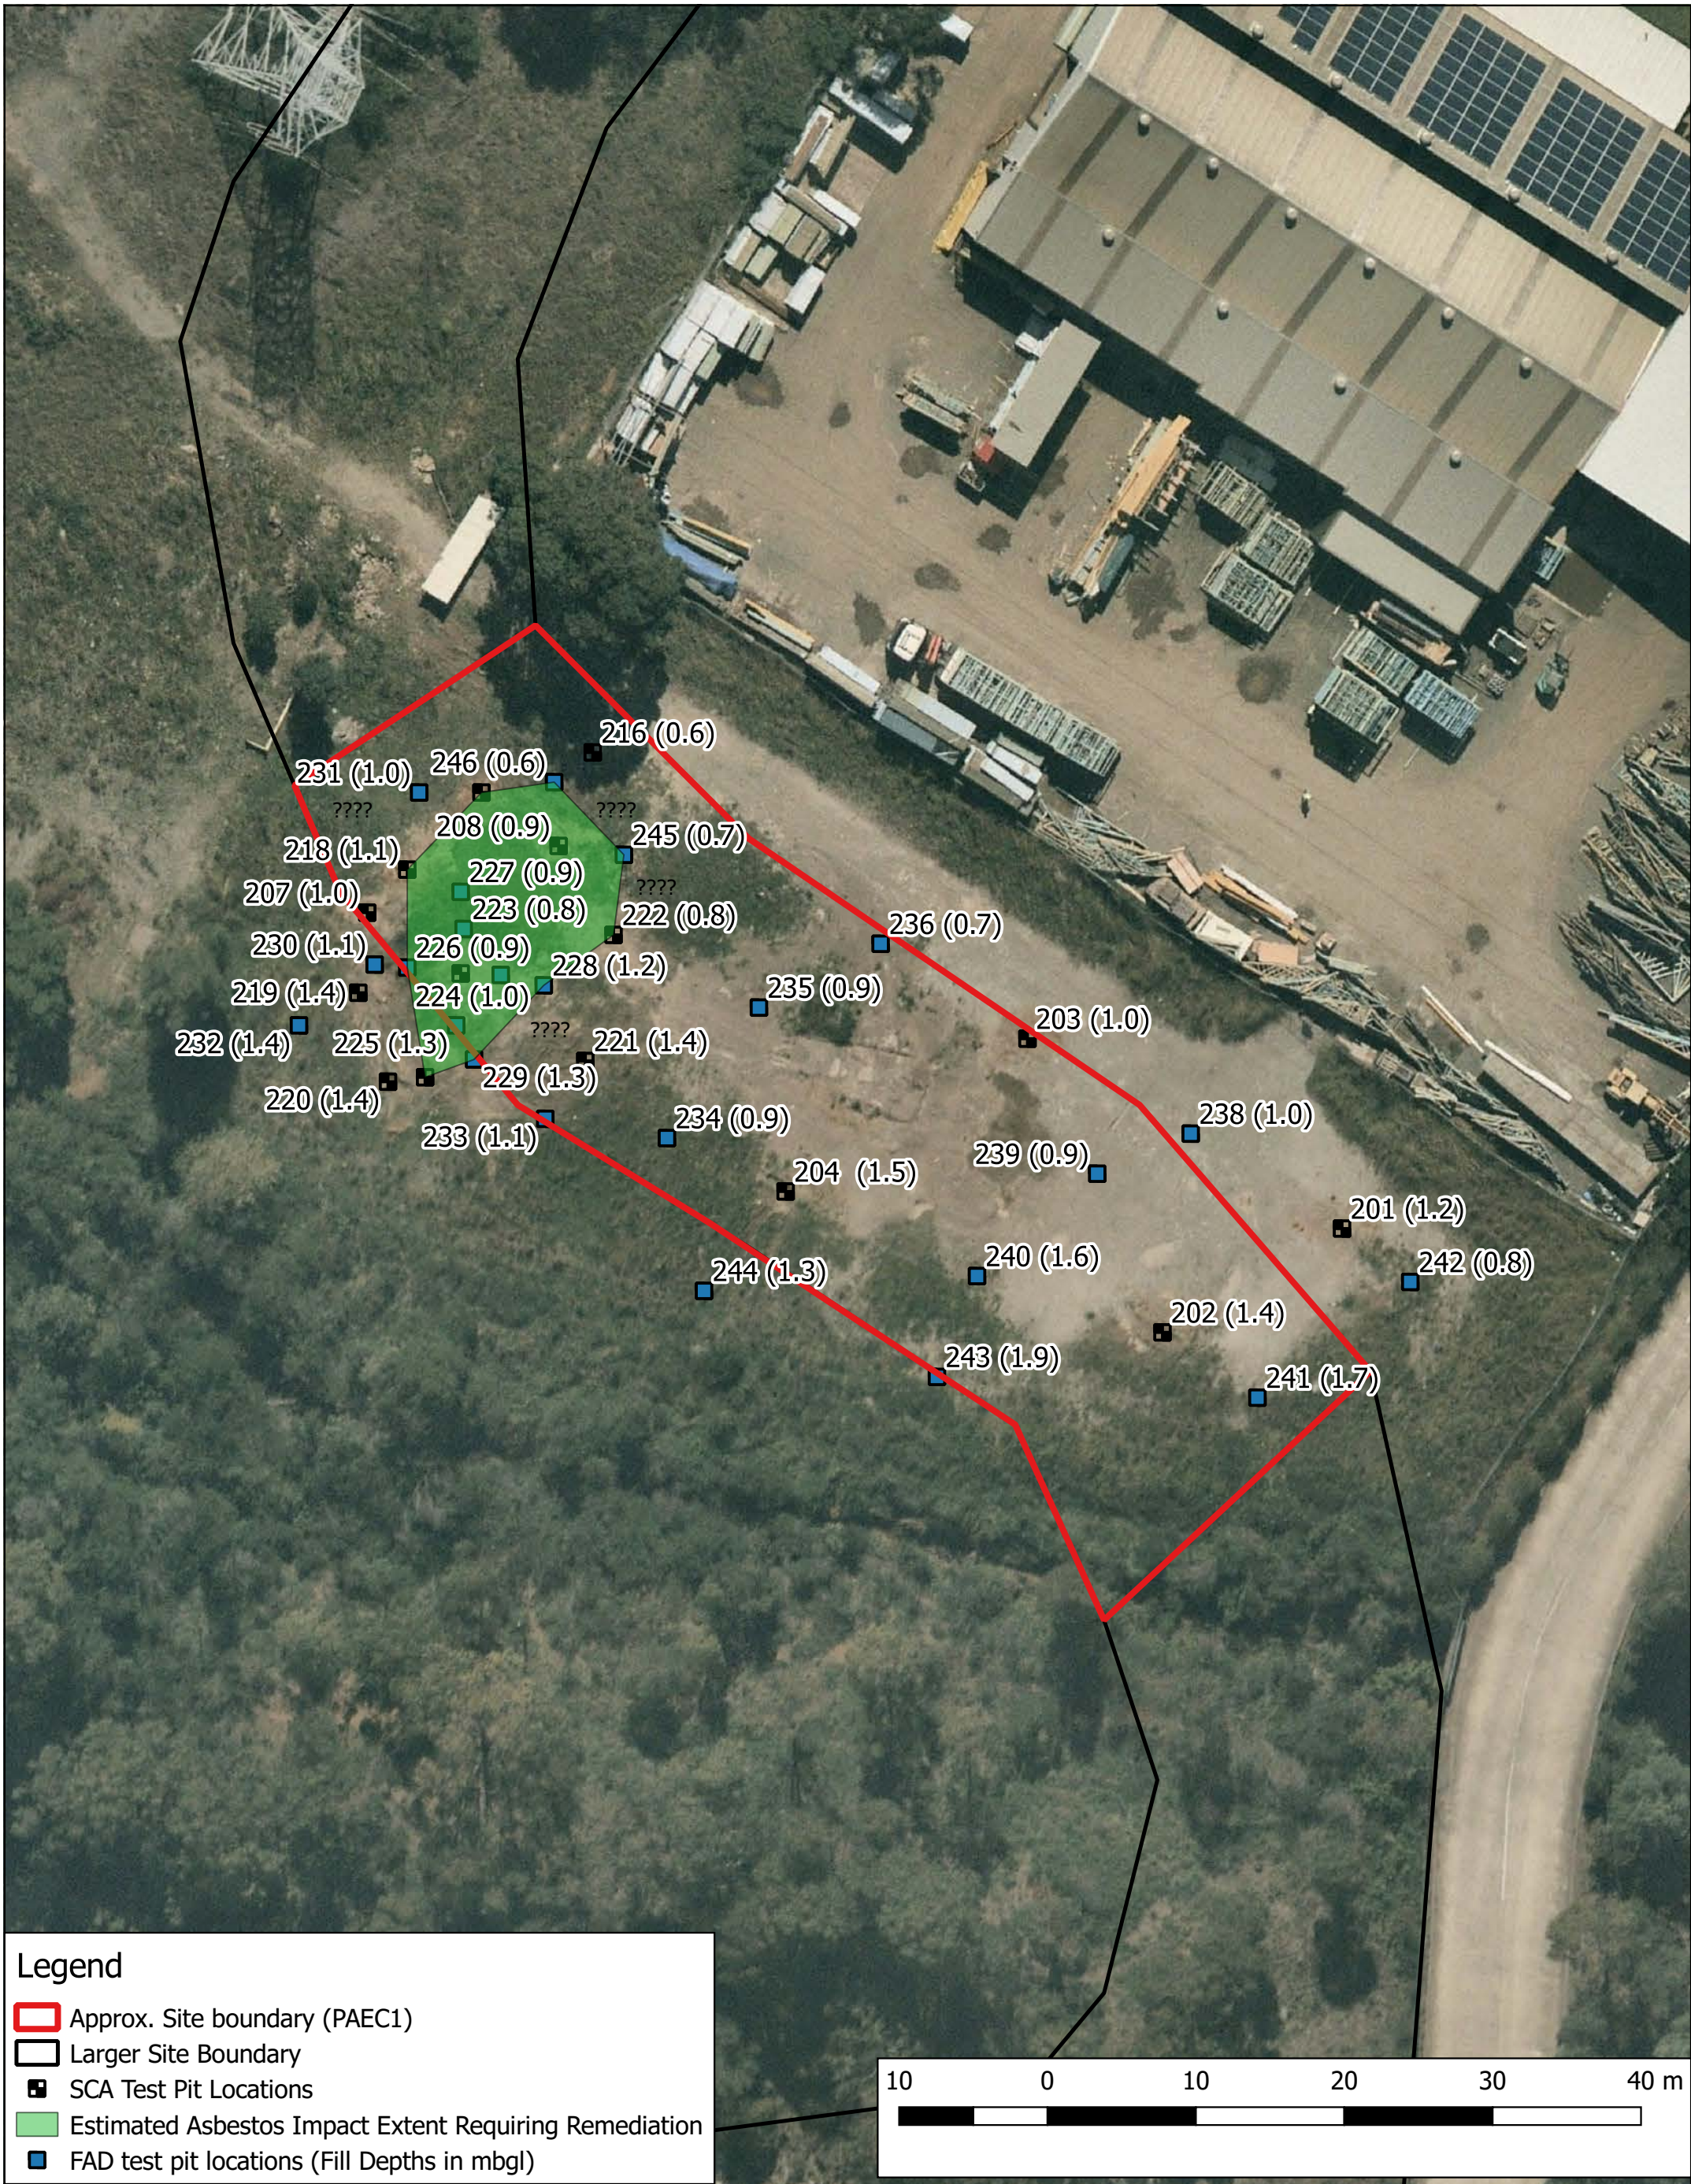
The approximate lateral extent of known fill (and fill depths encountered) requiring remediation based on the test pit data to date is presented on Drawing 4, attached.

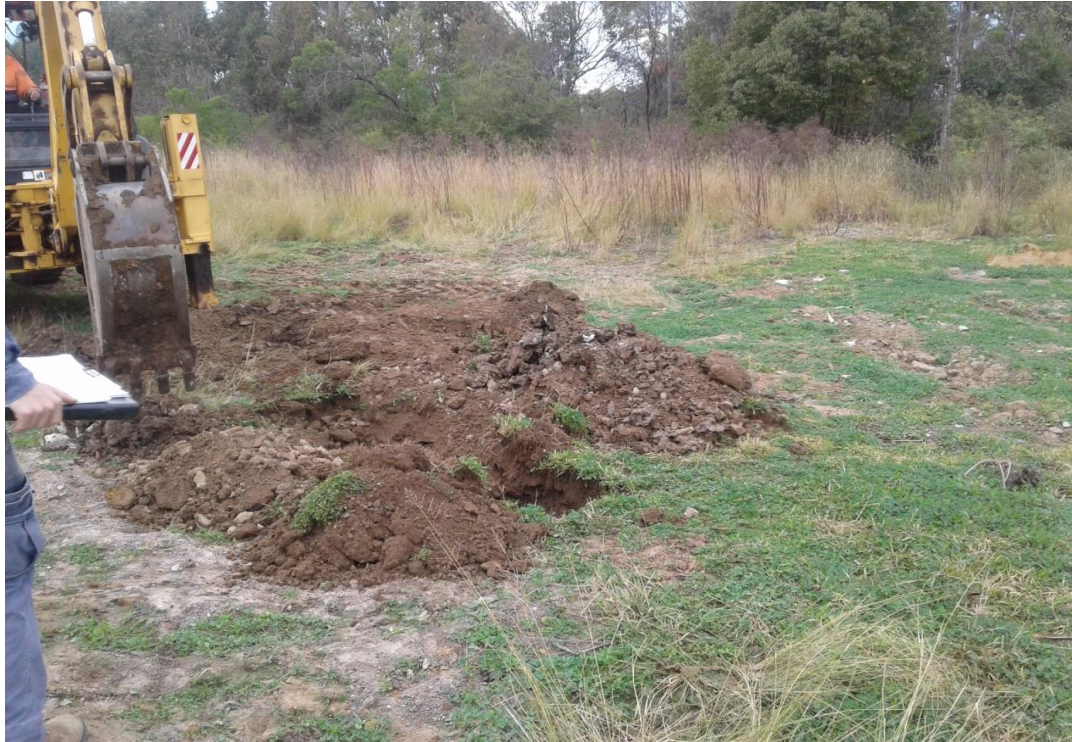
- Test pit TP224 at depths of 0.0 to 1.0 m bgl at a concentration of 0.085% w/w; and
- Test pit TP225 at depths of 0.0 to 1.3 m bgl at a concentration of 0.63% w/w.

Photo 1 - Test Pit TP225

Given that friable asbestos has now been identified within the area requiring remediation emu-picking is no longer considered an appropriate remedial option. Adherence to the RAP should enable appropriate management of any potential impacts on the environment which may occur during the course of the remediation works.

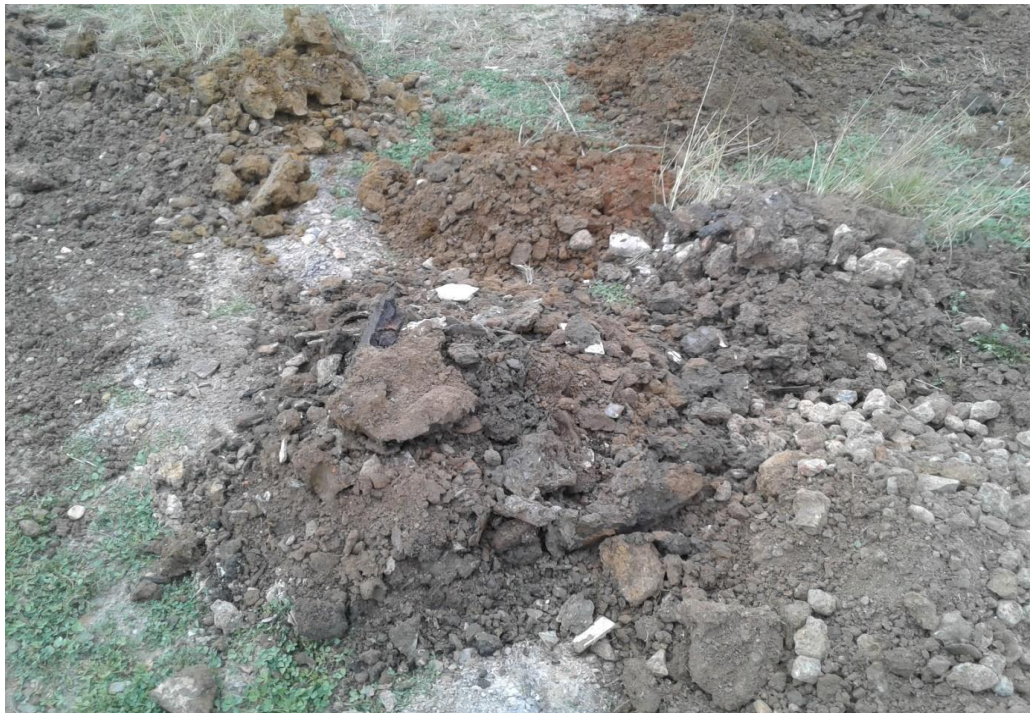
- Test pit TP224 at depths of 0.0 to 1.0 m bgl at a mass of 4.269 g which equates to 0.11% w/w of the 500 mL sample; and
- Test pit TP225 at depths of 0.0 to 1.3 m bgl at a mass of 24.136 g which equates to 0.62% w/w of the 500 mL sample.

Photo 2 - Fragments of ACM in fill at test pit TP225

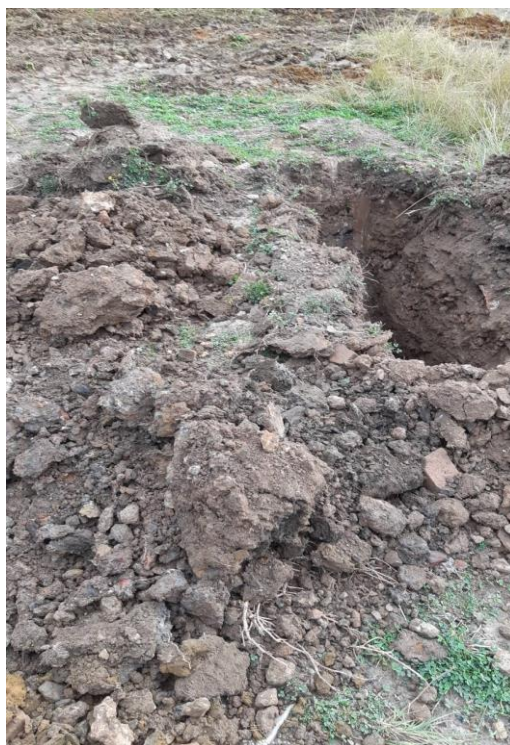
Photo 3 - Test Pit 224

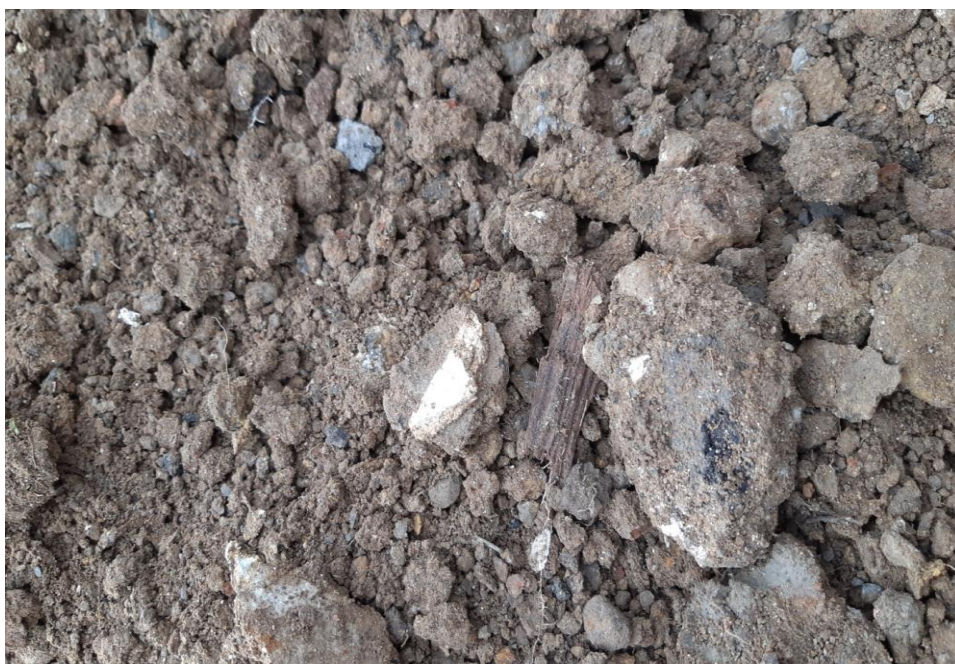
Photo 4 - ACM in test pit TP224

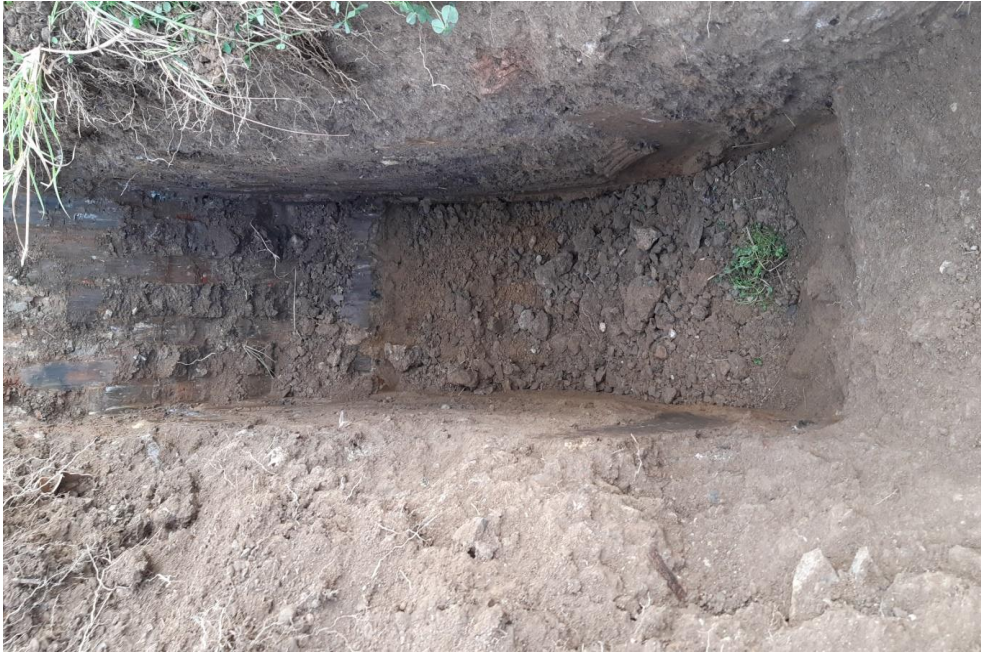
Photo 5 - Test Pit 226

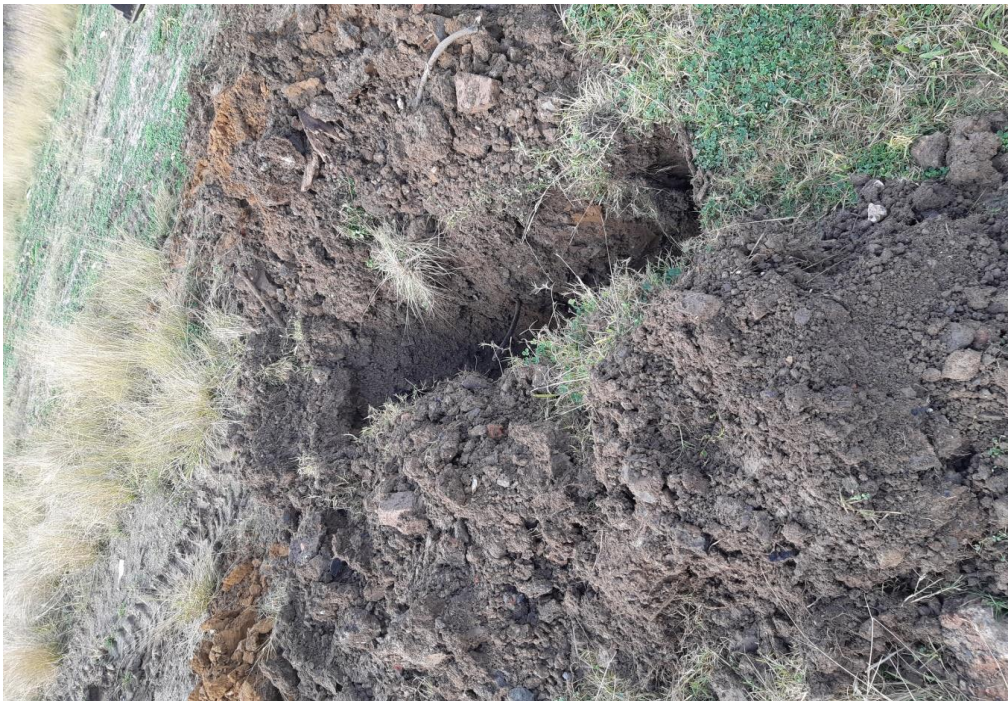
- Test pit TP227 at depths of 0.0 to 0.9 m bgl at a concentration of 0.004% w/w.

Photo 6 - Test Pit 227

In addition, friable asbestos (FA/AF) was also identified within fill in one test pit TP227 during this investigation at a concentration exceeding SAC. Therefore all fill within the known area requiring remediation should now be treated as impacted with both friable and bonded forms of asbestos.
