Remediation Action Plan

Stage 1 - St Mary's Intermodal Freight Terminal
Lot 2 Forrester Road, St Mary's, NSW

Prepared for
Pacific National (NSW) Pty Ltd

Project 94525.03
August 2019

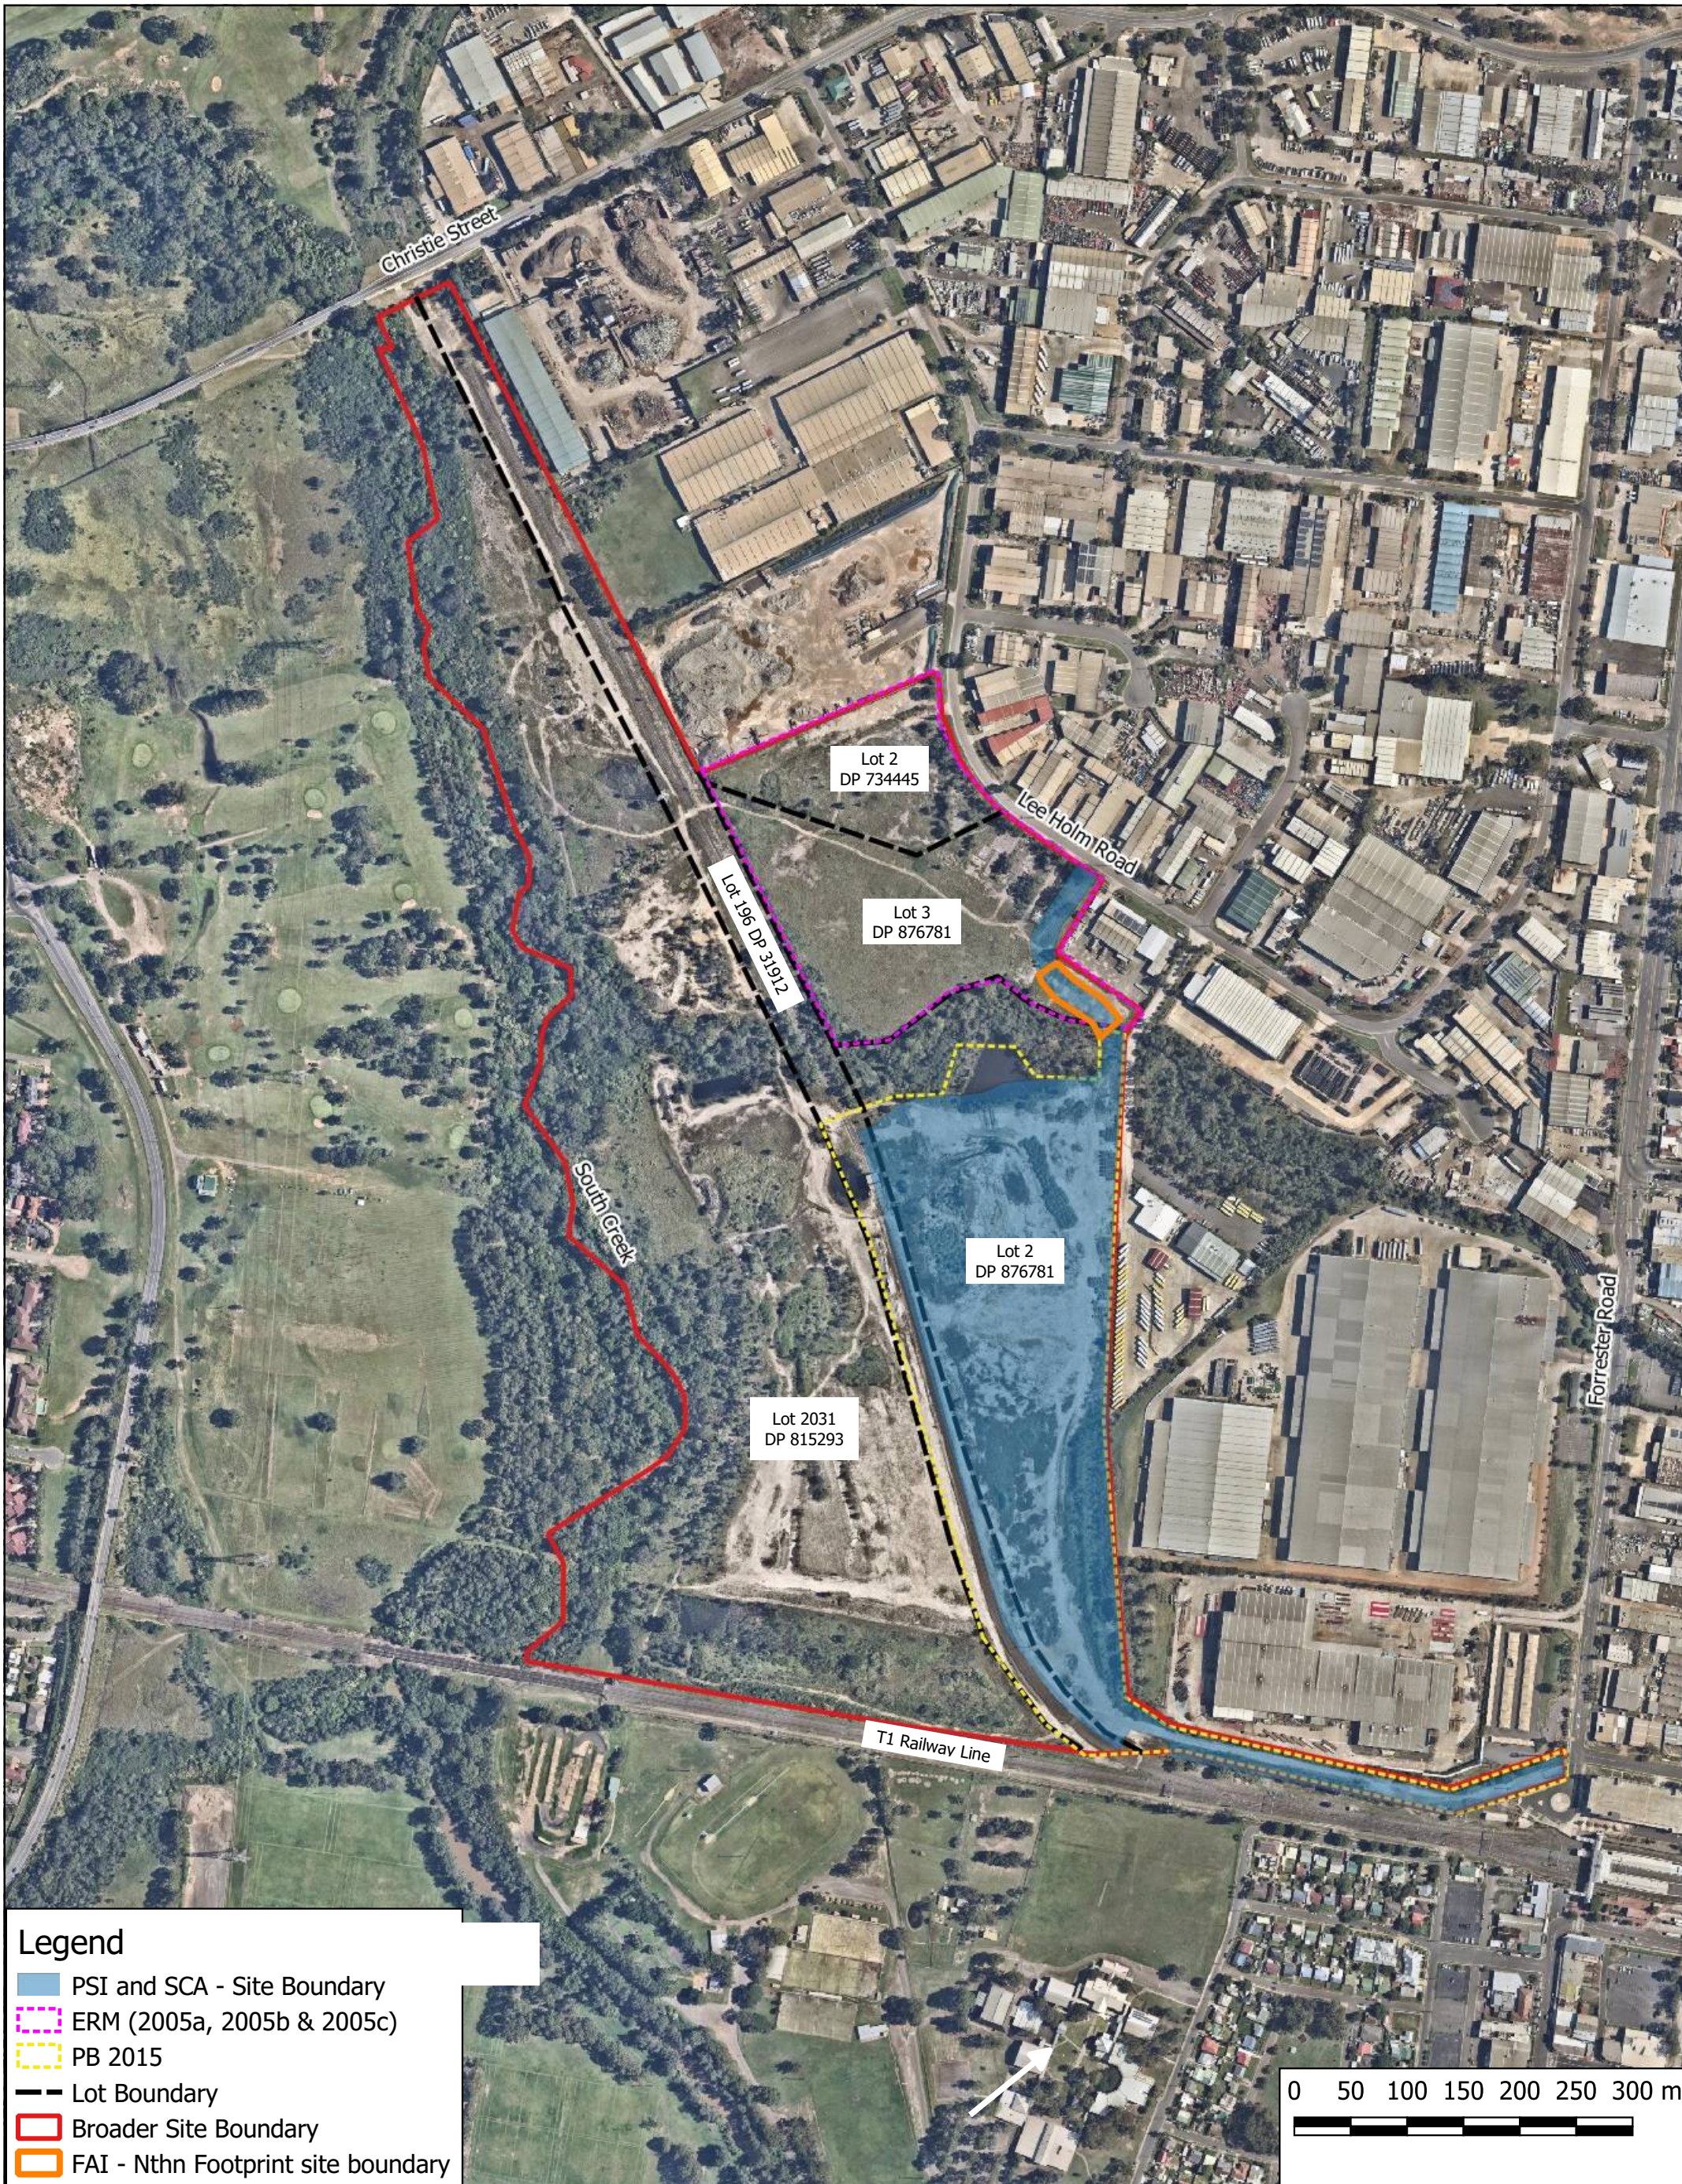
DRAWING No: 3

- PSI and SCA - Site Boundary
- ERM (2005a, 2005b & 2005c)
- PB 2015
- Lot Boundary
- Broader Site Boundary
- FAI - Nthn Footprint site boundary

The key findings of the above-listed investigations that are relevant for this RAP are summarised in the following sub-sections. The boundaries of former investigations are shown on Drawing 3, Appendix B.

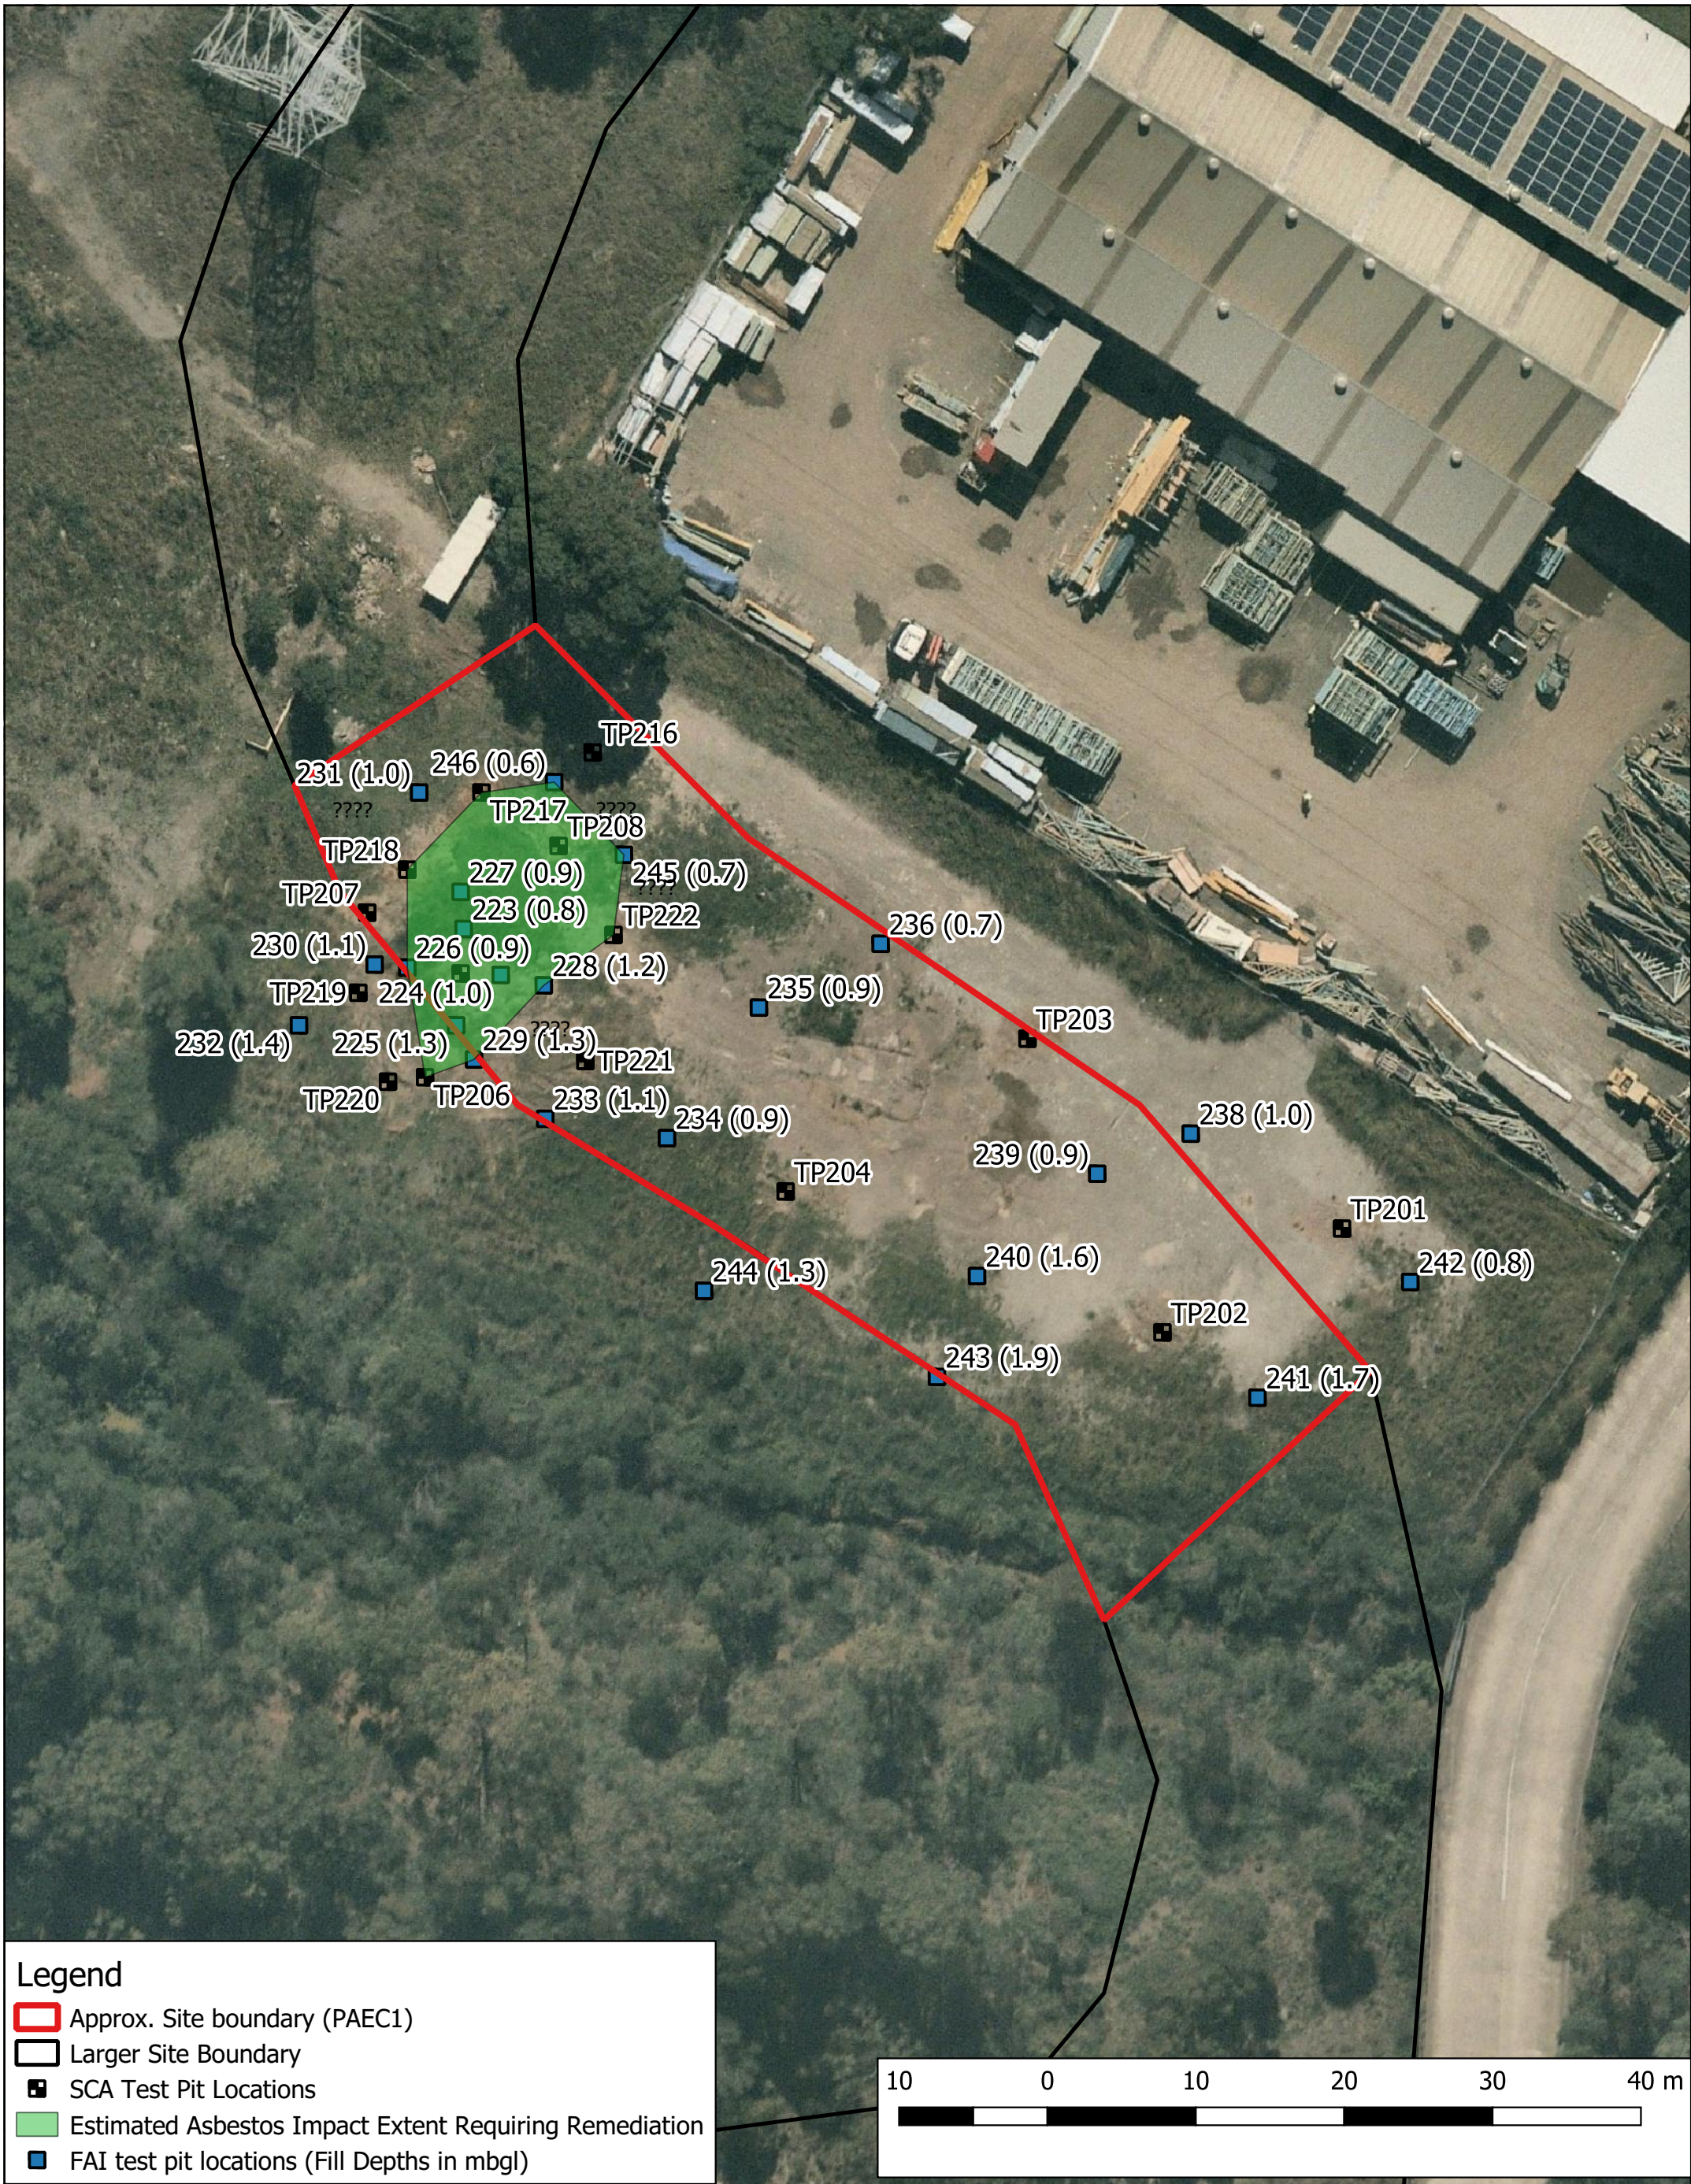
- Approx. Site boundary (PAEC1)
- Larger Site Boundary
- SCA Test Pit Locations
- Estimated Asbestos Impact Extent Requiring Remediation
- FAI test pit locations (Fill Depths in mbgl)

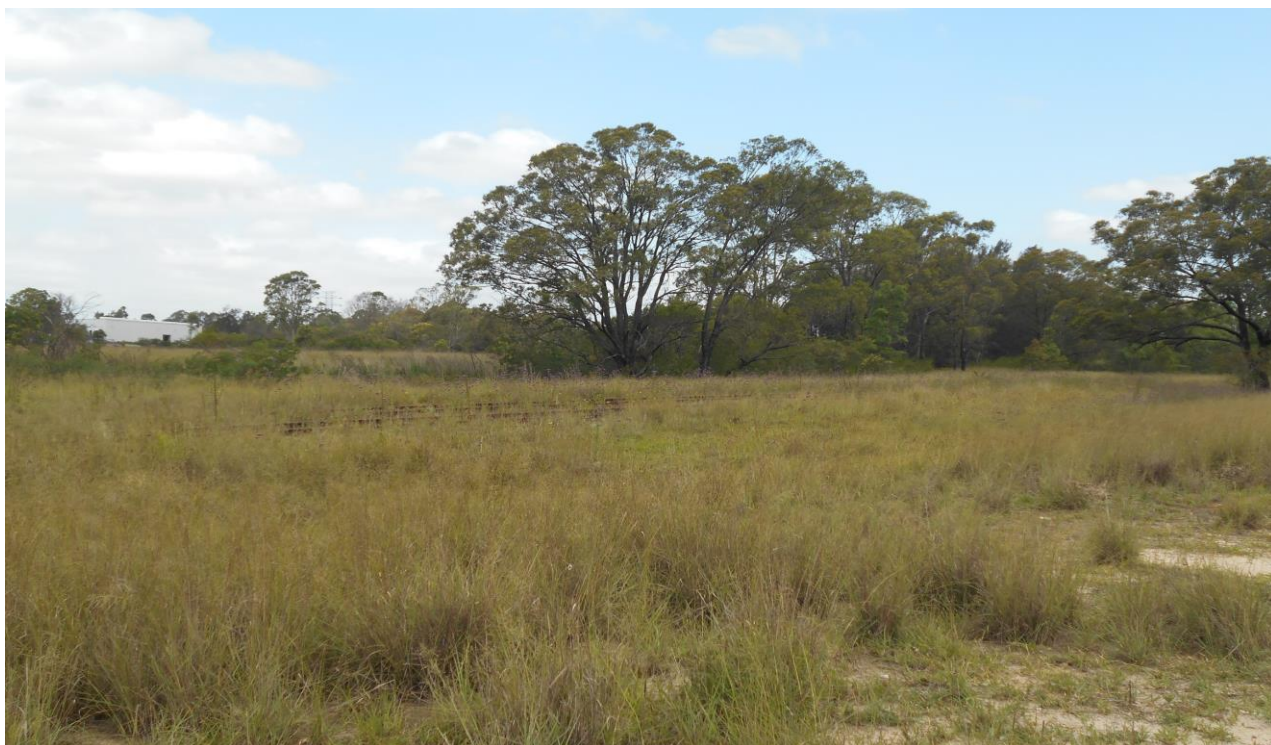
Photo 1 - Site surface covered with overgrown vegetation in parts of site

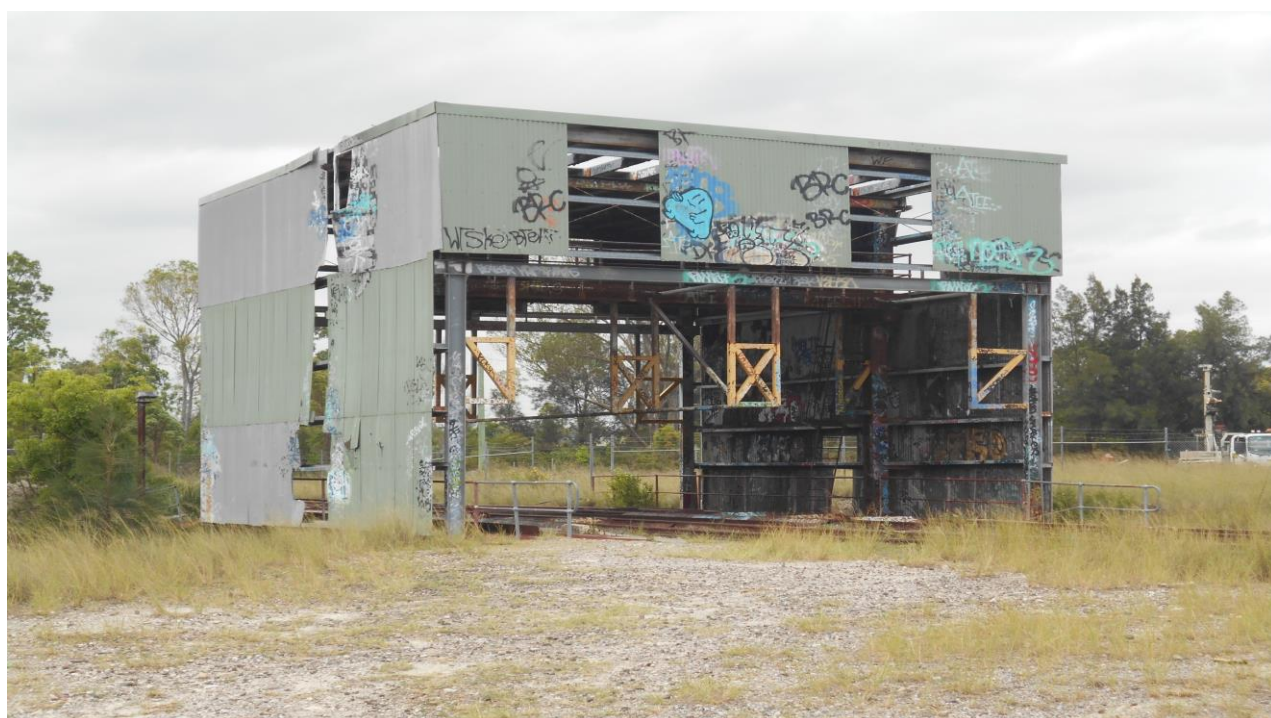
Photo 2 - Unloading facility along the railway corridor

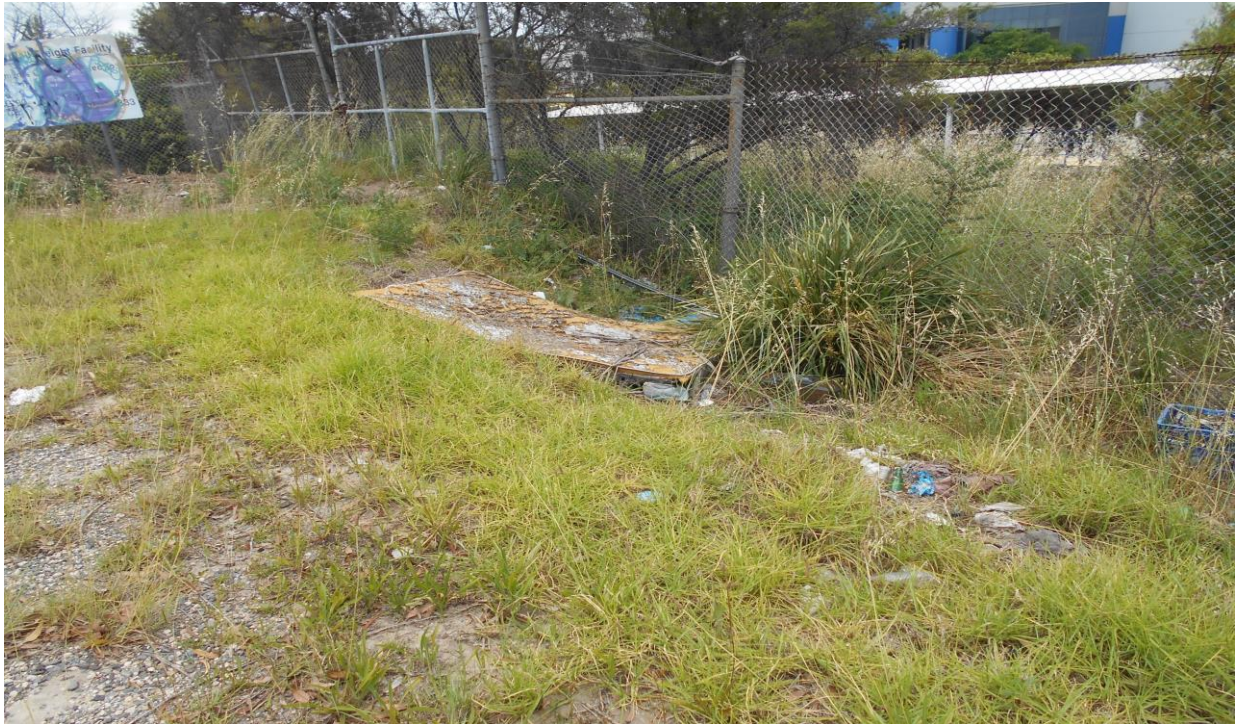
Photo 3 - Refuse on the side of access pathway from the Forrester Road entrance

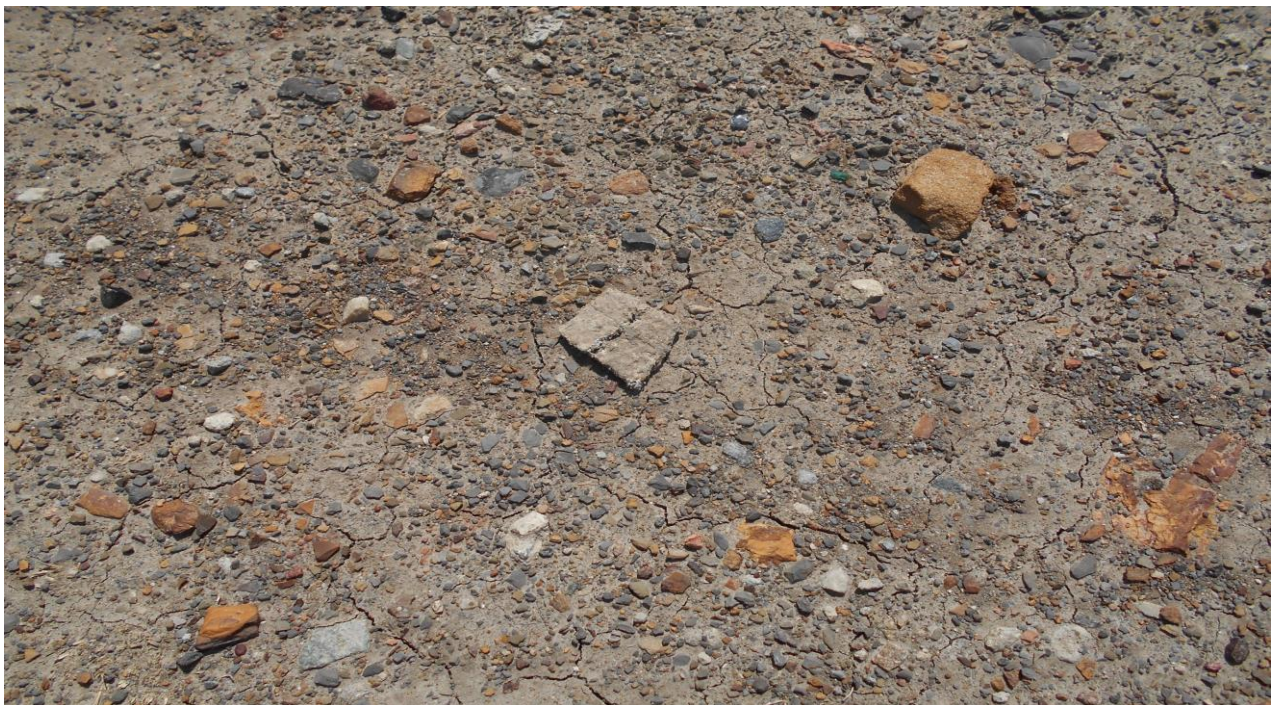
Photo 4 - Exposed site surface comprising aggregate filling with some anthropogenic material near Forrester Road entrance

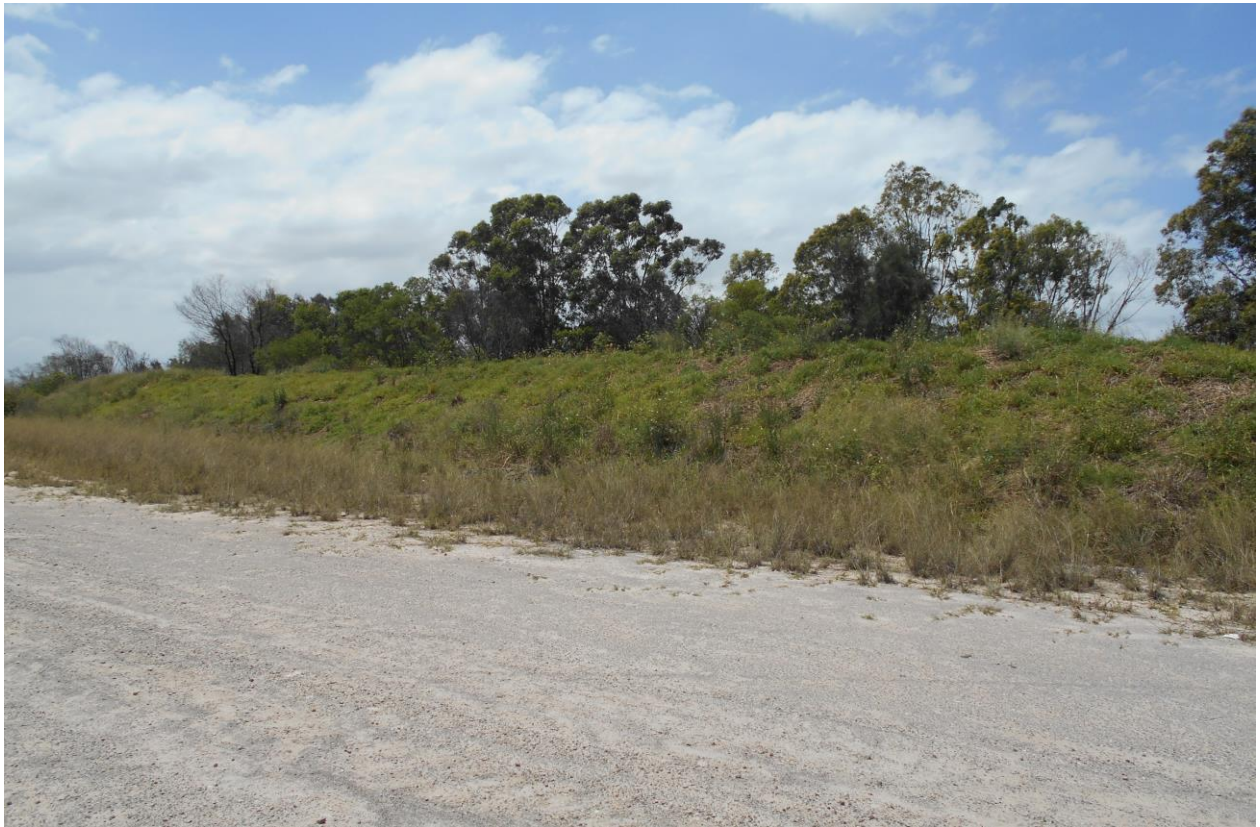
Photo 5 - Soil stockpile covered with overgrown vegetation along the eastern boundary

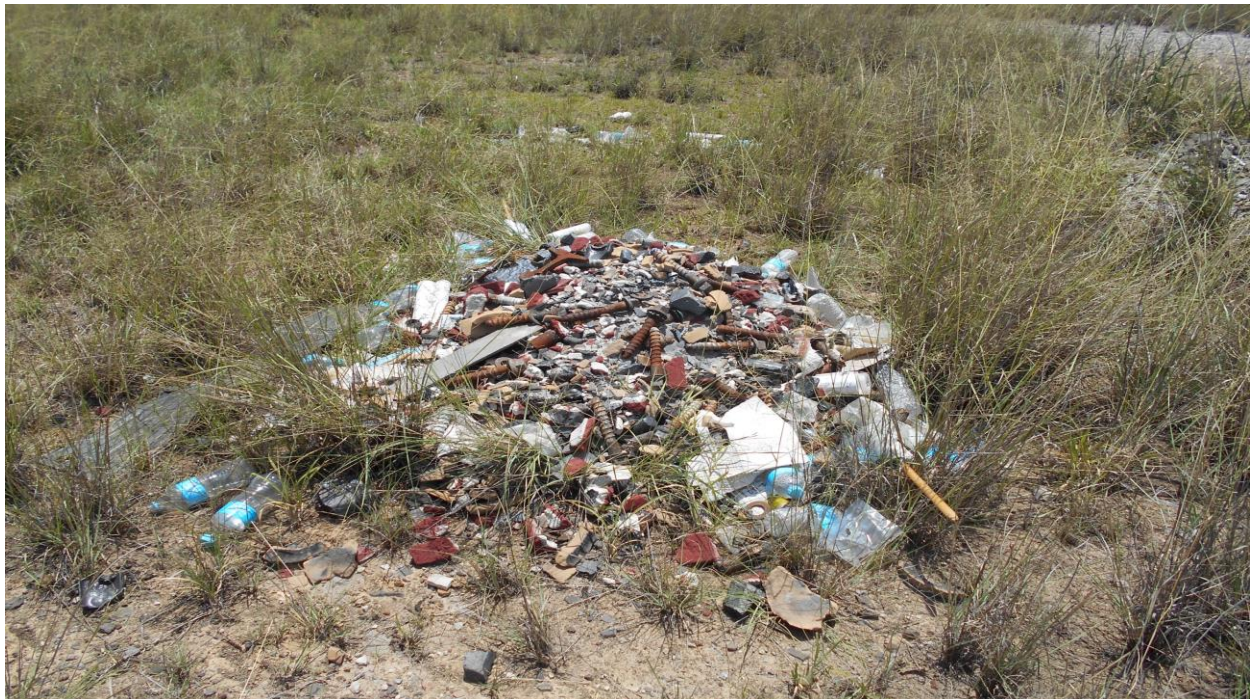
Photo 6 - Soil stockpile with demolition waste on top

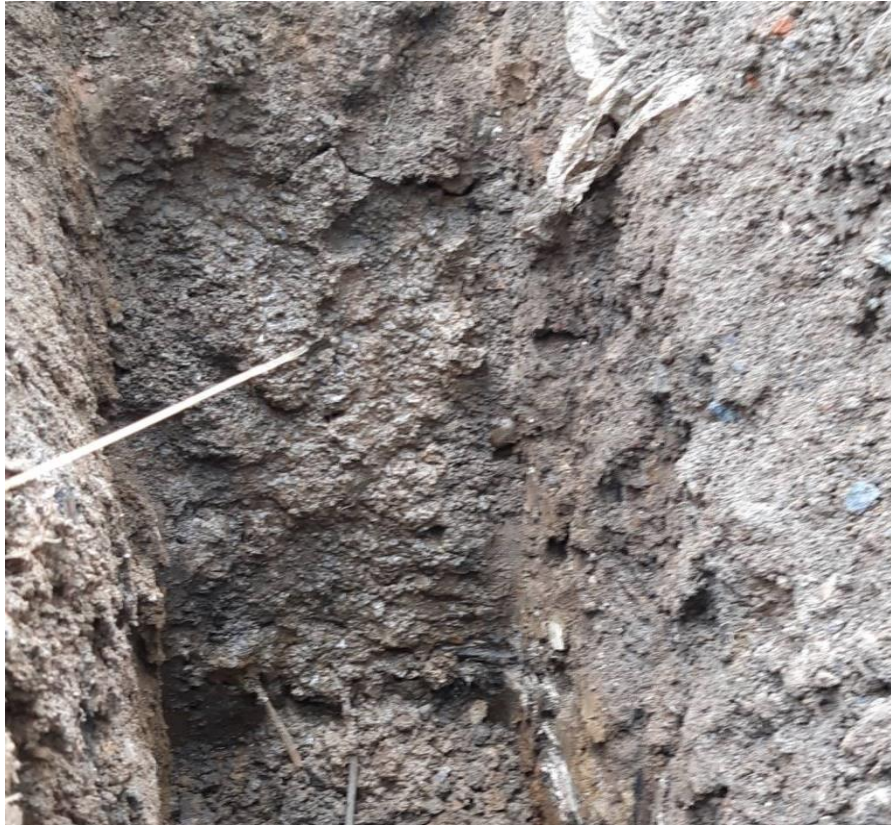
Photo 7 - Test pit 205 where ACM was identified in fill

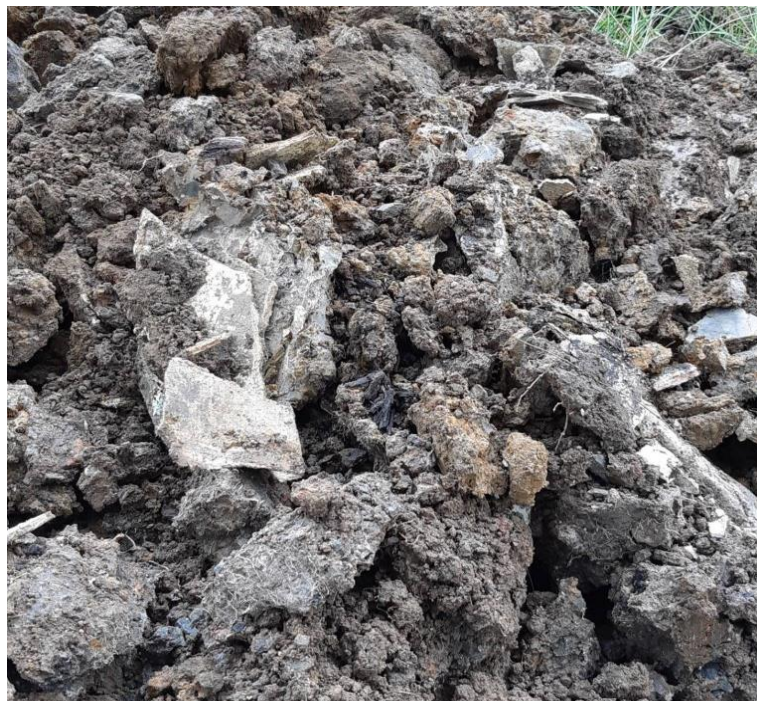
Photo 8 - ACM impacted fill excavated from test pit 205
