REPORT TO
KINCOPPAL – ROSE BAY SCHOOL

ON
SUPPLEMENTARY GEOTECHNICAL AND
HYDROGEOLOGICAL INVESTIGATION

FOR
PROPOSED CAR / BUS PARKING STRUCTURE

AT
CNR NEW SOUTH ROAD AND VAUCLUSE ROAD,
VAUCLUSE, NSW

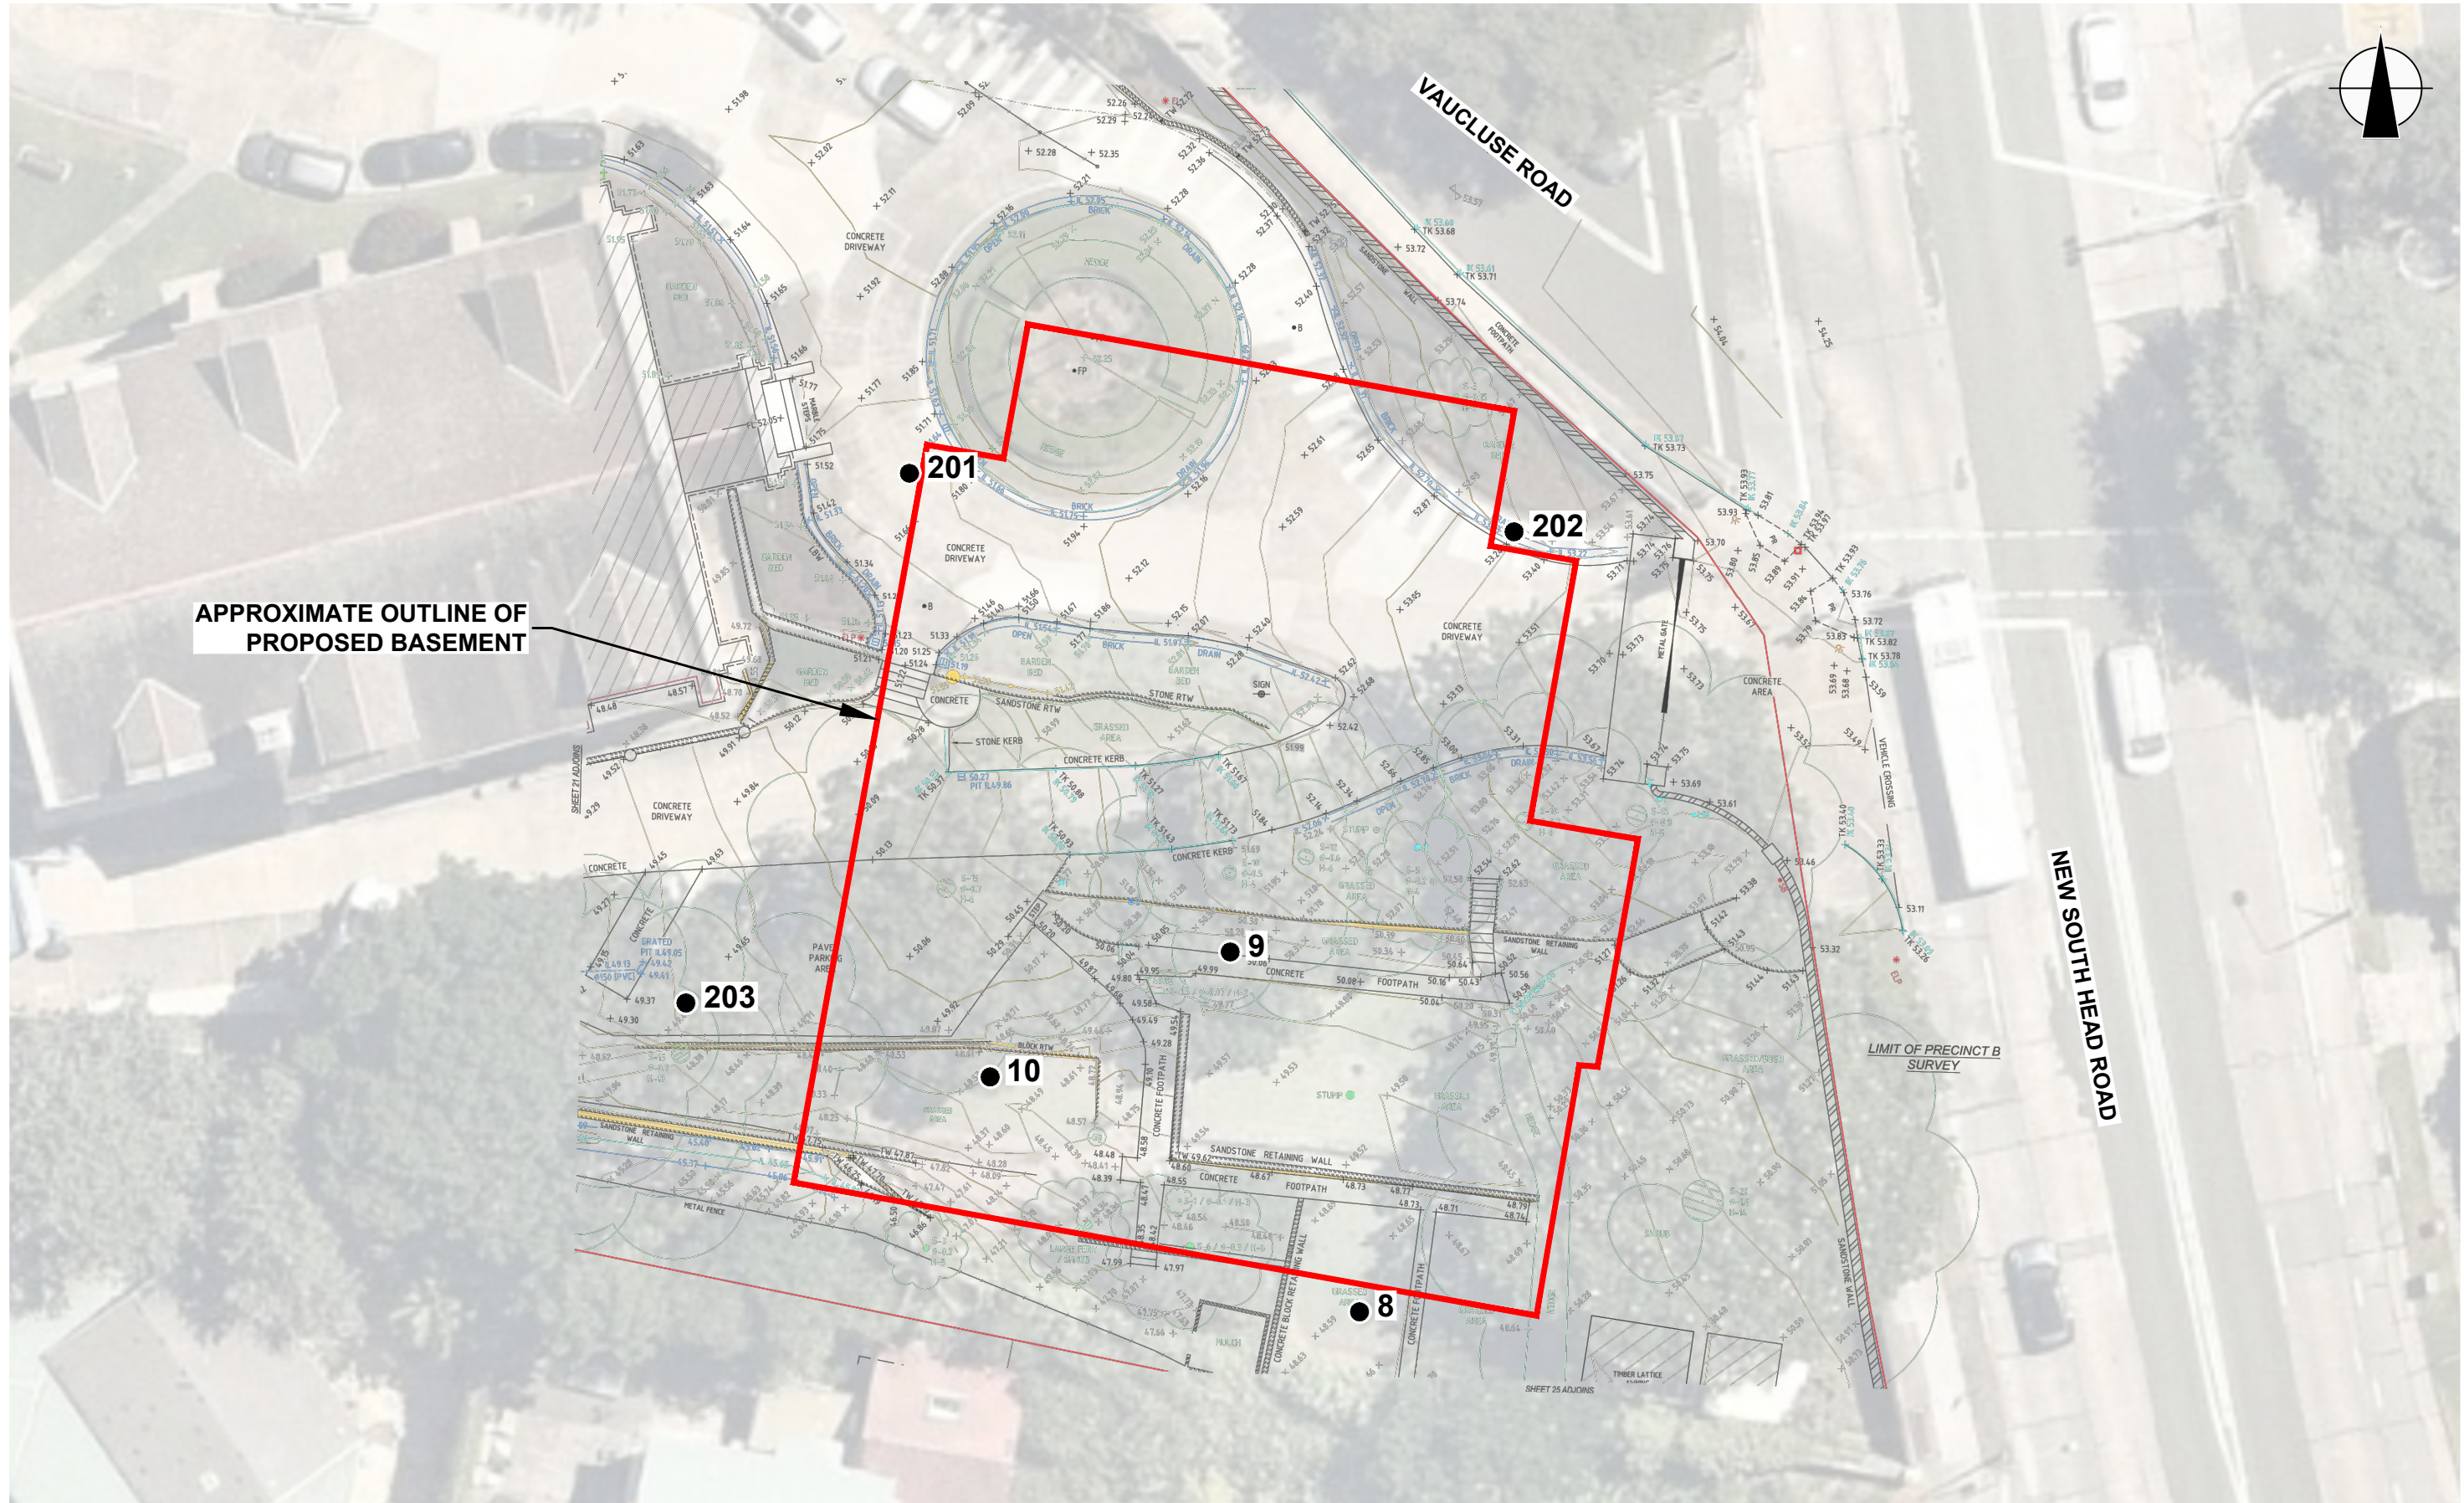
APPROXIMATE OUTLINE OF
PROPOSED BASEMENT

- NOTES:
1. BOREHOLES 8, 9 AND 10 ARE FROM OUR 2020 INVESTIGATION.
 2. BOREHOLES 201, 202 AND 203 ARE FROM THE CURRENT INVESTIGATION.
