KINCOPPAL – ROSE BAY SCHOOL

SUPPLEMENTARY GEOTECHNICAL AND HYDROGEOLOGICAL INVESTIGATION

PROPOSED ELC BUILDING

CNR NEW SOUTH ROAD AND VAUCLUSE ROAD, VAUCLUSE, NSW

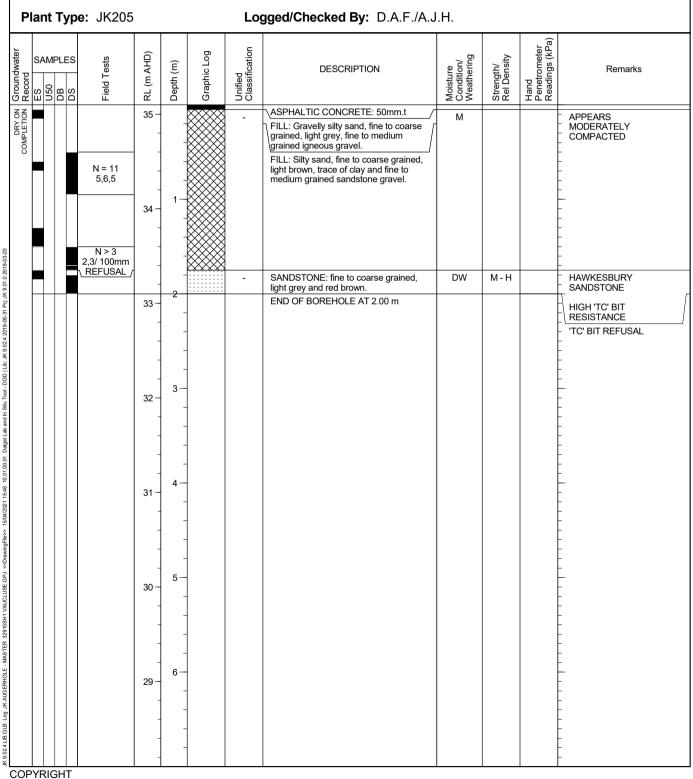
BOREHOLE LOG

Job No.: 32915SH1 Method: SPIRAL AUGER R.L. Surface: 35.1 m

Date: 28/1/20 **Datum:** AHD

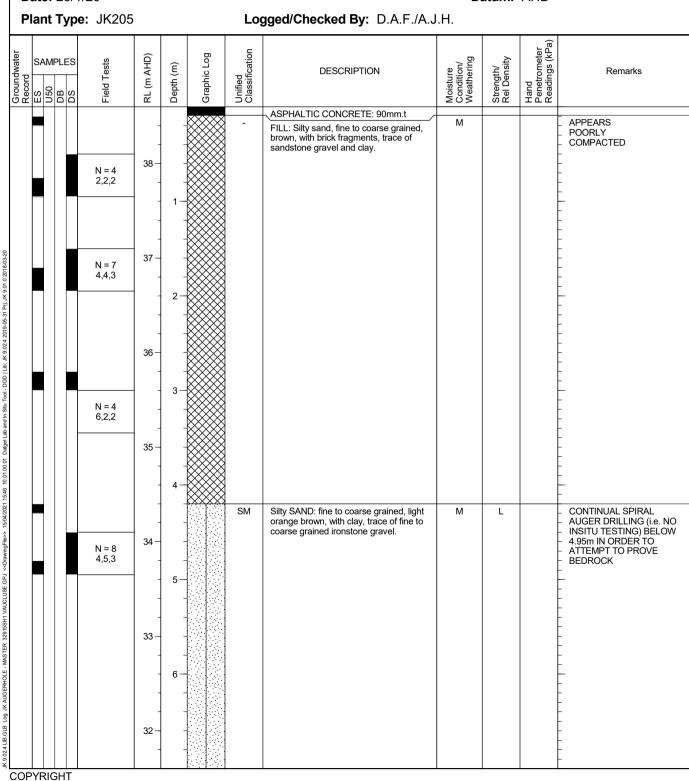
BOREHOLE LOG

Job No.: 32915SH1 Method: SPIRAL AUGER R.L. Surface: 38.6 m

Date: 28/1/20 **Datum:** AHD

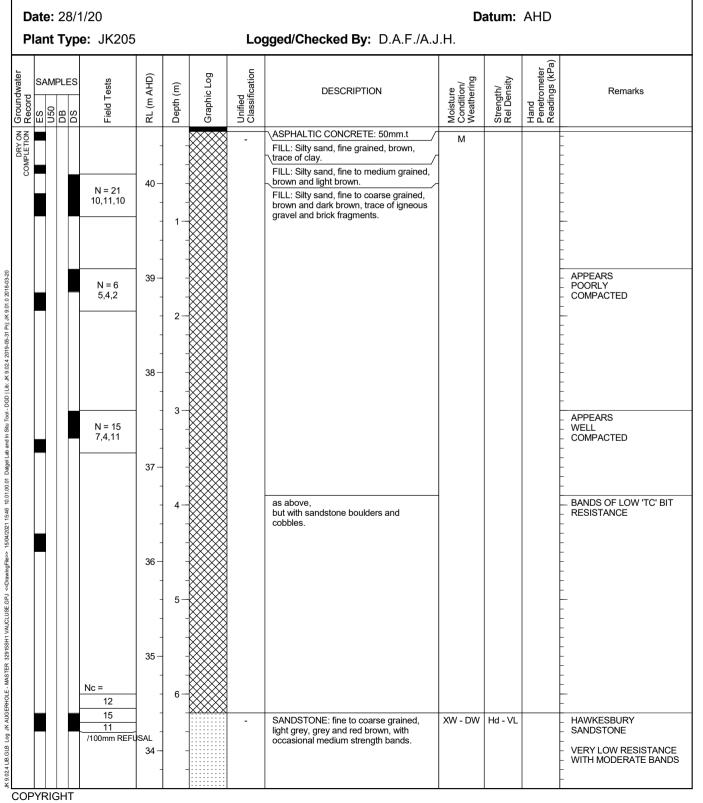
BOREHOLE LOG

Location: CNR NEW SOUTH HEAD ROAD & VAUCLUSE ROAD, VAUCLUSE, NSW

Job No.: 32915SH1 Method: SPIRAL AUGER R.L. Surface: 40.6 m

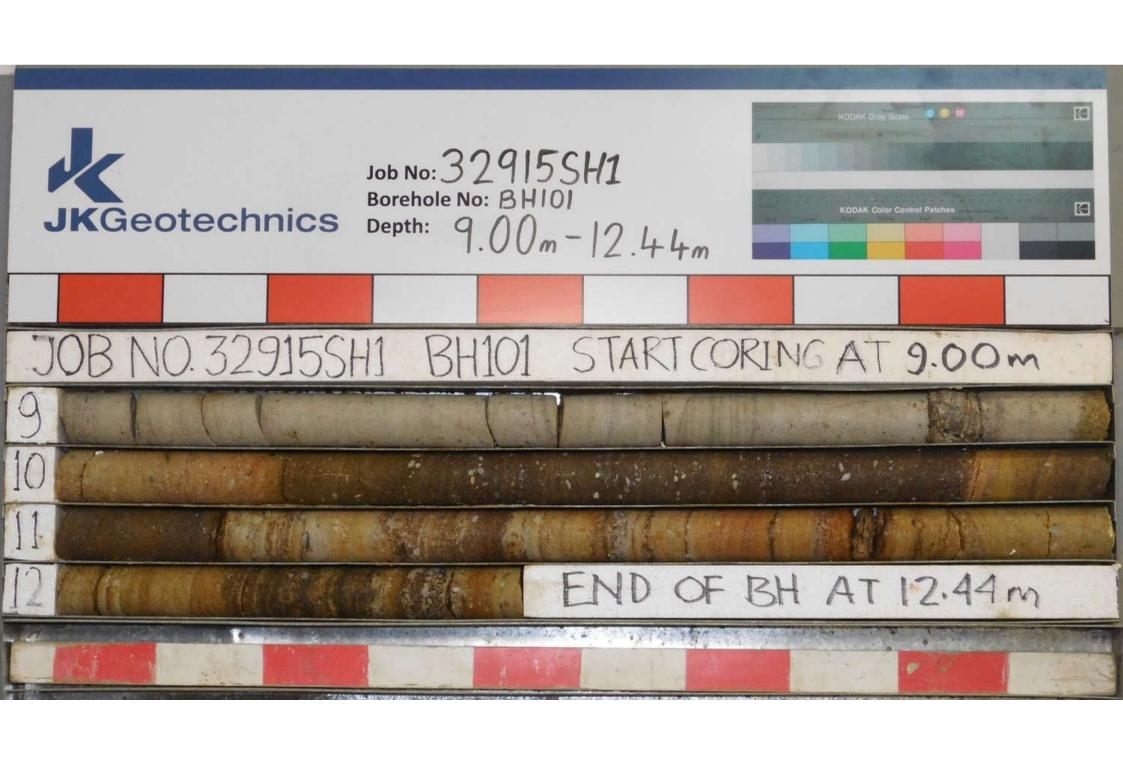
BOREHOLE LOG

L		· · <i>)</i> r		011203	Dearing. 14/					gged/Checked by. D.A./A.s.ii.	
					CORE DESCRIPTION			POINT LOAD	1	DEFECT DETAILS	
Water Loss\Level	Barrel Lift	RL (m AHD)	Depth (m)	Graphic Log	Rock Type, grain characteristics, colour, texture and fabric, features, inclusions and minor components START CORING AT 9.00m	Weathering	Strength	STRENGTH INDEX I _s (50)	(mm)	DESCRIPTION Type, orientation, defect shape and roughness, defect coatings and seams, openness and thickness Specific General	Formation
		31 —	-		SANDSTONE: fine to medium grained, light grey with occassional grey laminae, bedded at 0-10°.	FR	M - H	0.80 ₁		—— (9.85m) XWS, 0°, 60 mm.t	
0% RETURN		30 —	10		SANDSTONE: medium to coarse grained, light grey, yellow brown and dark brown, with quartz gravel, trace of occassional carbonaceous lenses, bedded at 0-15°.	HW					Hawkesbury Sandstone

- - 29 –	11-							- (11.16m) Be, 3°, Ir, R, Fe Sn - (11.75m) Be, 2°, Ir, R, Fe Sn (11.78m) Be, 3°, Ir, R, Fe Sn	Hawkes
		-	12 -		END OF BOREHOLE AT 12.44 m		Н	#1.4 		(11.78m) Be, 3°, Ir, R, Fe Sn	
		28 - - -	13-	- - - - - -						-	
		27 — -	- - - - 14 –	- - - - - -						-	
		26 –	- - - -	- - - - - - -

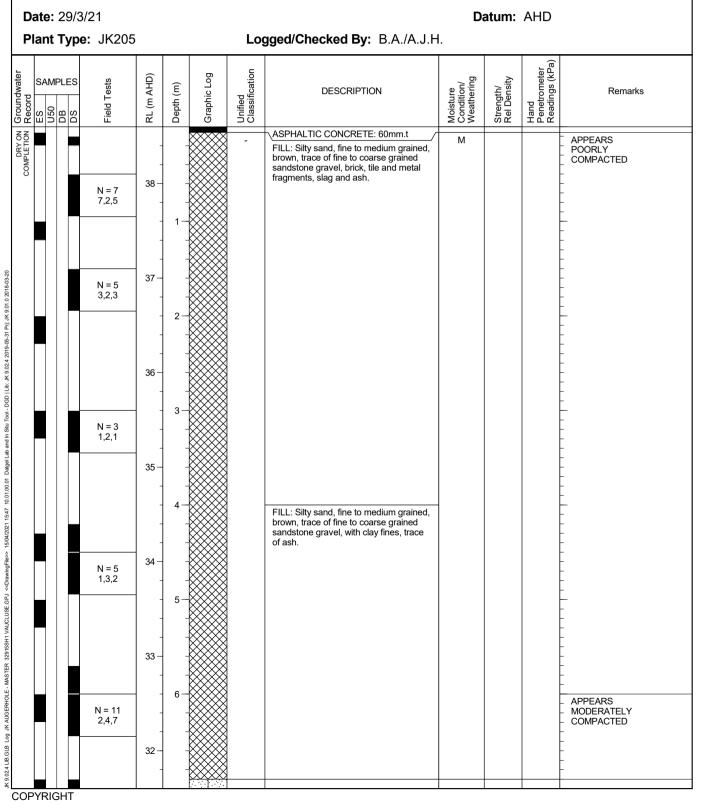
BOREHOLE LOG

Location: CNR NEW SOUTH HEAD ROAD & VAUCLUSE ROAD, VAUCLUSE, NSW

Job No.: 32915SH1 Method: SPIRAL AUGER R.L. Surface: ~38.6 m

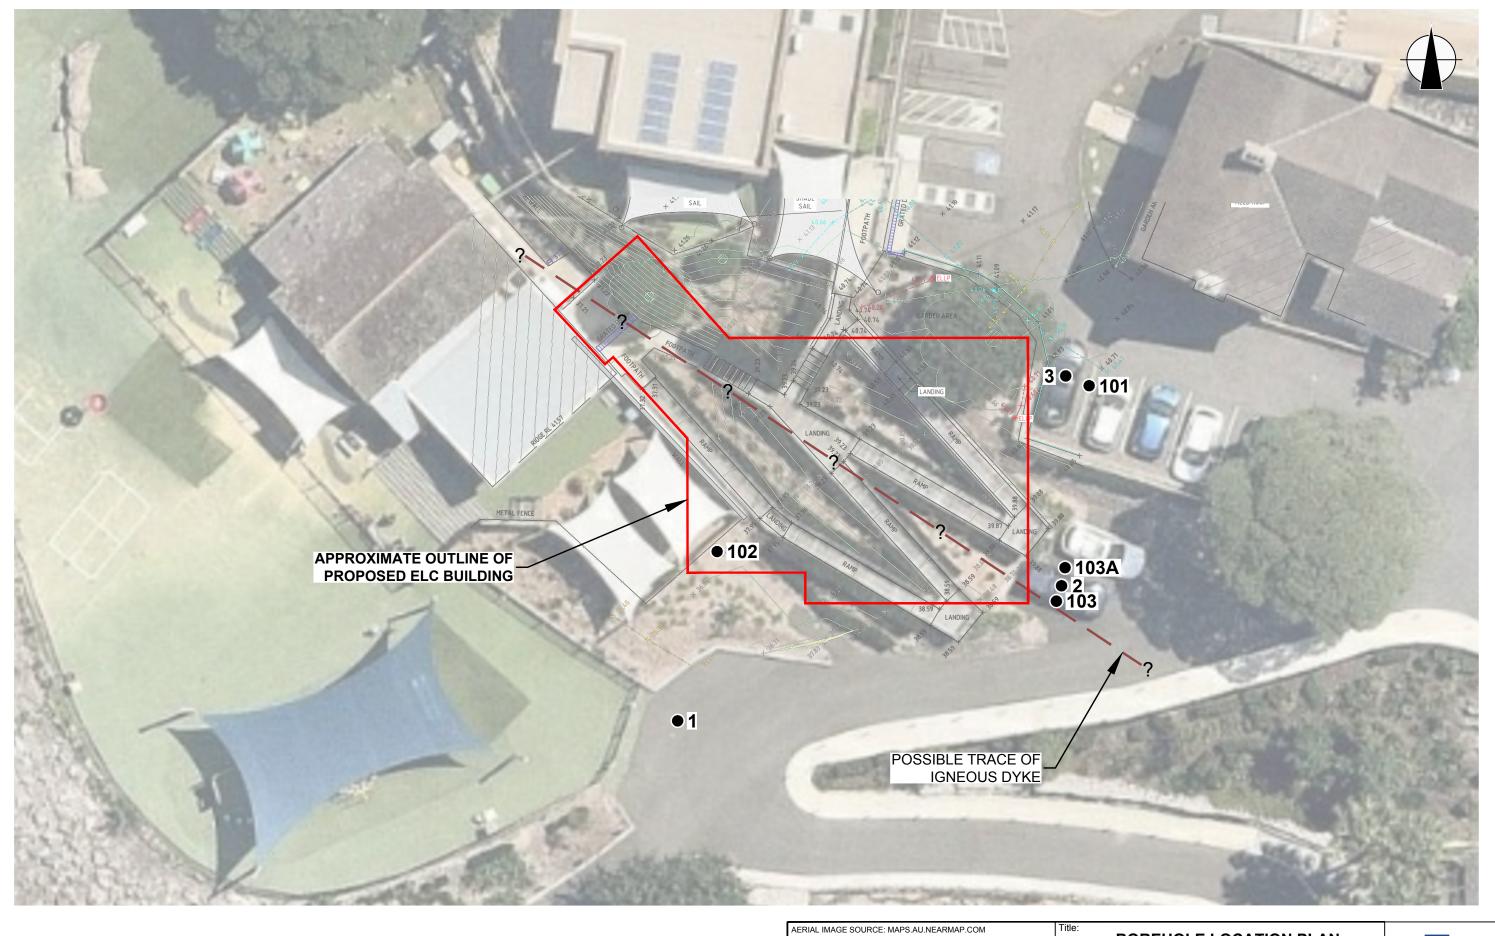
- BH1, BH2 AND BH3 ARE FROM OUR 2020 INVESTIGATION.
 BH101, BH102, BH103 AND BH103A ARE FROM THE CURRENT INVESTIGATION.

With reference to the relevant geological map of the site and based on investigation results, the trace of an igneous dyke may cross the central portion of the proposed building footprint, as shown on Figure 2. BH103 appears to have extended into the inferred dyke, as well as possibly BH2. Based on our previous experience on nearby sites, the dyke may manifest as a sub-vertical open defect within the sandstone bedrock with an upper portion of sandy infill overlying residual clay, that may include corestones of higher strength dolerite rock. The open defect representing the dyke and/or dyke infill can range from centimetres to many metres and can extend laterally for very large distances. Alternatively, the material in BH103, interpreted to be weathered igneous rock, could be a horizontal offshoot of the known dyke to the north of the school; it is known for such offshoots to penetrate along major bedding partings in the sandstone.
