**REPORT TO
KINCOPPAL-ROSE BAY SCHOOL**

**ON
REMEDIATION ACTION PLAN**

**FOR
PROPOSED DEVELOPMENT AT KINCOPPAL-ROSE
BAY SCHOOL**

**AT
CORNER NEW SOUTH HEAD ROAD AND
VAUCLUSE ROAD, VAUCLUSE, NSW**

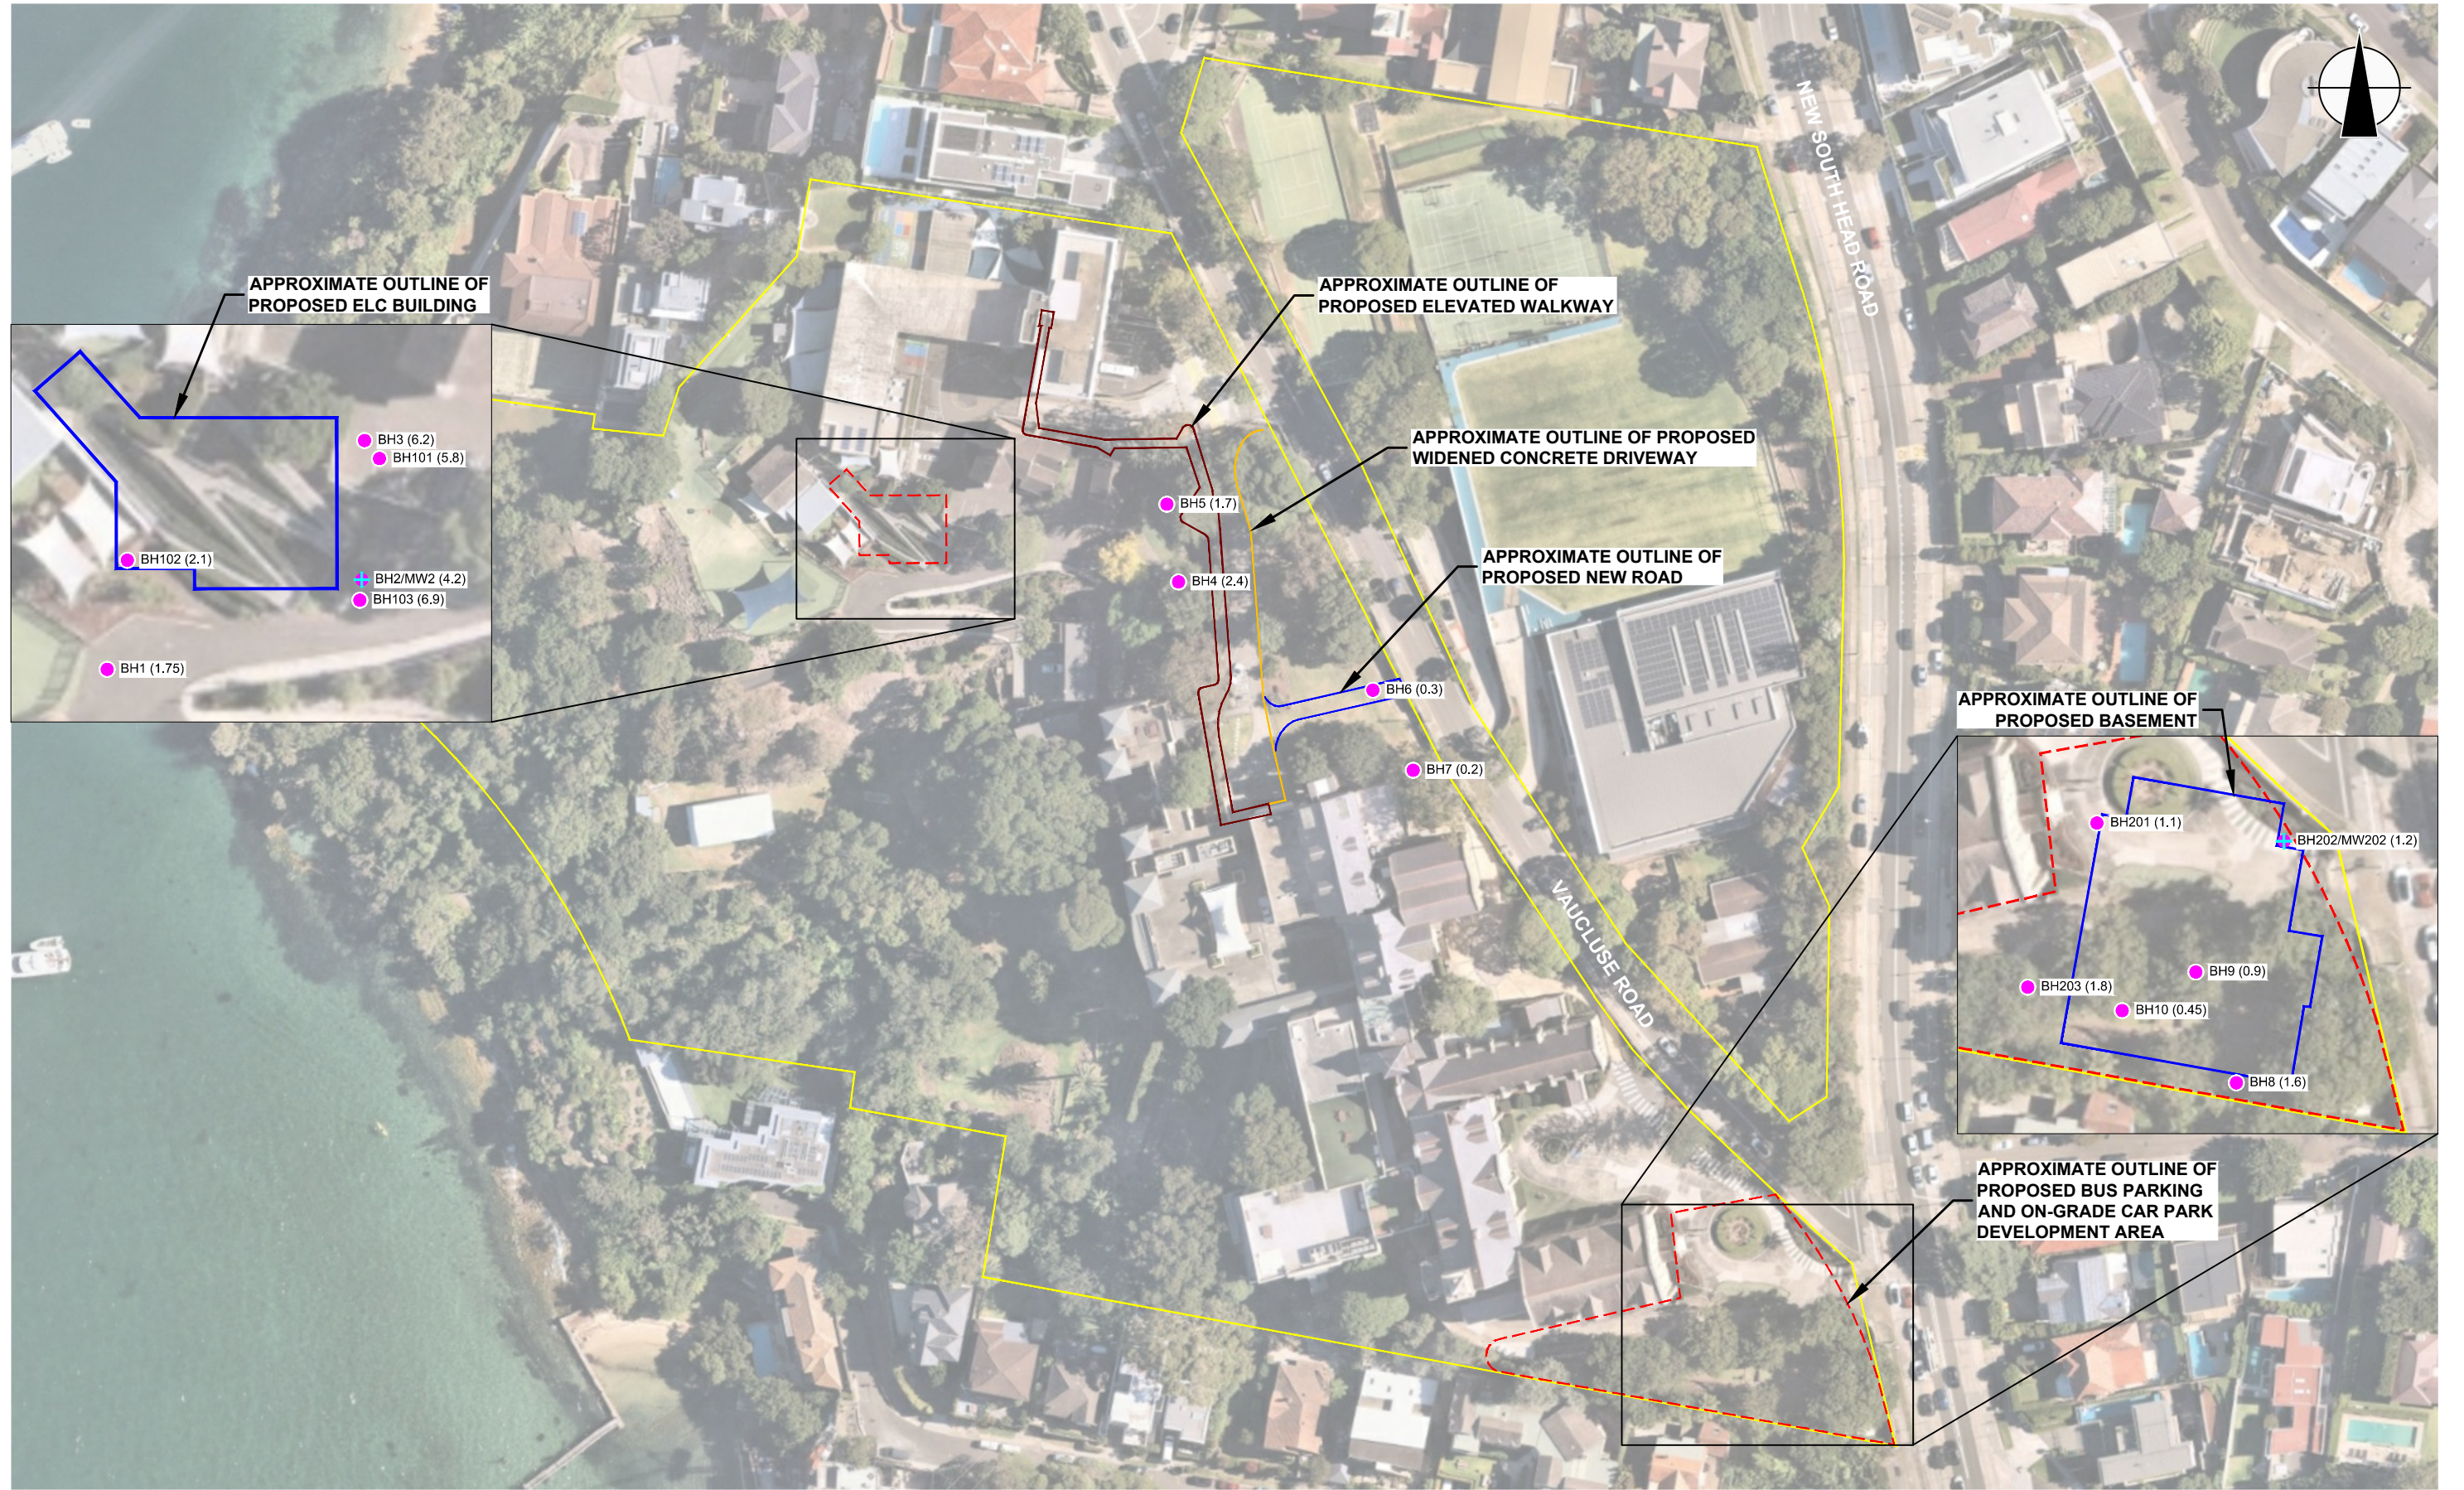
LEGEND	
	APPROXIMATE SITE BOUNDARY
	APPROXIMATE WIDER PROPERTY BOUNDARY
	BH(Fill depth) BOREHOLE LOCATION, NUMBER AND DEPTH OF FILL (m)
	BH/MW(Fill depth) BOREHOLE AND GROUNDWATER MONITORING WELL LOCATION, NUMBER AND DEPTH OF FILL (m)
