13 May 2021

**RE: Kincoppal-Rose Bay School, 1A and 2 Vaucluse Road, Vaucluse NSW
Additional Aboriginal heritage advice**

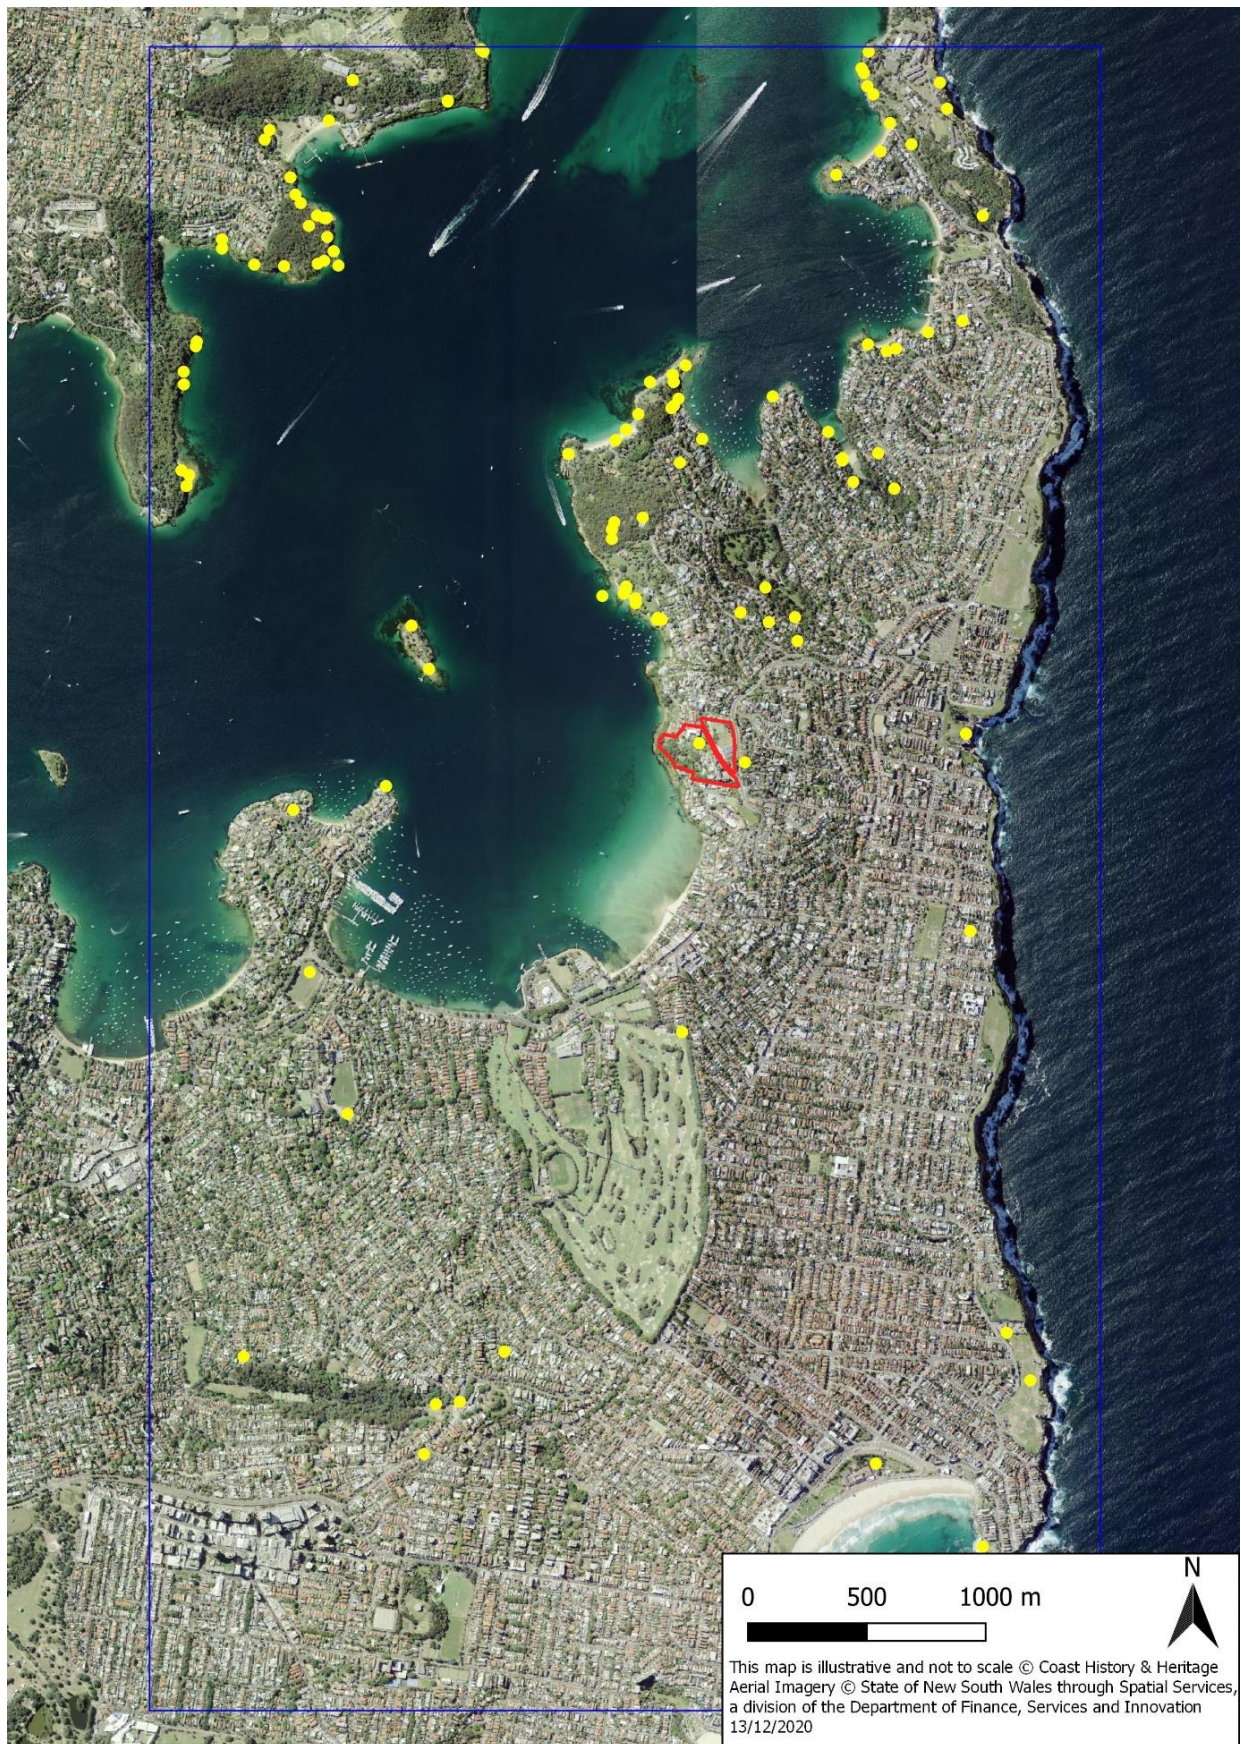
Figure 1. The results of the AHIMS search

A search of AHIMS was undertaken on 2 March 2021.¹ The search covered an area of 7x4km, centred on the study area. The results are included in **Appendix 1** and shown in **Figure 1** and **Figure 2**. The results indicate that there is one registered site within the study area: AHIMS #45-6-3754 (KRB Rockshelter). This is the possible Aboriginal archaeological site that was identified during the preparation of the 2020 ACHAR.

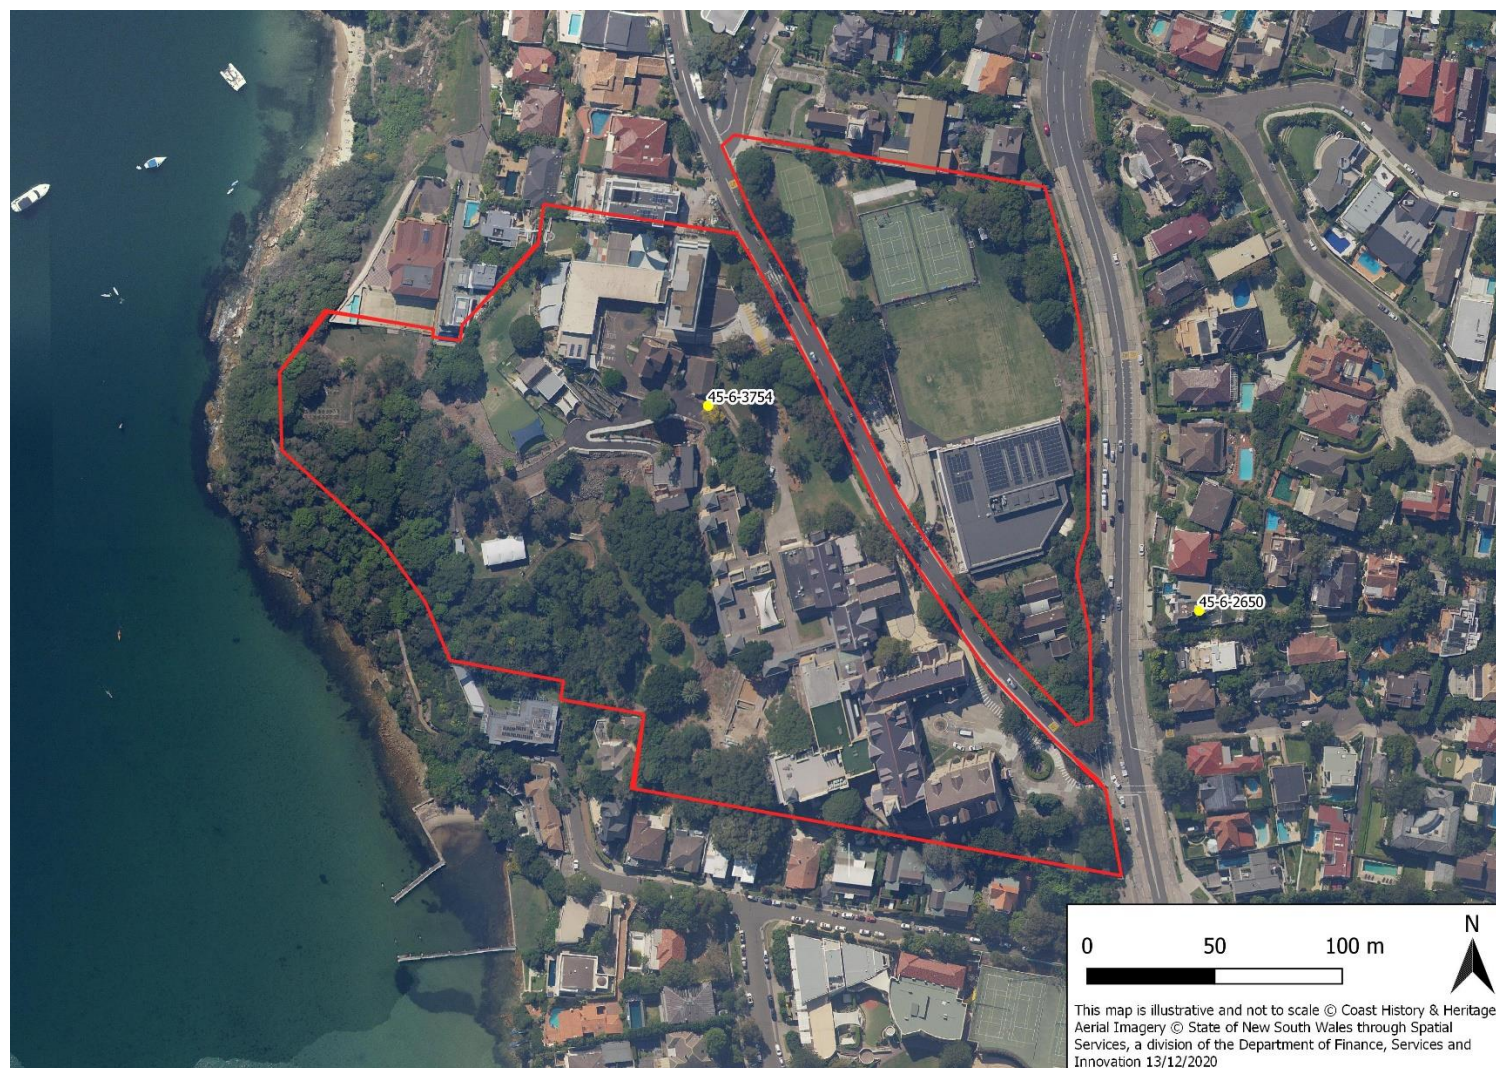
Figure 2. Detail of the results of the AHIMS search

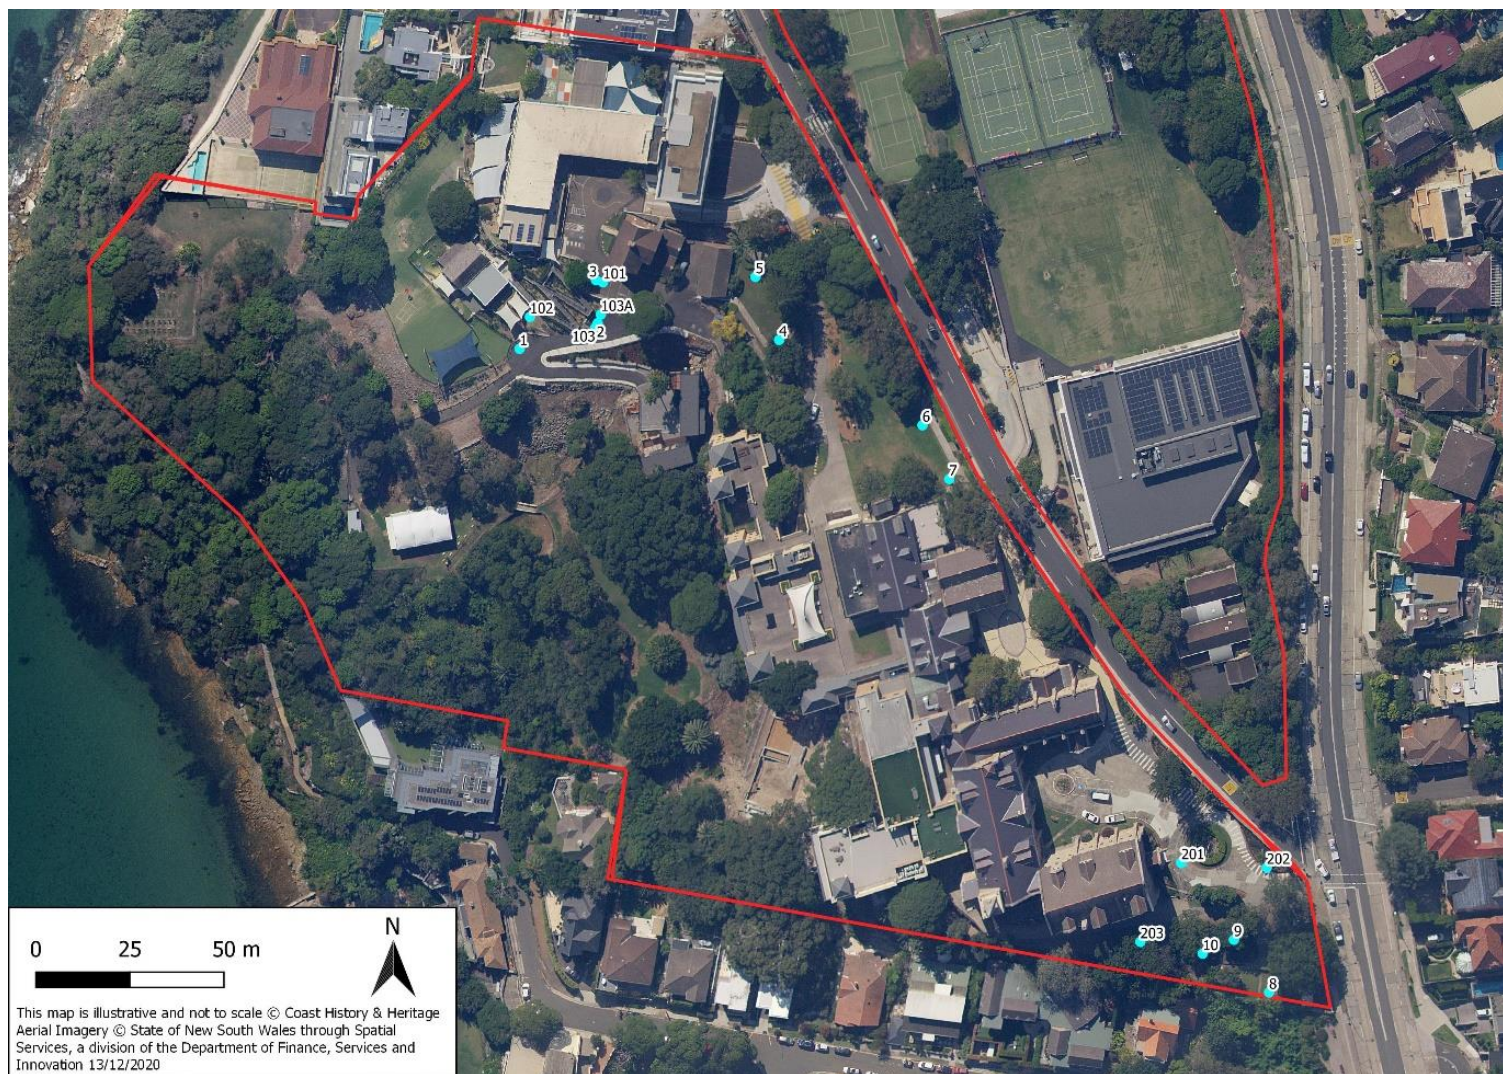
Figure 3. Location of the geotechnical boreholes

Since completion of the ACHAR, a program of geotechnical investigation has been undertaken (**Figure 3**). The geotechnical investigation has provided information on the subsurface conditions for the locations where deeper and/or more extensive excavation will be required as part of the proposed works. The results can be compared against the expected soil profile for the landscape, and, to an extent, against the results of the previous historical archaeological monitoring program on the eastern part of the school campus.

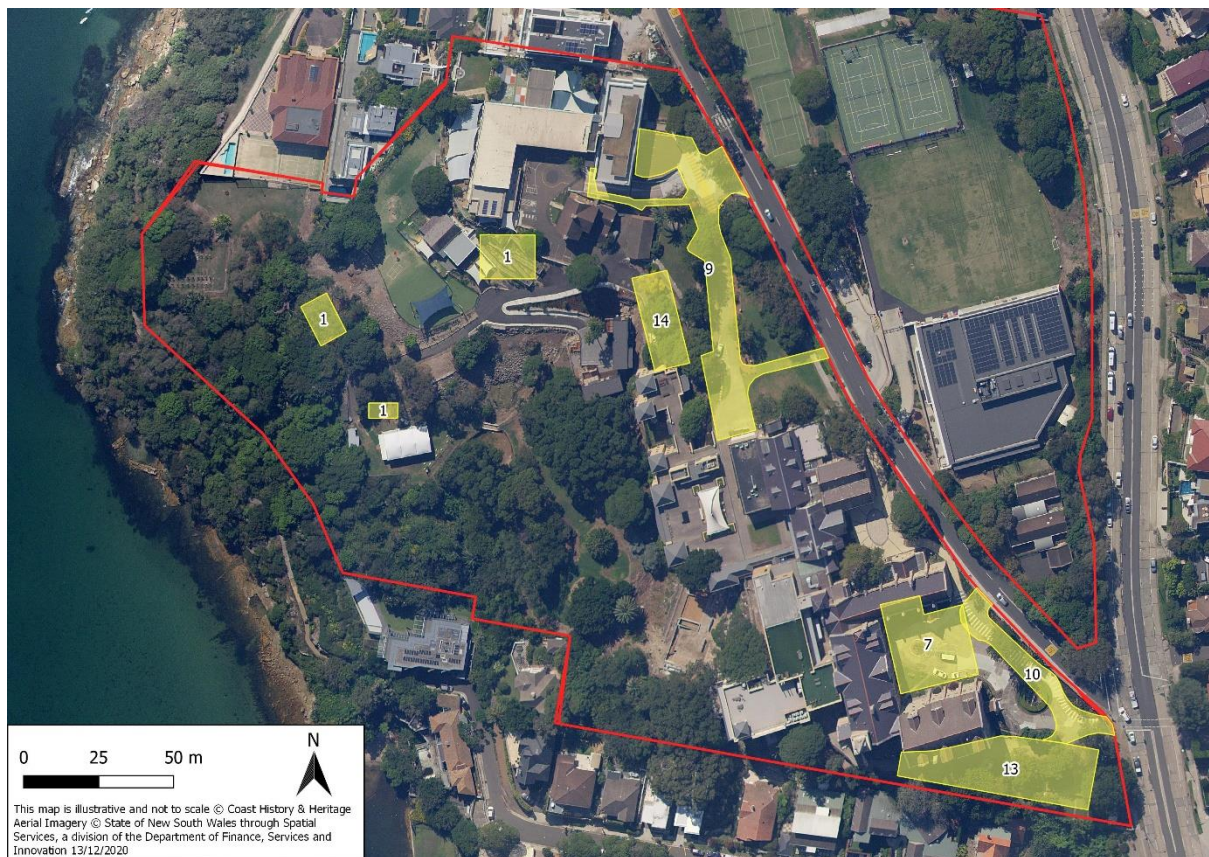
Figure 4. The location of the proposed works in the areas of high and moderate sensitivity (excluding the landscaping works in Section 3.2.6)

An updated architectural set has been prepared since the ACHAR was completed. The information in these drawings, together with the data from the geotechnical investigation, has been used in the following sections. These provide additional detail on the potential Aboriginal heritage impact of the proposed development in the identified areas of high and moderate sensitivity (**Figure 4**). The development components are numbered following the architectural set.

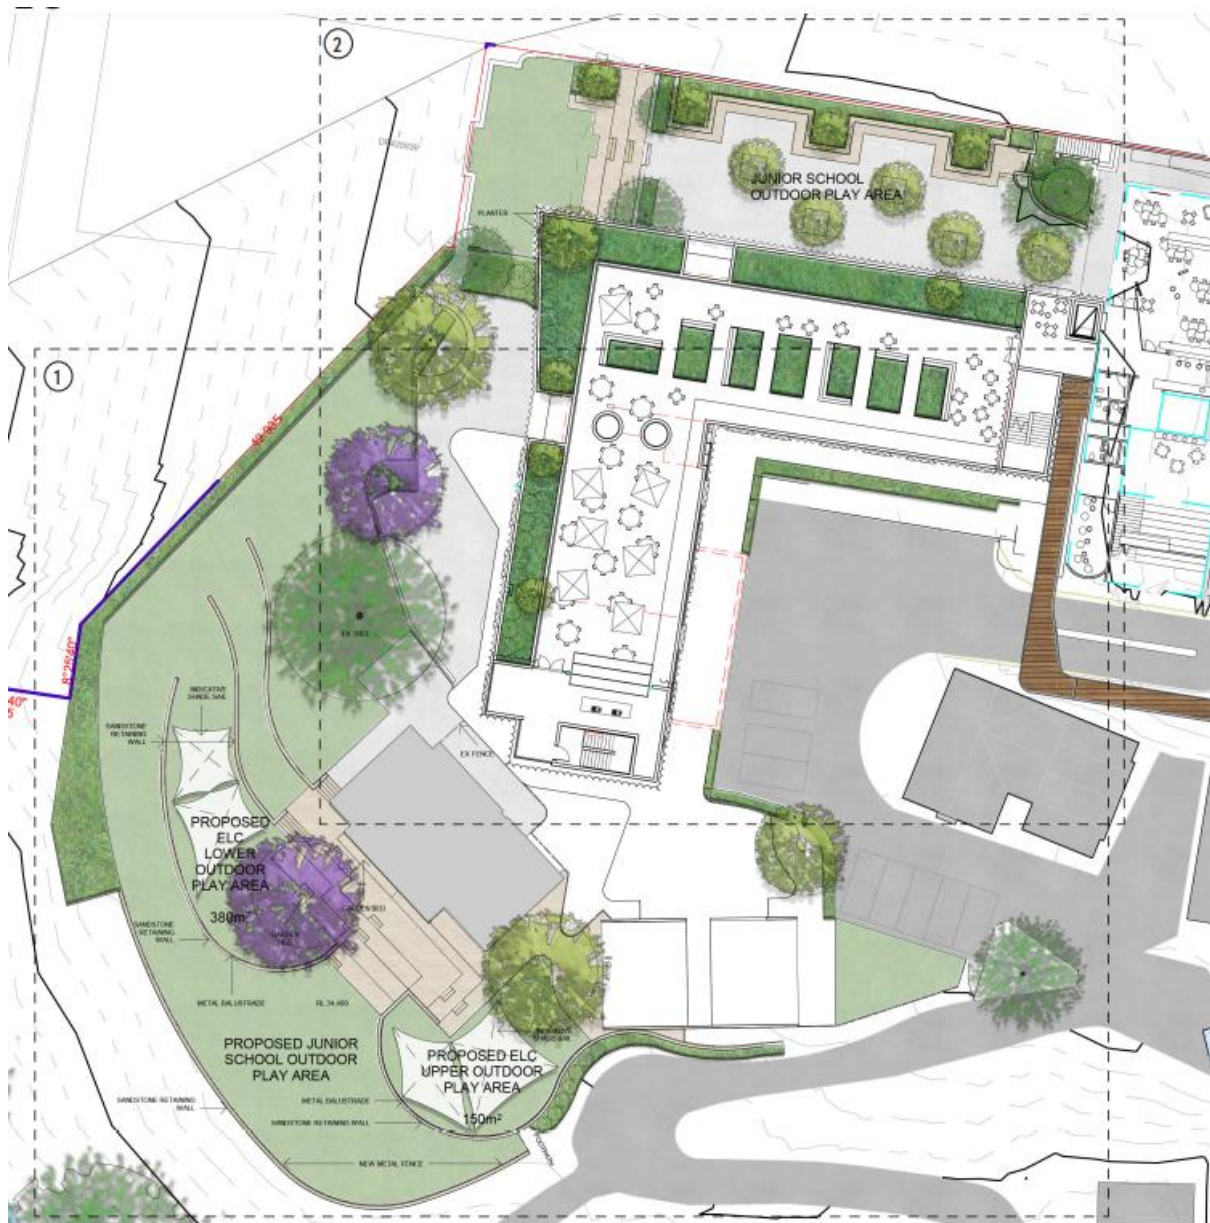
Figure 5. Overview of the proposed landscaping surrounding the Junior School and ELC

Plans have been prepared for the proposed landscaping surrounding the Junior School and ELC (**Figure 5**). Exact details of the extent and depth of any earthworks are not available, however the landscaping does not require bulk excavation or modification to the outcropping bedrock.

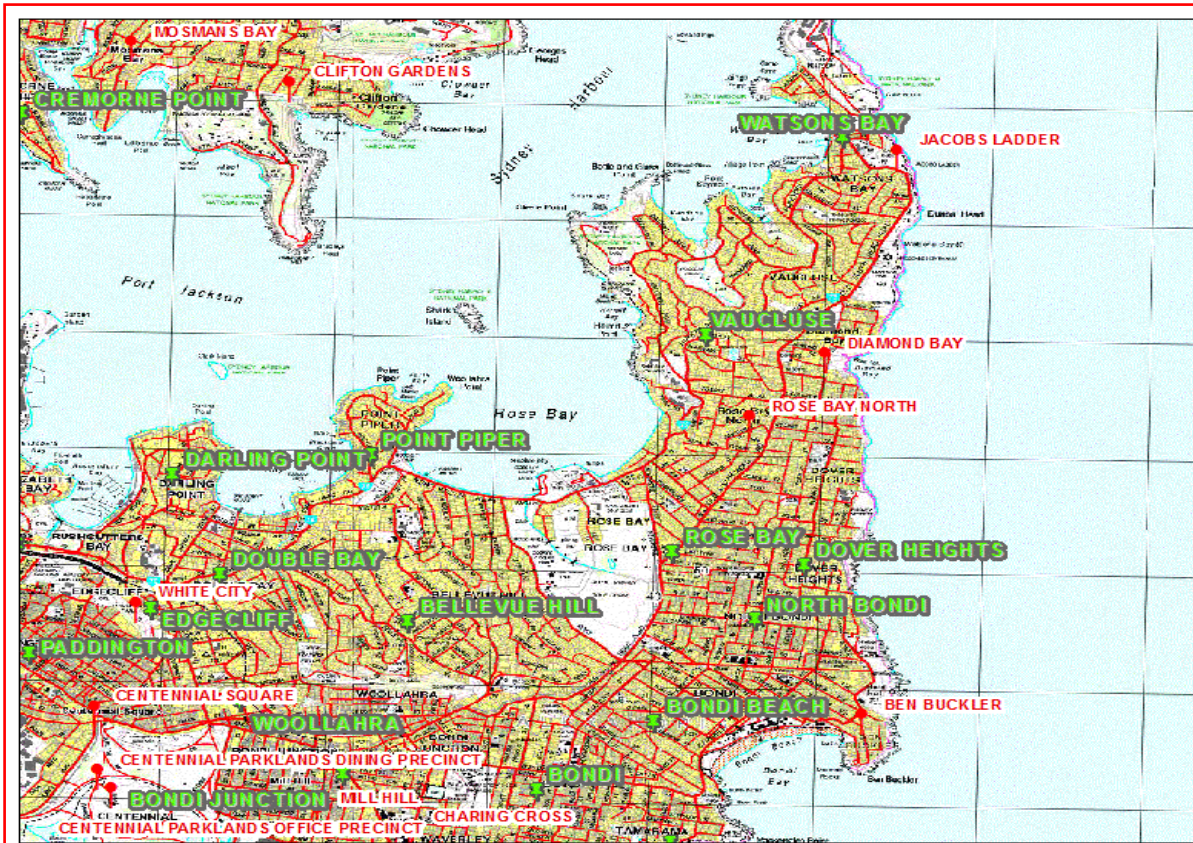
AHIMS Web Service search for the following area at Datum :GDA, Zone : 56, Eastings : 337700 - 341700, Northings : 6247700 - 6254700 with a Buffer of 0 meters, conducted by Fenella Atkinson on 02 March 2021.

The context area of your search is shown in the map below. Please note that the map does not accurately display the exact boundaries of the search as defined in the paragraph above. The map is to be used for general reference purposes only.

A search of the Office of the Environment and Heritage AHIMS Web Services (Aboriginal Heritage Information Management System) has shown that:

110	Aboriginal sites are recorded in or near the above location.
0	Aboriginal places have been declared in or near the above location. *
