<b>Client</b>	Qantas c/o Michael Terrett, Senior Project Manager, APP
<b>Location</b>	Qantas, 297 King Street, Mascot.
<b>Document Type</b>	Arboricultural Impact Assessment
<b>Date</b>	30 <sup>th</sup> July 2019

# The Ents Tree Consultancy

## 1. Contents

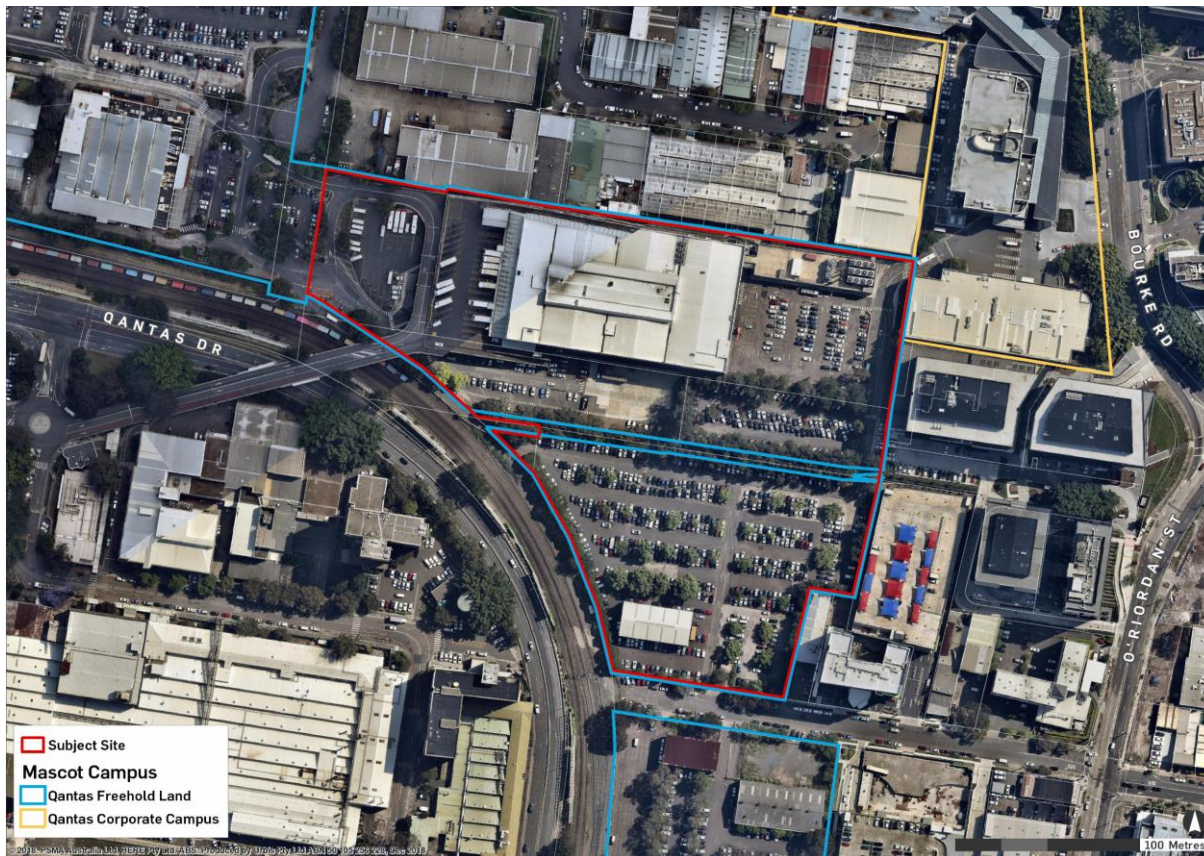
Figure 1 - The Site

- The site is approximately 5.417ha and is an irregular shape. It is approximately 240m in length and maintains a variable width of between approximately 321m in the northern portion of the site and approximately 93m along the King Street frontage (refer to Figure 1).

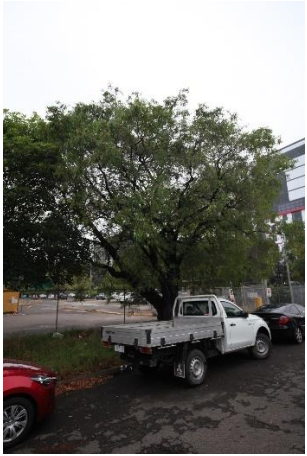
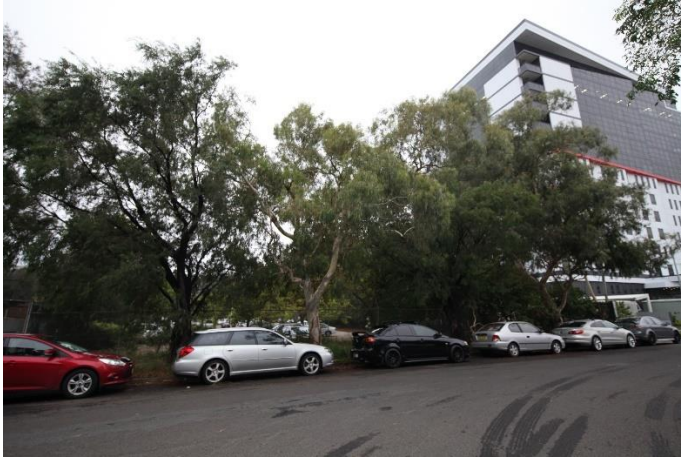
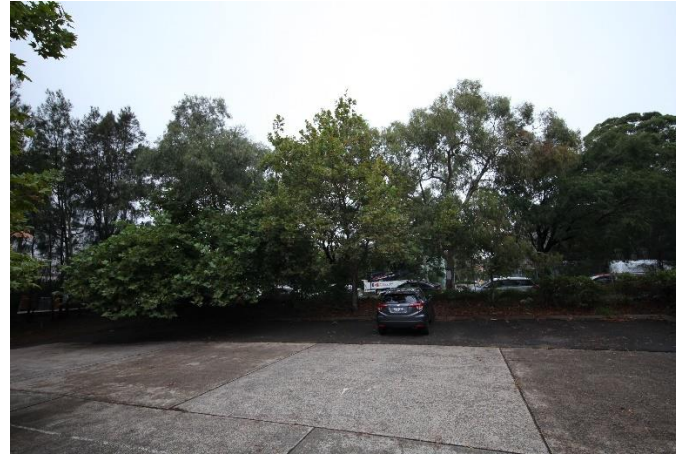
Image 1 above left shows tree 1 on site. Image 2 shows trees 2-5 on the council nature strip to the front of the site. Image 3 above right shows trees 6-9 on site. Image 4 shows tree 9 near the existing entry gate. Image 5 below centre shows trees 14 & 15. Image 6 below right shows trees 16 & 17.

4.3 **Trees 1, 2 & 3** are council street trees that are located in the nature strip on the King Street frontage adjoining the site. These trees are compatible with the works and are proposed to be retained within a new landscape plan. There are limited impacts proposed for these trees in their projected structural root zones and tree protection zones. The impact to the trees will be for the installation of a path that will be permeable and built without excavation within the structural root zone and tree protection zone of each tree. No roots 50mm+ are permitted to be damaged or removed within the Structural Root Zone. The disturbance calculated for the tree protection zone is less than 10% for each tree. To the north of the trees some of the existing bitumen will be returned to garden bed and there will be a footing excavated for a boom gate. All of the proposed disturbances are acceptable for these species.

4.5 **Trees 4 & 5** are council street trees that are in the position of the proposed driveway. These trees are proposed to be removed and replaced within a new landscape plan. **Trees 6 to 51** are trees within the existing car park area. Most of the trees are *Platanus orientalis* or *Platanus x hybrida*, Plane Trees. The majority of the trees have poor health and or poor form with insect and pest infestation such as Sycamore Lace Bug, Powdery Mildew and Anthracnose. These trees are not compatible with the works because they are either in the position of the proposed building or are in the position of the proposed new entry paths. An attempt will be made to replace some of the trees within a new landscape plan.

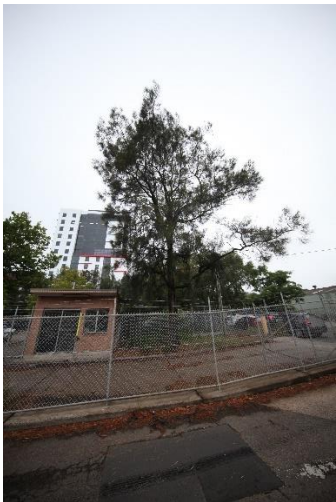
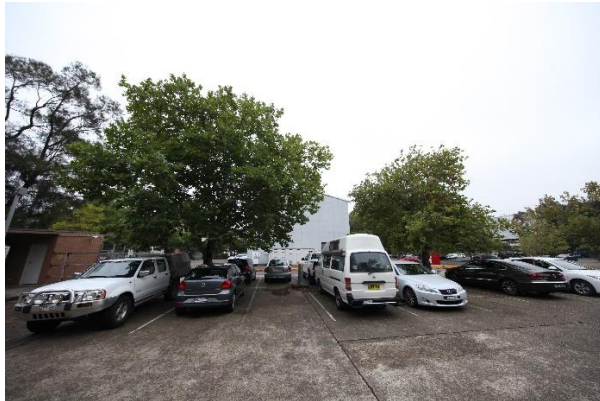
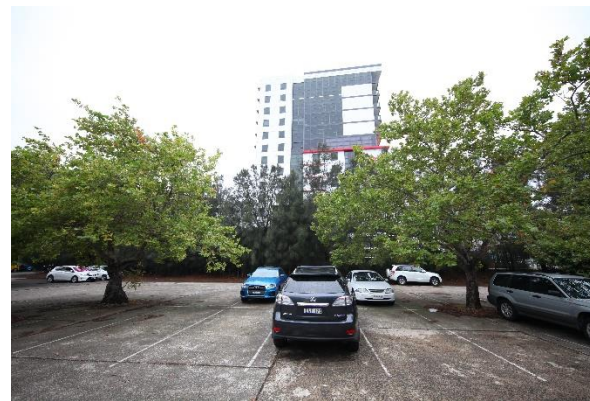
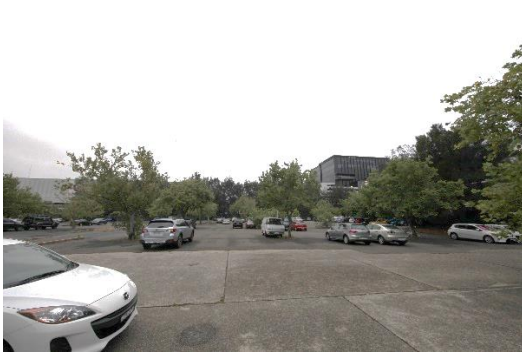
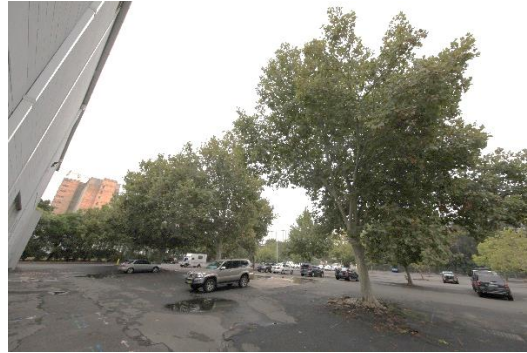
Image 7 above right shows trees 18-20. Image 8 above right shows trees 21-24. Image 9 below left shows trees 25-29. Image 10 below centre shows trees 30-32. Image 11 below right shows trees 34-42.

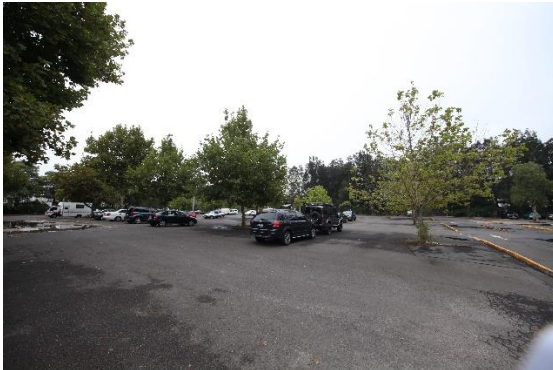
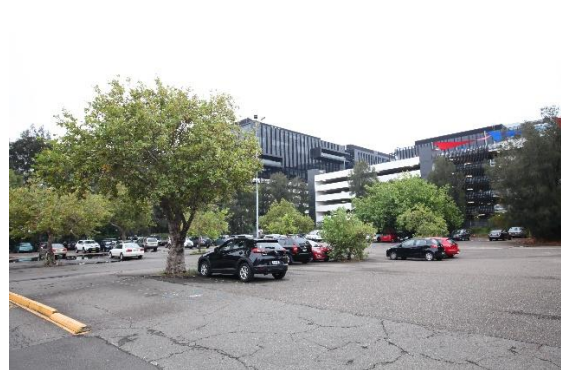
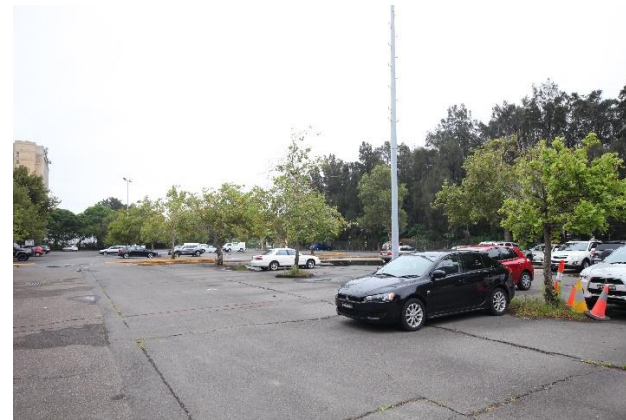
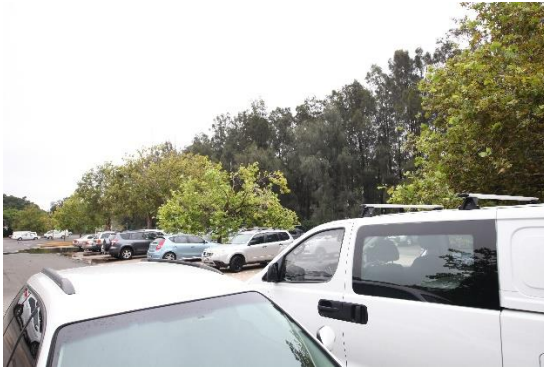
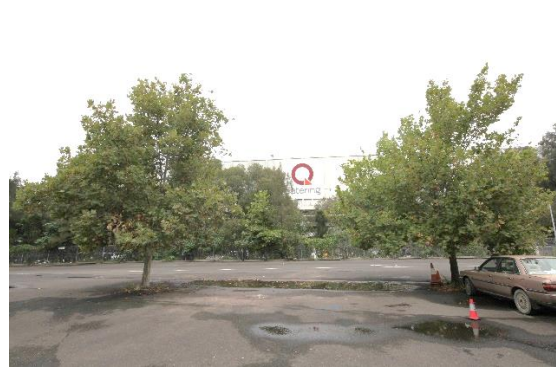
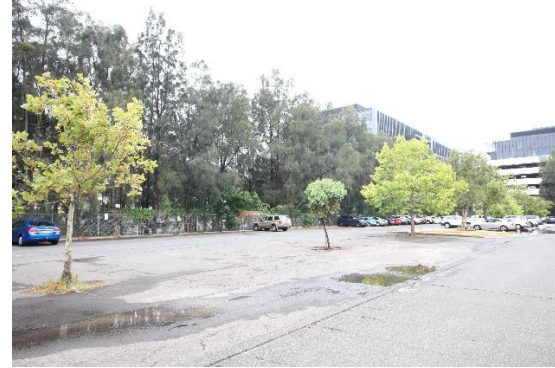
Image 12 above right shows trees 37- 42. Image 13 shows trees 43 & 44. Image 14 above right shows trees 45-51. Image 15 below left shows tree group 52. Image 16 below centre shows tree group 52 from the side. Image 17 below right shows tree group 53 on site.

4.6 **Tree Group 52** is a stand of She Oaks, (*Casuarina glauca*). There are 3 parent trees that have been lopped in the past which has resulted in them having poor form and heavy suckering from the roots forming a dense thicket of suckers which will mature into trees. The trees are semi mature trees located on the eastern boundary of the site. There are minor disturbances planned for the trees projected structural root zone. The disturbance is for the installation of a concrete pathway that has no excavation within the trees structural root zone. The existing levels will be retained and there will be a pre-fabricated concrete slab or a custom-made structure installed (suspended) over the section of the structural root zone. The disturbance calculated for the projected tree protection zone (TPZ) is less than 25% (by area), which is at the upper limit of what is acceptable for this species at this age. In reality the disturbance will be lower as there is already hardstand over 25% of the root zone, taking the disturbance to 15-20%. This tree species has a moderate tolerance to construction impacts. These trees can be retained and protected for the duration of the works with minimal impacts anticipated for their health.

4.8 **Tree Group 53** is a stand of She Oaks, (*Casuarina glauca*). There are 2 parent trees that have been lopped in the past which has resulted in heavy suckering from the roots forming a dense thicket of suckers which will mature into trees. The trees are semi mature trees located on the south - eastern boundary of the site. There are no disturbances planned for the trees projected structural root zone and a minor disturbance for the projected tree protection zone (TPZ). The proposed works increase the size of the garden area surrounding the trees which will improve their long-term viability. These trees can be retained and protected for the duration of the works with minimal impacts anticipated for their health. Any excavation works to remove bitumen within 2.5m of the trees will need to be supervised by the AQF level 5 site Arborist.

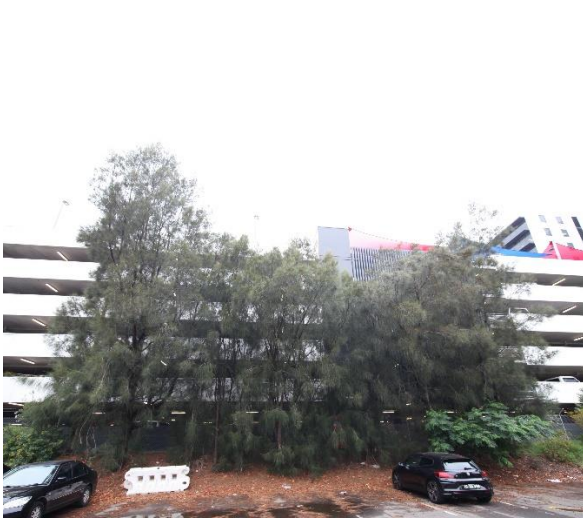
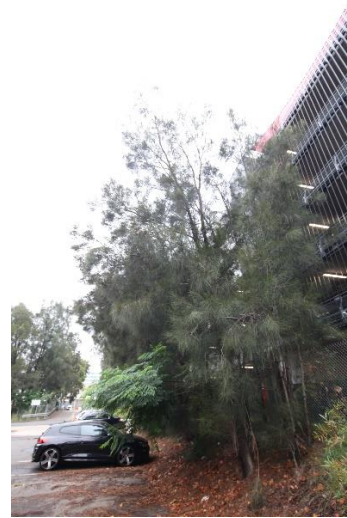
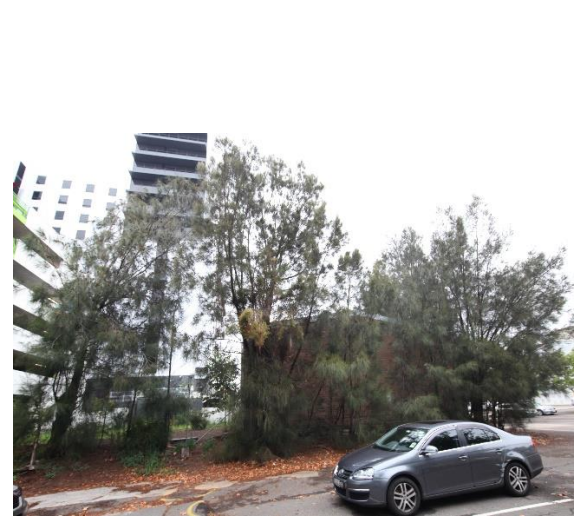
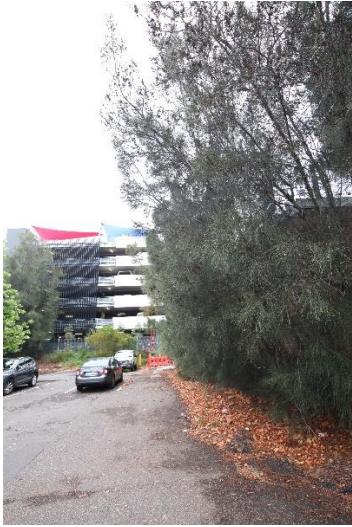
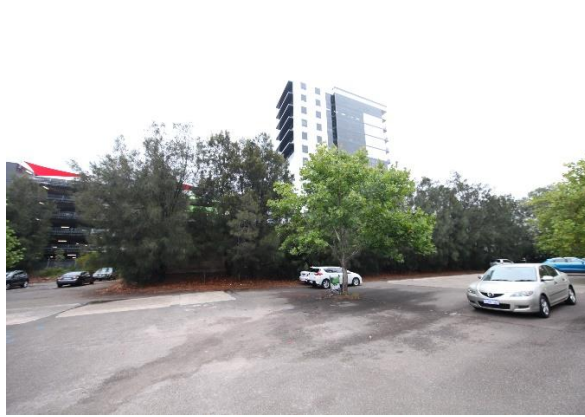
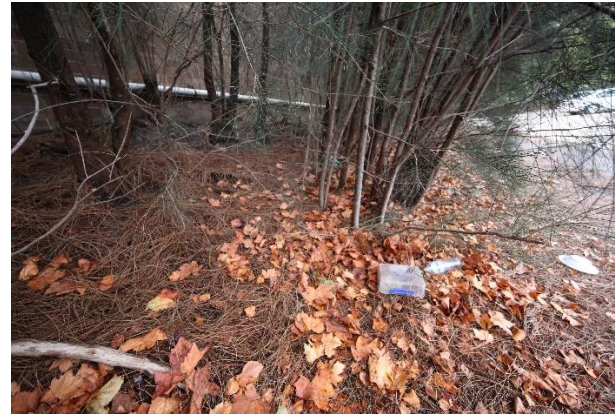
Image 18 shows tree group 53 from the west to review the crown profile. Image 19 above centre shows tree group 54 to the east of the site. Image 20 above right shows the regrowth from the base of a casuarina tree. Image 21 below right shows trees 54 from the site to show the crown profile to the west. Image 22 below left centre shows the parent tree (Blue Arrow) and the rest of the trees present are suckers from the roots. Image 23 below right centre shows trees 55-60 on the western side of the site. Image 24 below right shows the crown profile of trees 55-60 looking south.

**4.10 Tree Group 54** is a stand of She Oaks, (*Casuarina glauca*). There are 10 parent trees that have been lopped at 2-3m in the past which has resulted in the loss of the trees form and heavy suckering from the roots. The root system is forming a dense thicket of suckers which will mature into trees. The trees are semi mature trees located on the eastern boundary of the site. The crowns extend 7m to the west and the roots can be seen 5m to the west. There are four trees that are not compatible with the works which will require removal to allow for pedestrian access from King Street. There are some disturbances planned for the trees projected structural root zone which are for the installation of a pre-fabricated concrete footpath or a custom made structure (suspended) above grade. The installation of the suspended slabs for each parent tree will remove the risk of destabilising the trees.

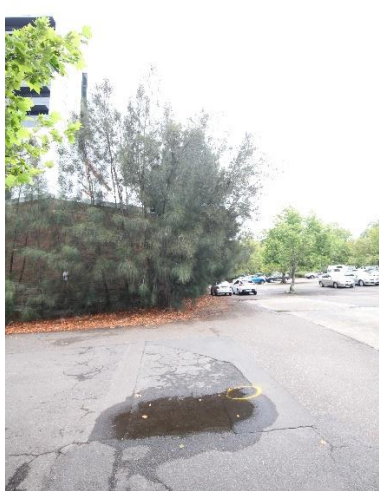
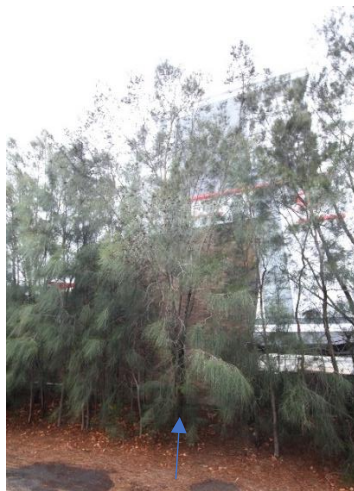
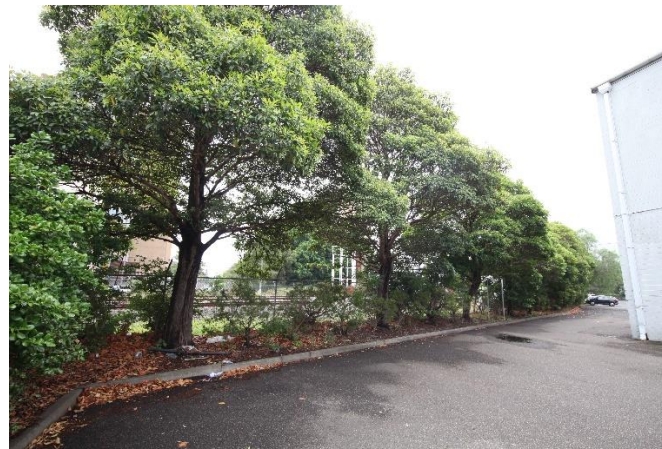
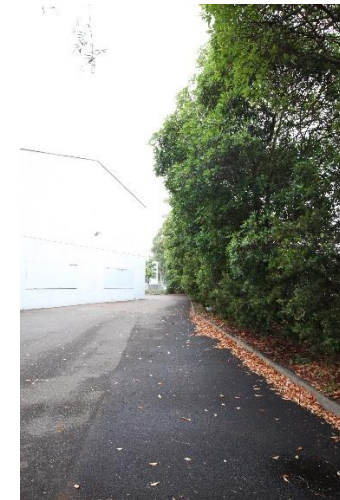
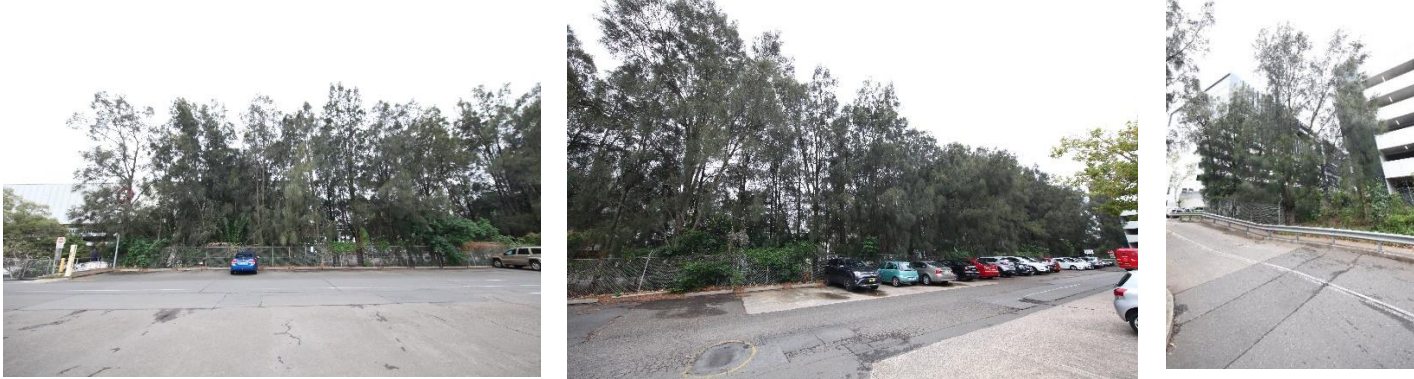
Image 25 above left shows tree group 70. Image 26 above centre shows tree group 71. Image 27 above right shows tree 120. Image 28 below left shows tree group 72. Image 29 below centre shows the crown profile of tree group 72 to the north and the existing hardscapes. Image 30 below right shows tree group 73.

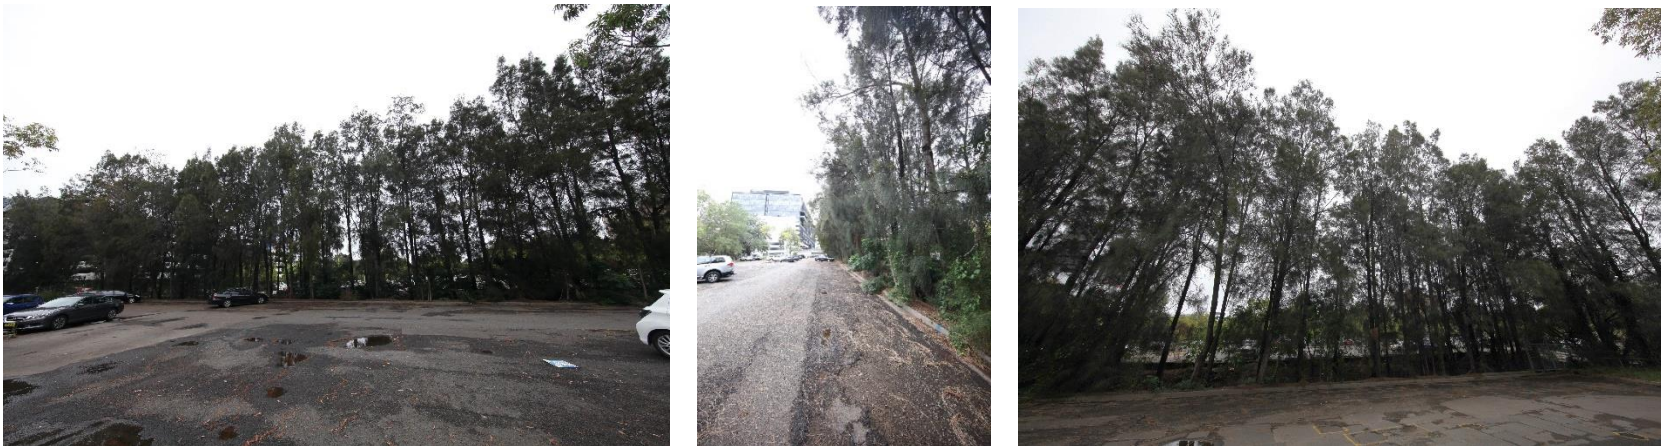
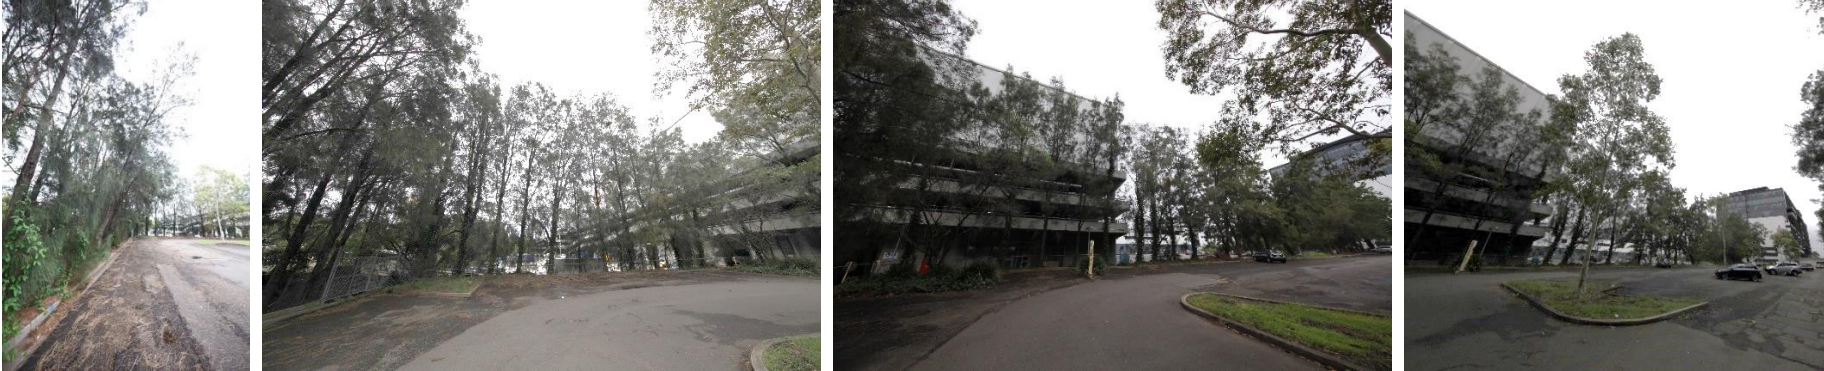
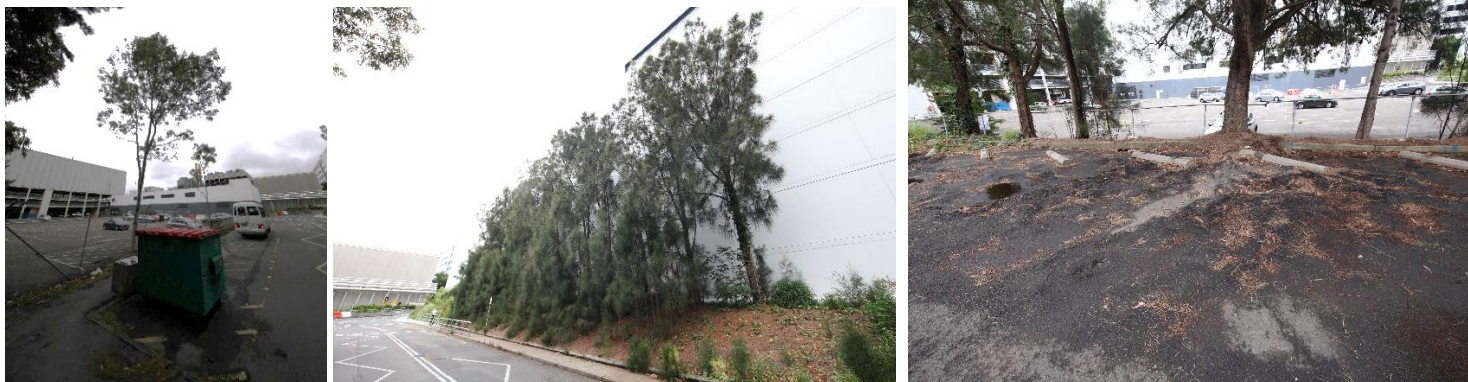
Image 31 shows the profile of tree group 73 and the adjoining hardscapes. Image 32 above left centre shows trees 75-86. Image 33 above right centre shows trees 87-108. Image 34 above right shows trees 112-118. Image 26 below left shows trees 110 & 111. Image 37 below centre shows tree group 119. Image 38 below right shows the developing root system of *Casuarina cunninghamiana* (River She Oak).
