MEMO

TO: Michael Terrett
FROM: Josie Stokes
SUBJECT: Targeted Microbat Surveys- Qantas Flight Training Project
OUR REF: PS113050-ECO-MEMO-001 RevA
DATE: 7 August 2019

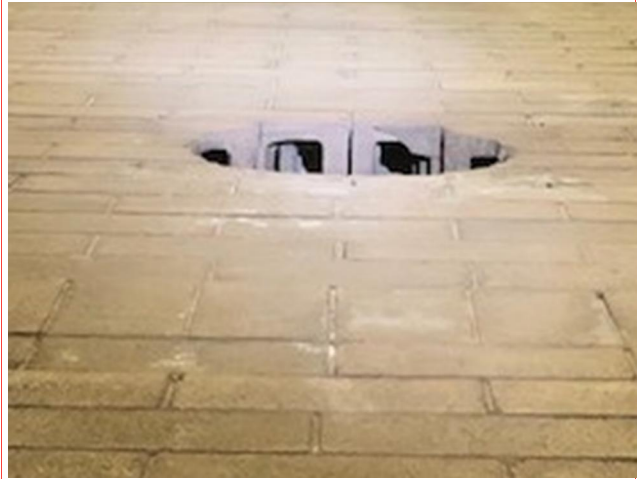
Figure 2. Potential microbat roosting habitat within the wall of the warehouse. This was inspected during the diurnal survey and no microbats or signs of microbats were observed.

The types of potential microbat roosting habitat in the buildings included roof space cavities in a disused security building (Figure 4), and broken sections of Hebel blocks in the wall of the large, still in use warehouse (Figure 2). All holes and roof cavities were inspected and no microbats or signs of microbats were found.

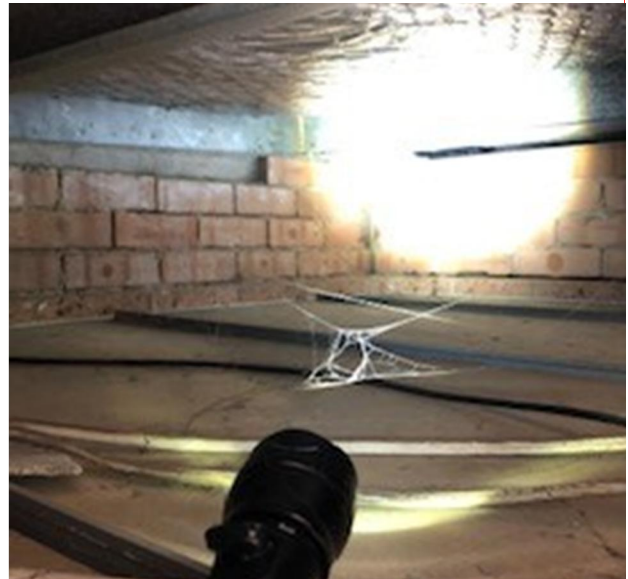
Figure 4. Roof cavity space in disused security building being inspected for microbats. This was inspected during the diurnal survey and no microbats or signs of microbats were observed.

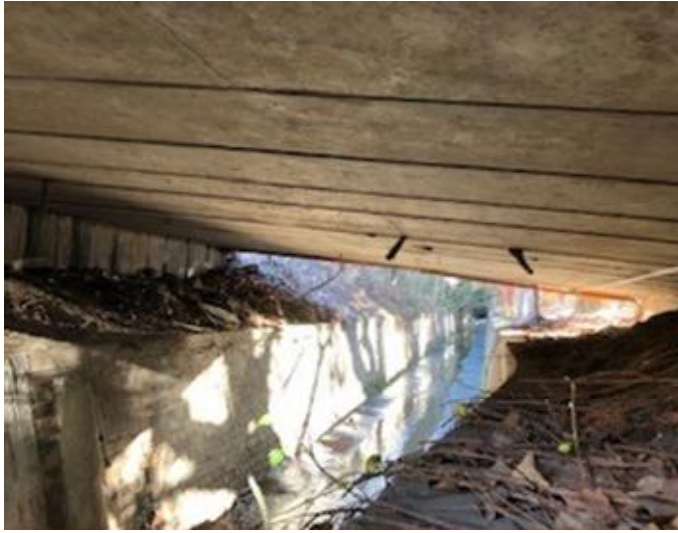
Figure 5. Concrete plan bridge decking (underside) spanning concrete lined canal approx. 100m north of the buildings. Water was present in the canal during the diurnal survey.

No microbats or signs of microbats were observed when this bridge was inspected on 31 July 2019.

There is more suitable roosting habitat for both Large-footed Myotis under two concrete plank bridges that span the canal, approximately 100 metres north of the buildings. The underside of one of the bridges was inspected during the diurnal targeted survey but no microbats, or signs of microbats, were observed (Figure 5).
