# St John of God

## Historical Archaeological Assessment

FINAL REPORT

25 June 2021

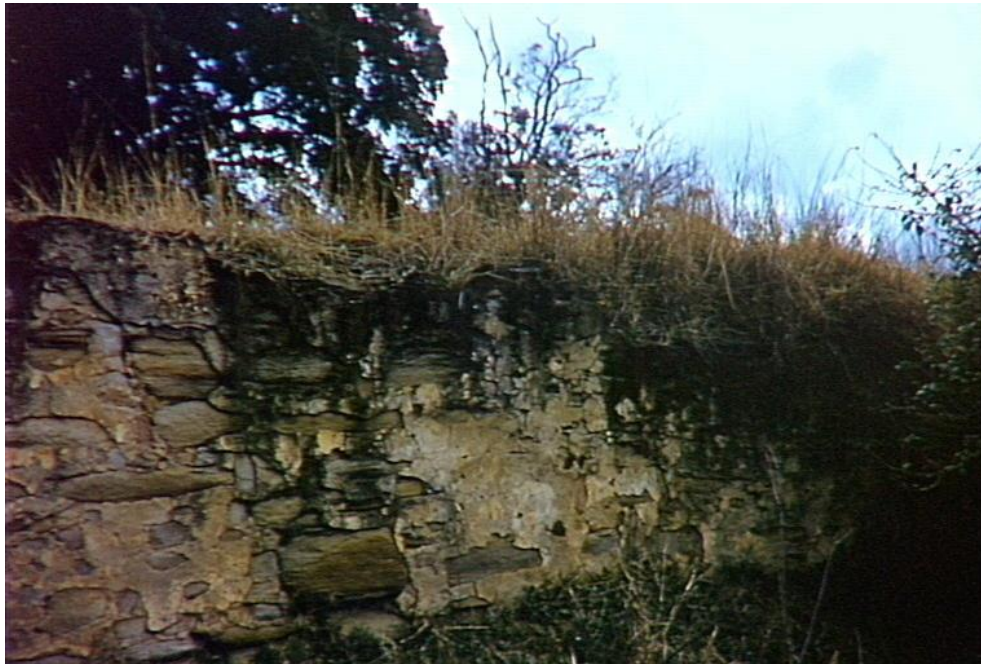
Bell House [1] was demolished in 1892, which was said to be haunted with ghost sounds and flickering light. A photograph dating to c1960s is noted to be the 'foundations of old Bell at Belmont, North Richmond, Grose Vale'; it is possible that these are the foundation remains of the original Belmont House [1] (Photo 13). However, the location of the photograph is not known.<sup>51</sup> Charley commissioned further buildings and works in the 1890s, including a new stable block [7] in 1896; prior to this the original Bell stable [2] was utilised. In 1897, wind breaks of pines were planted around the estate paddocks with vegetable and

**Photo 13** c.1960s photograph of the 'Foundations of old Bell at Belmont', possibly the original Bell House [1] (Source: Hawkesbury Library, Image no. 013835)

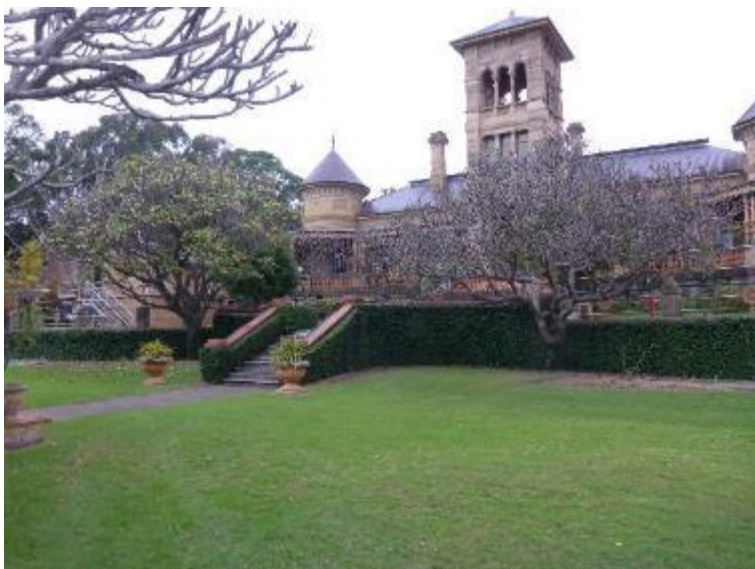
**Photo 30** View of Belmont House [3] and associated terraced landscaping, facing south

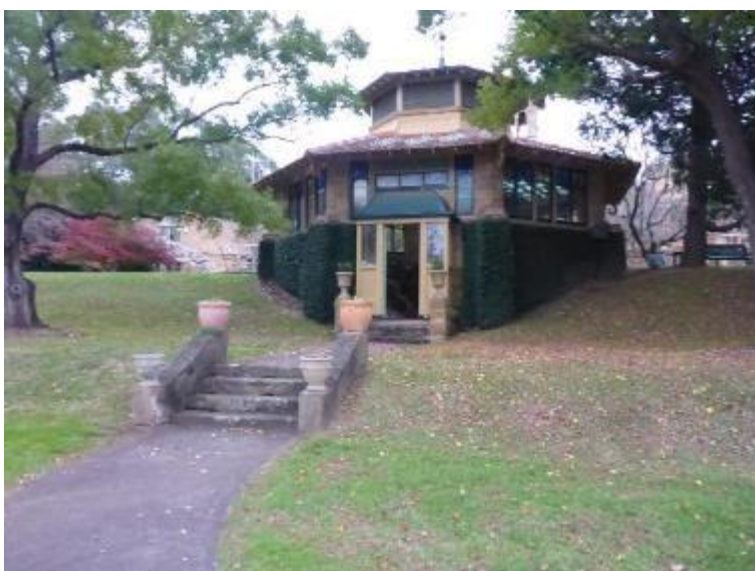
**Photo 31** View of the conservatory [5] and associated terraced landscaping

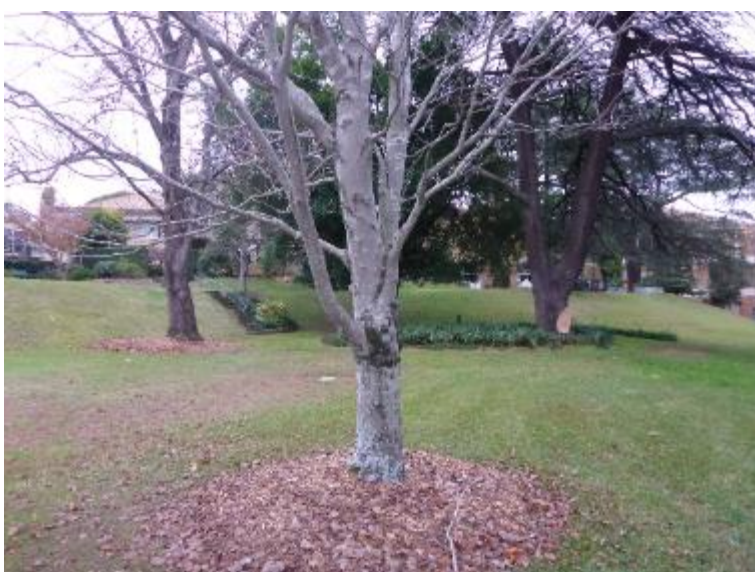
**Photo 32** View of terracing to the north-east of Belmont House [3], facing west

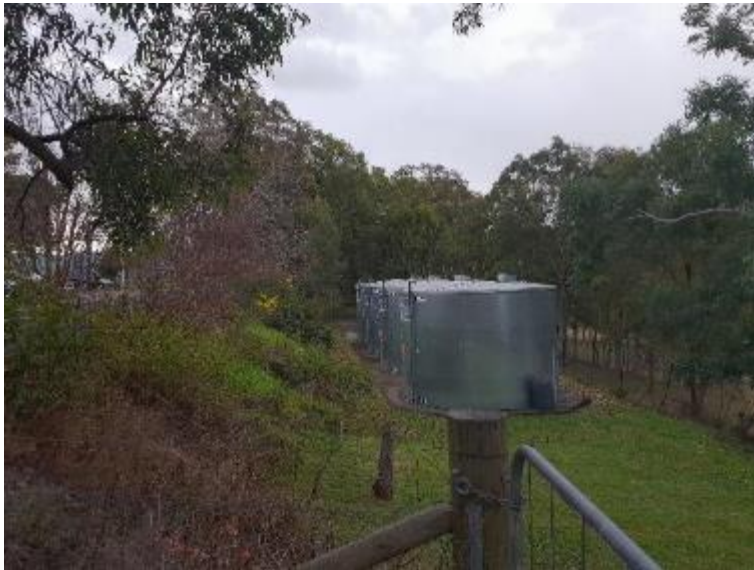
**Photo 39** View of utilities adjacent to terraced landscaping and the hospital carpark in the northern portion of the study area, facing north-west

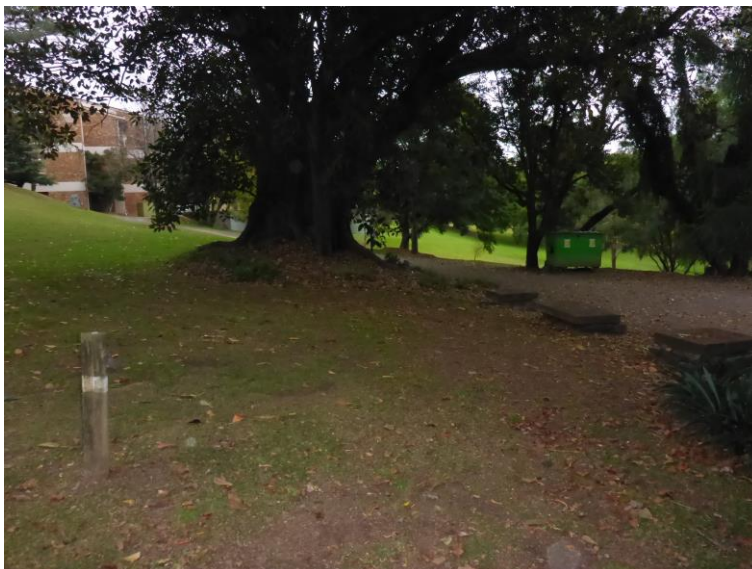
**Photo 43** Area near current maintenance shed / engineering building [32] which may be location of Bell House [1], facing north

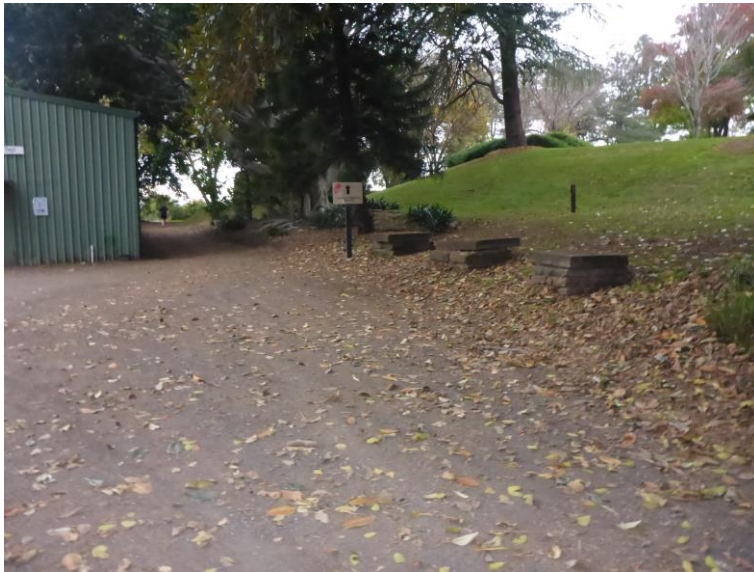
**Photo 44** Area near current maintenance shed / engineering building [32] which may be location of Bell House [1], facing south

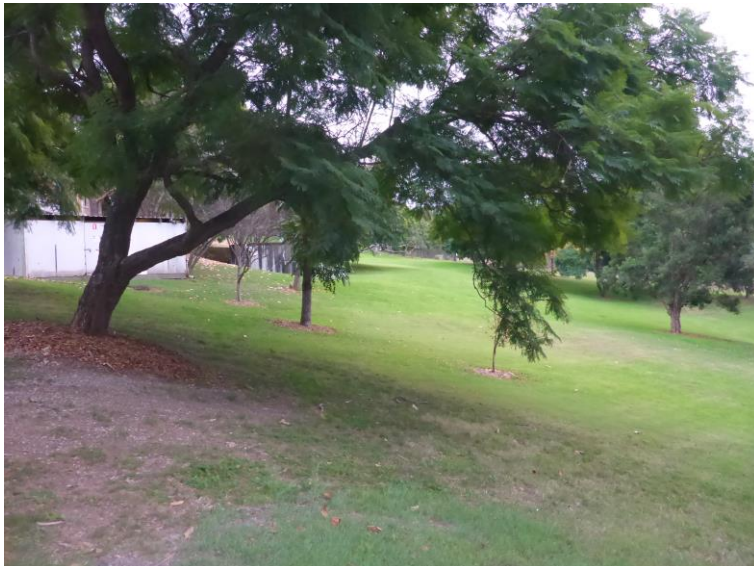
**Photo 45** View towards area near current new tennis courts [31] which may be location of Bell House [1], facing north-west

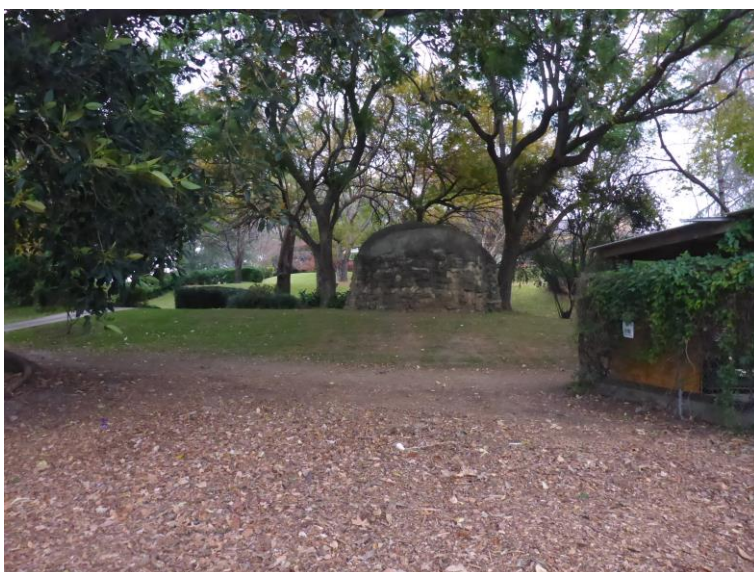
overgrown with climbing vegetation) and for the Grotto of the Lady of Lourdes near the conservatory [9] (Photo 46).<sup>74</sup>

**Photo 46** Grotto of the Lady of Lourdes which may contain reused stone from Bell House [1] or other early buildings [3] [4], facing south-west

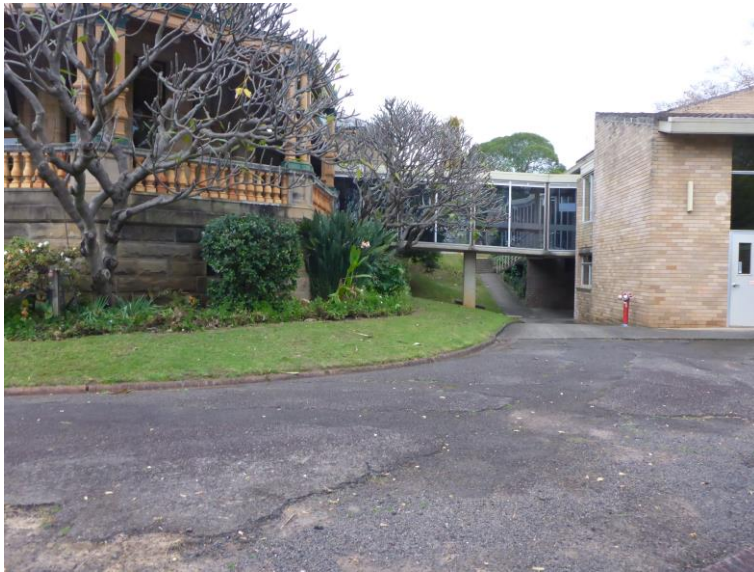
**Photo 48** View of Phase 2 and 3 structures cutting into the slope, also showing infrastructure and utilities, facing south-west

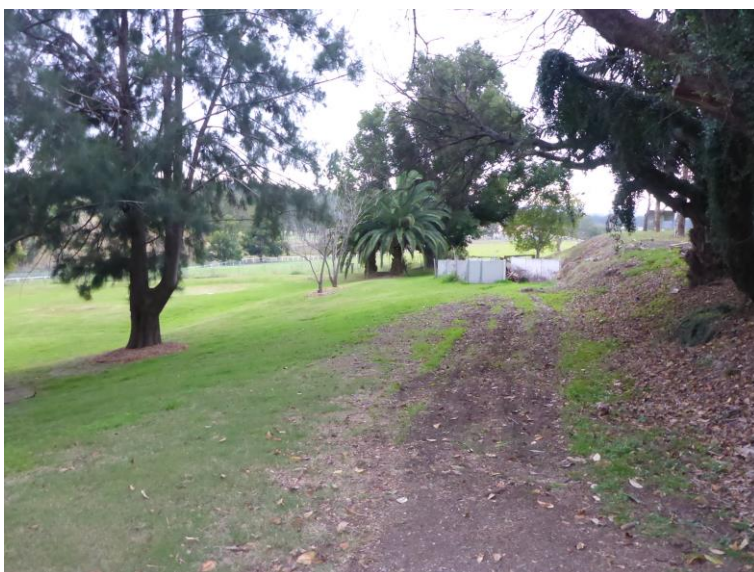
**Photo 50** View of Phase 2 and 3 modifications through terracing and landscaping, facing north-east

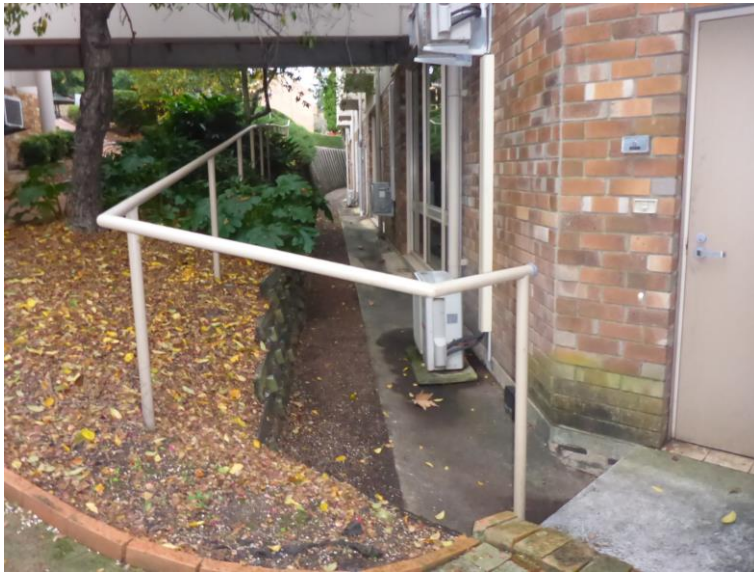
**Photo 51** Example view of Phase 3 structures cutting into the slope, also showing infrastructure and utilities

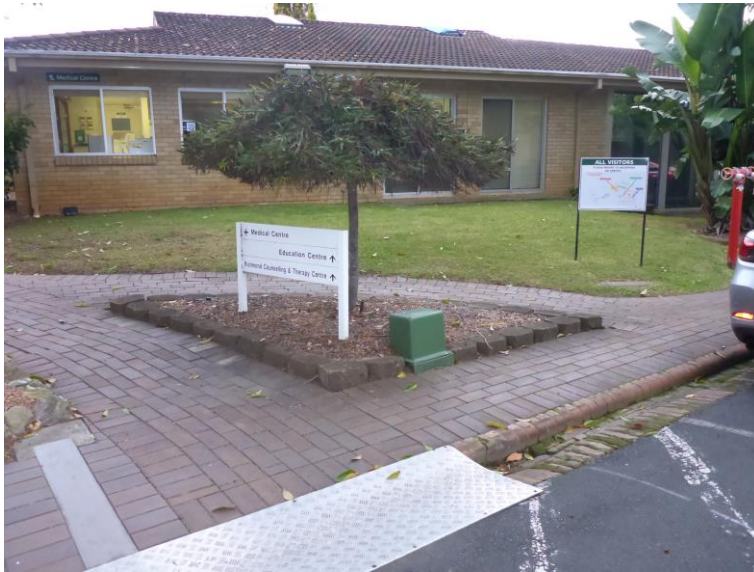
**Photo 54** View of Phase 3 structures, and infrastructure and utilities, facing south

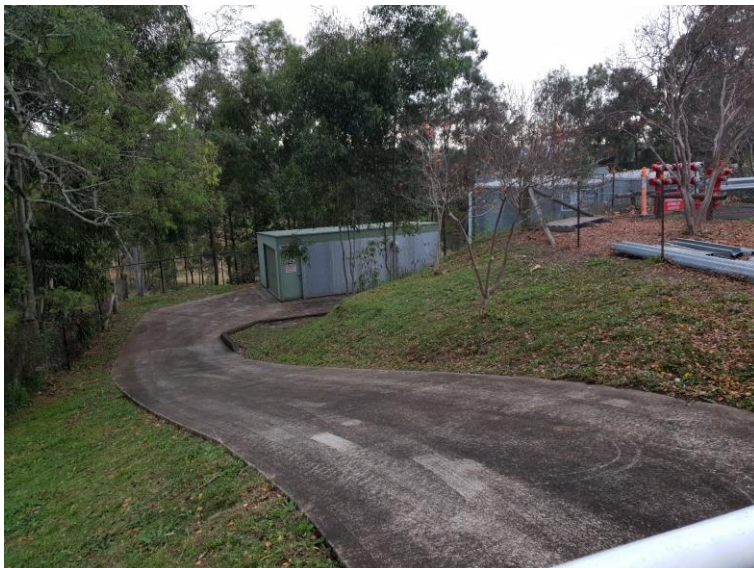
**Photo 55** View of Phase 3 structures and terracing cutting into the slope, also showing infrastructure and utilities, facing east
