181202 TAAB

**LORETO NORMANHURST**  
**P3 Osborn Road Driveway Review**

Existing stage road safety audit

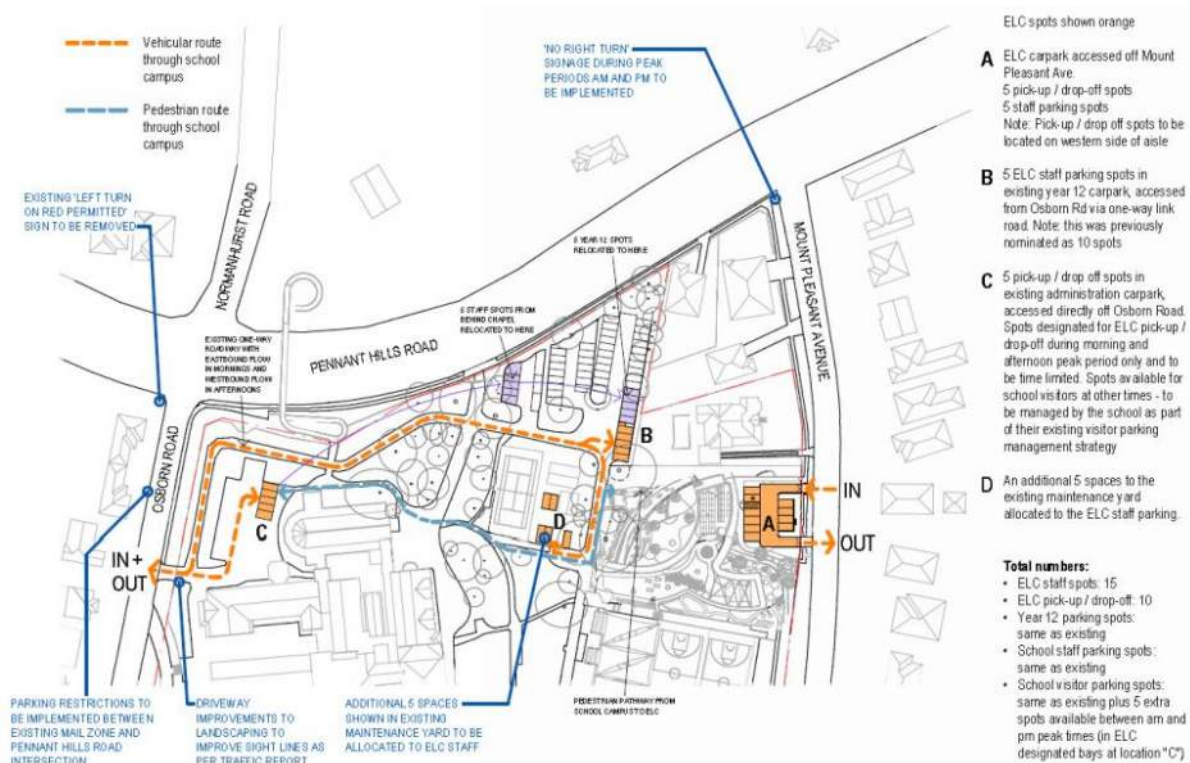
**Figure 1: ELC Original Parking Strategy**

The 15 spaces required for the Early Learning Centre development application will be located within the spaces shown in Figure 1, once the P1A carpark and through site link is constructed, the parking spaces that will be impacted by the works (at location 'B' and 'D' in the figure) will be located within the P1A car park. These spaces will be clearly line marked as well as indicated to staff as part of the staff allocation discussed in Section 6.2.1 of the Operational Traffic Management Plan.

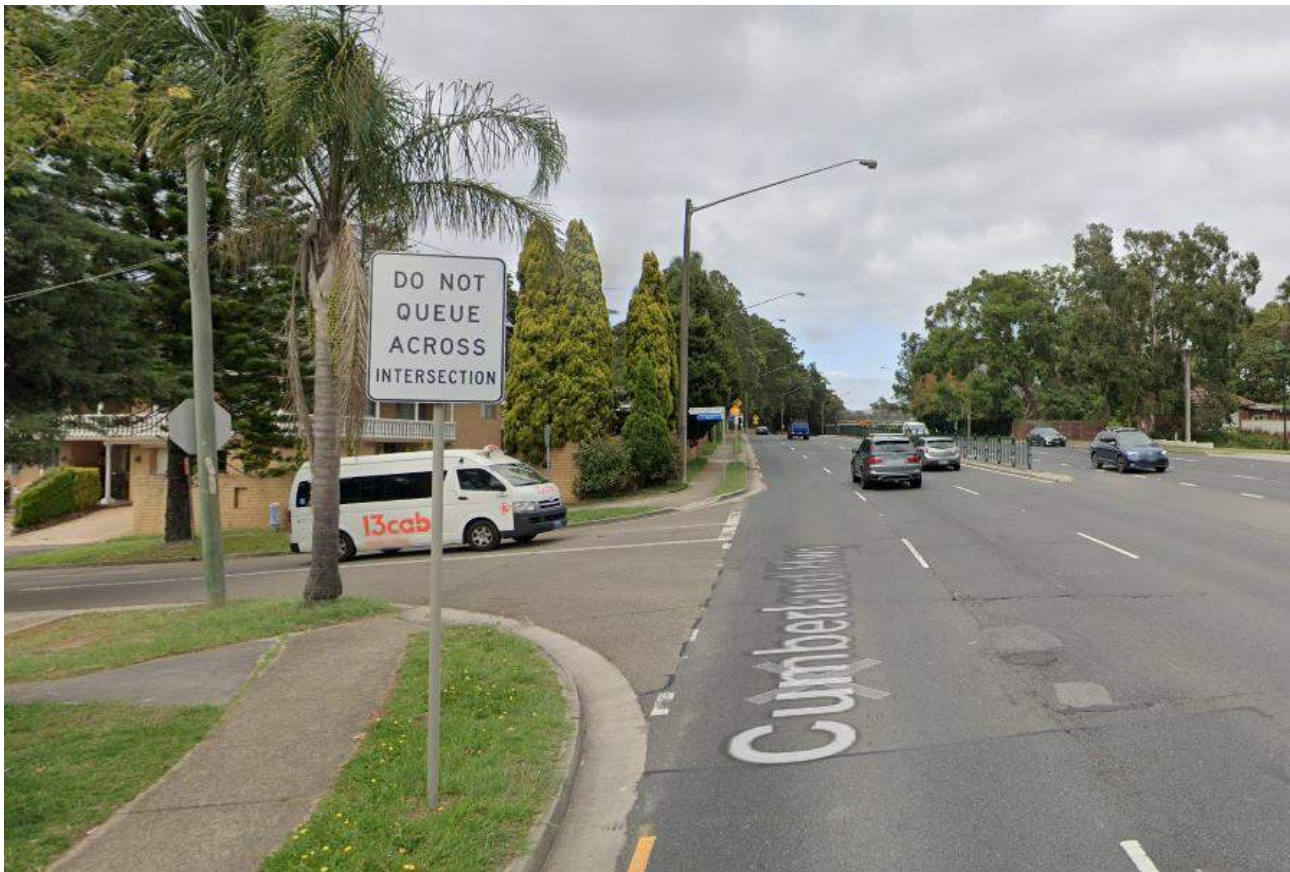
**Figure 2: Existing Signage at Mount Pleasant Avenue and Pennant Hills Road Intersection**

Refer to revised SIDRA model results in Appendix C with the intersections modelled as a network model. While the westbound queues extend past Mount Pleasant Avenue, this is an existing issue shown in the 2019 existing model and evidenced by the installation of signage to prevent queuing over the intersection. Queues are shown to reduce in the future due to reduced vehicle volumes as a result of Northconnex.

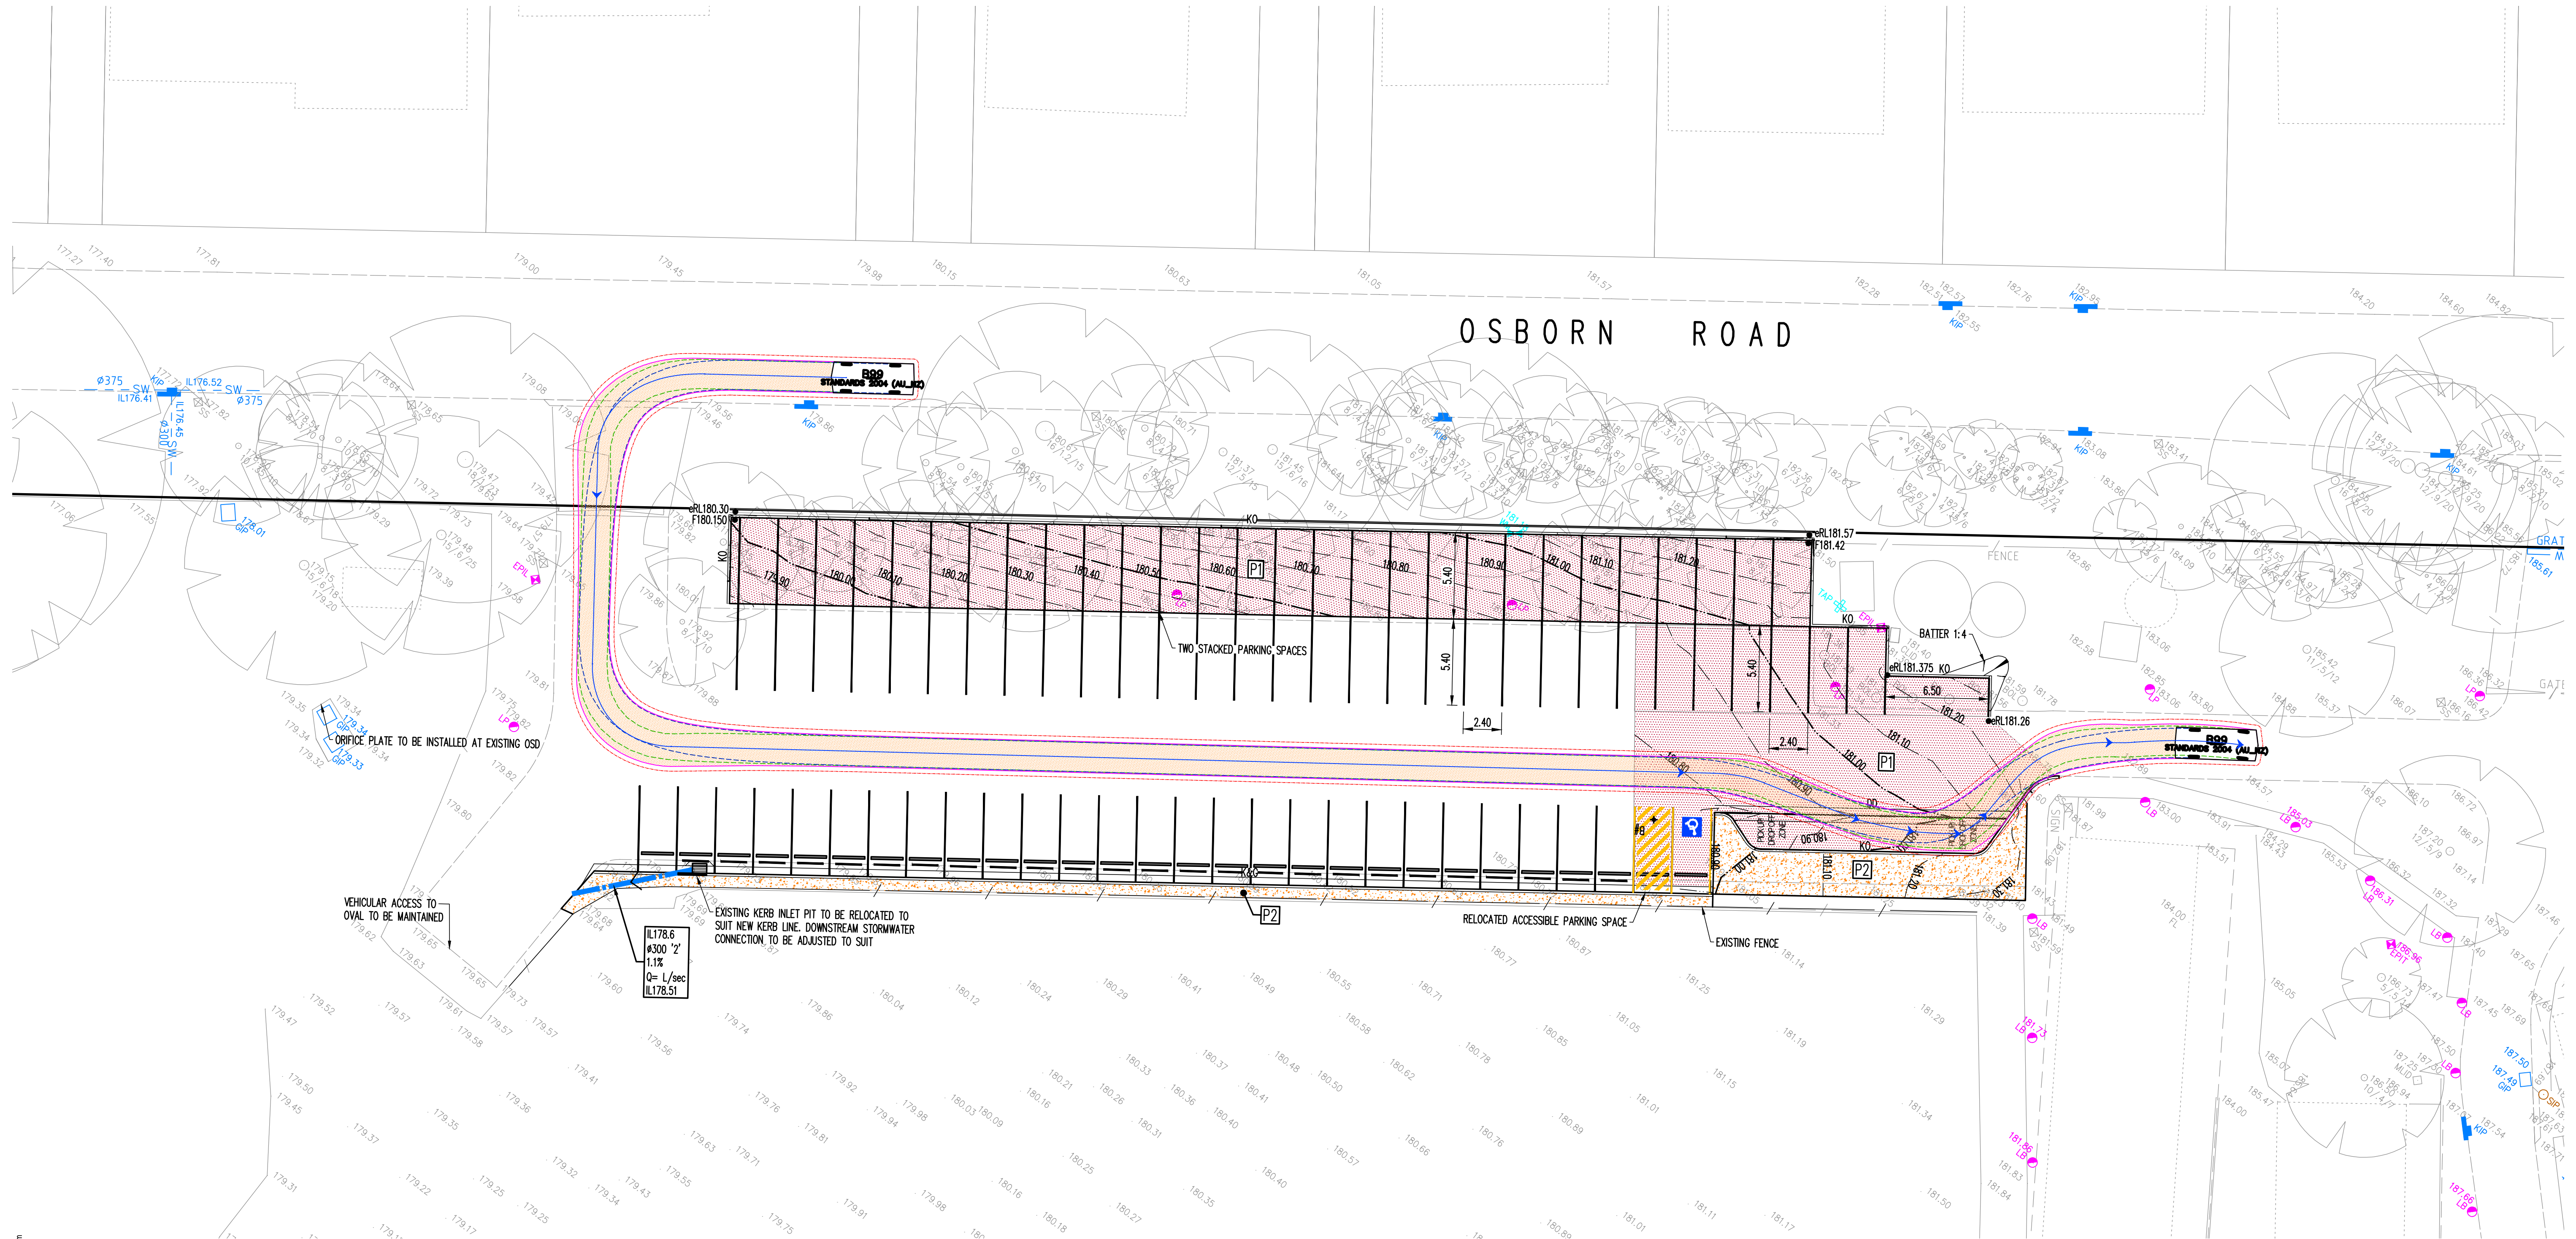
P3A CAR PARK – B99 SWEEP PATH

## Appendix A – Swept Path Analysis for P3A Pick Up and Drop Off

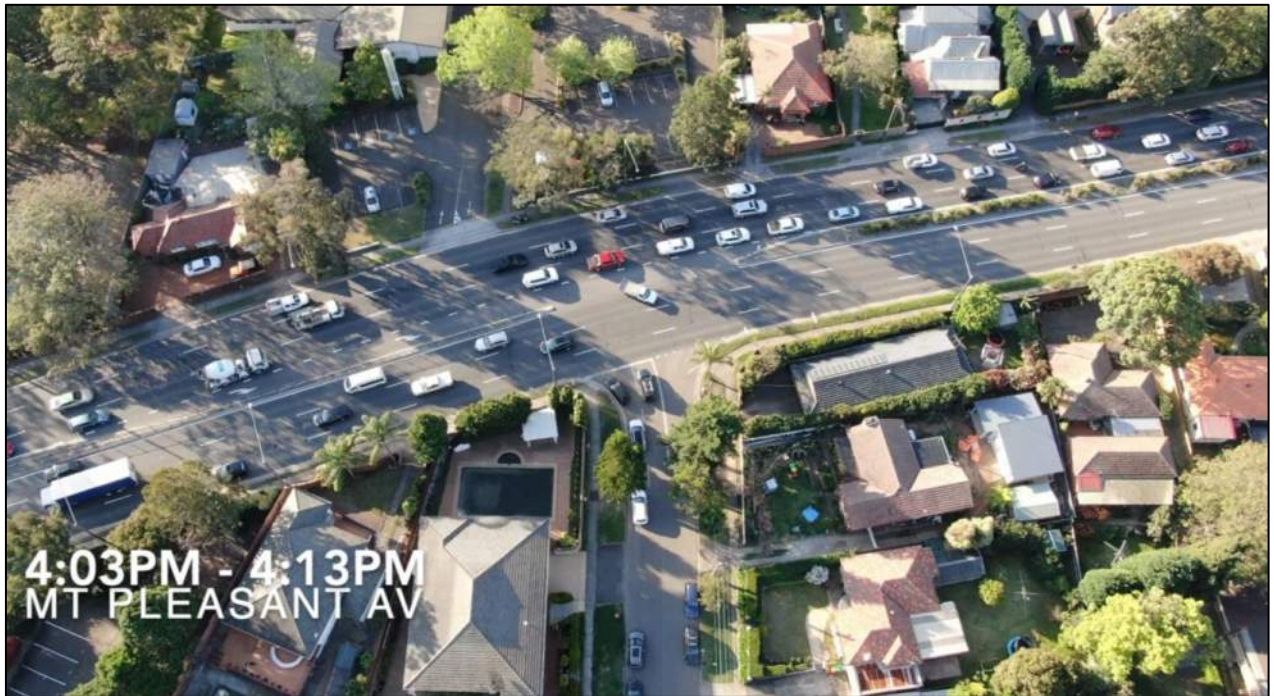
The footage of these videos can be found at the below link, with screenshots of typical and peak queuing observed (found during the drone surveys undertaken on Wednesday 25<sup>th</sup> September) provided by **Figure 1, Figure 2 and Figure 3:**

**Figure 3: Typical Queuing Observed on Mount Pleasant Avenue**

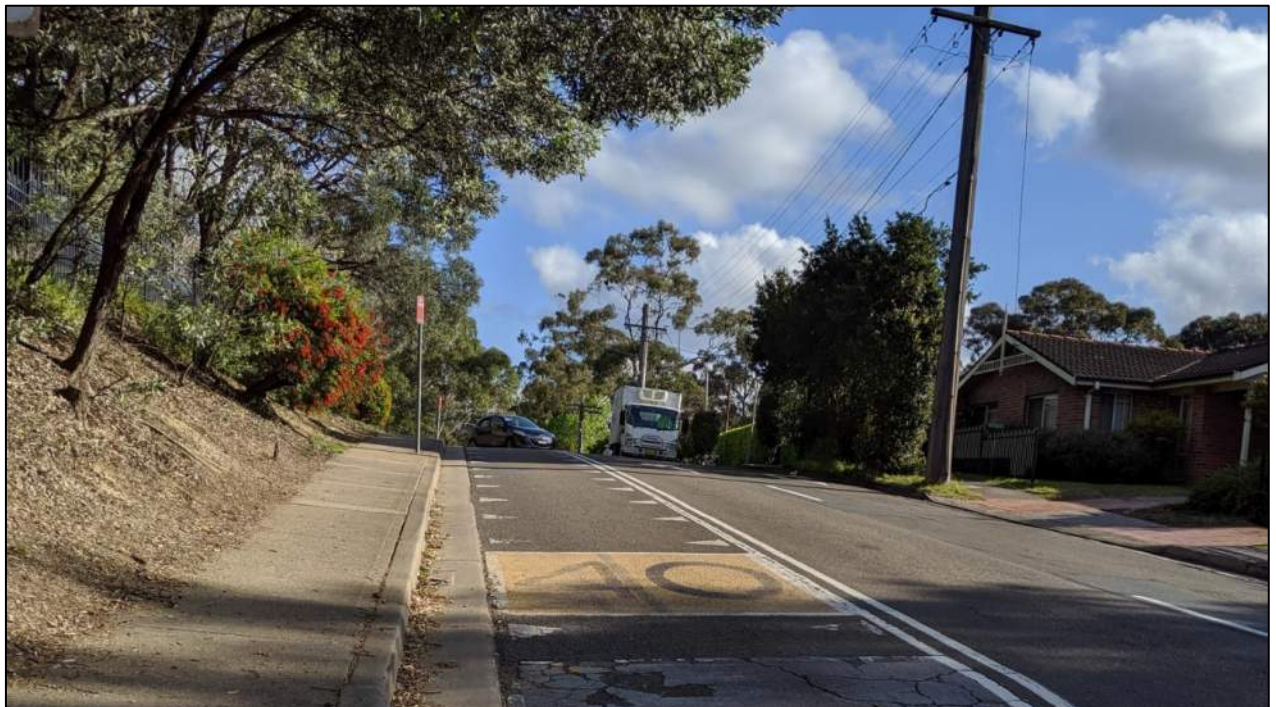
Notwithstanding the above, it was observed during the surveys that parking within Osborn Road on the eastern side does impact the ability of vehicles (notably for buses) to merge into the left-hand lane during peak periods (**Figure 4** and **Figure 5**). Based on the observed surveys, it is our recommendation that the spaces north of the Post Box, as illustrated by **Figure 6**, either be removed or be limited to times outside of School peak to improve the traffic flow in Osborn Road.

**Figure 4: Osborn Road On-street Parking**

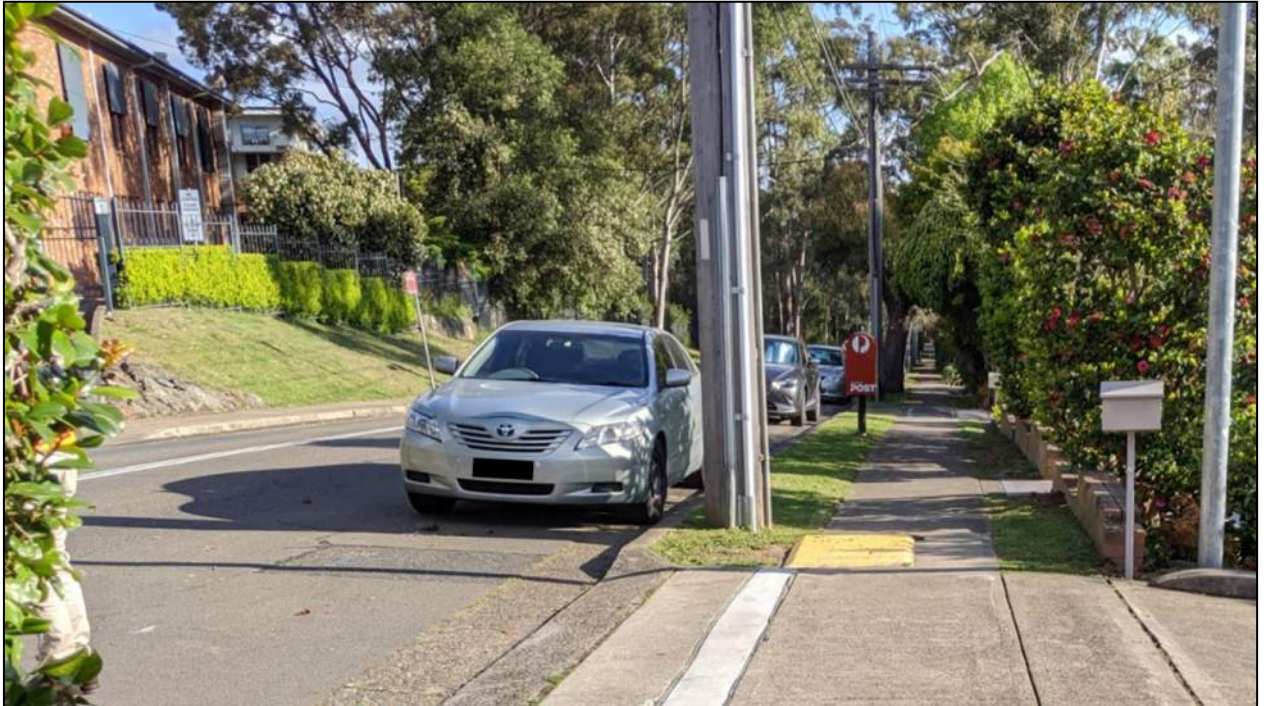
Figure 5: Osborn Road On-street Parking

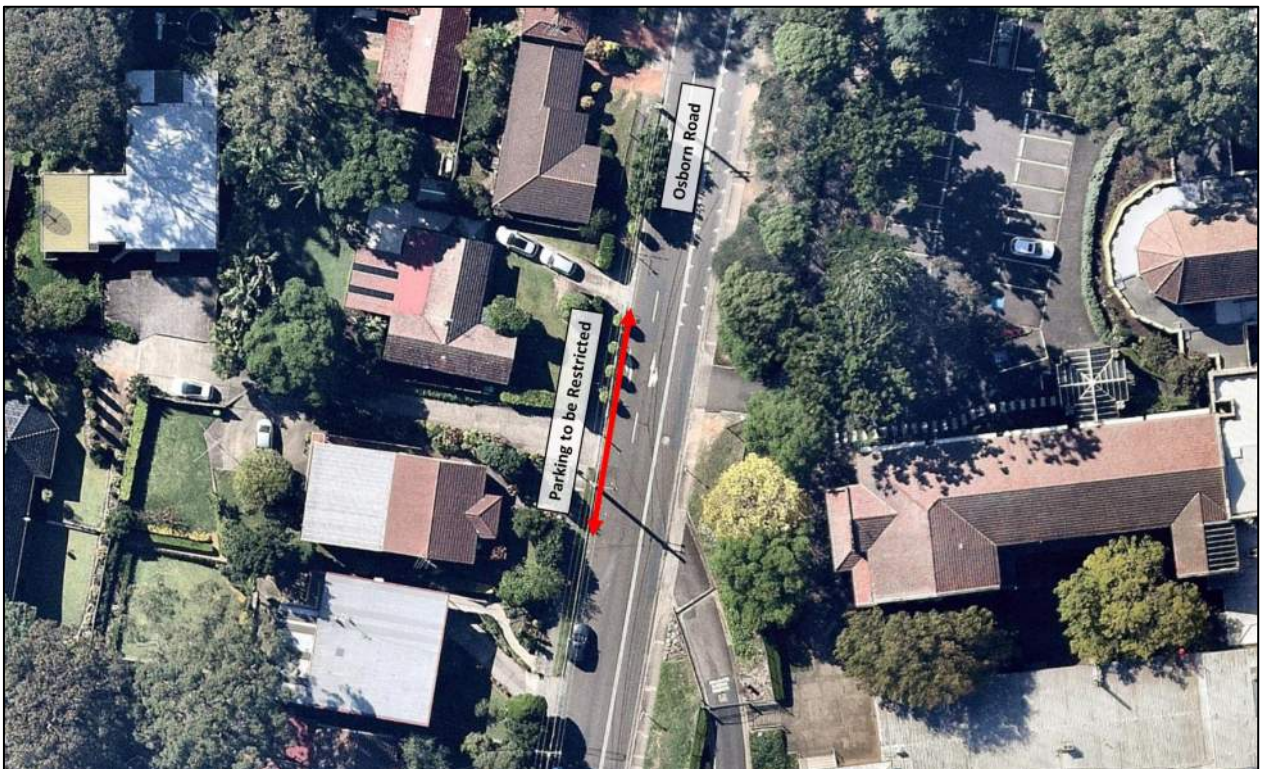
Figure 6: Osborn Road On-street Parking to be Restricted

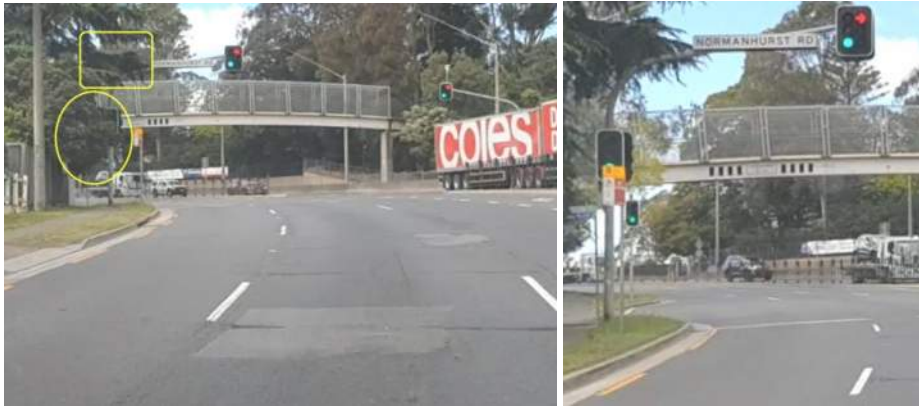
Ref	Theme/ location	Road safety audit finding	Priority
1	Eastbound travel direction of Pennant Hills Road in approach to Osborn Road.	<p>The Pennant Hills Road/ Osborn Road/ Normanhurst Road intersection is traffic signal controlled. However, the combined effect of the curvature of this road, and overhanging tree foliage on the inside (northern) side of the curve have affected the <i>approach sight distance</i> (ASD) available between eastbound drivers and the primary signal lanterns. These are the lanterns on the north-western corner of the intersection. With reduced ASD, drivers may not be aware of the prevailing signal phasing which may lead to red-light breaches and associated crashes with cross traffic streams. Furthermore, as the primary signals are typically placed in line with the hold line of the approach, they also advise drivers <i>where</i> to stop. As such, the restricted view of the signals may lead to drivers over-shooting the hold line and encroaching into the controlled area of the intersection.</p> <p>The left-hand image shows the view from a driver in lane 2 towards the primary signals when approximately 50m upstream of the intersection. The signals on the vertical portion of the mast-arm post are obscured by the tree foliage in the yellow oval. The foliage in the yellow box is starting to visually obscure the street name sign to Normanhurst Road. With further growth, it is likely that this street name sign could become blocked as well. The sight line from lane 1 would be even worse since this is further inside the curve.</p> <p>The right-hand image shows a view from approximately 25m upstream of the intersection where the primary signals are no longer visually blocked by the overhanging tree foliage. However, the signals are partially and momentarily blocked by the parking restriction signs.</p> <p>Driver visibility to the primary signals could be improved by pruning the tree foliage and relocating the parking restriction signs. The restored visibility to the primary signals would also improve pedestrian safety, especially if red signal holds/ delays are in place to safeguard pedestrians on the northern crossing.</p>

<p><b>Left:</b> Looking eastbound along Pennant Hills Road towards the intersection with Osborn Road-Normanhurst Road from approximately 50m upstream. <b>Right:</b> Looking eastbound towards the signals from approximately 25m upstream.</p>	High

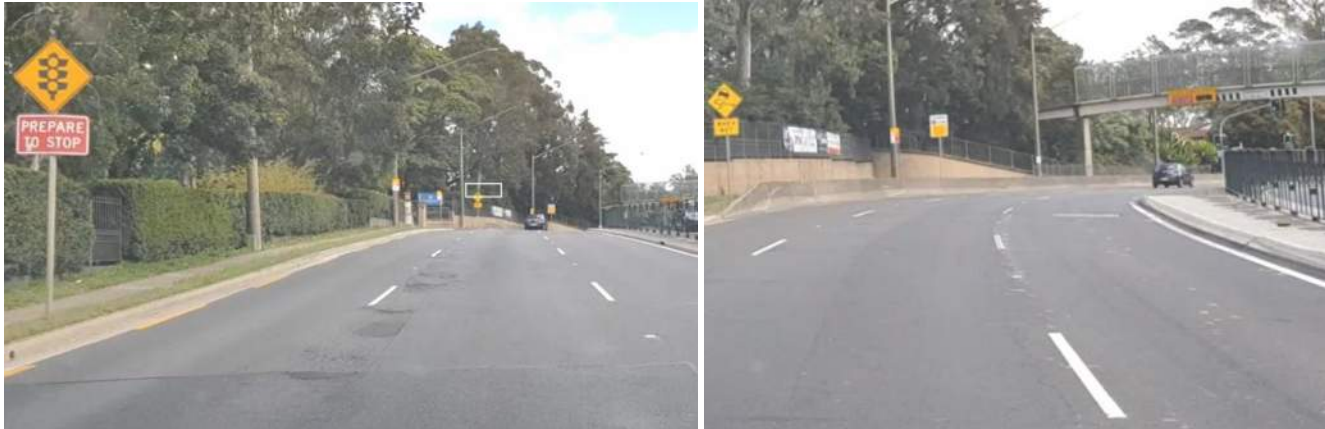
Ref	Theme/ location	Road safety audit finding	Priority
2	Westbound travel direction of Pennant Hills Road in approach to Osborn Road.	<p>Due to the curvature of Pennant Hills Road and the potentially sight-obstructing pedestrian bridge, a dynamic flashing light unit has been provided to alert westbound drivers of the traffic signals in the road ahead. These appear to flash when the downstream signals (at Osborn Road) are on red signal display. This is a compensatory measure for the reduced <i>approach sight distance</i> to the traffic signals. However, the flashing light unit is not optimally positioned.</p> <p>As shown in the images below, the flashing light unit is mounted to the pedestrian bridge above lane 2 (middle lane). When the driver is on the straight line (tangential) portion of the curve (see left-hand image), the flashing light unit is well outside the forward field of view. Some drivers may not have a clear sight line to the flashing lights if they cannot see over the median pedestrian fence. Also, since the road contains a curve-crest combination, any tall vehicles in the road ahead may also block this sight line. If drivers lack clear visibility to the flashing light unit, it renders the device ineffective as an advanced warning system. By the time the driver can see the flashing light unit, they would be able to see the actual signals anyway and would no longer need advanced warning.</p> <p>Using the left-hand image, the flashing light assembly would be more effectively relocated to the projection of the straight line (tangential) portion of the curve. An indicative location is depicted by the white rectangle. This puts the flashing lights in clear view of approaching drivers when they are well upstream of the sight-limiting curve and crest. Also, by being placed further upstream, this would more effectively warn drivers and allow them to control speeds with respects to approaching the back-of-queue. Typically, the back-of-queue would be well upstream of the signals themselves. Also, evident in the left-hand image, if the flashing light unit was relocated, it would also be visible in the same "picture frame" as the TRAFFIC SIGNALS + PREPARE TO STOP signage combination. As such, the flashing light unit would be more meaningful as the driver would receive both advanced warning messages at the same time.</p>

<p><b>Left:</b> Looking westbound along Pennant Hills Road towards the curve and crest in approach to the traffic signals at Osborn Road. The advanced warning flashing light unit could be better placed on the projection to this straight line (tangential) portion of the curve. <b>Right:</b> Further downstream from the first photo. As shown, by the time the flashing light unit is visible to the driver, they would already be able to see the signals themselves.</p>	High

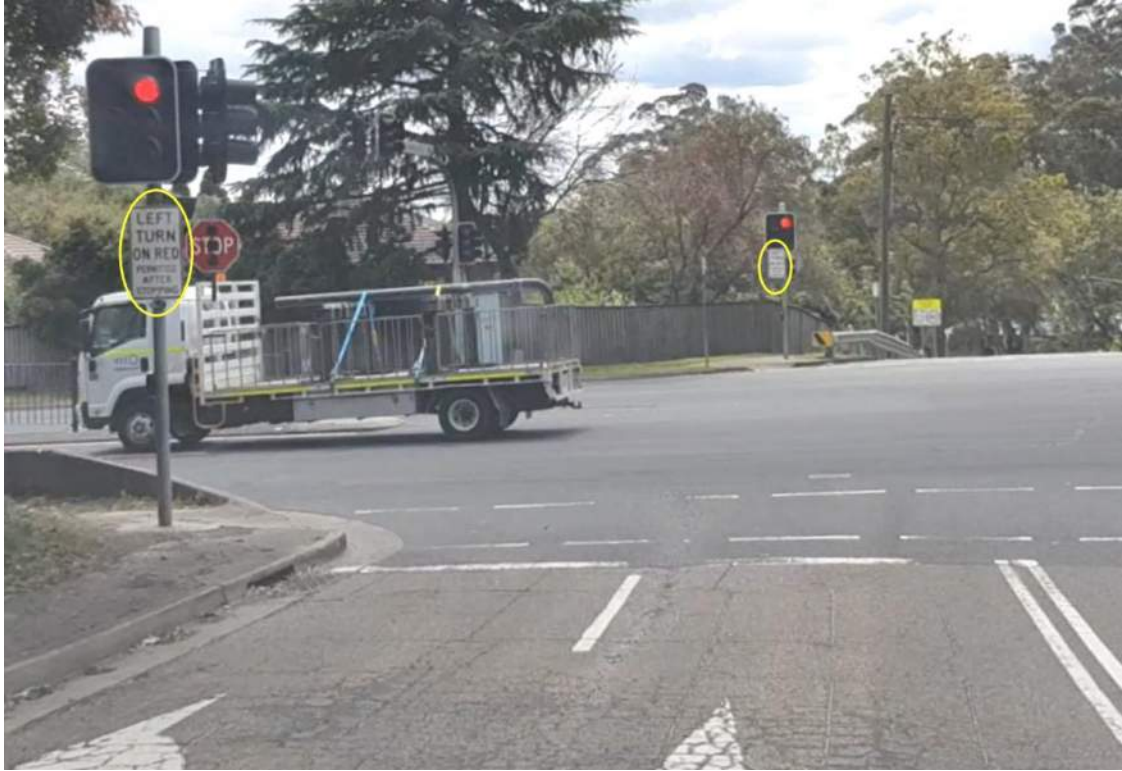
Ref	Theme/ location	Road safety audit finding	Priority
3	Northbound left-turn movement from Osborn Road to Pennant Hills Road	<p>The northbound left-turn movement from Osborn Road to Pennant Hills Road contains LEFT TURN ON RED PERMITTED AFTER STOPPING signs (LTOR rule). This does not appear to be appropriate for a left-turn onto Pennant Hills Road, as a major and high-volume arterial route. This is especially in light of its function as a major feeder and receiver route to/from the M1 motorway, less than 1km to the north-east. Uncontrolled left-turn movements would require gap detection and selection in a high-volume receiving road. Furthermore, as Pennant Hills Road contains a sight-limiting horizontal curve to the south, this could also limit the ability to see and select safe gaps to perform this left-turn manoeuvre. There may be <i>cross traffic</i> crashes as a result.</p> <p>The audit team notes that the primary and tertiary signal lanterns contain five signal aspects – (i) the red, amber and green full circle aspects which control general outbound movements from Osborn Road, and (ii) amber and green left-turn arrow aspects. With minor adjustment works to include red arrow aspects, the left-turn movement to Pennant Hills Road West could easily become fully controllable, and adaptive to differing traffic conditions of the day. The adjusted signal hardware and phasing may also be able to replace the LTOR rule such that there are no longer any uncontrolled left-turn movements.</p>

<p><b>Above:</b> Looking northbound from Osborn Road to Pennant Hills Road showing the LEFT TURN ON RED PERMITTED AFTER STOPPING signs in place.</p>	High

3.	<p><b>Comment:</b> The northbound left-turn movement from Osborn Road to Pennant Hills Road contains LEFT TURN ON RED PERMITTED AFTER STOPPING signs (LTOR rule). This does not appear to be appropriate for a left-turn onto Pennant Hills Road, as a major and high-volume arterial route.</p> <p><b>Suggestion:</b> With minor adjustment works to include red arrow aspects, the left-turn movement to Pennant Hills Road West could easily become fully controllable, and adaptive to differing traffic conditions of the day. The adjusted signal hardware and phasing may also be able to replace the LTOR rule such that there are no longer any uncontrolled left-turn movements.</p>	<p>Any alterations to the phasing of the signals are the responsibility of RMS. However, it is noted that the safety concern raised has regard for uncontrolled left-turns onto the high-volume PHR.</p> <p>As recorded by the drone survey, this intersection is operating safely and efficiently and therefore, Ason Group does not deem the suggestion to change the phasing of the signals to be required at this stage.</p>

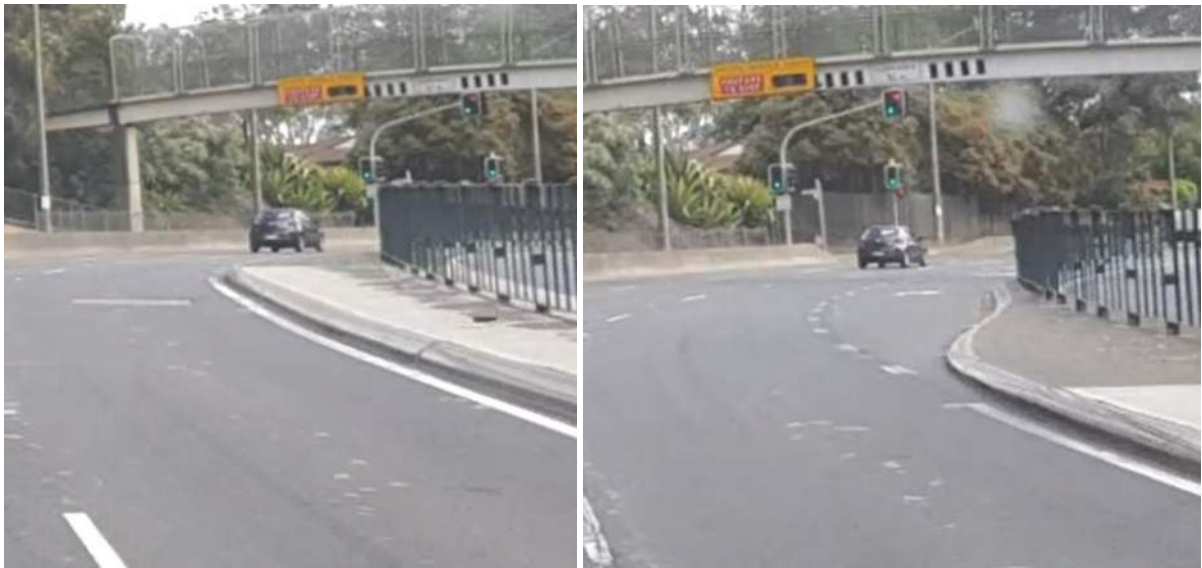
Ref	Theme/ location	Road safety audit finding	Priority
4	Westbound travel direction of Pennant Hills Road in approach to Osborn Road-Normanhurst Road – Visibility to the right-turn lane to Normanhurst Road.	<p>In the westbound direction of Pennant Hills Road, there is a curve-crest combination in approach to the Osborn Road-Normanhurst Road intersection. There is also a pedestrian fence on the median which obstructs the sight bench available across the median. This restricts the <i>stopping sight distance</i> (SDD) from westbound drivers to the right-turn lane to Normanhurst Road. The sight line is most affected in lane 3 (median-side lane) since (i) this is the westbound lane that is furthest on the inside of the curve, and (ii) this the westbound lane that would be most critically affected by conditions in the right-turn lane.</p> <p>The left-hand image shows the view from a westbound driver when approximately 35m upstream of the right-turn lane. At this point, the driver has limited view of the conditions in the right-turn lane including the kerb alignment and pavement conditions. They may also lack full visibility of any vehicles stopped in the right-turn lane, including their brake and indicator lights. The full detail of the right-turn lane only becomes visible a further 20m downstream (see right-hand image) which is only 15m upstream of the start of the right-turn lane. The driver may lack awareness to the conditions in the right-turn lane, and may not have enough time or space to react, such as adjusting their approach speed or even aborting the right-turn altogether.</p> <p>As the pedestrian fence is a major contributor to the loss of sight line to this right-turn lane, and this is also a critical safety amenity itself, the audit team does not recommend any adjustment or removal of this fence. Without increasing the length of the right-turn lane, there is little that could be done to improve driver advanced visibility and awareness of conditions in this lane. As such, consideration should be given to relocating the dynamic flashing light unit as described in item 2. This would at least help to control approach speeds and give drivers real-time advice of the prevailing signal phasing.</p>

<p><b>Left:</b> Looking westbound along Pennant Hills Road from approximately 35m upstream of the right-turn lane. There is limited visibility to the conditions in the right-turn lane to Normanhurst Road due to the curvature of the road and the median pedestrian fence. <b>Right:</b> Looking westbound from approximately 15m upstream, where the alignment and pavement condition in the right-turn lane are more visible.</p>	Medium

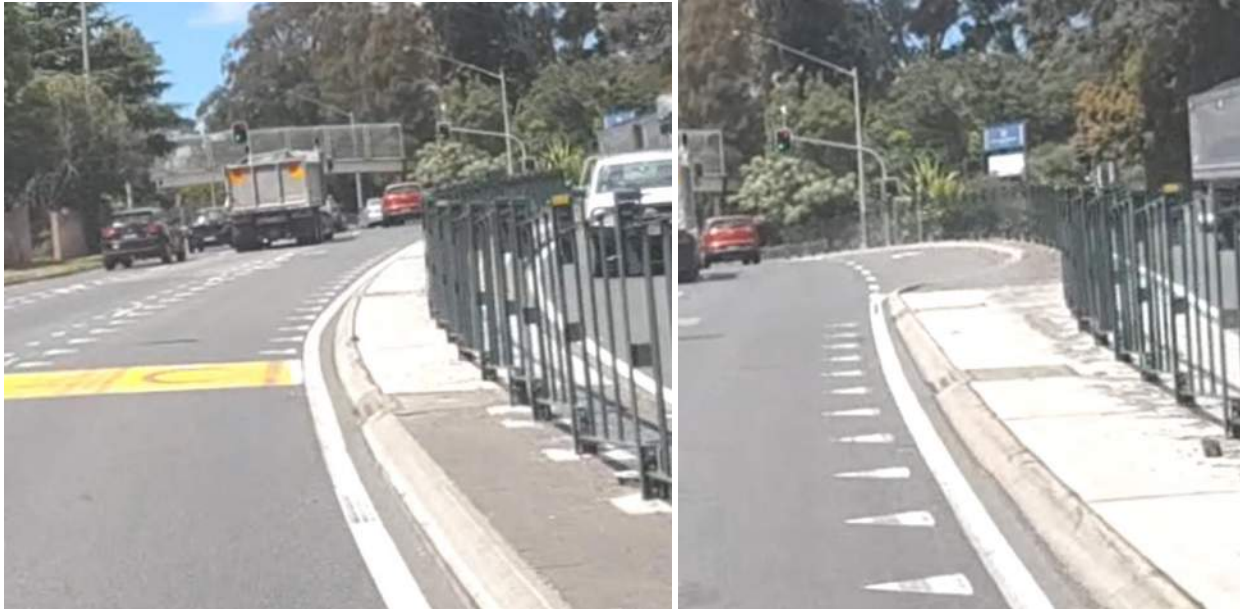
Ref	Theme/ location	Road safety audit finding	Priority
5	Eastbound travel direction of Pennant Hills Road in approach to Osborn Road- Normanhurst Road – Visibility to the right-turn lane to Osborn Road.	<p>In the eastbound direction of Pennant Hills Road, there is a right-hand curve in the immediate approach to the right-turn lane to Osborn Road. There is also a pedestrian fence on the median which obstructs the sight bench available across the median. This restricts the <i>stopping sight distance</i> (SDD) from eastbound drivers to the right-turn lane to Osborn Road. The sight line is most affected in lane 3 (median-side lane) since (i) this is the eastbound lane that is furthest on the inside of the curve, and (ii) this the eastbound lane that would be most critically affected by conditions in the right-turn lane.</p> <p>The left-hand image shows the view from an eastbound driver when approximately 50m upstream of the right-turn lane. At this point, the driver has limited view of the conditions in the right-turn lane including the kerb alignment and pavement condition. They may also lack full visibility of any vehicles stopped in the right-turn lane, including their brake and indicator lights. The full detail of the right-turn lane only becomes visible a further 20m downstream (see right-hand image) which is only 30m upstream of the start of the right-turn lane. The driver may lack awareness to the conditions in the right-turn lane, and may not have enough time or space to react such as adjusting their approach speed or even aborting the right-turn altogether.</p> <p>As the pedestrian fence is a major contributor to the loss of sight line to this right-turn lane, and this is also a critical safety amenity itself, the audit team does not recommend any adjustment or removal of this fence.</p>

<p><b>Left:</b> Looking eastbound along Pennant Hills Road from approximately 50m upstream of the right-turn lane to Osborn Road.  <b>Right:</b> Looking eastbound from approximately 30m upstream of the right-turn lane.</p>	Medium

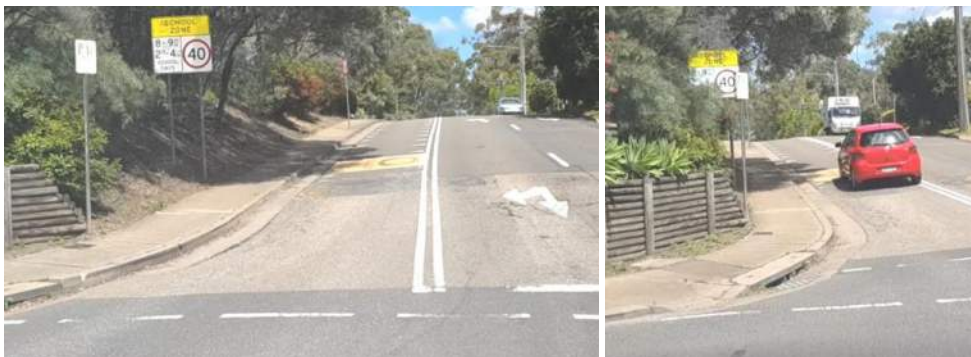
Ref	Theme/ location	Road safety audit finding	Priority
6	Osborn Road in its immediate departure from Pennant Hills Road.	<p>The Osborn Road southbound departure from Pennant Hills Road is narrow (see left-hand image). This is due to the lack of shoulder, limited flaring of the kerblines, and the BB double barrier centreline which appears to have been shifted as far east as possible. The limited departure width would have several road safety implications including:</p> <ul style="list-style-type: none"> <li>There is limited space for vehicles to negotiate this departure. Any vehicles that turn left from Pennant Hills Road East could cross the BB double barrier centreline and increase the risk of <i>head-on</i> crashes with northbound vehicles. Any right-turning vehicle from Pennant Hills Road West could also be at risk of striking the south-eastern kerb return, or tracking across the lane 2 of the northbound direction.</li> <li>Normanhurst Road contains two lanes in the southbound direction approaching Pennant Hills Road. Lane 1 (left-hand lane) is a shared <i>left-through</i> lane. Lane 2 is a dedicated right-turn lane. As such, the southbound straight through movement from Normanhurst Road to Osborn Road would need to commence from lane 1, negotiate a kinked travel path in the control area of the intersection to then enter the narrow departure lane in Osborn Road. The right-hand image shows the view from a driver negotiating this path and illustrates the extreme kinked travel path involved. This kinked travel path could lead to wheel-strikes on the south-eastern kerb return (including pedestrians standing at this location). Alternatively, if the driver avoids impacts with this kerb, they could be at risk of <i>side-swipe</i> crashes with the adjacent right-turn lane.</li> <li>Even if southbound vehicles are able to negotiate this narrow departure channel without striking kerbs or causing a <i>head-on</i> crash, the driver may be required to slow down excessively to successfully negotiate this channel. This could introduce <i>rear-end</i> crash risks in this departure. Alternatively, drivers that hesitate/ baulk could cause “shockwaves” which may also cause <i>rear-end</i> crash risks and queue spillback into the control area of the Pennant Hills Road/ Osborn Road/ Normanhurst Road intersection.</li> </ul> <p>Also evident in the images below, the eastern footpath of Osborn Road is narrow and is bounded by a batter slope. This increases the risk of <i>vehicle-pedestrian</i> crashes, especially in light of the wheel-strike risks described above. Pedestrians would be unwilling to walk on the batter slopes due to its slippery surface. The batter slope could also increase risks of debris spillage onto the footpath.</p> <p>There are very few easy solutions to addressing these issues. However, if larger scale improvements are considered along Osborn Road, then consideration could also be given to widening works to improve lane and road widths, as well as safety on footpaths.</p> <div data-bbox="535 971 1503 1329">

</div> <p><b>Left:</b> Looking southbound into Osborn Road at the narrow departure channel. <b>Right:</b> The view of a southbound driver entering Osborn Road from Normanhurst Road – due to the kinked travel path from the southbound through lane of Normanhurst Road.</p>	Medium

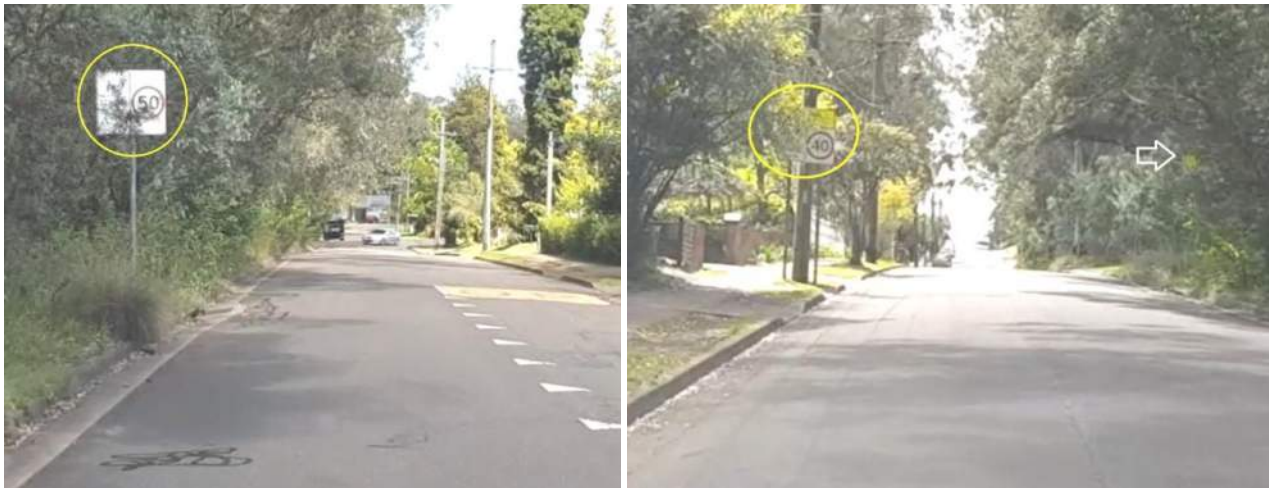
Ref	Theme/ location	Road safety audit finding	Priority
7a	General – Visually obscured signs.	<p>There are several signs along the audited length of Osborn Road which are visually obscured by tree foliage. The signs therefore lack effectiveness in conveying the regulatory and speed zoning advice. Many of these signs also contain time-based information, such as when the school zone (and hence variable speed limit of 40km/h) is in operation.</p> <p>The visually obscured signs are depicted below as well as in item 7b, with descriptions in the captions. These are generally mitigatable by tree pruning works.</p> <div data-bbox="535 357 1800 847">

</div> <p><b>Left:</b> Looking southbound along Osborn Road towards the END SCHOOL ZONE sign. The sign is visually obscured by tree foliage. <b>Right:</b> Looking northbound along Osborn Road at the southern gateway (entry point) to the school zone. The left-hand SCHOOL ZONE sign (circled in yellow) is partially obscured by tree foliage. The right-hand sign (marked by the white arrow) is totally obscured and rendered ineffective.</p>	Medium

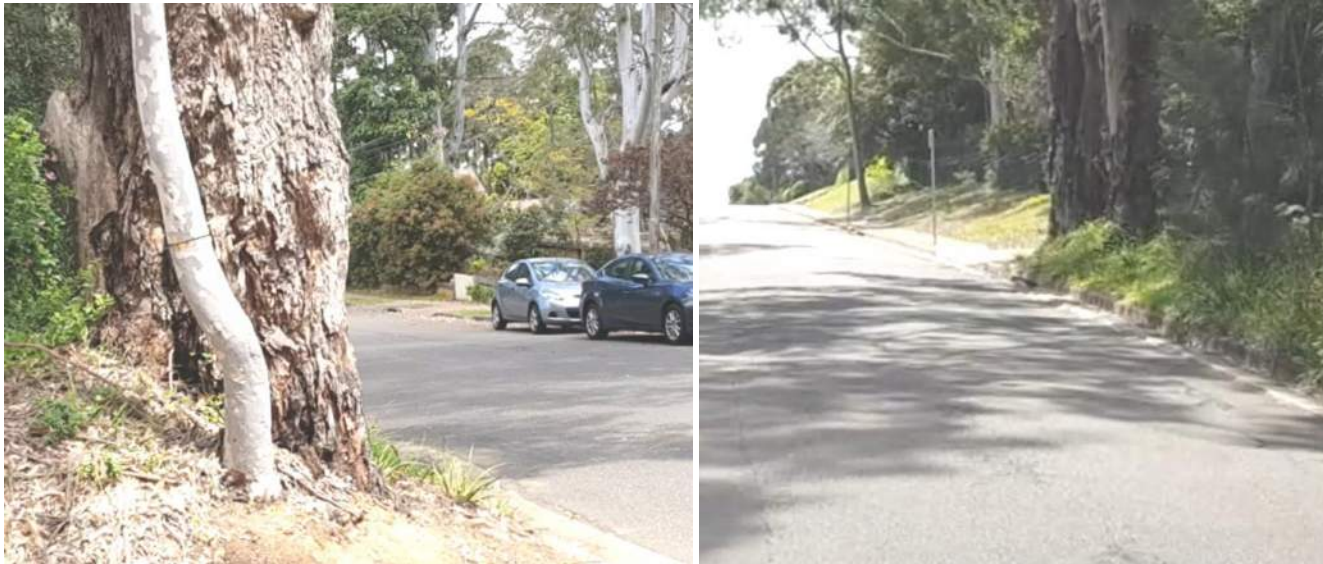
Ref	Theme/ location	Road safety audit finding	Priority
9	Gate O3 – Visibility conditions for outbound drivers.	<p>Outbound drivers from Gate O3 of Loreto Normanhurst would need to check for gaps in the northbound and southbound traffic streams of Osborn Road. This requires them to look to the left (south) and right (north). The driver view to the left (south) is shown in the left-hand image.</p> <p>As seen, there is limited <i>minimum gap sight distance</i> (MGSD) to the south due to a large tree (left-hand image). The driver is unlikely to have a clear view to northbound traffic and may not be able to judge suitable gaps. This could lead to poor gap selection and consequential <i>cross traffic</i> crashes. Alternatively, a common response is for drivers to “creep” out into the roadway to improve their sightline. This would leave them exposed to impacts by southbound vehicles when stopped in such a position.</p> <p>As the sight-limiting feature is a tree trunk and not the foliage, it is unreasonable to remove this tree on account of the affected sight line (unless other large-scale development changes were proposed at the school or along Osborn Road). As such, outbound drivers could be encouraged to use Gate O4 instead (provided that its MGSD sight lines are improved as described in item 8). Some degree of sight line improvement could be achieved by clearing out the understorey layer of low-level trees and plants. This would allow some “see-through” visibility between the large tree trunks. However, the resulting sight lines would not be totally failsafe.</p> <div data-bbox="535 592 1854 1158">

</div> <p><b>Left:</b> The view from Gate O3 to the south which is affected by the large tree trunk. <b>Right:</b> Looking northbound along Osborn Road showing the limited view to the driveway (behind the trees).</p>	Medium

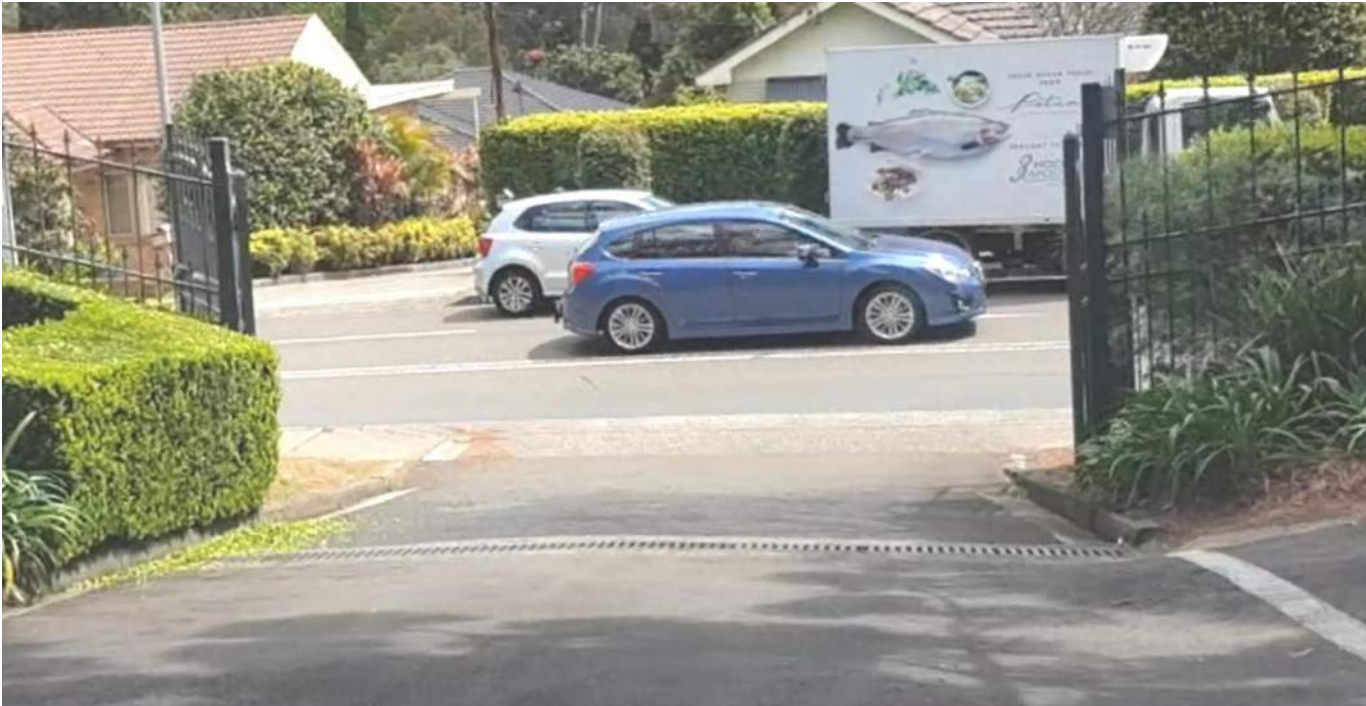
Ref	Theme/ location	Road safety audit finding	Priority
10	Gate O1 – Visibility of outbound drivers to pedestrians on the eastern footpath of Osborn Road.	<p>Gate O1 appears functions as a joint inbound and outbound gate to the school. Outbound drivers would have limited visibility to pedestrians on the eastern footpath of Osborn Road. This is due to the vegetation either side of the driveway. The limited visibility may increase the risk of <i>vehicle-pedestrian</i> crashes, particularly since the footpath is likely to be used by school children, including persons of shorter stature. Some mitigation measures would include:</p> <ul style="list-style-type: none"> <li>▪ Clearing the vegetation altogether.</li> <li>▪ Trimming the vegetation to achieve a wider outbound vista.</li> <li>▪ Trimming the vegetation to a lower height. This would work with respects to the shaped hedges. The un-shape-able trees could be “thinned out” to improve see through visibility.</li> <li>▪ Provision of STOP signs and a stop hold line.</li> <li>▪ Provision of convex mirrors. However, this is generally not failsafe since it does not entirely compensate for the lack of clear and unassisted visibility. Also, as the image is distorted, it is difficult to judge distances and speeds of pedestrians.</li> </ul>

<p><b>Above:</b> Looking outbound from Gate O1 showing the limited visibility to the footpath area either side of the gate.</p>	Medium

Ref.	Comment	Responsibility / Recommendation
	clear and unassisted visibility. Also, as the image is distorted, it is difficult to judge distances and speeds of pedestrians.

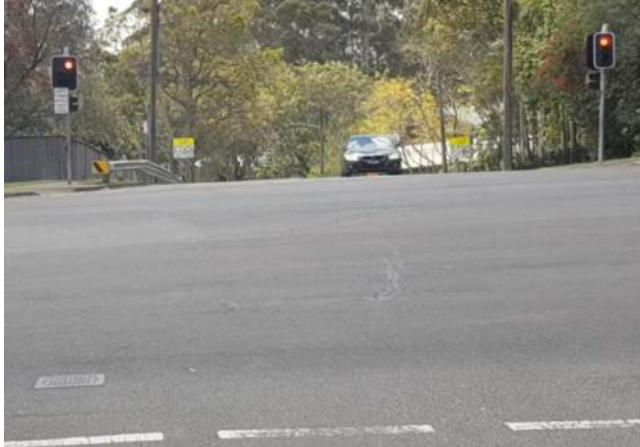
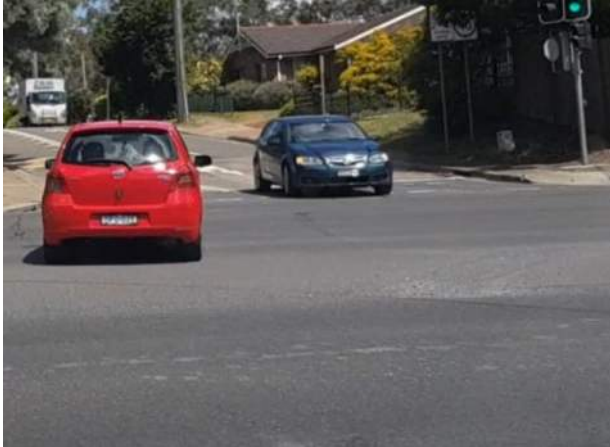
Ref	Theme/ location	Road safety audit finding	Priority
11	Pennant Hills Road/ Osborn Road intersection – Opposing right-turns.	<p>The northbound and southbound right-turns from Osborn Road and Normanhurst Road respectively, are both filtered right-turn movements. As such, the northbound right-turn is required to filter through the opposing (southbound) <i>through</i> movement, and left-turn movements from the Normanhurst Road leg. Similarly, the southbound right-turn is required to filter through the opposing (northbound) <i>through</i> and left-turn movements. Furthermore, both legs have two approach lanes, and hence two separate approach streams of traffic. The audit team notes the following visibility constraints:</p> <ul style="list-style-type: none"> <li>Northbound right-turning drivers could have restricted visibility to the southbound <i>through</i> and left-turn movements due to the crest vertical curve and downhill grade in Normanhurst Road (see left-hand image).</li> <li>Northbound right-turning drivers could also have restricted visibility due to southbound right-turning traffic, who are often in queue whilst waiting to filter through the intersection as well.</li> <li>Southbound right-turning drivers could have restricted visibility to the northbound left-turn movements due to the northbound right-turning traffic, who are often in queue whilst waiting to filter through the intersection as well.</li> </ul> <p>Increased controls on the right-turn movements could be considered including full control (non-filtered turns), part-day controls, or leading right-turn phases.</p> <div style="display: flex; justify-content: space-around;">

</div> <p><b>Left:</b> Looking northbound from Osborn Road into the intersection with Pennant Hills Road. Note the crest vertical curve in Normanhurst Road which limits drivers' visibility to the opposing (southbound) <i>through</i> and left-turning traffic streams. The stopped southbound right-turning vehicle also blocks the sightline to any vehicles that may be moving up in the adjacent traffic lane. <b>Right:</b> Looking southbound into the intersection from Normanhurst Road. The driver's view to northbound left-turning traffic (there are no such vehicles performing this manoeuvre in this picture) could be blocked by the opposing (northbound) right-turning vehicle which has stopped at the hold line.</p>	Medium
