181202 TAAB

**LORETO NORMANHURST**  
**P3 Osborn Road Driveway Review**

Existing stage road safety audit

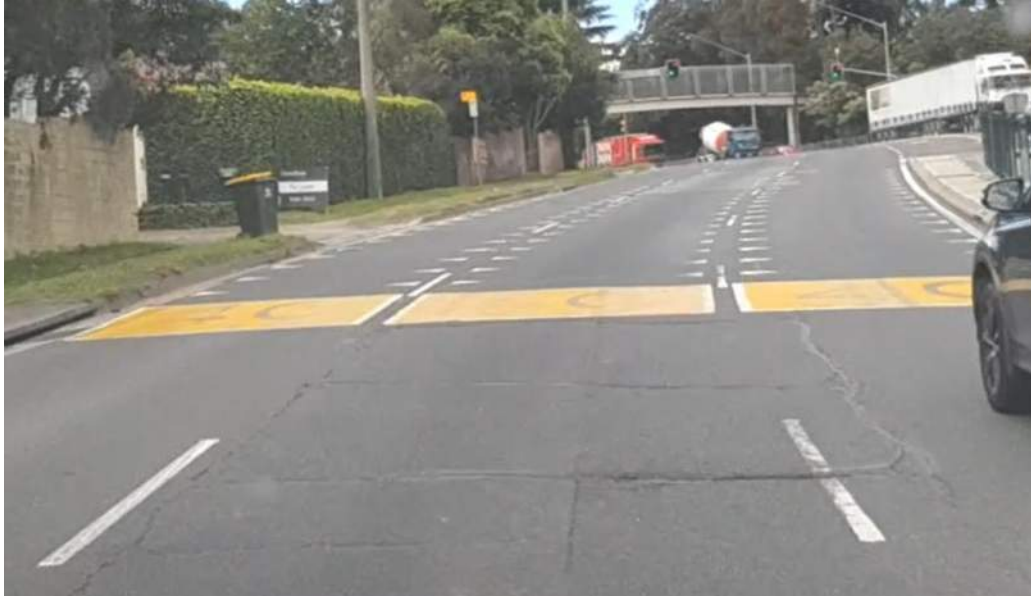
Ref	Theme/ location	Road safety audit finding	Priority
12	Pennant Hills Road to the west of Osborn Road.	<p>The 40k pavement patches associated with the start of the school zone have faded. These are critical features of the school zone signifying (i) the start of the school zone and (ii) the prevailing speed limit during school zone hours. As such, with the faded condition of the markings, drivers may lack awareness of the school zone and speed zoning conditions. Drivers may also use this as a legal excuse for non-compliance as well.</p> <p>Pennant Hills Road carries a high volume of traffic as one of the principle access routes to the M1 Motorway. Under heavy traffic conditions, pavement markings are especially beneficial to drivers since they need to maintain focus on the road ahead, and could be more likely to overlook signs on each side of the road. Also, as there are many school zones along Pennant Hills Road, it is important that drivers are aware of the start and end points of these zones.</p> <p>The pavement markings should be re-instated to improve the prominence of the western gateway to the school zone.</p>

<p><b>Above:</b> Looking eastbound along Pennant Hills Road with a view of the faded 40k pavement patches to the west of Osborn Road.</p>	Low

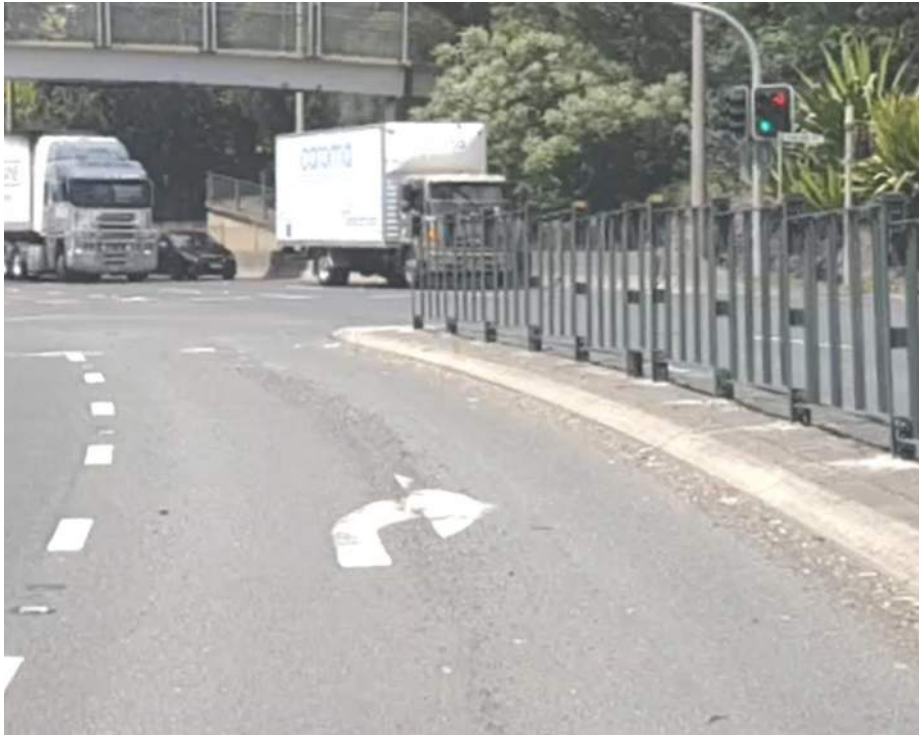
Ref	Theme/ location	Road safety audit finding	Priority
13	Pennant Hills Road, eastbound right-turn lane to Osborn Road and control area of the intersection.	<p>In general, the audit team noted that there was a substantial volume of loose gravel and debris at the Pennant Hills Road/ Osborn Road/ Normanhurst Road intersection. This included the eastbound right-turn lane to Osborn Road and the control area of the intersection. Loose gravel and debris tend to compromise skid resistance and tyre-to-pavement friction. This could affect braking performance and braking distance. It could also affect the stability of the vehicle as it negotiates turns. As such, the reduced skid resistance could increase the risk of <i>loss of control</i> crashes, <i>rear-end</i> crashes and even <i>cross traffic</i> crashes since some vehicles may not stop clear of the control area of the intersection.</p> <p>There is no immediately obvious source of this loose material. As such, the mitigations would tend to be reactive, such as street sweeping and maintenance.</p>

<p><b>Above:</b> Evidence of loose gravel along the midline of the eastbound right-turn lane to Osborn Road. Note also the loose debris along the fringe of the median SF kerb.</p>	Low

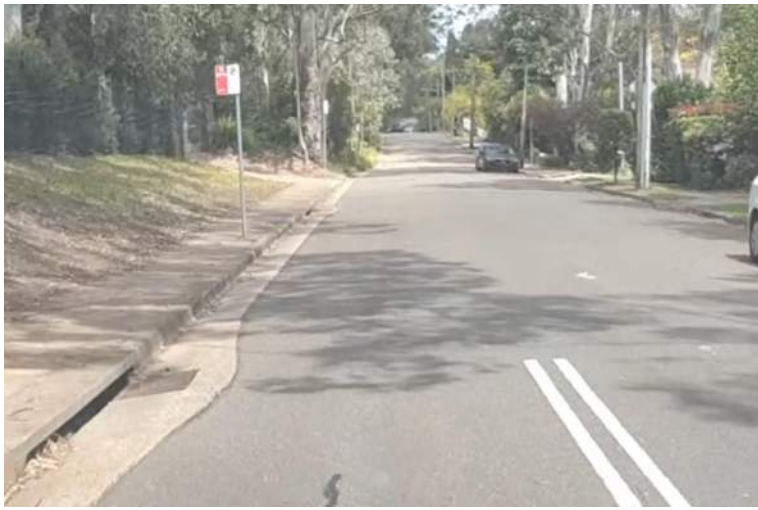
Ref	Theme/ location	Road safety audit finding	Priority
15	Eastern kerbline of Osborn Road between Gates O2 and O3.	<p>A portion of the eastern kerbline between Gates O2 and O3 is signposted as a NO PARKING zone (see below). NSW Road Rule 168 stipulates that drivers are permitted to stop along a kerbline signposted with NO PARKING signs provided that they are dropping off or picking up passengers, remain attending the vehicle, and do not layover for more than two minutes. The audit team acknowledges that the logical management method for formal pickup and drop off of students, and delivery of goods to the school, would be via the internal roadway. However, the audit team envisages that this kerbline would still be used in less formal situations. This could include:</p> <ul style="list-style-type: none"> <li>Drop off and pick up of students outside the typical peak period such as for before-school or after-school activities.</li> <li>Buses and other long vehicles that are unwilling to enter the school grounds.</li> </ul> <p>If this kerbline is to remain as a NO PARKING zone, it would need to be managed to minimise risks of congestion at this point. The audit team highlights a number of risky scenarios, as follows:</p> <ul style="list-style-type: none"> <li>If the kerbline is mis-used by parents/ carers that are too impatient to enter the school grounds, it could lead to congestion and potential queue spill back to the north. The audit team noted that there is only 50m of kerb length available which is signposted as a NO PARKING zone. This could lead to upstream congestion if the kerbline is fully occupied (approximately seven passenger cars), or if vehicles stop midway along its length or towards the northern end of this zone. If the queue spills back to the BB double barrier centreline, it may also force trailing southbound drivers to cross this line to pass around the queue.</li> <li>Any vehicles stopped along this kerbline, or moving slowing into or out of a stopped position could also be exposed to <i>rear-end</i> crashes by trailing southbound vehicles. This kerbline is also located on the departure side of a sight-limited crest vertical curve. Trailing drivers may not see or expect slow-moving or stopped vehicles at this point.</li> </ul> <p>Consideration could be given to extending the NO STOPPING designation to cover this zone. Alternatively, the risks described above would need to be “managed out” by the school and its policies and traffic management plan.</p>

<p><b>Left:</b> Looking southbound along Osborn Road towards the NO PARKING zone on the eastern kerbline.</p>	Low

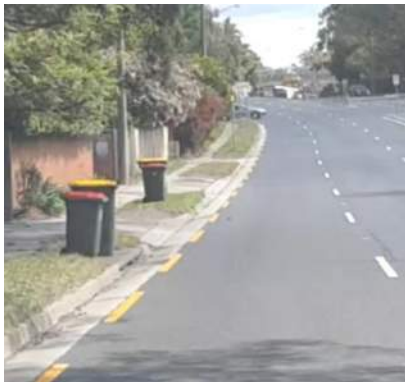
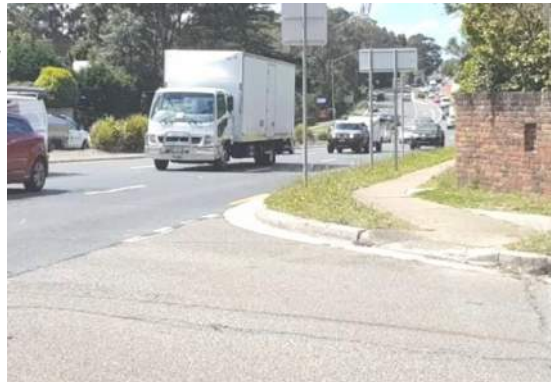
Ref	Theme/ location	Road safety audit finding	Priority
2	Sight line from the hold line of Mt. Pleasant Avenue to Pennant Hills Road North.	<p>The Mt. Pleasant Avenue approach to its intersection with Pennant Hills Road is STOP controlled. As such, all outbound drivers are required to stop, and then assess gaps and traffic conditions in Pennant Hills Road before turning left or right. There is limited <i>minimum gap sight distance</i> (MGSD) from this hold line to the north. The sight constraining features include (i) a brick property wall on the south-eastern corner of the intersection, and (ii) overhanging hedges and tree foliage from properties along the southern side of Pennant Hills Road. The limited MGSD sight line may result in poor gap detection and selection and consequential <i>cross traffic</i> crashes. This is also since there are three southbound approach lanes which makes the gap detection process very complicated. As an initial measure, the overhanging tree foliage from the southern properties could be pruned back to improve the MGSD sight line.</p> <p>Further to the above, right-turn movements are permitted from Mt. Pleasant Avenue to Pennant Hills Road North. This is a high-risk manoeuvre due to several constraining factors, as follows:</p> <ul style="list-style-type: none"> <li>▪ The MGSD sight line to the north is restricted as discussed above.</li> <li>▪ The MGSD sight line to the south is also restricted due to the median pedestrian fence and the limited “see through” visibility as a result of the fence balusters and posts.</li> <li>▪ The right-turn movement requires gap detection and selection, and then crossing of three individual westbound traffic lanes. It also requires gap detection and selection in the eastbound carriageway (up to six lanes altogether). Ideally, the driver should make the right-turn when there are gaps in all three eastbound lanes. However, in reality, many drivers may resort to using gaps in lanes 2 and 3, knowing that vehicles in lane 1 eastbound (kerbside lane) are less of a collision threat. The gap checking process is extremely complicated, and many drivers may also attempt a staggered crossing method, where they accept a gap in the westbound carriageway and then drift forwards slowly in the hope that a gap presents itself in the eastbound carriageway. This is a risky method of entry. If gaps do not present themselves in the eastbound carriageway, the right-turning vehicle would be left stranded and exposed to collisions by westbound vehicles.</li> </ul> <p>Consideration should be given to banning the outbound right-turn from Mt. Pleasant Avenue, or at least implementing a part-day ban.</p> <div style="display: flex; justify-content: space-around; align-items: flex-start;"> <div style="text-align: center;">

<p><b>Left-hand image:</b> Looking westbound along Pennant Hills Road towards Mt. Pleasant Avenue from lane 1. Note the restricted sight line between this traffic lane and the outbound vehicle from Mt. Pleasant Avenue. The sight-constraining features are the overhanging tree foliage from the southern properties. Note also how the outbound vehicle has advanced forwards into the westbound carriageway, to establish a better MGSD sight line.</p> </div> <div style="text-align: center;">

<p><b>Right-hand image:</b> The view from the hold line of Mt. Pleasant Avenue to the north. Note the impact of the brick property wall on the MGSD sight line. To establish a better sight line, the driver would need to advance further out and possibly into the westbound carriageway of Pennant Hills Road. This would increase the risk of cross traffic crashes.</p> </div> </div>	High

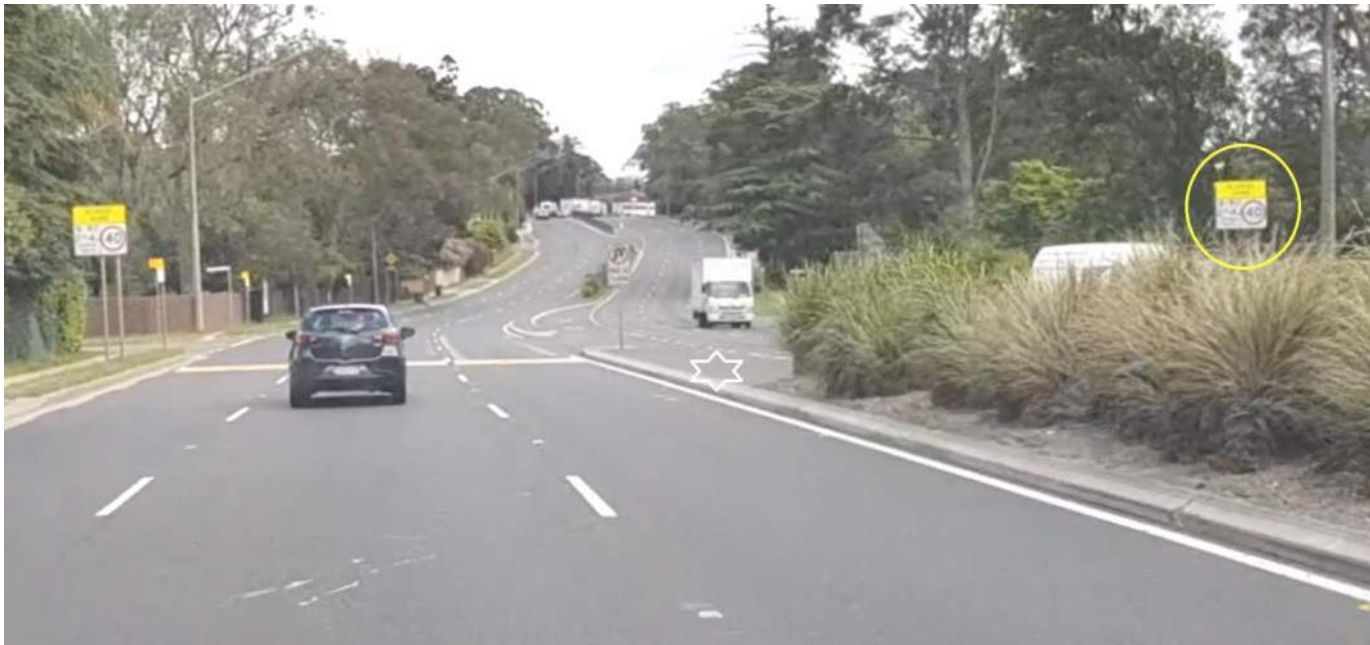
Ref	Theme/ location	Road safety audit finding	Priority
3	Westbound travel direction of Pennant Hills Road in approach to Mt. Pleasant Avenue.	<p>In the westbound travel direction of Pennant Hills Road, the school zone commences to the immediate east of Mt. Pleasant Avenue. This consists of a pair of SCHOOL ZONE signs, and 40k patches and dragon's teeth markings in each travel lane. However, the right-hand SCHOOL ZONE sign (circled in yellow) is placed on the northern side of the road which is well outside the forward field of view of westbound drivers. This sign would be more appropriately placed on the median (marked by the white star) to improve its visual prominence. If relocated to the median, the sign face should be mounted sufficiently high to maintain the sight lines between eastbound right-turners (in the right-turn lane to Mt. Pleasant Avenue) and westbound traffic that are approaching this point.</p> <p>The audit team also notes that whilst the eastbound travel direction of Pennant Hills Road contains a flashing light unit on the SCHOOL ZONE sign, there is no corresponding flashing light unit provided in the westbound direction (at the location shown below). This is a point of inconsistency. Whilst the flashing light assembly is not a mandatory requirement, it greatly enhances compliance with the 40km/h school zone speed limit since drivers are more certain as to when the school zone conditions are in effect. That is, there is less ambiguity as to whether the road is under a 40km/h school zone speed limit, or operating to the default 70km/h speed limit. In these respects, consideration should also be given to retrofitting a flashing light assembly at this point.</p> <p>The audit team also notes that the 40k pavement patches have faded which reduces the effectiveness of these as regulatory and advisory devices.</p>

<p><b>Above:</b> Looking westbound along Pennant Hills Road showing the large lateral offset of the right-hand SCHOOL ZONE sign and the lack of flashing light units on either sign.</p>	Medium

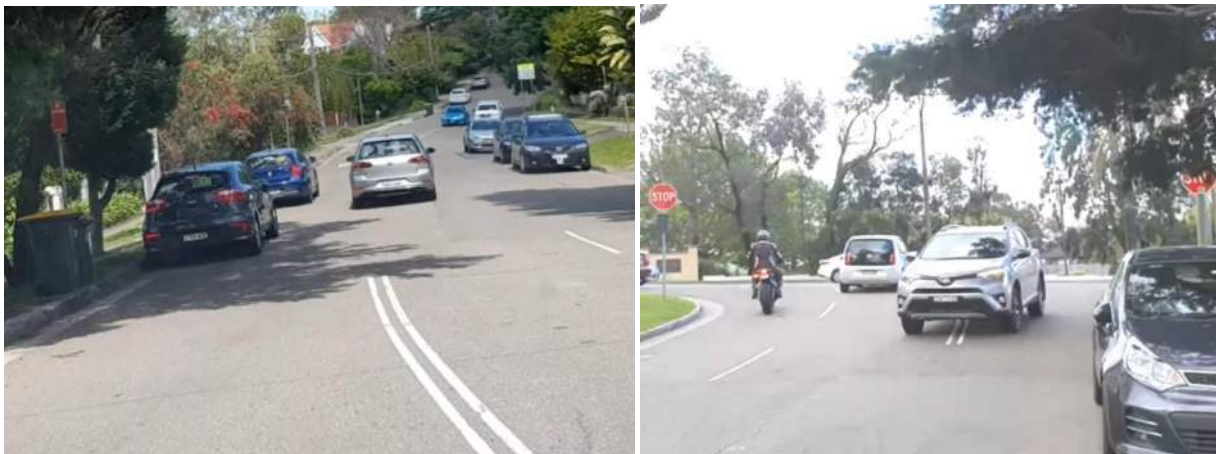
Ref	Theme/ location	Road safety audit finding	Priority
4	Eastern kerb line of Mt. Pleasant Avenue to the south of Pennant Hills Road.	<p>On the eastern side of Mt. Pleasant Avenue to the south of Pennant Hills Road, there is a NO STOPPING sign with a single-sided, north-facing arrow. As such, this allows vehicles to stop/ park along the eastern kerbline to the south of this point. As shown in the left-hand image, any vehicles parked along this kerb, would severely limit the space available for other southbound vehicles. The silver southbound vehicle has encroached well into the space of the opposing traffic stream. Furthermore, to take this travel path, it also crossed over the BB double barrier centreline. This presents <i>head-on</i> crash risks with the opposing (northbound traffic stream). The blue vehicle approaching this point would either need to stop to allow the southbound vehicle to clear through this squeeze point, or else they would be exposed to this <i>head-on</i> crash risk.</p> <p>Another risk scenario would be when there are queues in the northbound travel direction such that there is insufficient space/width for the southbound vehicle to pass (due to the parked vehicle on one side and a queued vehicle on the other). The southbound vehicle would be forced to stop until the queue dissipates. This is in the immediate departure from the intersection where they could be exposed to a rear-end impact by other trailing traffic.</p> <p>To reduce the risk of cross centreline breaches and <i>head-on</i> crashes, the NO STOPPING sign should be relocated further south.</p>

<p><b>Left:</b> Looking southbound along Mt. Pleasant Avenue showing the impact of vehicles (legally) parked on the eastern kerbline, on the residual passing clearance for other southbound traffic. <b>Right:</b> Another example where a southbound vehicle was forced to cross the BB centreline due to a vehicle parked on the eastern kerbline. Note also the potential risk to queued vehicles in the northbound direction. If there were more vehicles in this queue, there would have either been (i) a crash risk between the cross centreline southbound vehicle and the queued vehicle or (ii) the southbound vehicle would be forced to stop in the immediate departure from the intersection where it would be exposed to rear-end crash by other trailing southbound vehicles.</p>	Medium

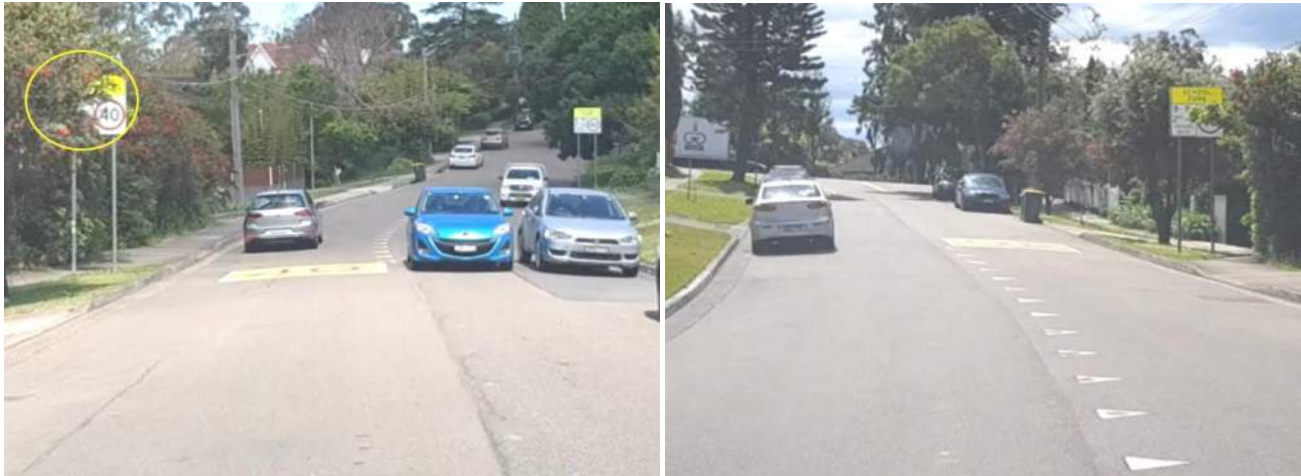
Ref	Theme/ location	Road safety audit finding	Priority
5a	General – Visually obscured signs along Mt. Pleasant Avenue.	<p>There are several signs along the audited length of Mt. Pleasant Avenue which are visually obscured by tree foliage. The signs therefore lack effectiveness in conveying the regulatory and speed zoning advice. Many of these signs also contain time-based information, such as when the school zone (and hence variable speed limit of 40km/h) is in operation.</p> <p>The visually obscured signs are depicted below as well as in item 5b, with descriptions in the captions. These are generally mitigatable by tree pruning works.</p>

<p><b>Left:</b> Looking southbound along Mt. Pleasant Avenue with a view of the partially obscured SCHOOL ZONE sign. <b>Right:</b> Looking northbound at the reverse side of the first sign. The SCHOOL ZONE sign in this direction is also partially obscured by tree foliage.</p>	Medium

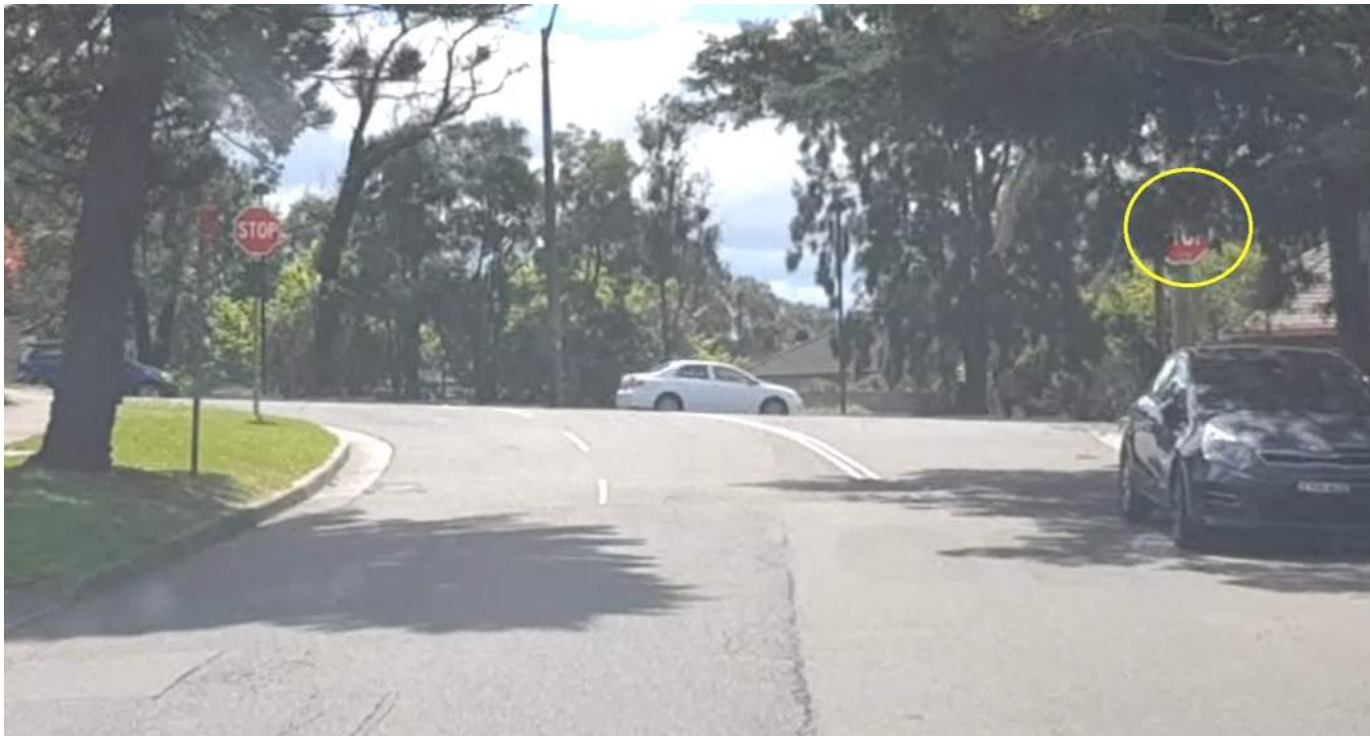
Ref	Theme/ location	Road safety audit finding	Priority
5b	General – Visually obscured signs.  Continued from item 5a...	<p>Continued from item 5a...</p>

<p><b>Above:</b> Looking northbound along Mt. Pleasant Avenue towards its intersection with Pennant Hills Road. The right-hand STOP sign is almost entirely obscured by tree foliage. This is critical since there is also limited viewing time to the left-hand STOP sign due to trees and foliage on the western side of the road.</p>	Medium

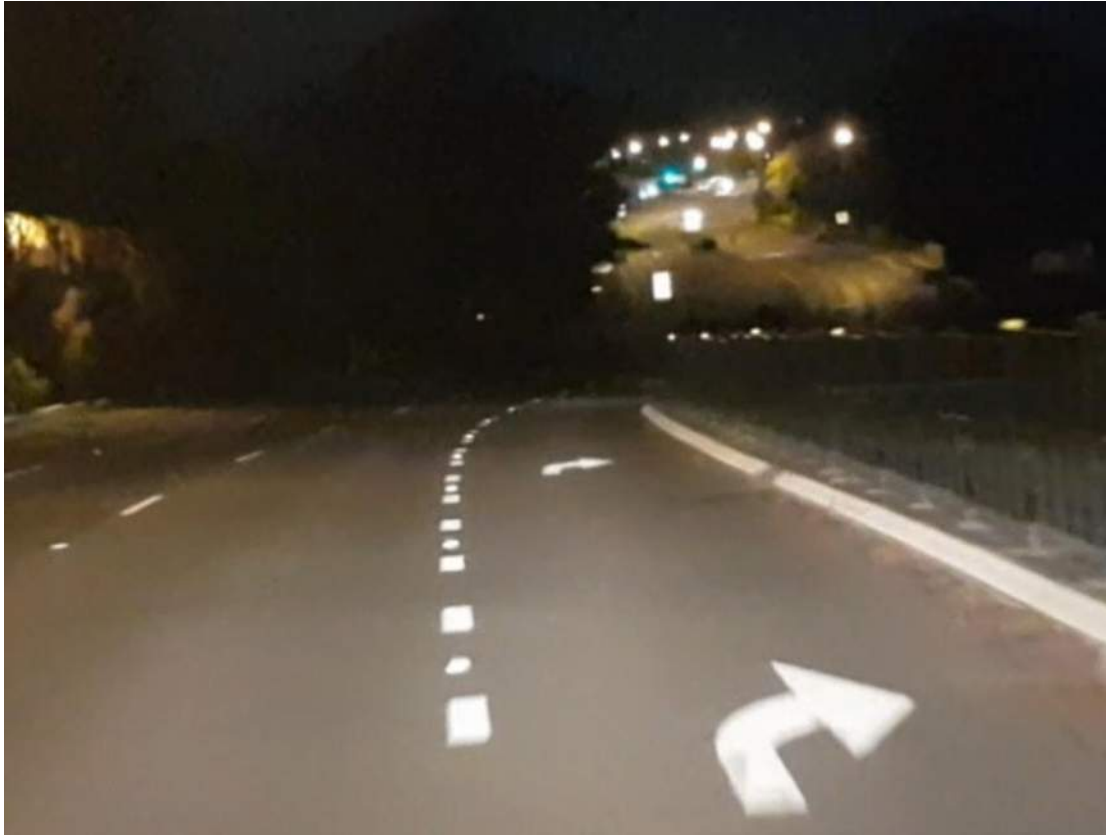
Ref	Theme/ location	Road safety audit finding	Priority
6	Pennant Hills Road, at its intersection with Mt. Pleasant Avenue.	<p>From the night time inspection of the site, the audit team noted that there is a relative dark patch along Pennant Hills Road at its intersection with Mt. Pleasant Avenue. This appears to be a result of missing or malfunctioning street light luminaires. The impact of the poor lighting is evident in the image below, showing the contrast between the poorly lit roadway in the foreground and the much better lighting performance further downstream (east).</p> <p>The poor lighting at this location could increase the risk of night time crashes. Especially if the object being struck is non-reflective or non-illuminated. Eg. a fallen load, damaged tyre etc. The poor lighting also means drivers would have less awareness of pavement conditions.</p>

<p><b>Above:</b> Looking eastbound along Pennant Hills Road during the night time inspection, showing the poor lighting standard at the Mt. Pleasant Avenue intersection.</p>	Medium

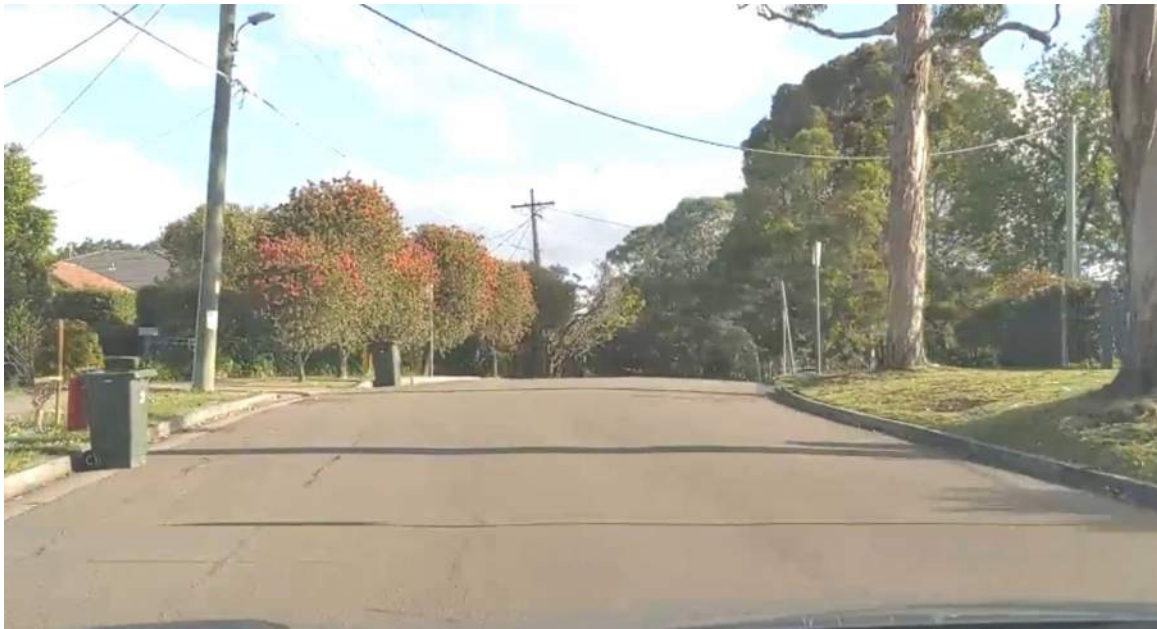
Ref	Theme/ location	Road safety audit finding	Priority
7	Section of Mt Pleasant Avenue at the main entrance to Loreto Normanhurst.	<p>There is a pair of right-left reverse curves in combination with a crest vertical curve. The combined effect of the horizontal curves and the crest has reduced driver visibility to the road ahead. As such, drivers may not be aware of the road alignment in the road ahead. This is particularly critical if drivers in either direction drift towards the midline of the road where there could be corresponding <i>head-on</i> crash risks with opposing vehicles. Consideration should be given to providing a centreline to define and separate opposing traffic streams.</p>

<p><b>Above:</b> Looking southbound along Mt Pleasant Avenue towards the crest-curve combination.</p>	Medium

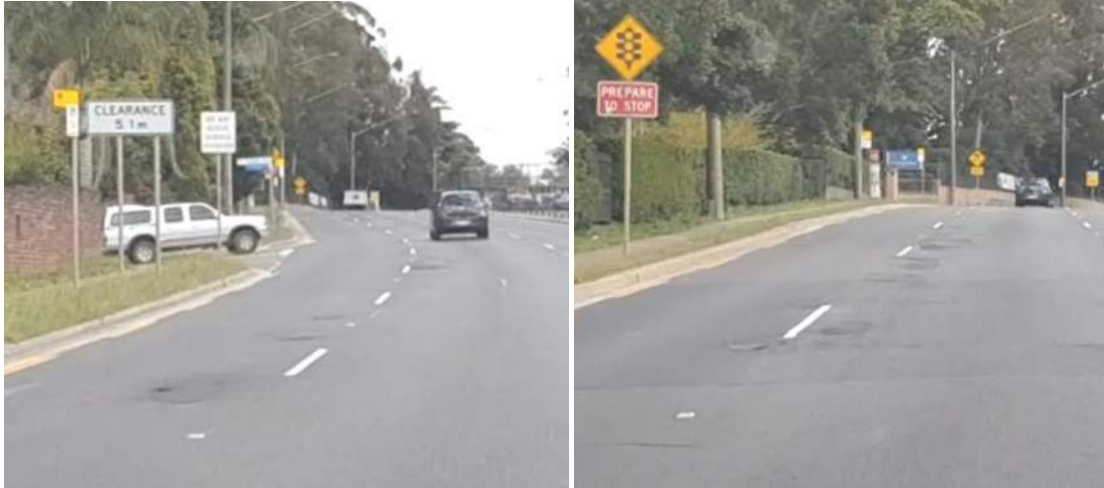
</div> <p><b>Left:</b> Looking westbound along Pennant Hills Road with a view of pavement failures in lanes 1 and 2 of the westbound carriageway. <b>Right:</b> More potholes along the left-wheel path in lane 2, to the west of Mt. Pleasant Avenue.</p>	Low

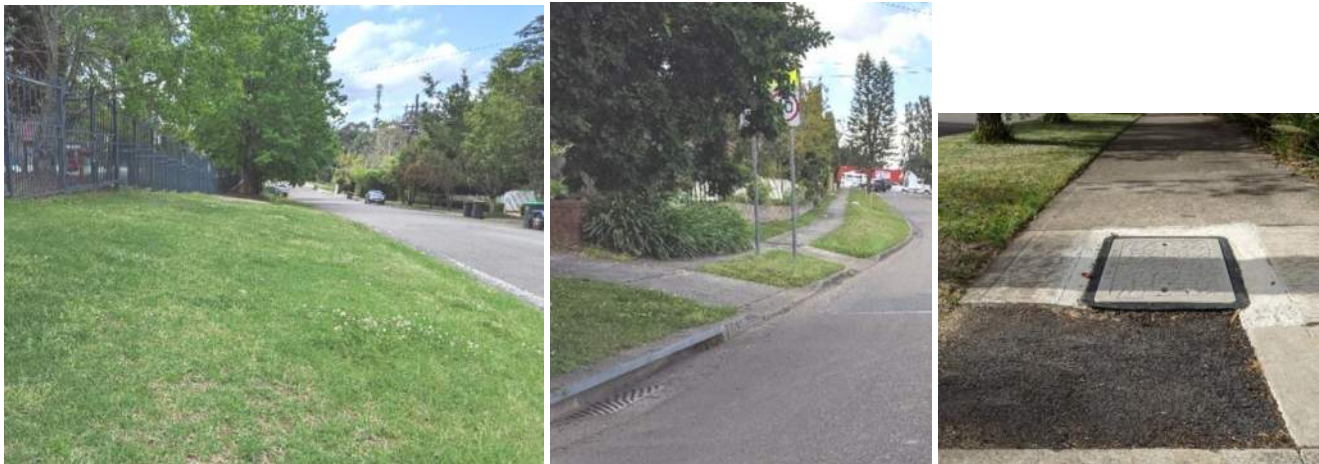
</div> <p><b>Left:</b> There are no footpaths on the western side of Mt Pleasant Avenue along the school frontage. <b>Middle:</b> the effective width of the footpath (further north) is reduced due to overhanging trees/ bushes. <b>Right:</b> An example of uneven path levels at this utility lid and backfilled trench.</p>	Low

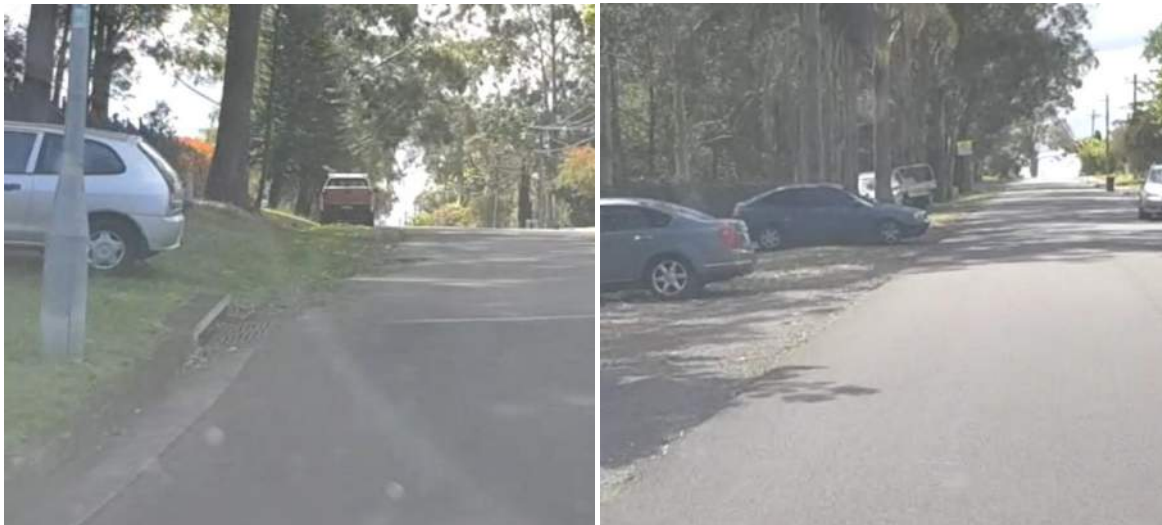
<p><b>Left:</b> Looking northbound along Mt. Pleasant Avenue at the point where the road transitions from kerb-bounded to an informal road-verge interface with variable edge conditions. <b>Right:</b> The narrower width of sealed and trafficable roadway allows parked cars to be positioned much closer to traffic with risks of impacts.</p> </div>	Low

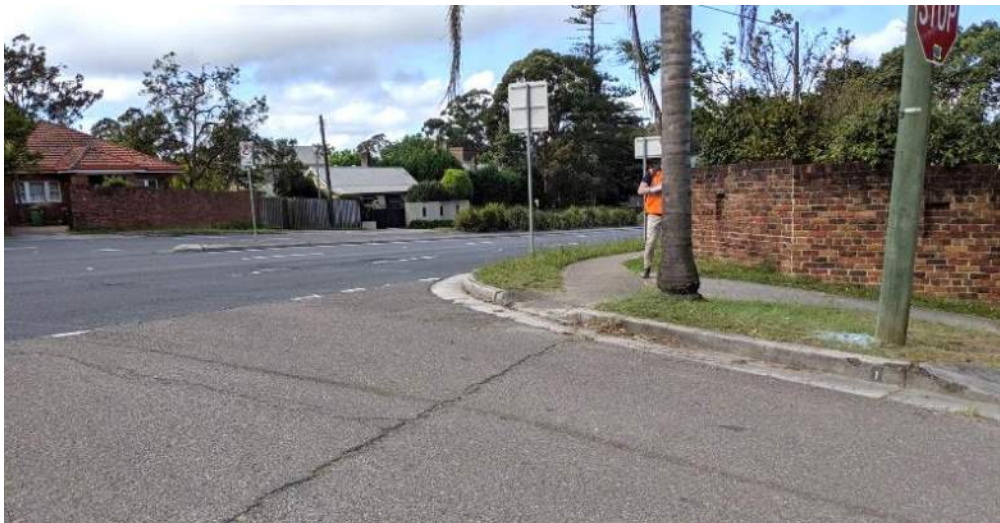
<p><b>Above:</b> The kerb ramp on the south-eastern corner of the intersection.</p>	Low
