## ARBORICULTURAL IMPACT ASSESSMENT REPORT

### Mosman High School REVISION L

04 June 2021

Prepared for  
Multiplex

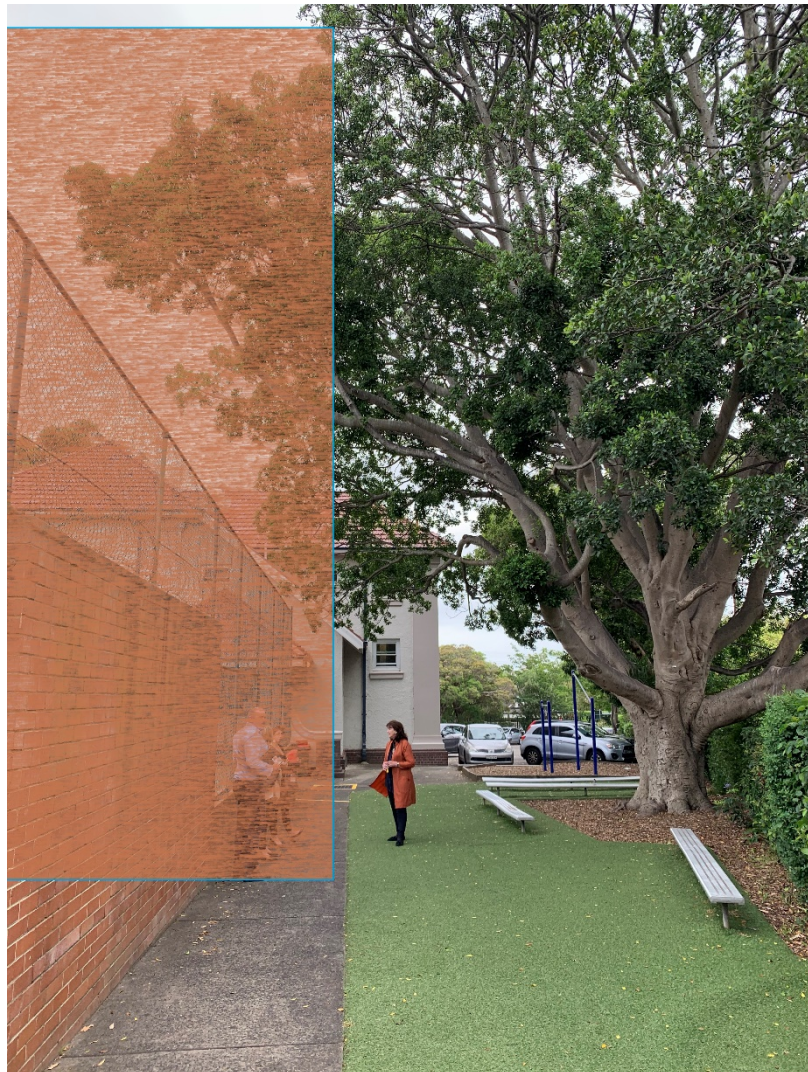
**Figure 1 - Canopy Encroachment Tree 22**

The Tree Protection Zone (TPZ) of this tree in accordance with AS 4970-2009 Protection of Trees on Development Sites will be encroached by the proposed development by 17% which is slightly greater than the minor encroachment as defined by AS 4970-2009. The Structural Root Zone (SRZ) of this tree is not impacted by the proposed development. Based on consideration of the revised design based on the proposed suspension of the core of the building and entryway within the TPZ of this tree, this tree will remain viable to be retained under the proposed development. The proposed construction will encroach within the canopy of this tree, however the extent of this impact is less than 10% and the branching structure of the tree will permit canopy reduction pruning in accordance with AS4373-2007 Pruning of Amenity Trees that would reduce the

canopy without impacting the balance or form of the canopy. Scaffold design is required to minimise the impact on the canopy of this tree and a pruning specification is to be provided by the Site Arborist.

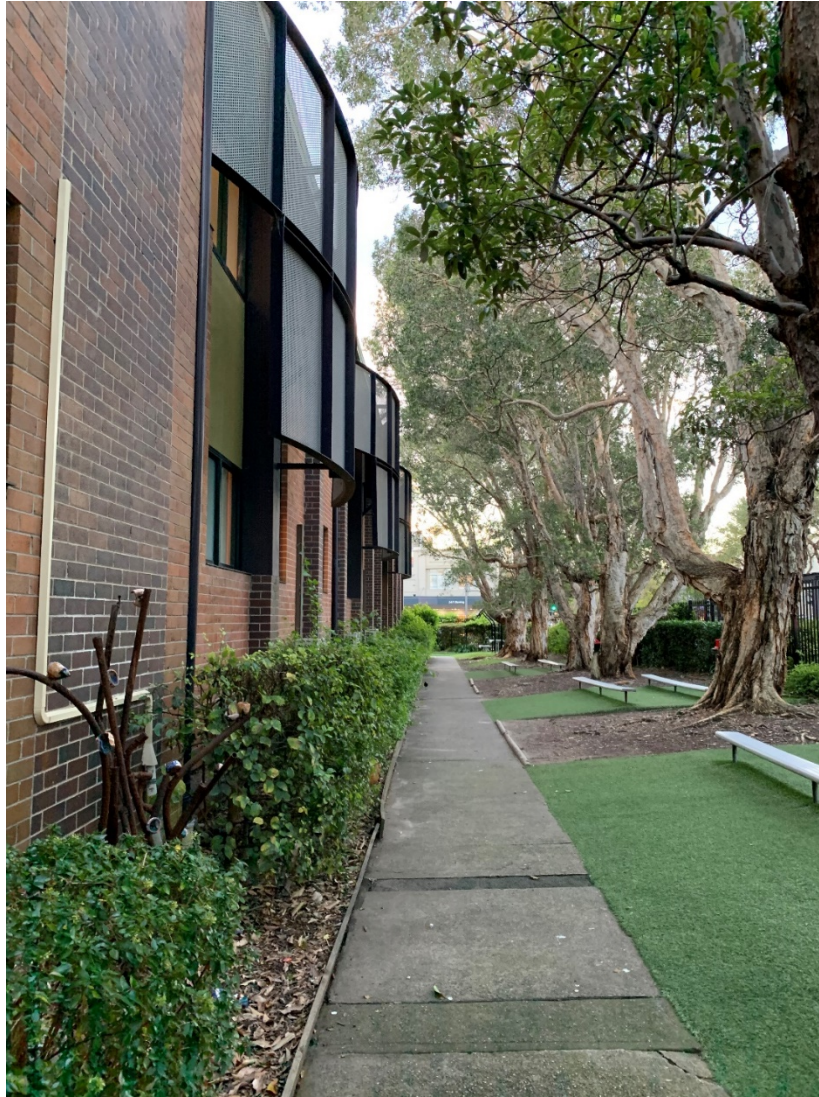
**Figure 2 Proximity of Existing Canopies relative to existing building**

The Tree Protection Zones (TPZ) of Trees 10, 11, and 19 will be encroached by the proposed development by slightly greater than the minor encroachment as defined by AS 4970-2009. The Structural Roots Zone (SRZ) of these trees are not impacted by the proposed development. Based on consideration of the revised design based on the proposed building line and façade being located behind the existing building line, the restriction to root growth provided by the existing building foundations and structures and these species tolerance to root disturbance, in accordance with clause 3.3.4 of AS 4970-2009, these trees will remain viable to be retained under the proposed development. There are two isolated sections of the proposed building that extend beyond the existing building line within the TPZ of Trees 13 and 16. Root mapping will be required for these areas using nondestructive excavation. All proposed excavation within the TPZ of these trees is to be carried out under the supervision and direction of the Site Arborist.

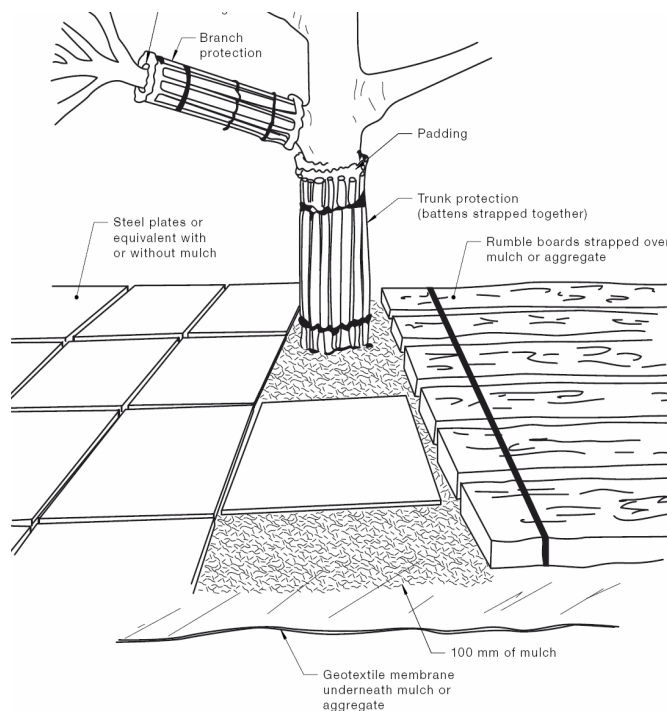
**Figure 3 - Trunk Protection**

Tree Protection Fencing is not viable to be installed to the full extent of the TPZ on the western side of as the fencing will impede construction traffic. Accordingly, Trunk and branch protection is required to be installed to this tree to the extent that they extend over the proposed construction access. The trunk and branches in the lower crown will be protected by wrapping 2 layers of hessian or carpet underfelt around the trunk and branches, then metal strapping secures 38x50 x2000 mm timber battens together around the trunk or branch (do not nail or screw to the trunk or branches). The number of battens to be used is as required to encircle the trunk and the battens are to extend to the base of the tree (AS4970 2009 Protection of trees on development sites, Figure 2 Examples of Trunk, Branch and ground protection).

All branches within 500mm of scaffold or hoardings are to receive branch protection in accordance with this report and SA4970-2009. All trunk and branch protection is to be to the direction and approval of the Site Arborist.

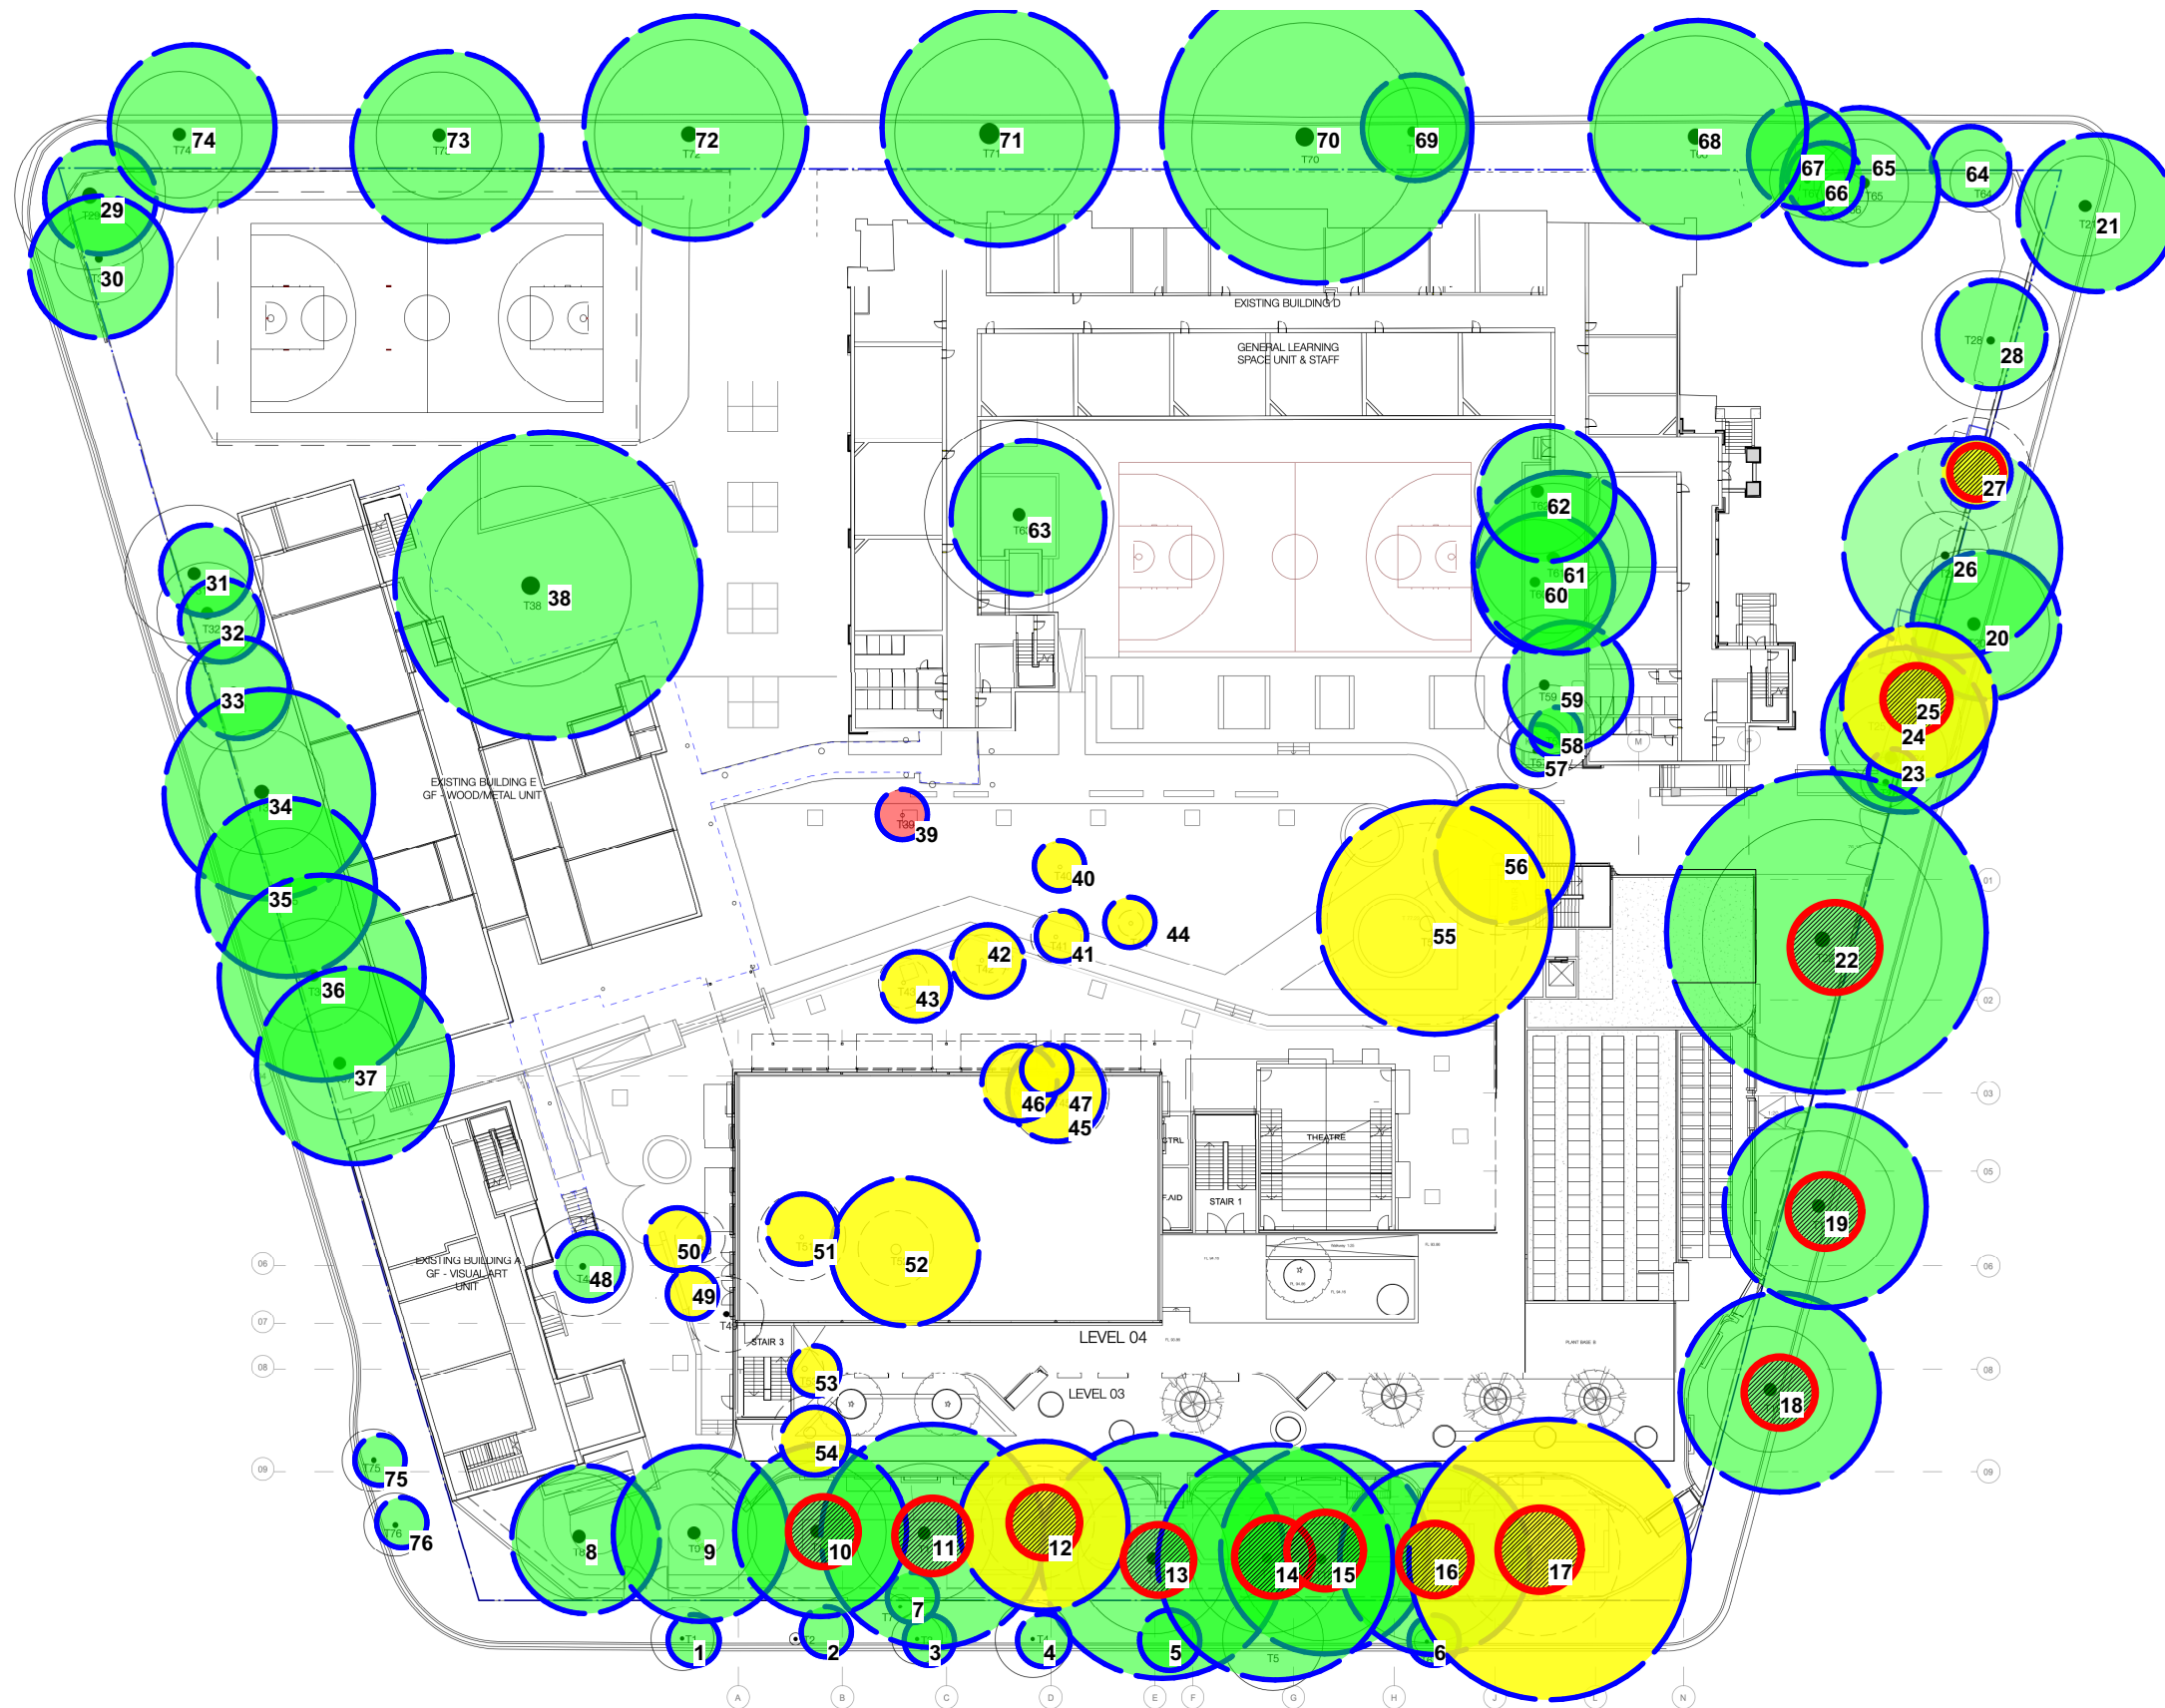
- Tree to be Retained and Protected
- Tree to be Removed under REF
- Tree Not Viable to be Retained due to Proposed Development
- Tree Protection Zone (TPZ) in accordance with AS4970-2009
- Structural Root Zone (SRZ) in accordance with AS4970-2009
