SoilFutures Consulting Pty Ltd

**REVIEW OF SOIL CONSERVATION SERVICE SITE
ASSESSMENT “BARANA”
&
ASSESSMENT OF WESTERN LIVERPOOL PLAINS
AREA WITH RESPECT TO RISKS ASSOCIATED
WITH PROPOSED BURIED
GAS PIPELINE INSTALLATION**

Prepared for the
MULLALEY GAS AND PIPELINE ACCORD
October 2011

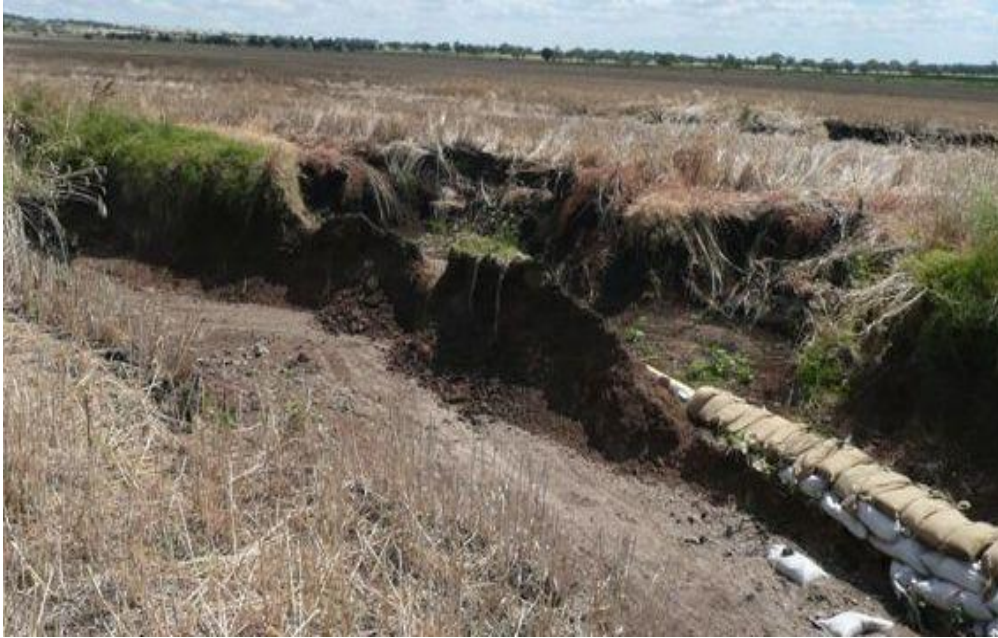
Photo 1 shows that a north eastern flowing spur of the gully had formed which followed the pipeline uphill, during the second erosion event. This photograph also shows that there has been some degree of turbulent flow where the pipe was sandbagged to support it between erosion events. The extension of the spur of the gully along the pipeline is significant, as the gully certainly follows the pipe in both directions.

Photo 1: Gully and exposed pipe at Barana with spur gully following pipeline

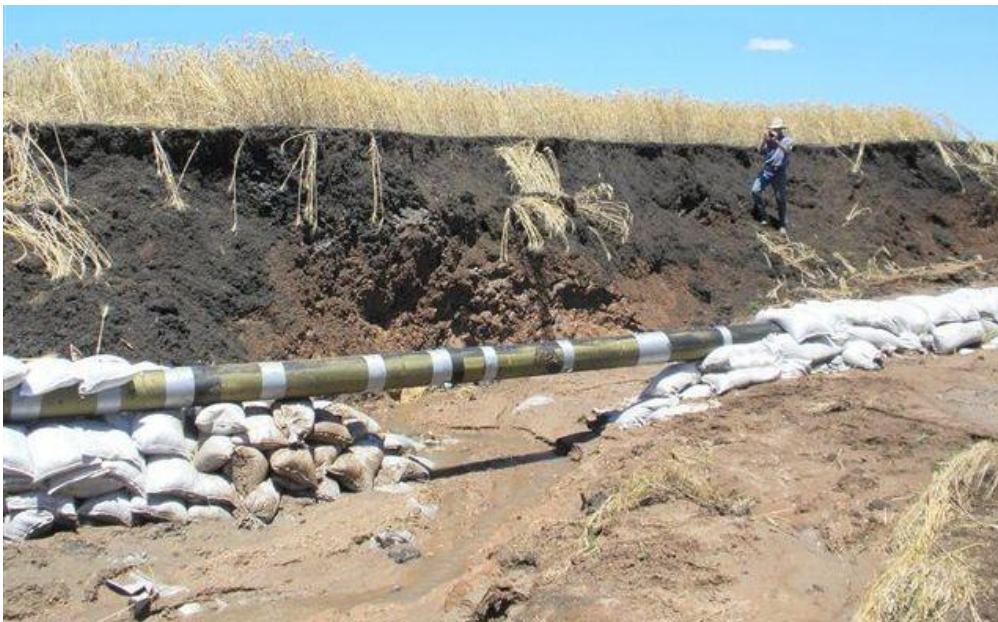
Photo 2: Gully and exposed pipe at Barana with failed sand bag supports

Photo 2 shows evidence of turbulent flow caused firstly by the presence of the pipe in the gully floor and secondly by the sand bagging of the pipe. The subsequent failure of the sand bags appears to have further exacerbated the extent of the erosion.

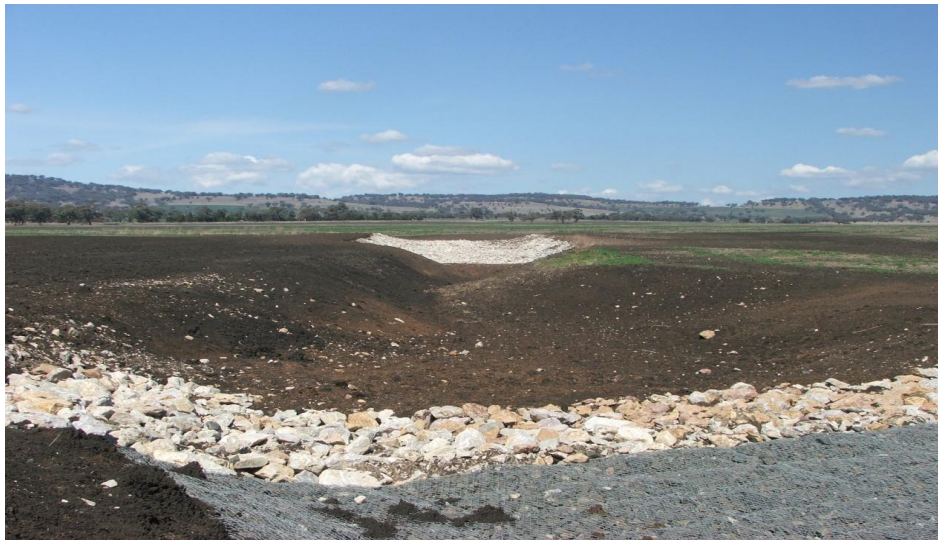
Photos 3 and 4 show the reshaped gully as it was during the site visit by SoilFutures Consulting Pty Ltd. The site of the pipe should now be relatively stable following these works. It is interesting to note that the width of the natural gully (downhill middle right of photo 4) which reflects the capacity of the gully to carry the run-on from the catchment above, is quite narrow relative to the site of the rehabilitation works. As such, the natural expansion of the gully uphill would have resulted in a gully of only a few metres width, not the width of at least 8 m which has occurred at the site of the pipe emplacement.

Photo 3: Looking uphill along rehabilitated pipe crossing failure at gully at “Barana”

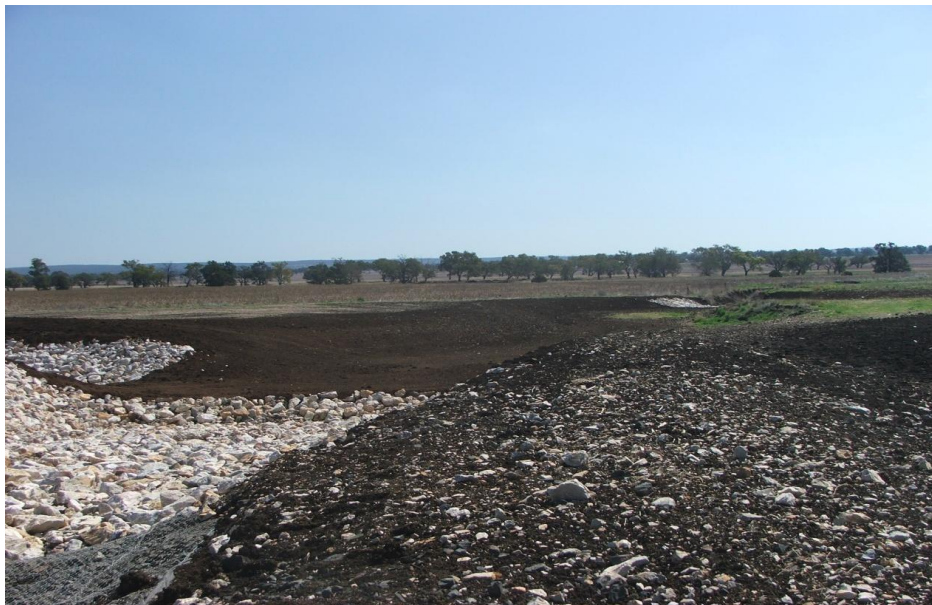
Photo 4: Looking downhill along rehabilitated pipe crossing failure at gully at “Barana”. Note natural gully width in right of mid ground.
