Our ref: 18SYD\_9907

**Re: Kellyville Station Precinct Riparian Assessment – Response to Submissions**

# Kellyville Precinct State Significant Development Application - Riparian Assessment

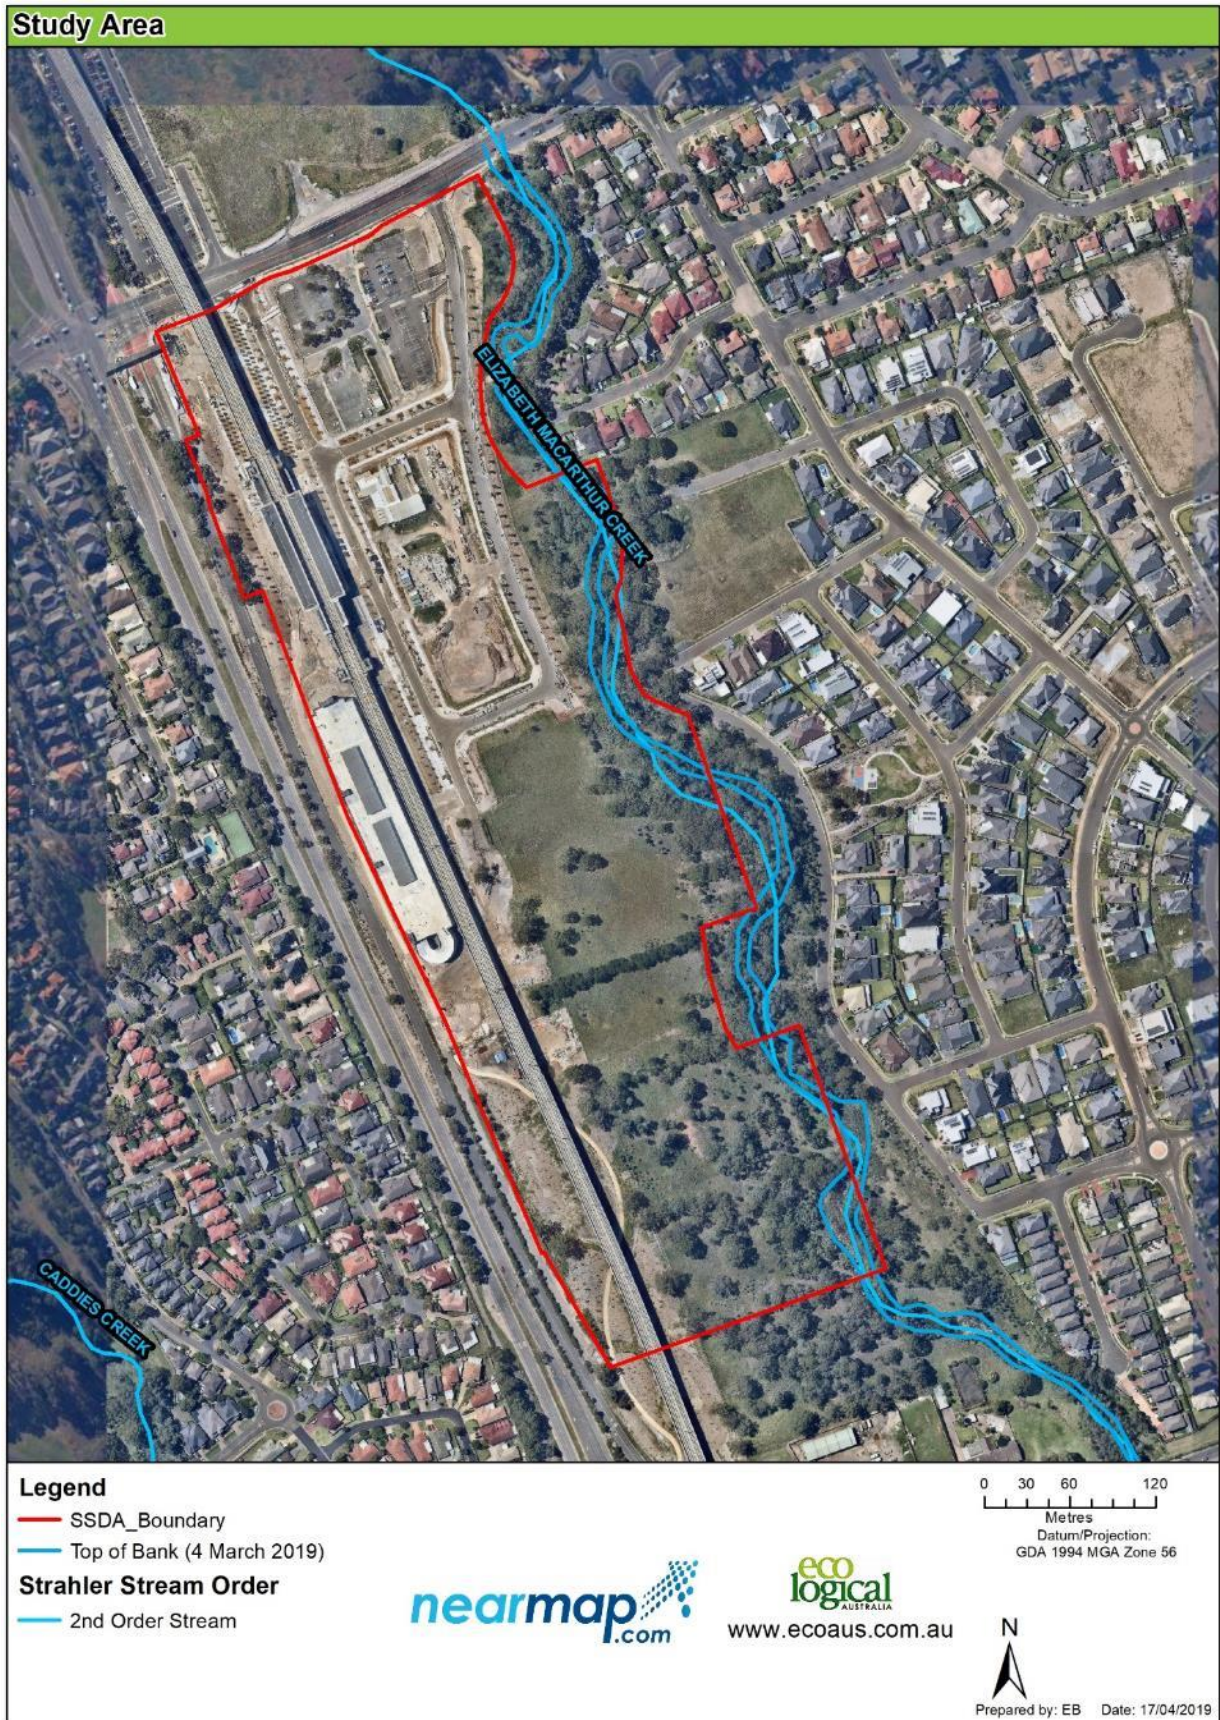
Figure 1: Study area

Located in the Hills Shire Council Local Government Area, Elizabeth Macarthur Creek is a tributary of Caddies Creek and is located within the Hawkesbury-Nepean River catchment. Within the SSDA boundary, Elizabeth Macarthur Creek extends for approximately 900 m, from Lot 1 DP1066762 in the south to where the creek flows under Samantha Riley Drive in the north (Figure 1).

The Precinct spans the alignment of the SMNW corridor that consists of an approximate 900 m stretch of government owned land, extending from Samantha Riley Drive in the north towards Memorial Avenue in the south, and bound by Old Windsor Road to the west, existing Roads and Maritime Services land to the south and Elizabeth Macarthur Creek to the east (Figure 1).

A road bridge is proposed to be constructed at the southern end of the SSDA boundary across the creek in order to connect Colonial Avenue on the eastern side of Elizabeth Macarthur Creek to the proposed residential area and playing fields on the western side of the creek (Figure 1). There are a number of potential impacts that could occur as a result of the construction of a bridge over the waterway:

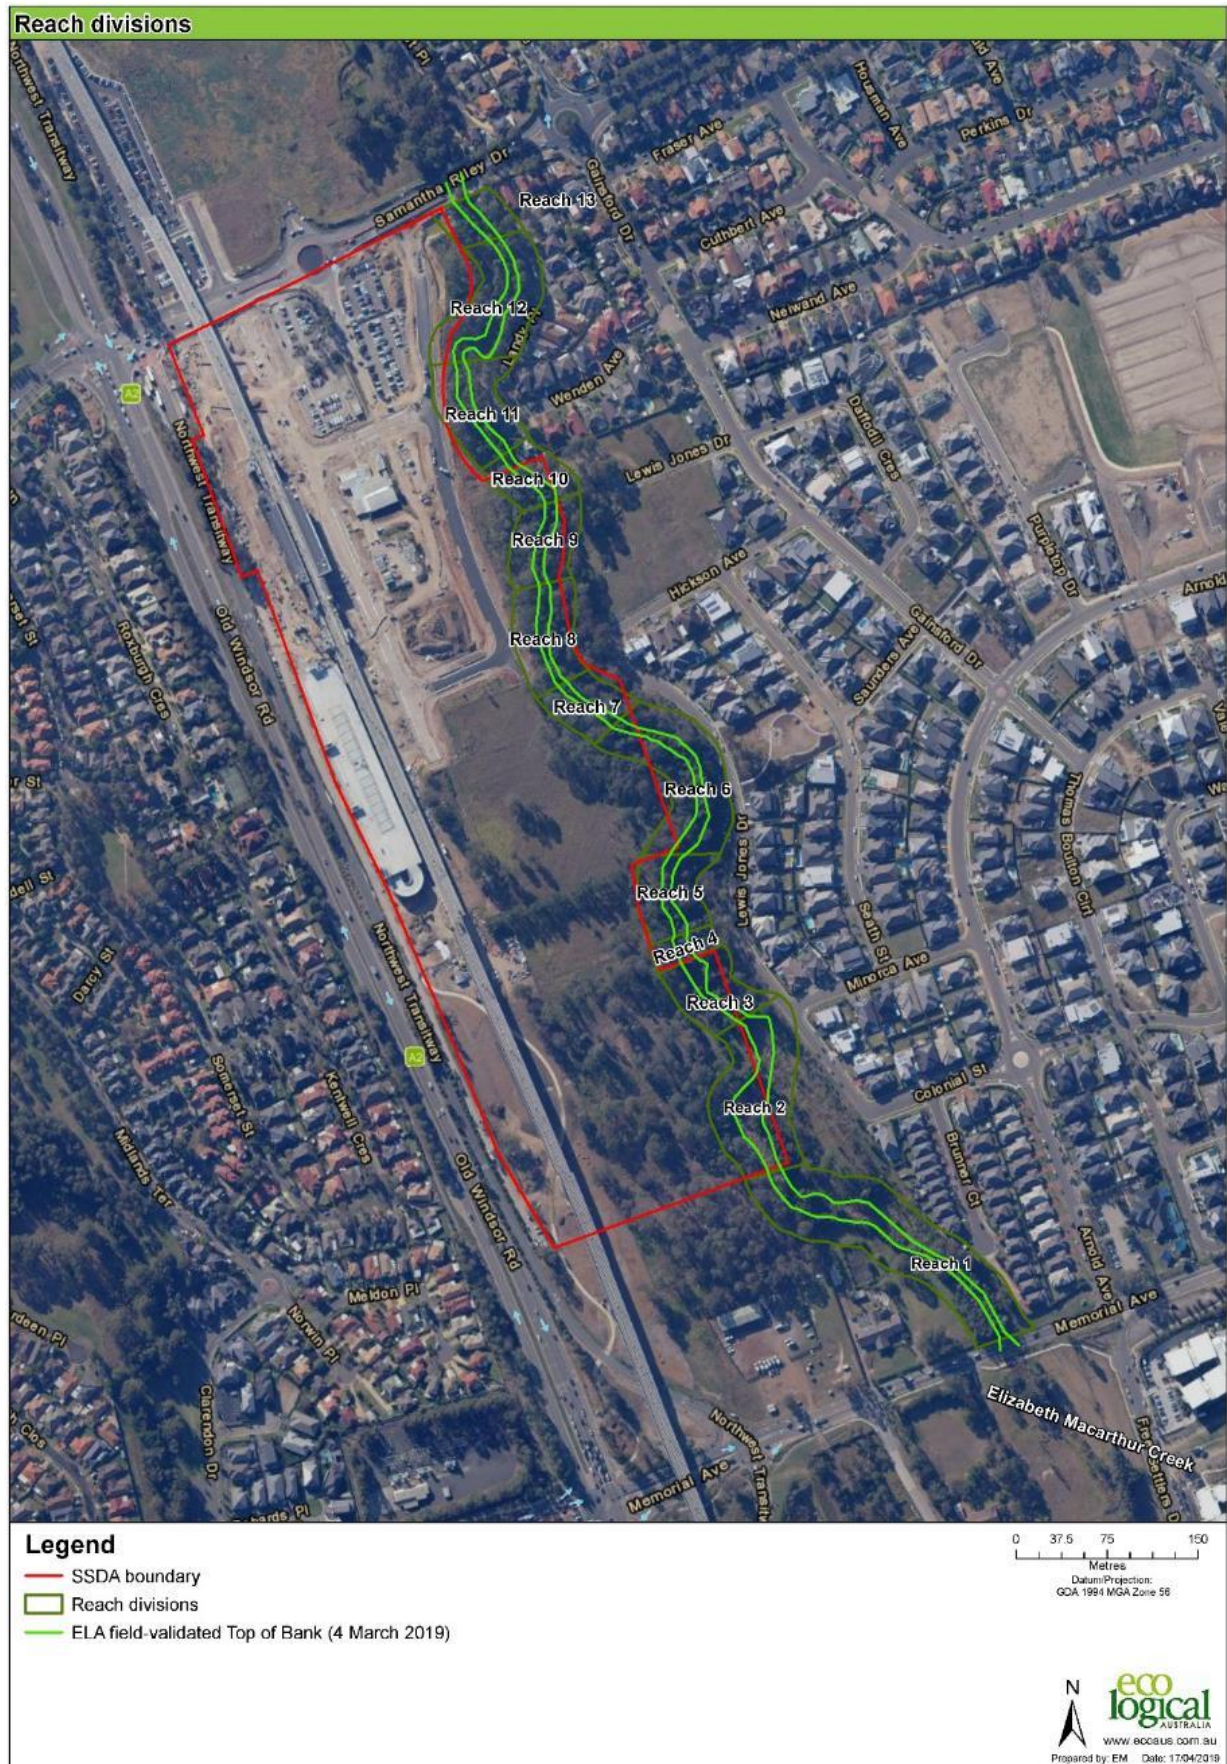
Figure 5: Reach delineation

To aid in the description of the waterway within the SSDA boundary, the site has been split into 13 reaches, starting from immediately south of the SSDA boundary (Figure 5). Photo location points have been mapped in Figure 7.

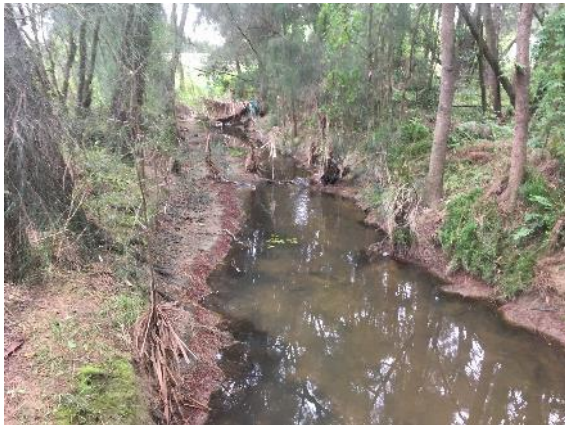
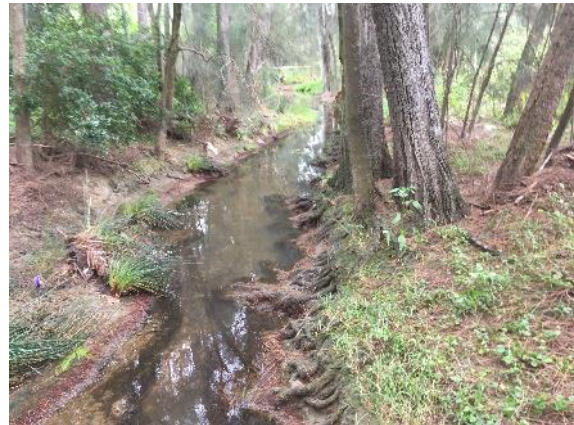
Although Reach 1 is outside of the SSDA boundary, it has been included in this assessment in order to provide context of the area upstream of the site. Elizabeth Macarthur Creek flowed under Memorial Avenue through three box culverts, where it formed a narrow creekline that displayed evidence of sediment deposition and historical disturbance. The adjacent riparian zone was densely covered in exotic species including *Rubus fruticosus* (Blackberry), *Tradescantia fluminensis* (Trad), *Asparagus asparagoides* (Bridal Creeper) and *Asparagus aethiopicus* (Asparagus Fern). Downstream of this area, the channel was lined by *Casuarina* sp. trees and erosion around the roots of these trees was observed (Figure 8 and Figure 9).

Figure 8: Photo point 1, looking upstream

Figure 9: Photo point 1, looking downstream

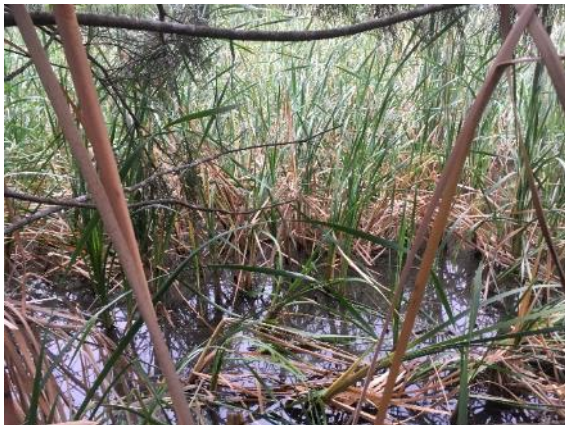
Figure 10: Photo point 2, looking upstream

At the upstream extent of this reach, at the southern extent of the SSDA boundary, Elizabeth Macarthur Creek was in the form of a swamp, with dense coverage of the emergent macrophyte *Typha orientalis* (Cumbungi) (Figure 10 and Figure 11). The water within this area was stagnant with a covering of surface algae in some areas, particularly on the edges of the swamp at the base of vegetation such as the *Casuarina* sp. trees. Dense *Casuarina* sp. leaf litter was present on the ground of the riparian area.

There was limited aquatic habitat variety within this reach, as it was predominantly swamp area with dense emergent macrophytes such as the Cumbungi. The water was stagnant and slightly turbid. The slope of the banks of the swamp were flat, with evidence of a wider floodplain area surrounding the top of bank within this area.

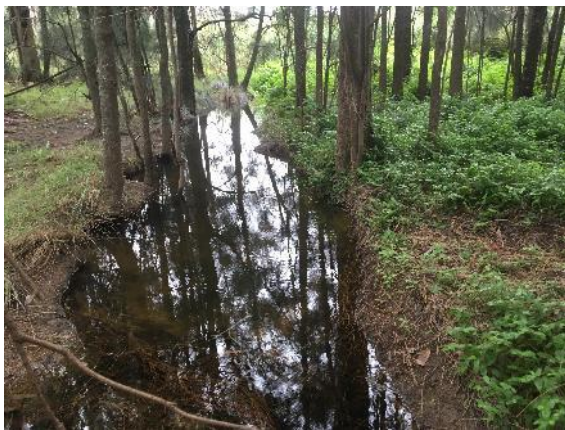
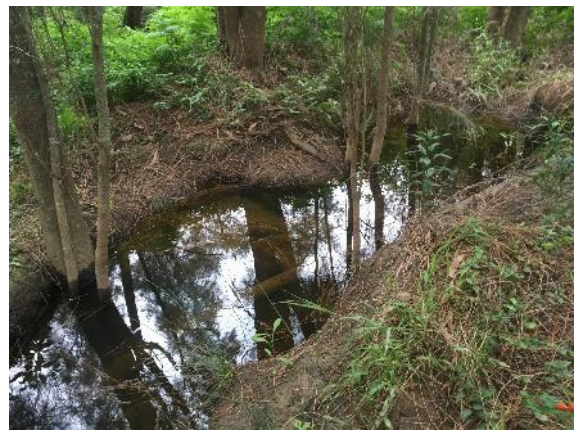
The riparian vegetation within this reach was quite dense, with thick *Casuarina* sp. canopy and predominantly Trad as the groundcover vegetation (Figure 12 and Figure 13). The condition of the vegetation within this reach was poor to moderate, as almost the entire ground layer was exotic species but with native canopy species.

Figure 12: Photo point 3, looking upstream

Figure 13: Photo point 3, looking downstream

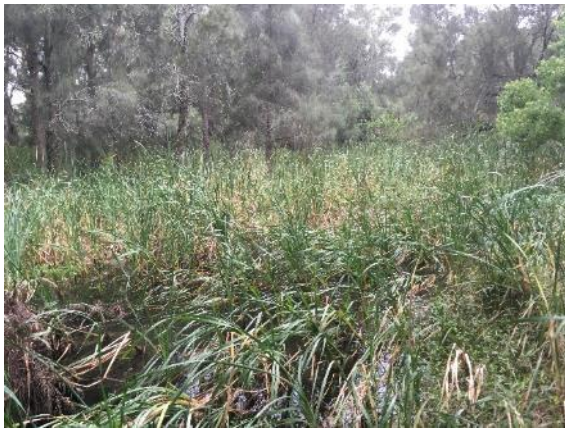
Figure 14: Photo point 4, looking upstream

Reach 4 was another small swamp area that was densely covered in Cumbungi (Figure 14 and Figure 15). It was a wide section of the channel with the banks of the swamp, particularly on the western side, approximately 1.2 m high and steeply sloped.

The swamp in Reach 4 was approximately 8 m wide and the water was stagnant but relatively clear. Frogs could be heard calling in this area. The adjacent *Casuarina* sp. trees provided shade over the edges of the water.

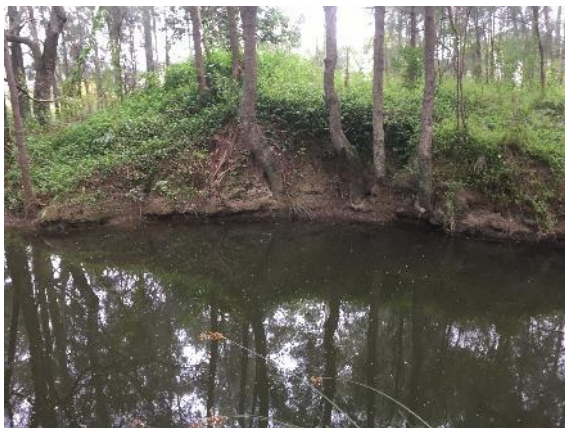
Figure 16: Photo point 5, looking east to right bank

Reach 5 was an area where the channel became very defined again following the wide swamp area. The right bank was very high in some areas, with vertical faces up to 2 m high (Figure 16).

Within Reach 5, the water was slow flowing but not stagnant. It was predominantly clear but there were small pools on the edge of this reach where the water was slightly turbid. The creek banks within this reach were heavily eroded and in some areas were near vertical. At the beginning of this reach it was the right bank that was heavily eroded, then downstream it was the left bank that exhibited signs of erosion, indicating a shift in the creek's thalweg within this reach. This erosion had exposed a clay soil and roots of *Casuarina* sp. trees (Figure 16). Flood debris of *Casuarina* sp. needles was deposited at the top of the banks and the channel contained a small amount of instream woody debris, which would provide good habitat for aquatic fauna.

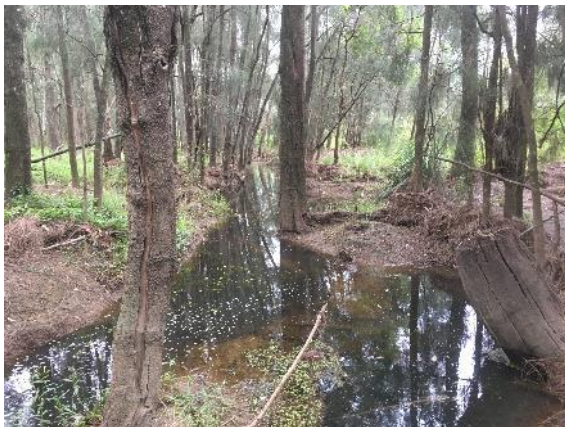
Figure 18: Photo point 6, looking downstream

Reach 6 was where the creek changed shape and geomorphologic features, in that it changed from the defined channel with incised banks of Reach 5 to an almost braided waterway, with multiple smaller channels flowing through a flat landscape (Figure 18).

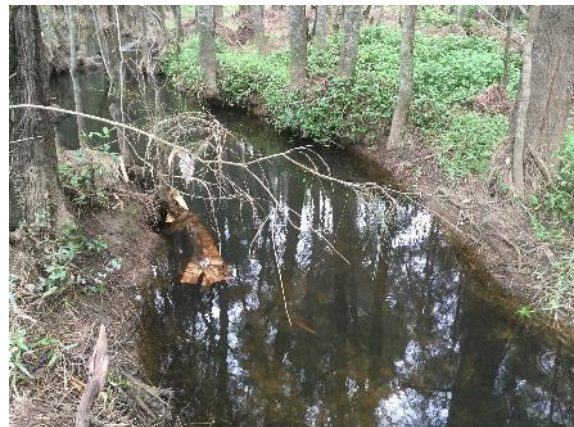
Figure 19: Photo point 6, looking upstream

Reach 6 provided a range of aquatic habitats, with pools of varying depths, instream debris (Figure 19), submerged aquatic vegetation, overhanging vegetation and emergent vegetation such as *Ludwigia peploides*. Creek banks in this reach were relatively flat and there was evidence of previous high flow events having overtopped the banks as there was flood debris within the riparian vegetation alongside the channels and isolated pools. There was a large headcut observed in this reach, where either overland flow over the right bank had eroded a section of the bank or water was eddying around the bank in this area, and a new channel was forming as the headcut retreated upstream.

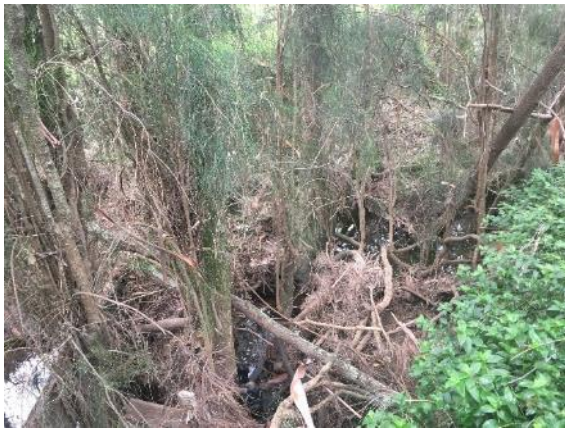
Figure 20: Photo point 7, looking downstream

Reach 7 signalled a shift back to a more incised, narrow channel. The banks were still lined with *Casuarina* sp. trees and there was a lot of instream woody debris and *Casuarina* sp. needles within and above the channel (Figure 20).

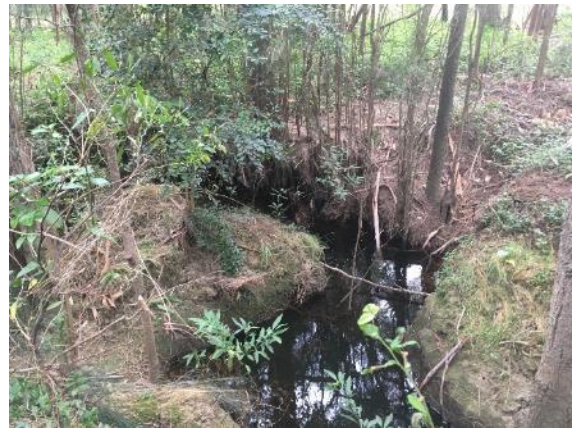
Figure 21: Photo point 7, looking upstream

Near vertical banks with some undercutting was observed within this reach (Figure 21), with the left bank at one point almost 3 m high. While undercutting is a sign of bank erosion, it can provide good aquatic habitat for small fauna and macroinvertebrates. The water was turbid within this reach but there was no obvious input of sediment-laden water nor was there any sign of sediment deposition. The water was relatively stagnant or slow flowing. Gambusia fish were seen within this reach.

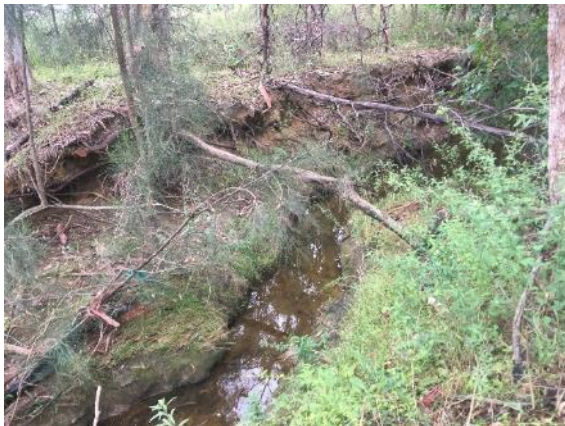
Figure 22: Photo point 8, looking downstream

There was evidence of erosion on both sides of the waterway within this reach. The left bank was eroded to near vertical (Figure 22) and there was also evidence of undercutting at the base of the bank. While the undercutting is a form of bank erosion, this area may also provide good quality habitat for aquatic fauna.

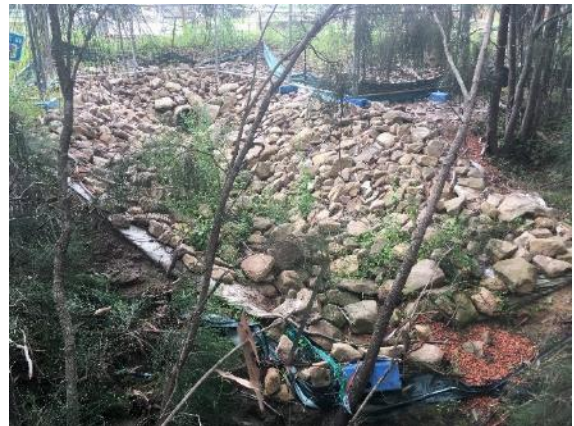
Figure 23: Photo point 8, looking west at stormwater outlet

Reach 8 was adjacent to the current area of construction works adjacent to the left bank. The construction fencing came quite close to the ToB in one area and was within the inner VRZ. At the downstream extent of this reach, a newly constructed stormwater outlet was discharging into the creek from the left bank. Rock rip rap had been placed around the outlet, however it appeared to have been poorly constructed in that there were sandstone boulders that looked like they had been displaced and were entering the waterway. A sediment fence that had been constructed at the base of this rip rap had fallen over (Figure 23) and was not capturing any sediment that may have been leaving the stormwater pipe.

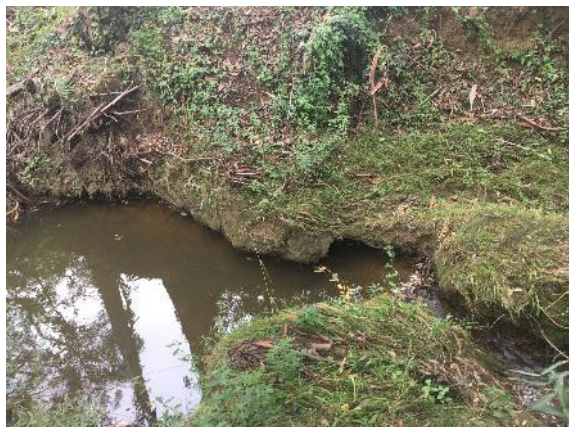
Figure 24: Photo point 9, looking downstream

Reach 9 was an area that exhibited recent erosion on the right bank in the form of slumping. Tension cracking was seen on the surface of the top of bank.

There was a narrow riffle zone within this reach that extended for approximately 10 m downstream and was approximately 0.1 m deep. There was also a deep pool within this reach, so aquatic habitat within this area would be considered good, as there are a range of habitat types.

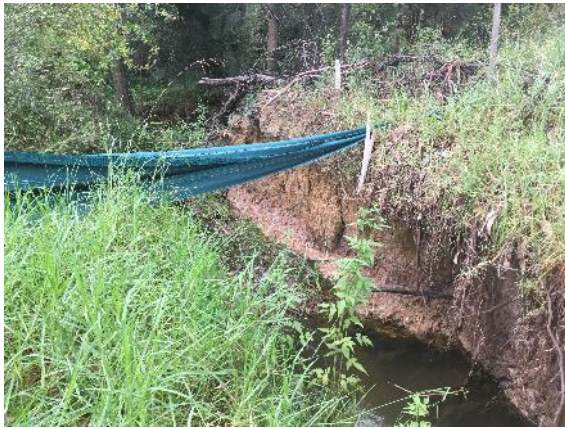
Figure 26: Photo point 10, looking west at end of drainage channel

Water quality in this reach was poor as it was rather turbid. The sediment that had eroded from the channel leading from the end of Lewis Jones Drive would have been deposited within this reach and elsewhere downstream.

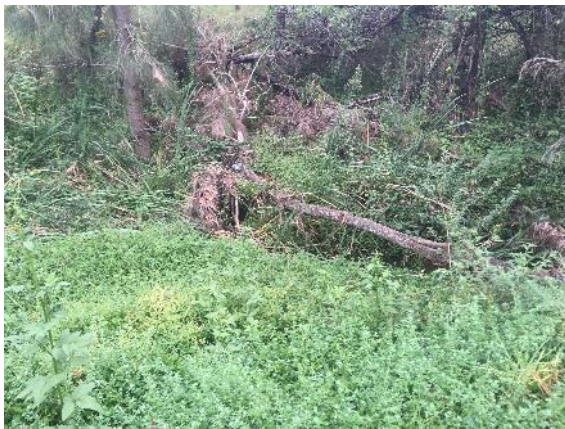
Figure 28: Photo point 11, looking downstream

Aquatic habitat was likely to be poor in this area. There were no open areas of water within this reach and the presence of litter would degrade water quality.

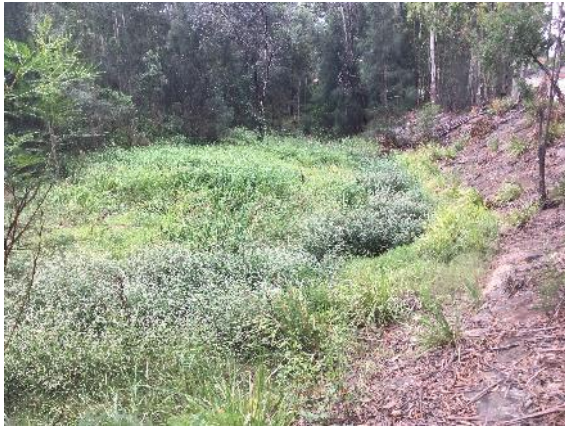
Figure 30: Photo point 12, looking downstream

There were few areas of visible water within this reach, especially at the upstream end where it was a wide detention basin, approximately 20 m wide. The reach was densely covered in emergent macrophytes including Cumbungi and Knotweed.

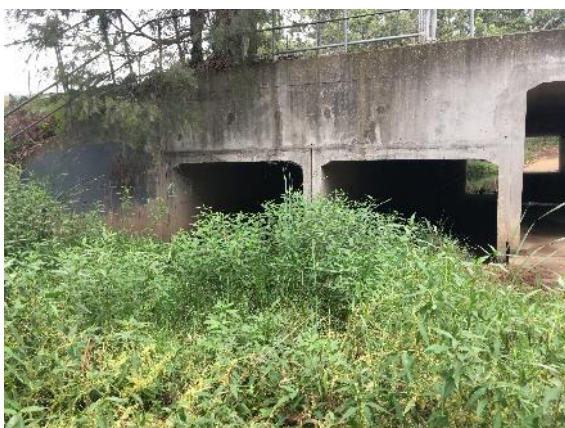
Figure 32: Photo point 13, looking downstream

The waterway within this reach was densely covered in Cumbungi and there were no visible areas of open water. Knotweed was also growing densely within this area. Aquatic habitat was likely to be poor in this area due to the dense macrophyte coverage. A stormwater outlet was discharging runoff from the adjacent road into the waterway, so it is likely that the water quality in this area was of moderate to poor condition due to the origin of this water.
