RE: INTERIM AUDIT ADVICE – SUITABILITY OF THE 2018 REMEDIAL ACTION PLAN

As a NSW Environment Protection Authority (EPA) accredited Contaminated Sites Auditor, I am conducting an Audit in relation to the site, described as 42 Honeysuckle Drive, Newcastle. This initial review has been undertaken to provide an independent review of the suitability and appropriateness of a Remediation Action Plan (RAP).

Ref 318000449

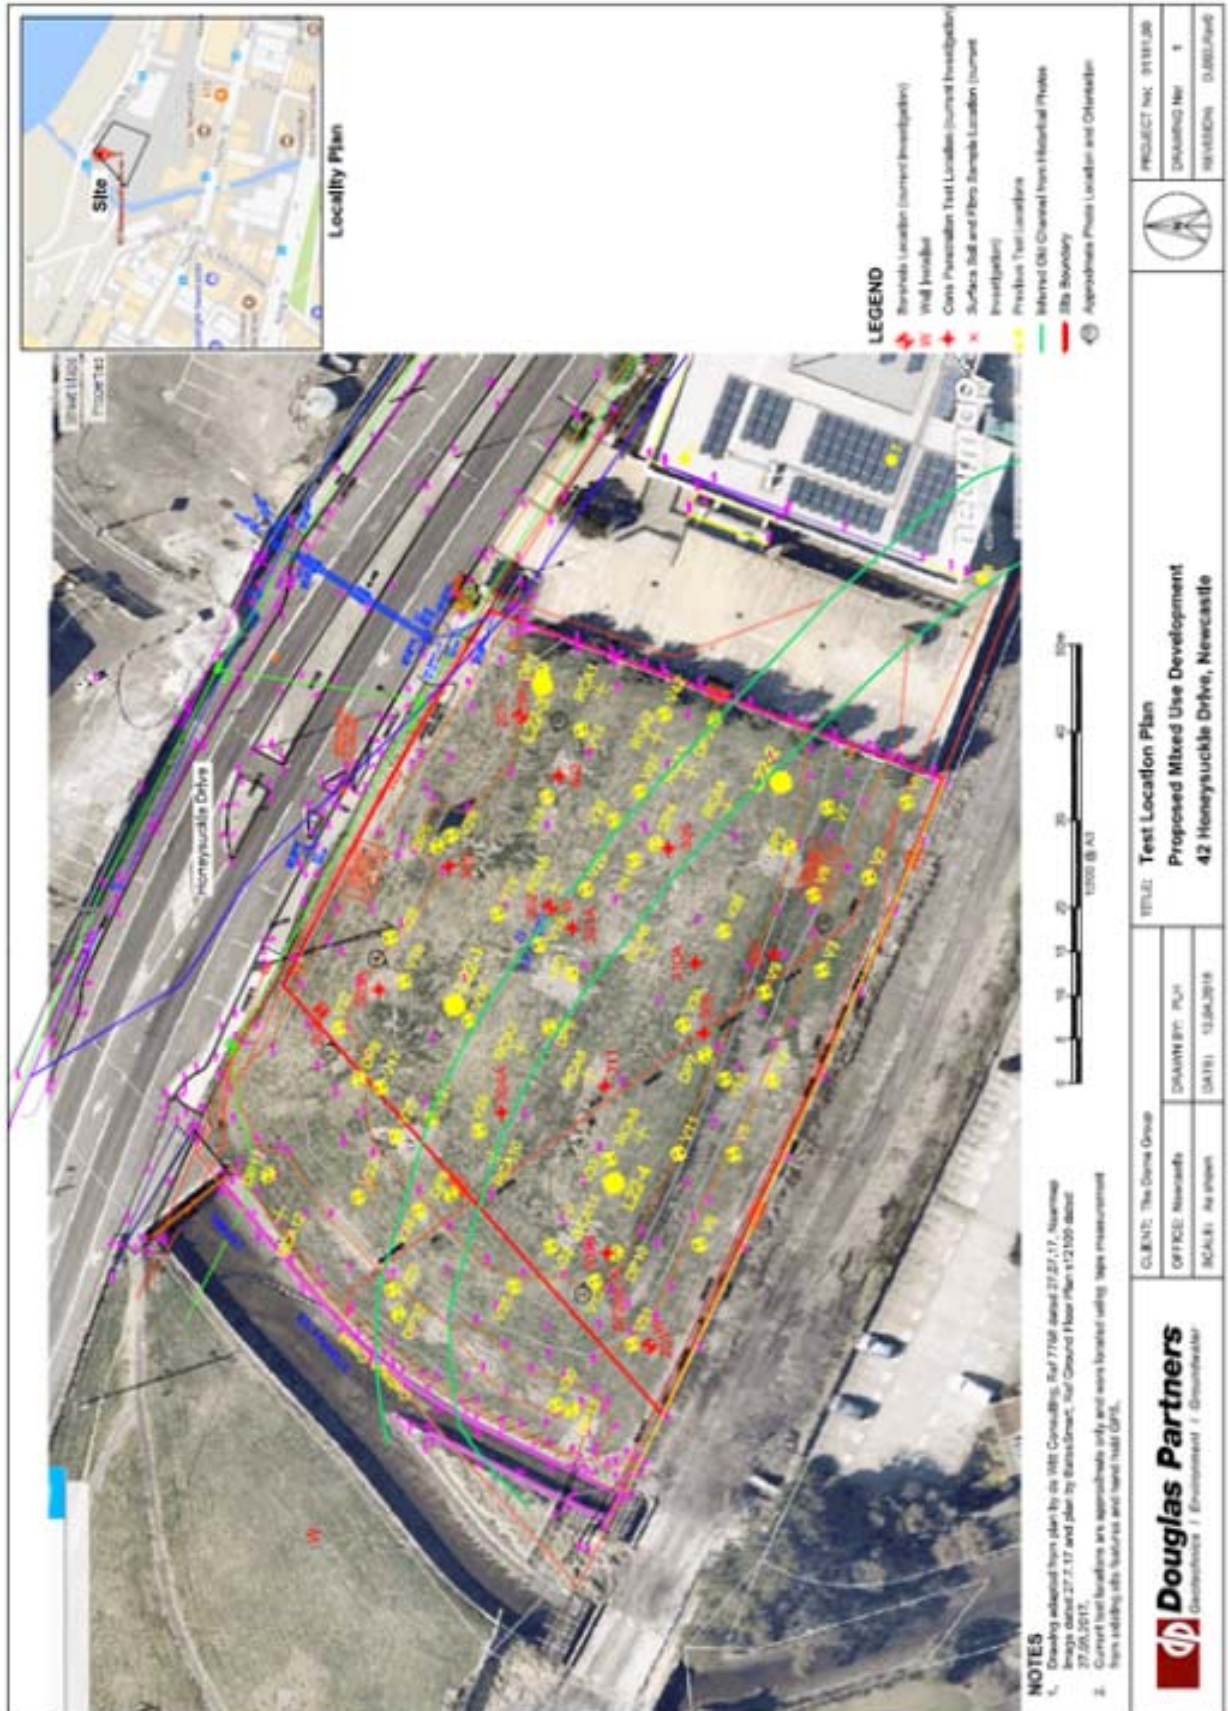
The historical investigations undertaken were reviewed by DP and pertinent information relating to the site history has been summarised by the Auditor below. Historical sample locations are shown on **Attachment 2**.

Soil samples were analysed for a variety of contaminants including petroleum hydrocarbons, PAHs, PCBs, OCP/OPP, asbestos and heavy metals. The historical results from investigations completed from 2004 until the current investigation have also been assessed against the environmental quality criteria and summarised in **Table 8.1**. Soil sampling locations are presented in **Attachment 2**.
