**RE: INTERIM AUDIT ADVICE LETTER NO. 1 - REVIEW OF  
INVESTIGATIONS, CHATSWOOD HIGH SCHOOL, 24 CENTENNIAL  
AVENUE, CHATSWOOD NSW**

Ref 318001008

This interim letter is based on a review of the documents listed below and observations made on a site visit on 24 June 2020, as well as discussions with Johnstaff who are the project manager.

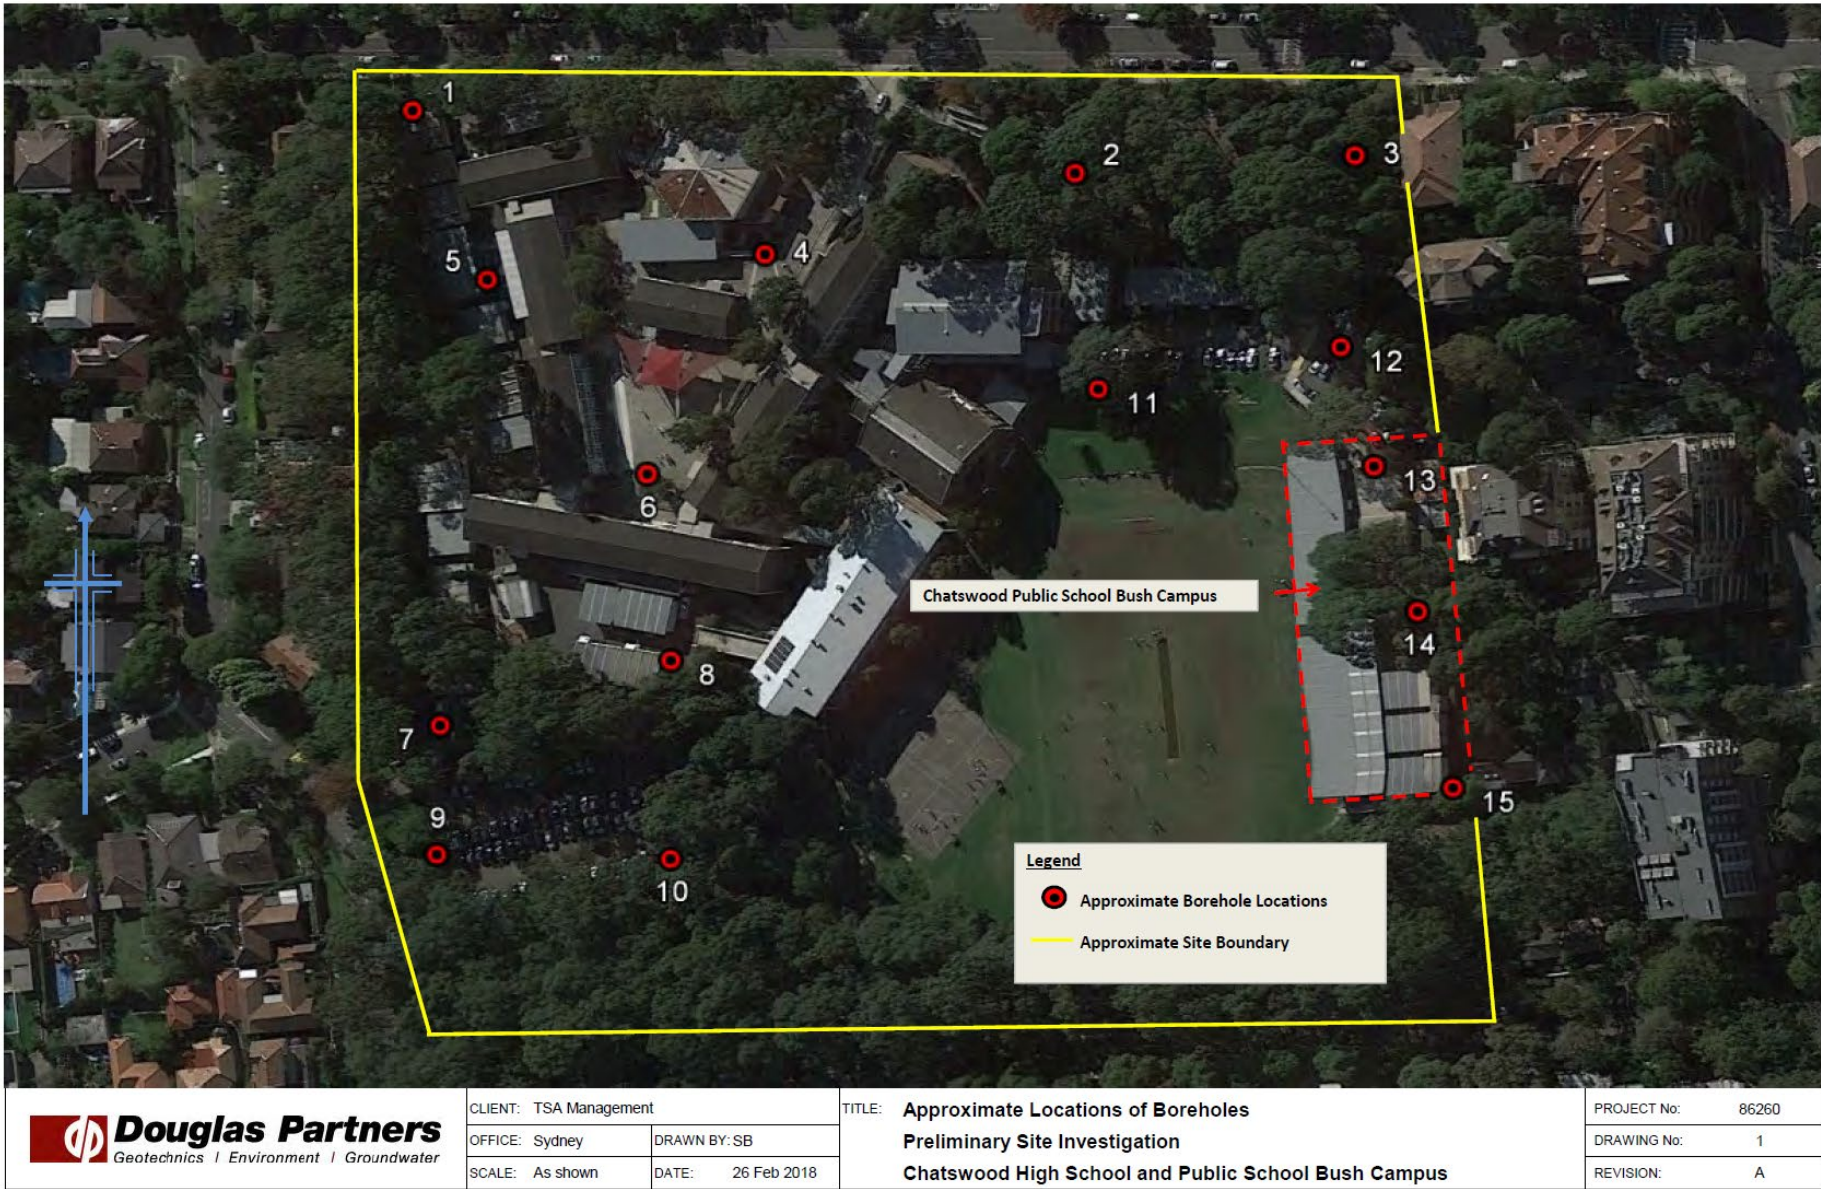
The site is currently an operational high school campus, incorporating a small primary school campus known as the 'Bush Campus' which is utilised by years 3-4 from Chatswood Public School in the eastern portion of the site. The main campus buildings are in the north-western portion of the site with a series of demountable classrooms in the south and east (including the Bush Campus) and a playing field, basketball courts, car park and vegetated land in the south. The playing field and car park are used by the public for recreational purposes. The site layout at the time of the DSI is shown in Attachment 2.

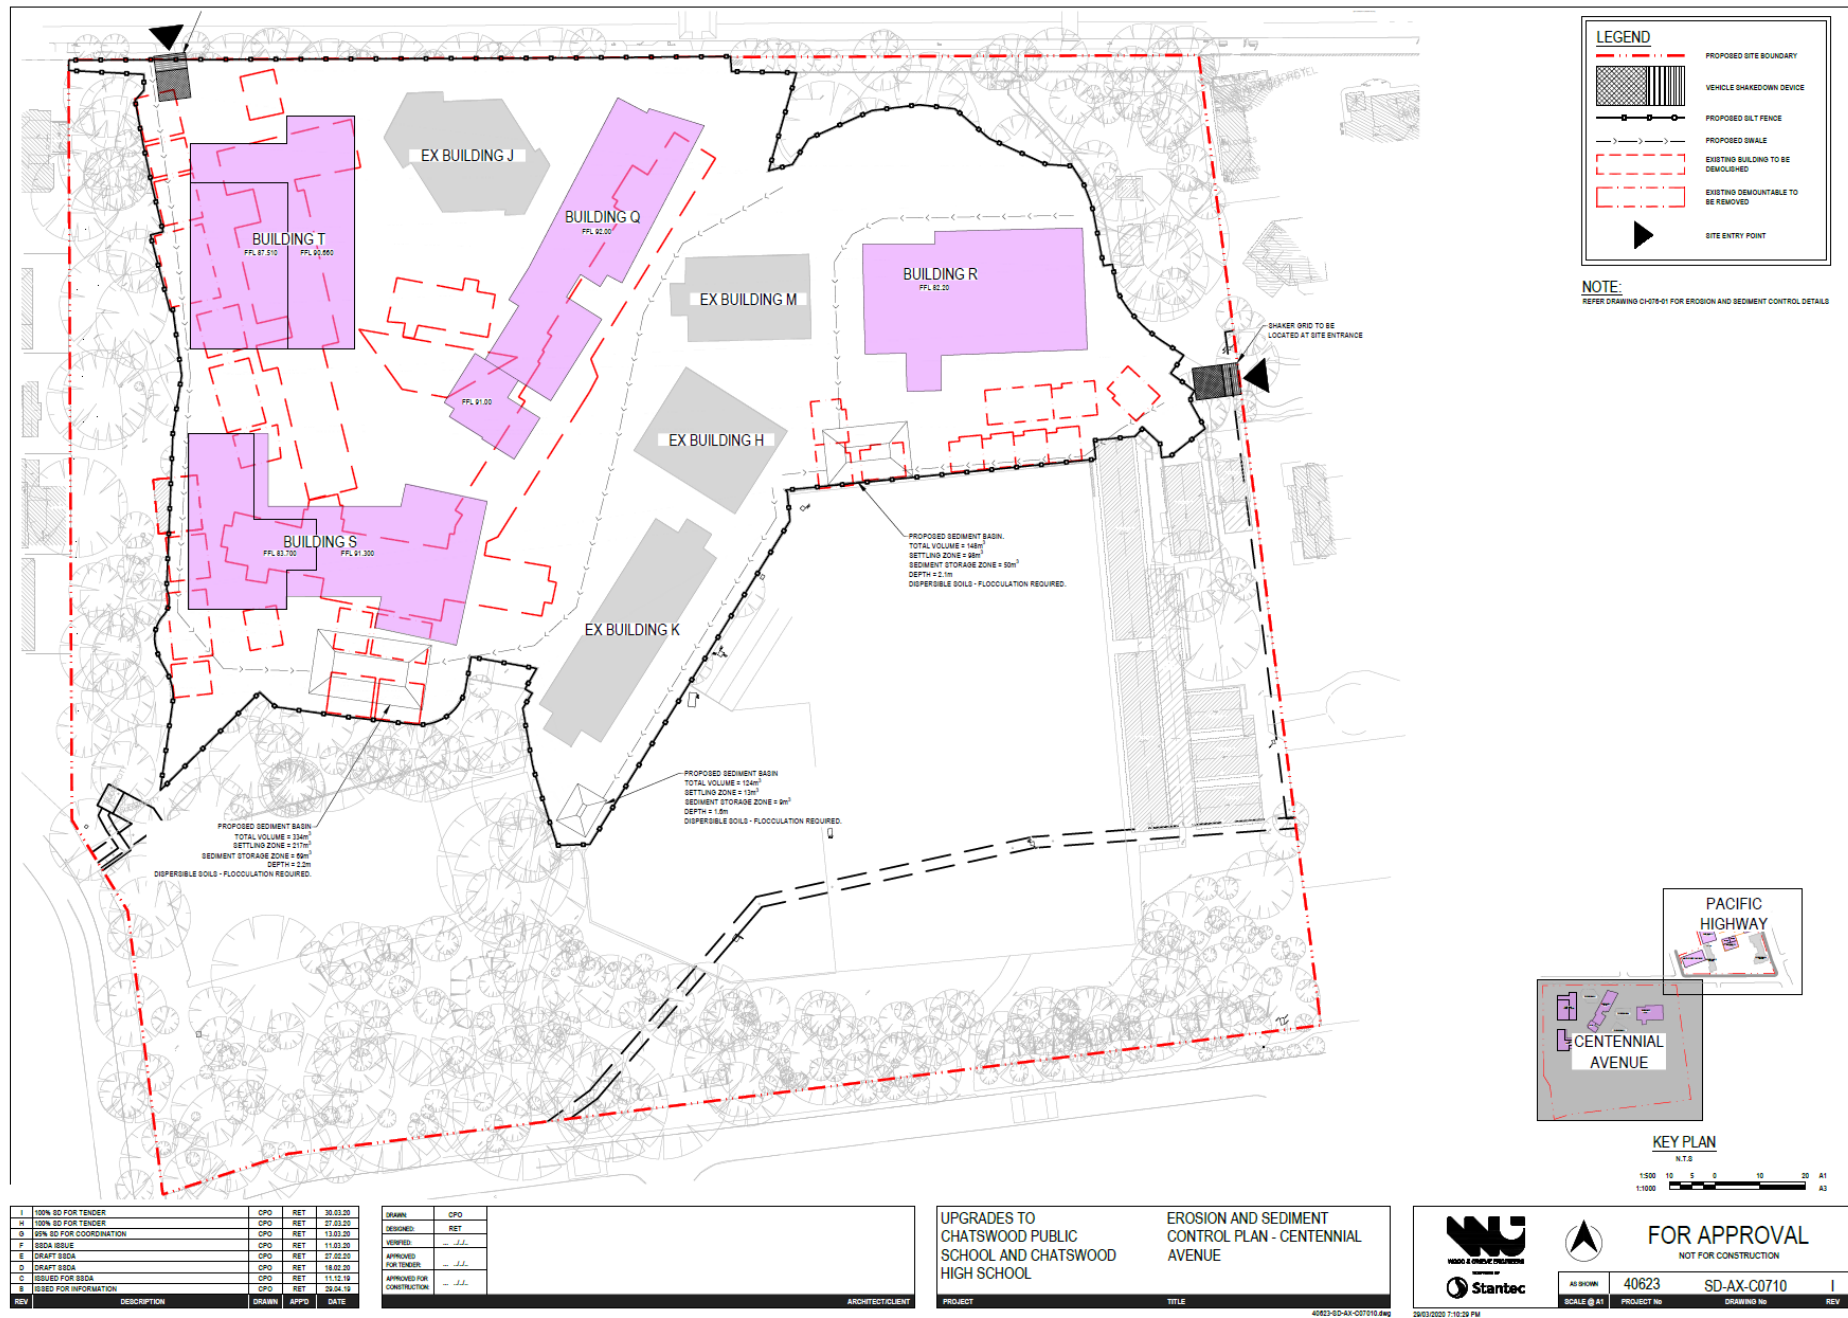
The site is to be redeveloped by SINSW for ongoing use as a high school, incorporating the Bush Campus for primary school children. As shown on Attachment 3, this will involve retention of four buildings to the northwest of the playing field (buildings K, H and M) and one on the northern site boundary (building J), demolition of buildings in the northwest of the site and construction of new buildings in this area and to the north of the playing field. The Bush Campus, playing field, basketball courts and car park are to remain unchanged, as will the vegetated area along the southern site boundary.

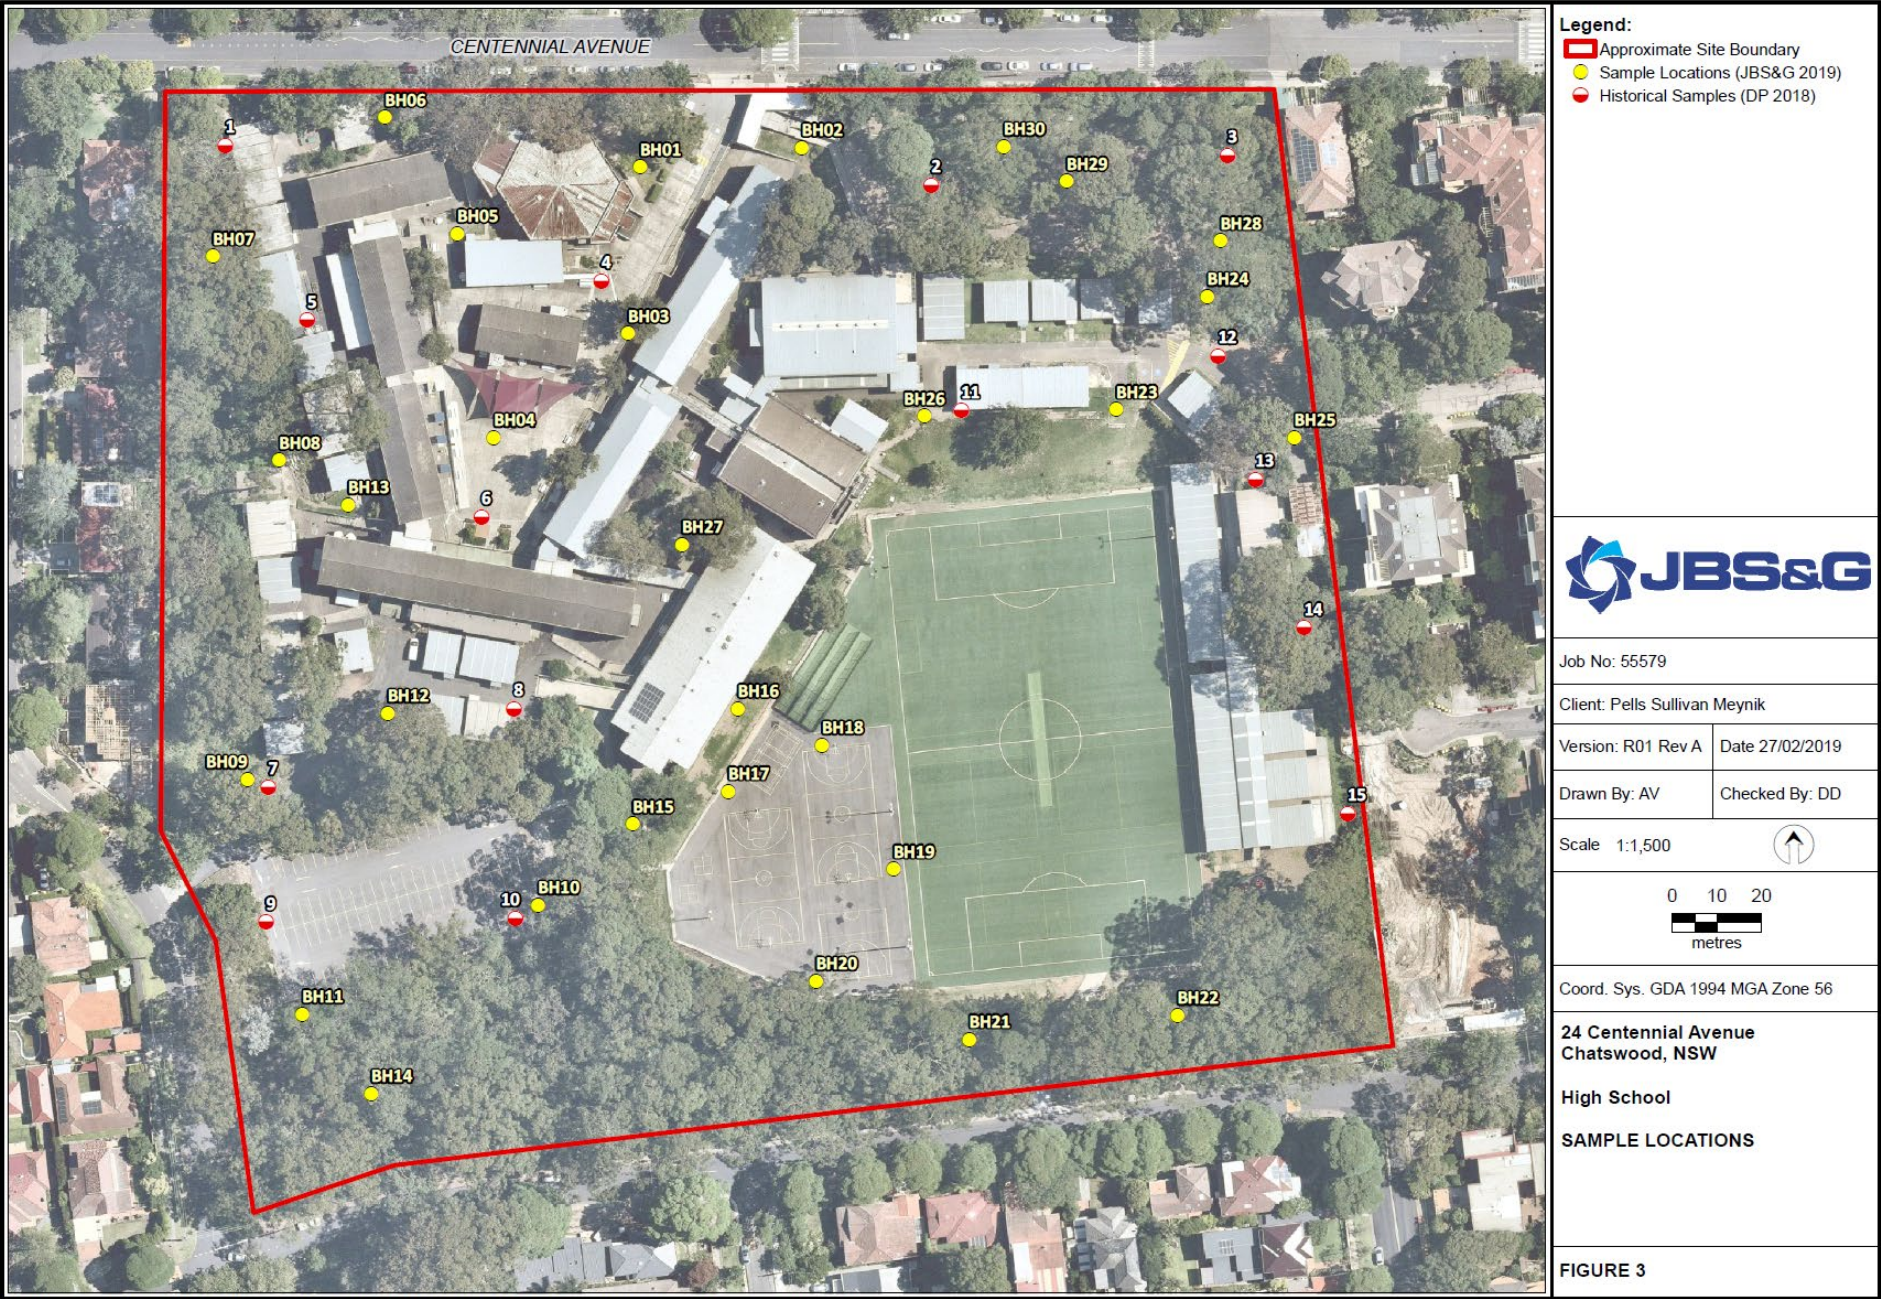
- A fragment of bonded asbestos containing material (ACM) was noted on the ground surface during the DSI near the locations of BH13 (Attachment 4). No other ACM fragments were detected.

One fragment of bonded ACM was identified on the ground surface during the DSI near JBS&G bore location BH13 in the north-western portion of the site, in the location of the demountables. The sample was removed from the site and confirmed by the laboratory to contain chrysotile and amosite asbestos. No other ACM was reported to have been observed on the site surface during the PSI or DSI.

2. It is recommended that an unexpected finds protocol be implemented during the redevelopment to manage any risks associated with potential ACM in fill material and the unknown soil conditions beneath buildings to be demolished during the redevelopment.
