**RE: INTERIM AUDIT ADVICE LETTER NO. 1 - REVIEW OF REMEDIAL ACTION PLAN, CHATSWOOD PUBLIC SCHOOL, 5 CENTENNIAL AVENUE, CHATSWOOD NSW**

## 1. INTRODUCTION

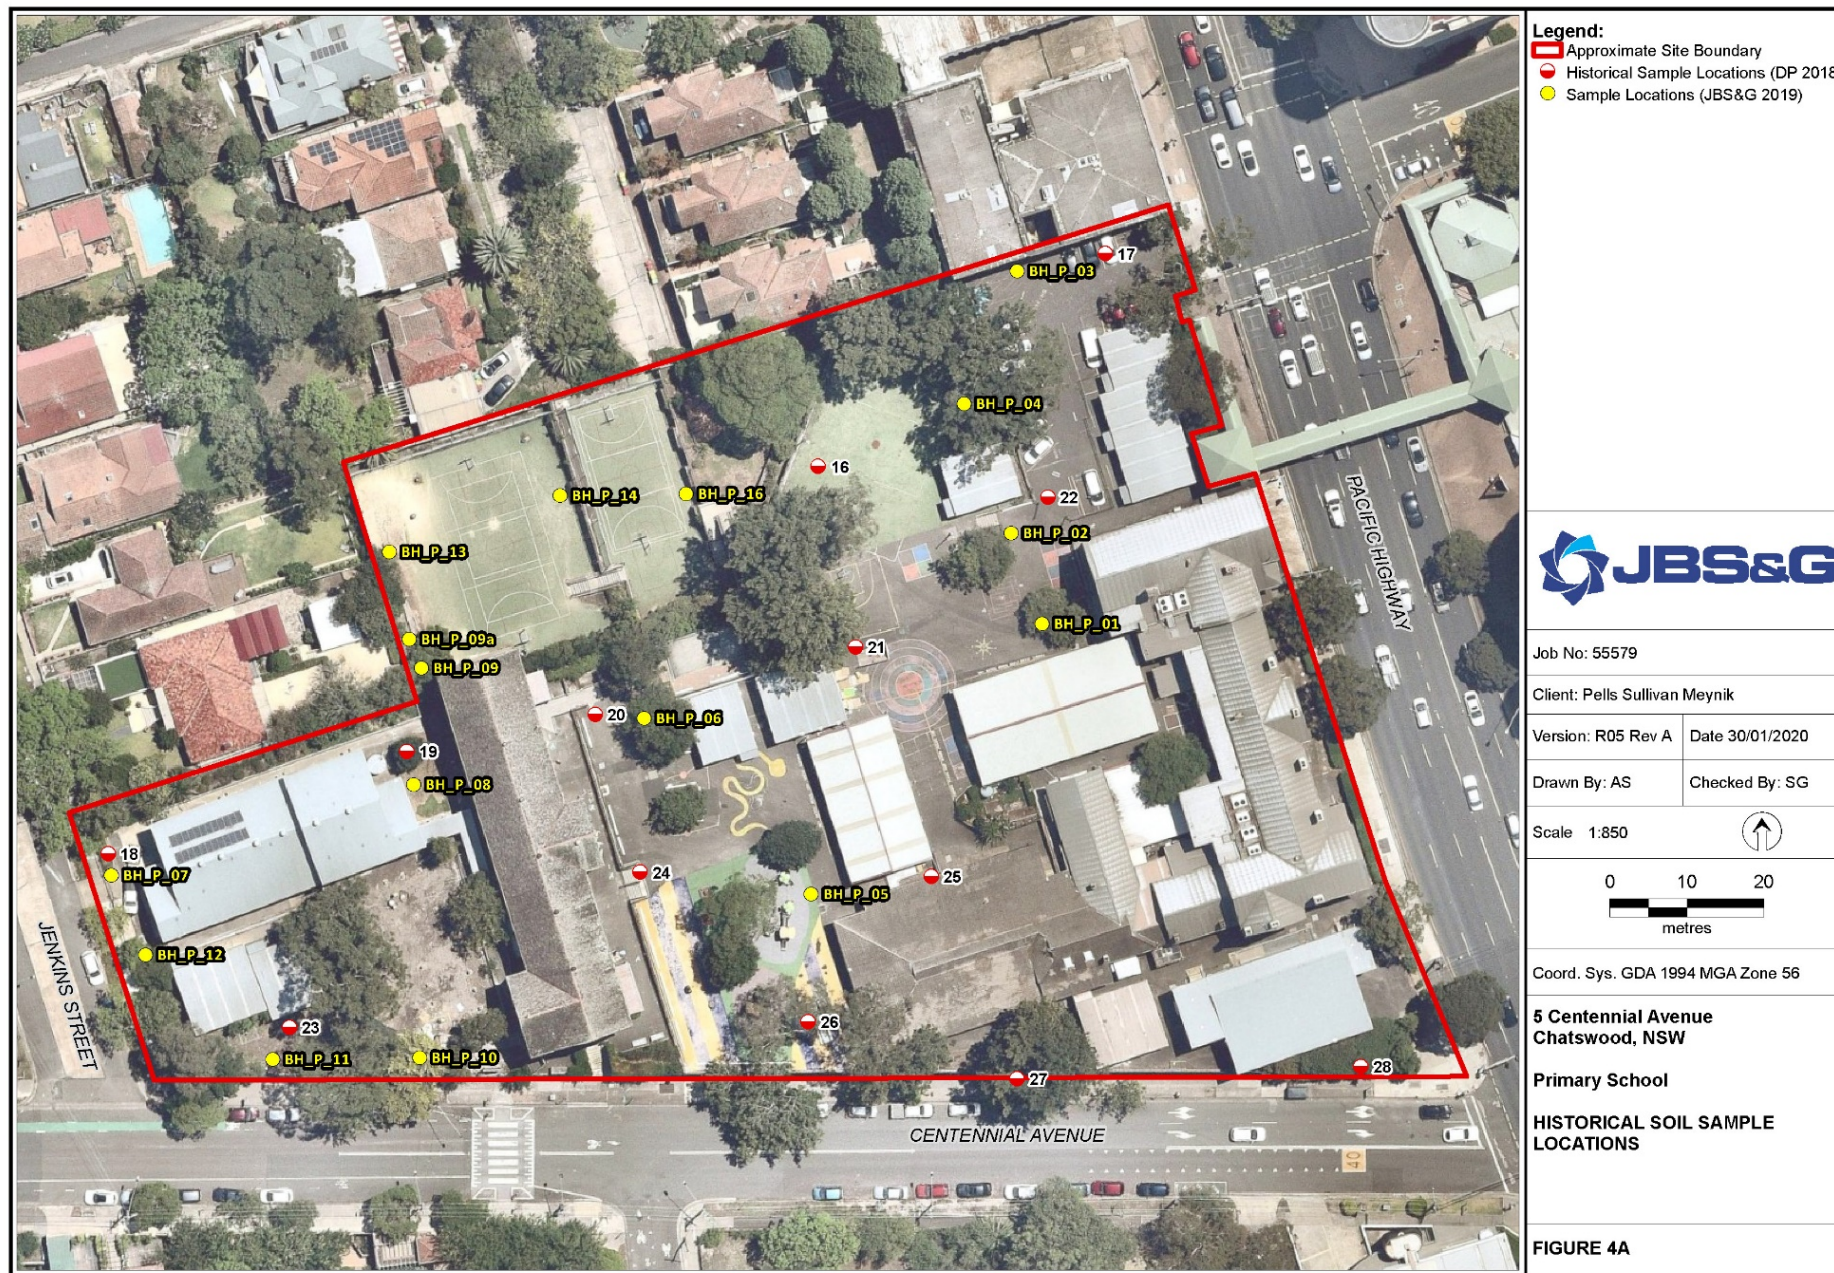
Douglas undertook 13 boreholes and JBS&G undertook 16 boreholes at the site as shown in Attachment 2. The sub-surface profile encountered is summarised by the Auditor in Table 5.1.

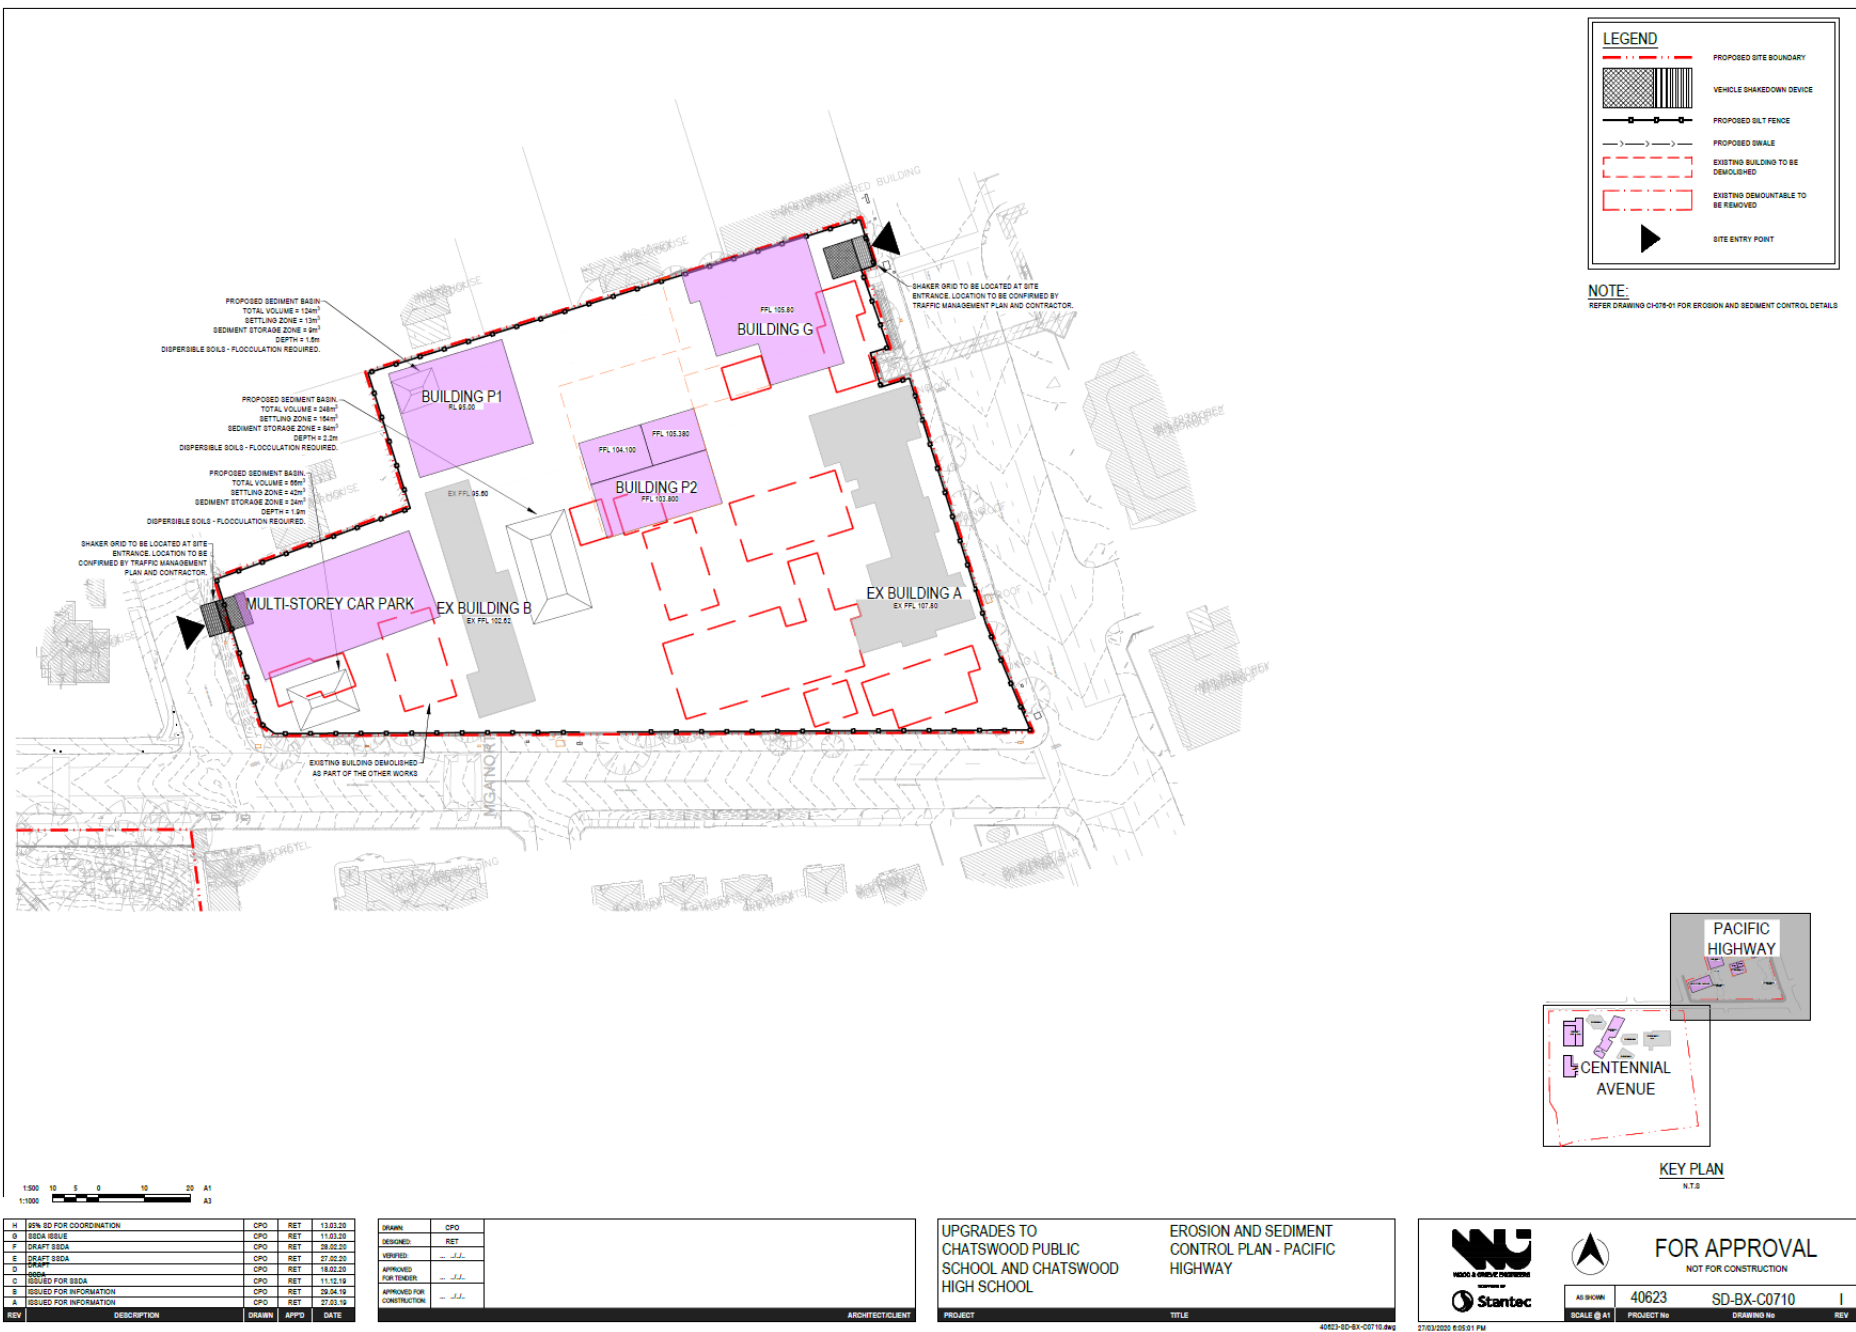
The site is to be redeveloped by SINSW for ongoing use as a primary school. As shown on Attachment 3, this will involve retention of the historical school buildings to the east and the west of the site and historical brick retaining walls, demolition of several buildings including the hall in the northeast, the building in the south and the building in the western-most portion of the site with construction of three new multi-level buildings in the north and new carpark and play area in the west. Most of the remaining hardstand and play areas will be resurfaced. The majority of trees will be removed, and new landscaped areas will be installed.
