**APPENDIX H  
ADDENDUM HISTORICAL  
ARCHAEOLOGICAL IMPACT  
ASSESSMENT REPORT**

# **Addendum Historical Archaeology Impact Assessment Report**

Powerhouse Parramatta  
Client: Infrastructure NSW  
Final Report, 15 September 2020

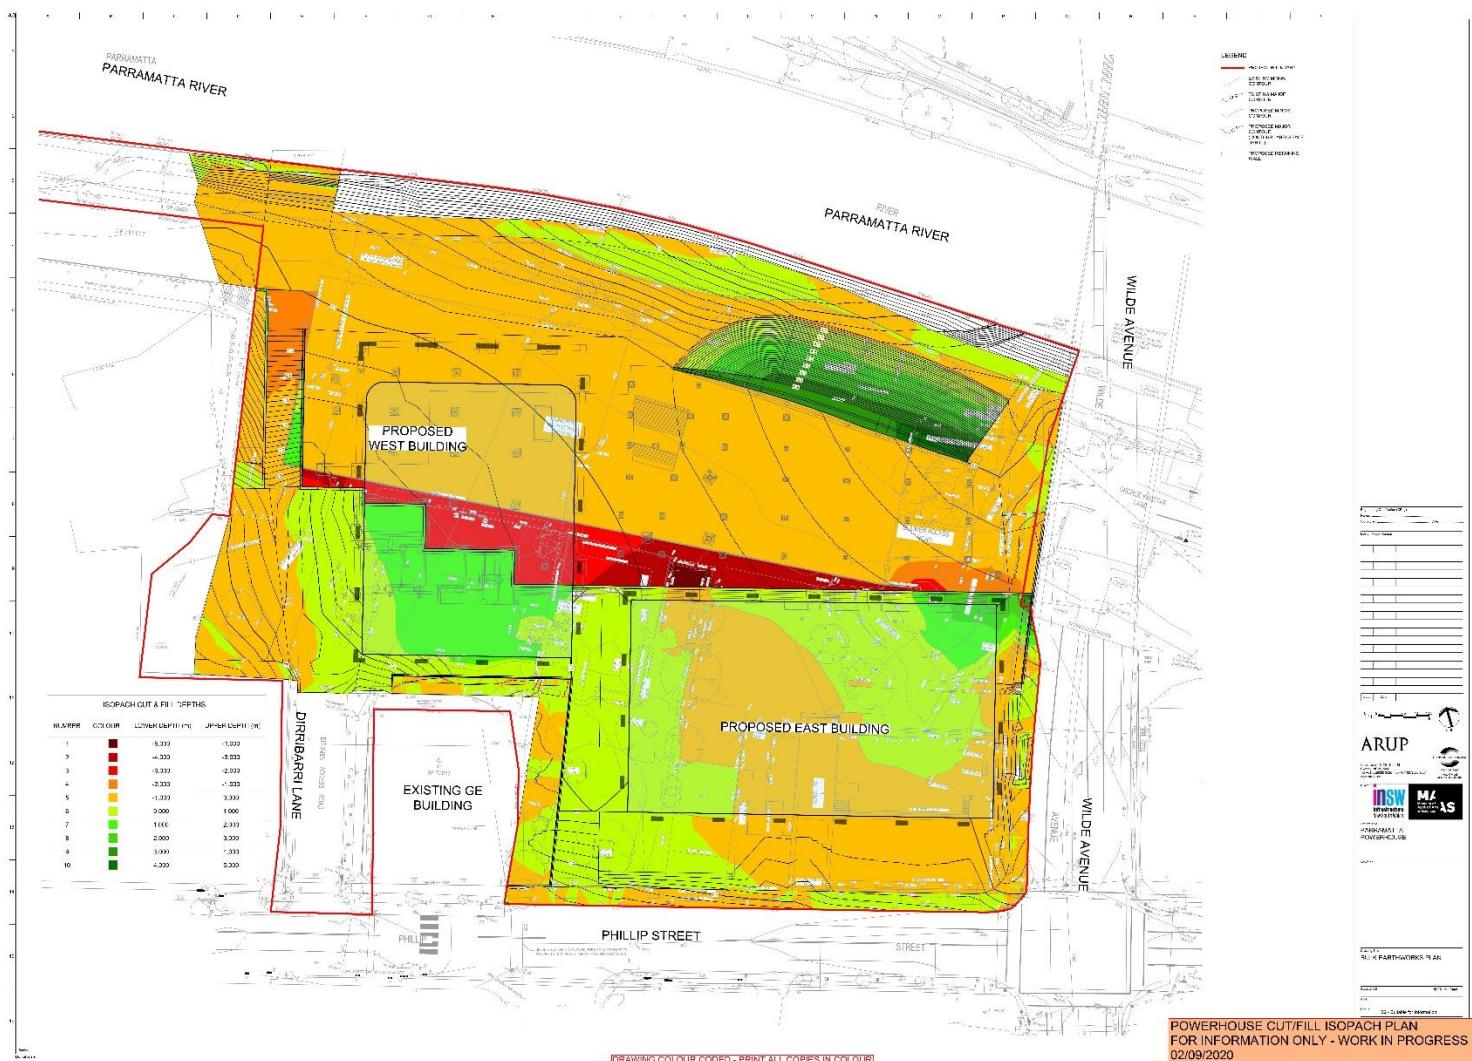
Figure 2-1 Plan of proposed cut and fill across the study area. Note the dark red excavation for the undercroft. (Source: ARUP)

Bulk excavation will be undertaken beneath the new western and eastern buildings to accommodate required services including grease arrestor, sewer and stormwater pumps, lift pits, plant, foundation piles and rainwater/waste tank. ARUP has advised that the majority of the site is "on grade" with some minor adjustments required according to computer modelling of the study area topography shown as dark yellow in Figure 2-1. More substantial excavations are shown as orange and red in the same figure. The red area reflecting the proposed undercroft to the Powerhouse.

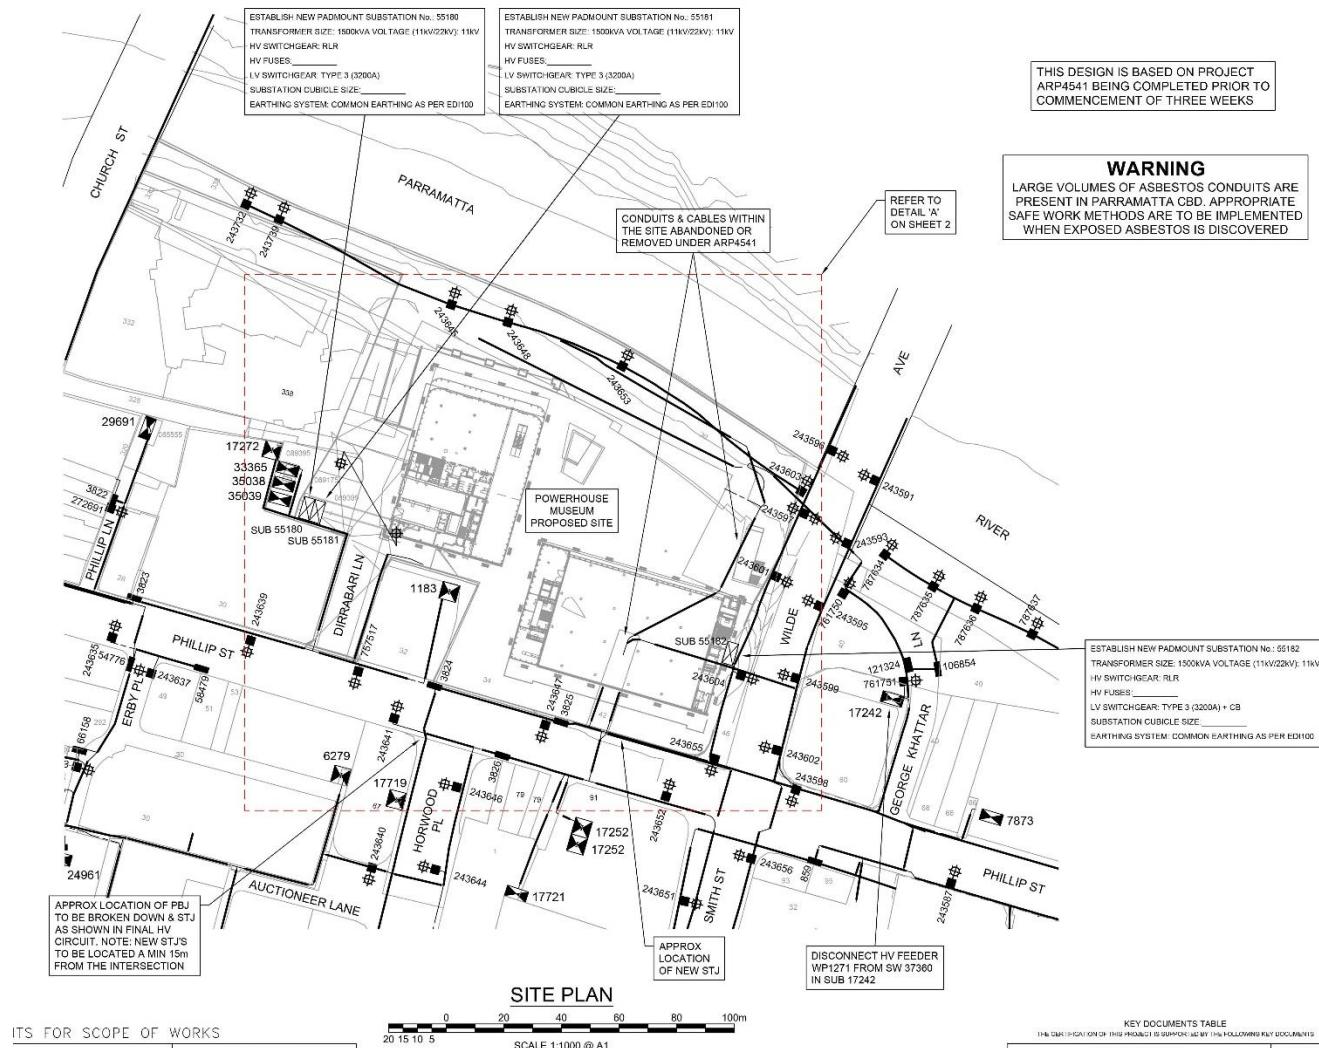
Figure 2-2 Plan of existing electrical services on the study area. (Source: ARUP)

Existing services lines have been identified and located. The larger service lines are shown in Figure 2-2.

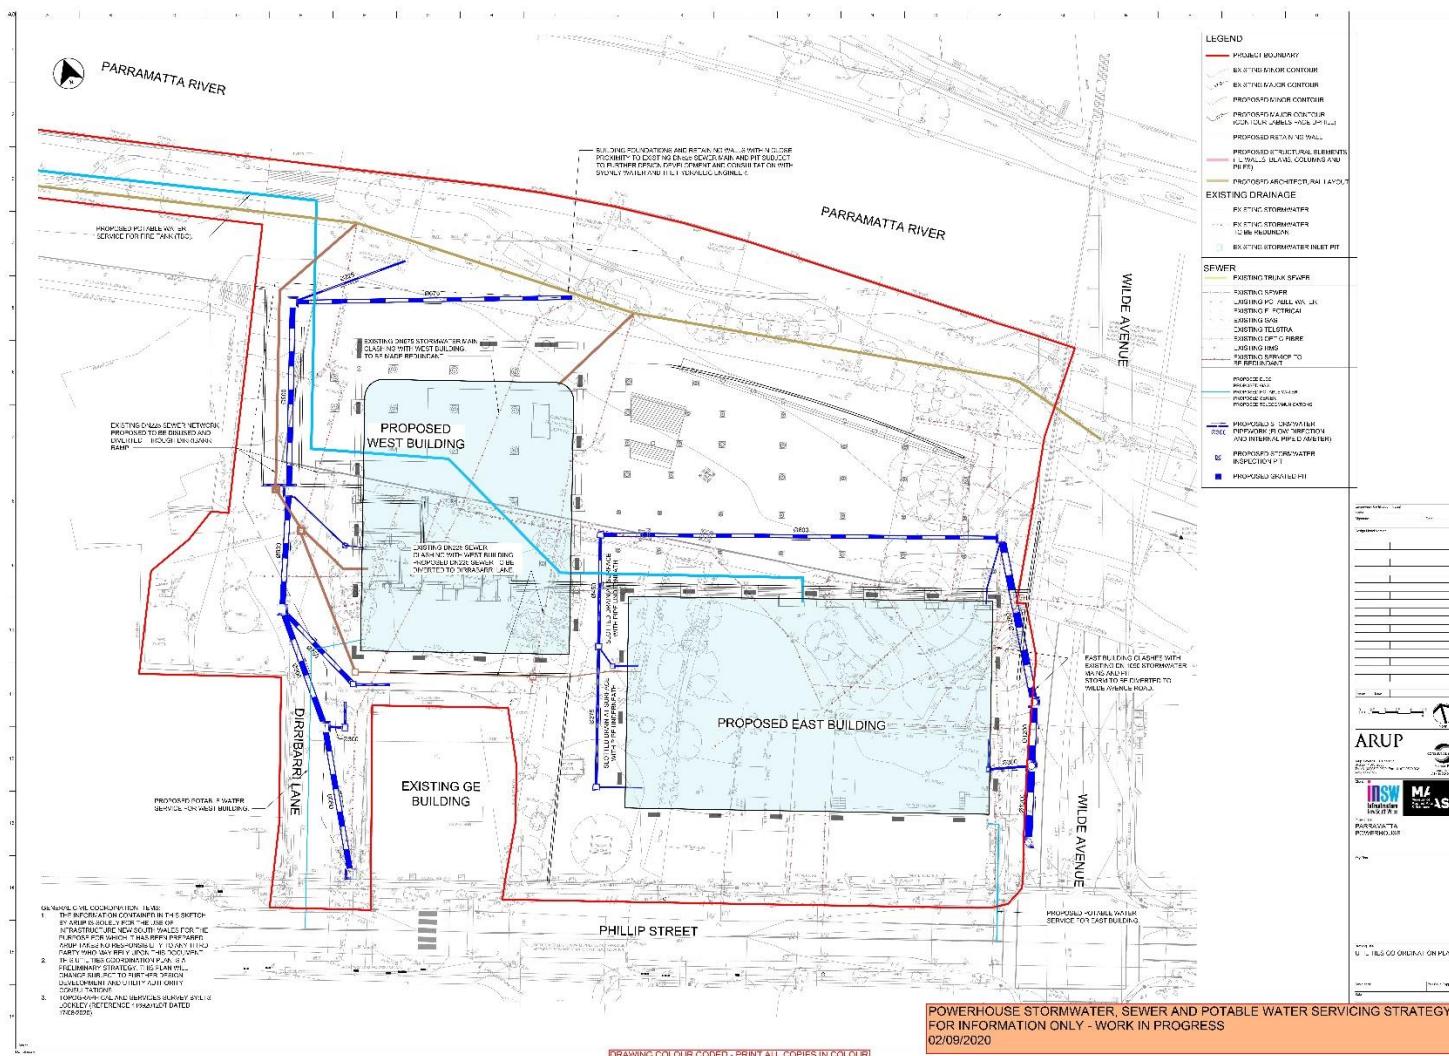
Figure 2-3 Plan of stormwater, sewer and potable water supply at the study area. (Source: ARUP)

The locations and dimensions of proposed service and utility trenching on the study area are shown in, Figure 2-3 and Figure 2-4 (in green). These trenches are likely to require excavation in the range of 1-7m depth and 600mm-3000mm (for each service) in width.

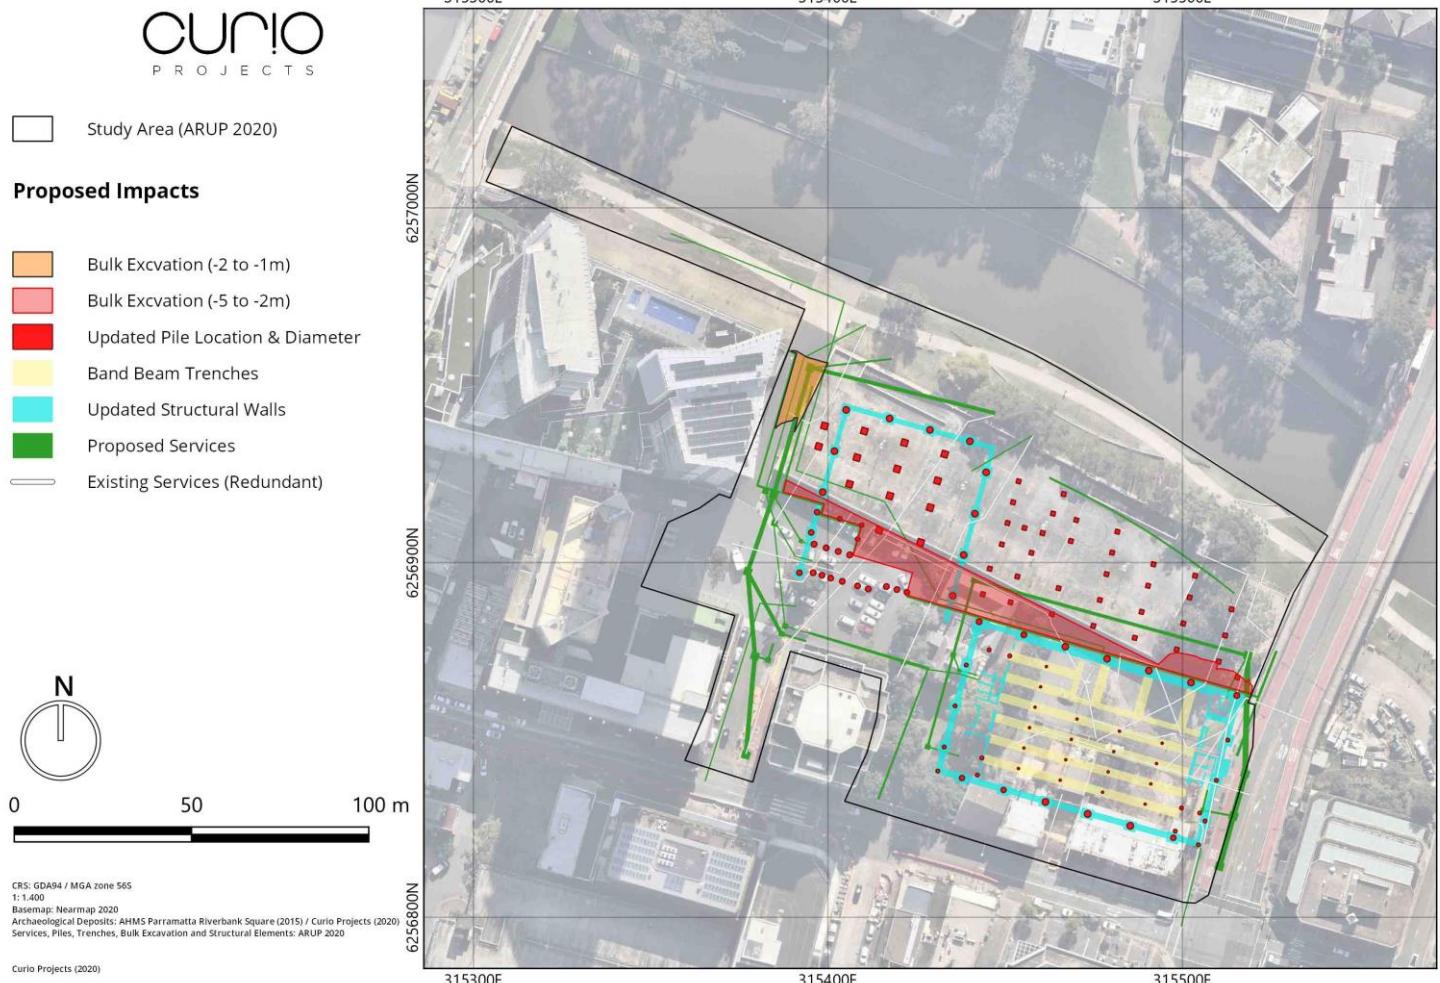
Figure 2-4 Plan of identified construction impacts. (Source: Curio projects).

Figure 2-4 presents the plan of proposed piling and support beams on the study area.

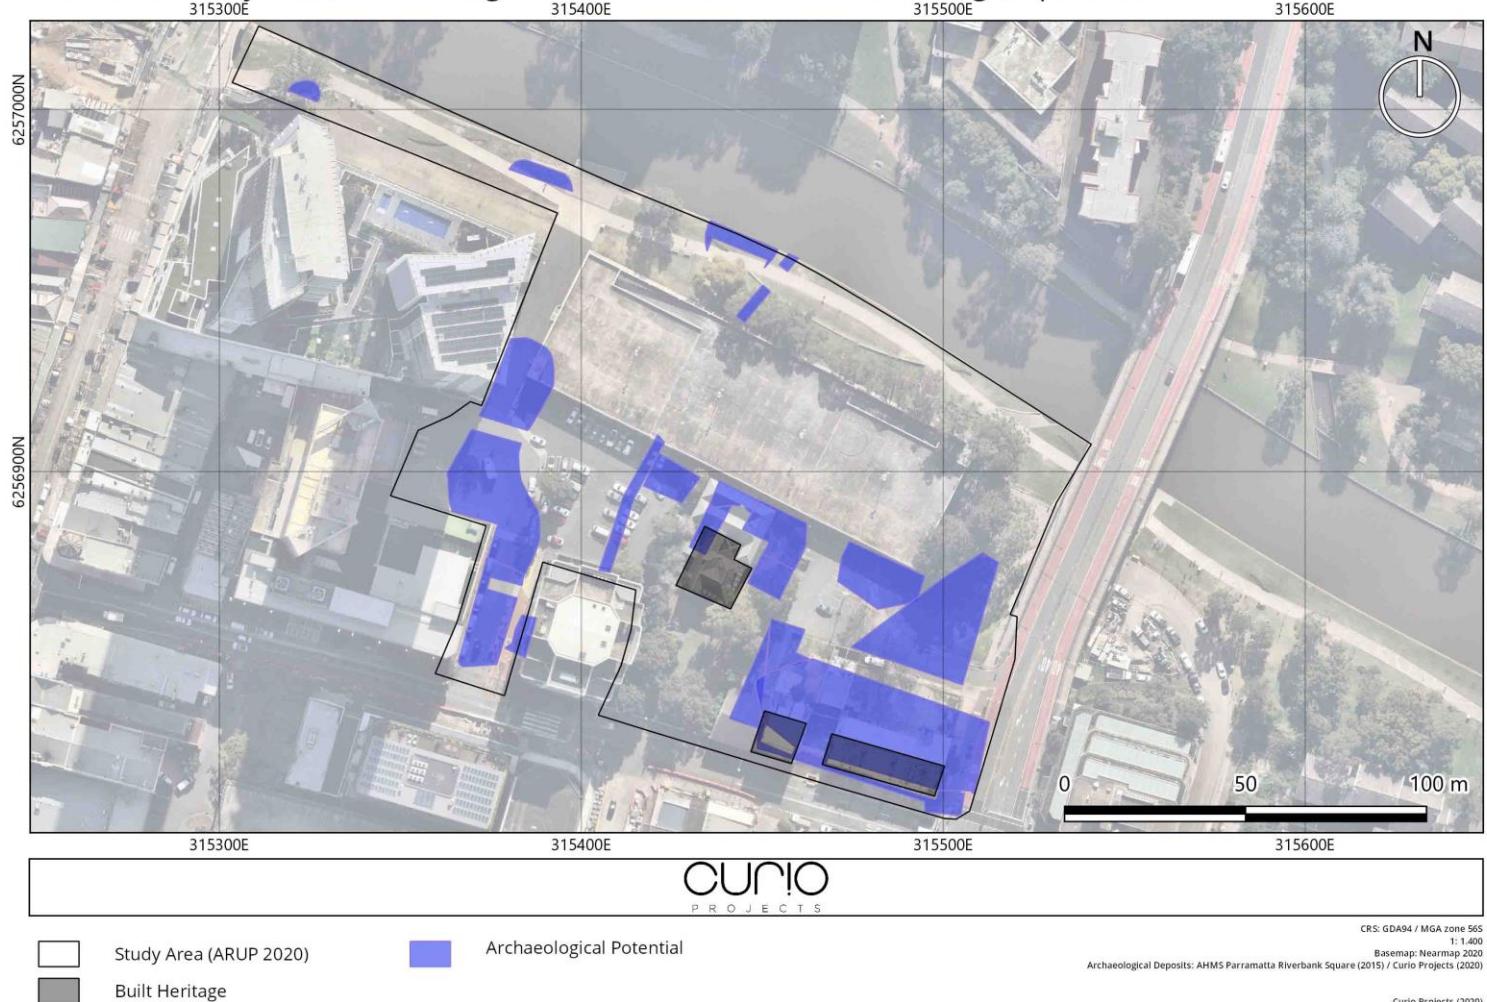
Figure 3-1 Areas of archaeological potential on the study area. (Source: Curio 2020 based on AHMS 2015)

The archaeological potential of the study area was established and mapped by AHMS and this was set out in their 2015 report (shown as Figure 3-1). This plan has been used as the basis for the following assessment of the physical impacts of the proposed works. The impacts set out in Section 2 show some potential to have physical impacts on the potential archaeological resource (Figure 3-2).

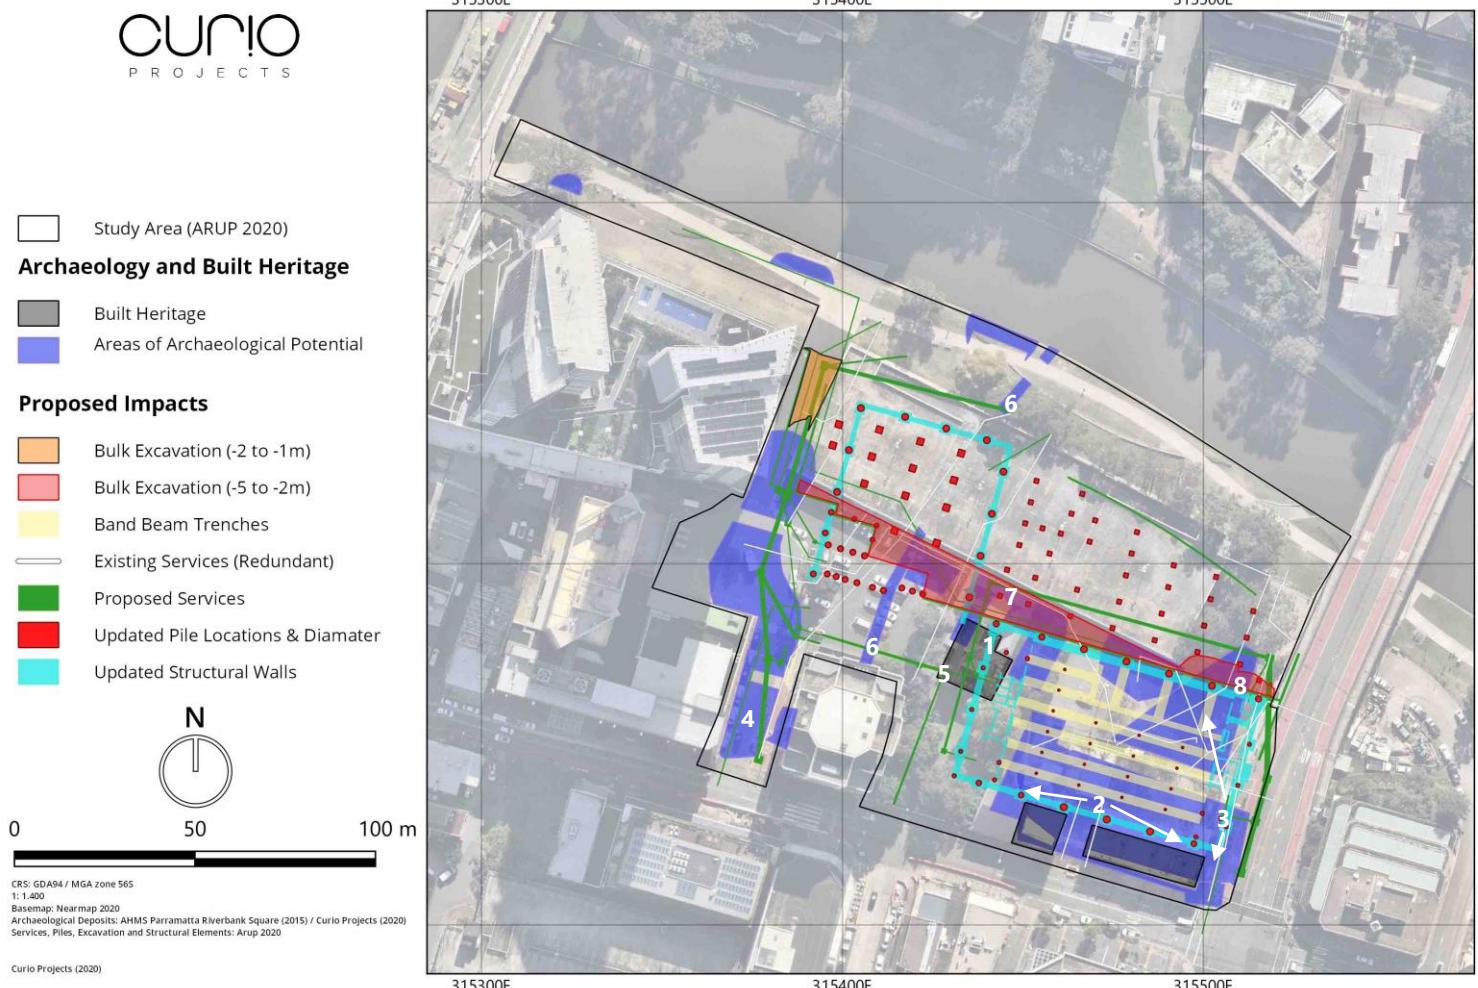
Figure 3-2 Plan of mapped impacts on archaeological potential. (Source: Curio 2020).

These include (refer to Figure 3-2 and Figure 6.14 in the 2020 ARD)

- Pile and band beam footprints,
  1. on the area now occupied by 'Willow Grove';
  2. through the area at the rear of St George's terraces;
  3. through areas at the south-eastern and eastern portions of the study area containing State significant archaeology, and

- Service Corridors,
  4. across an area on the south-western portion of the study area containing locally significant archaeology;
  5. through areas adjacent to 'Willow Grove' containing State significant archaeology;

6. through an identified brick barrel drain running north-south across the study area;
- Bulk Excavation,
  7. through areas containing potentially State significant archaeology in the centre of the study area;

8. through areas containing potentially State significant archaeology in the east of the study area;
- Tree plantings (not shown in Figure 3-2),
  9. through areas adjacent to 'Willowgrove' containing State significant archaeology;

10. through areas at the south and eastern portion of the study area containing State significant archaeology.

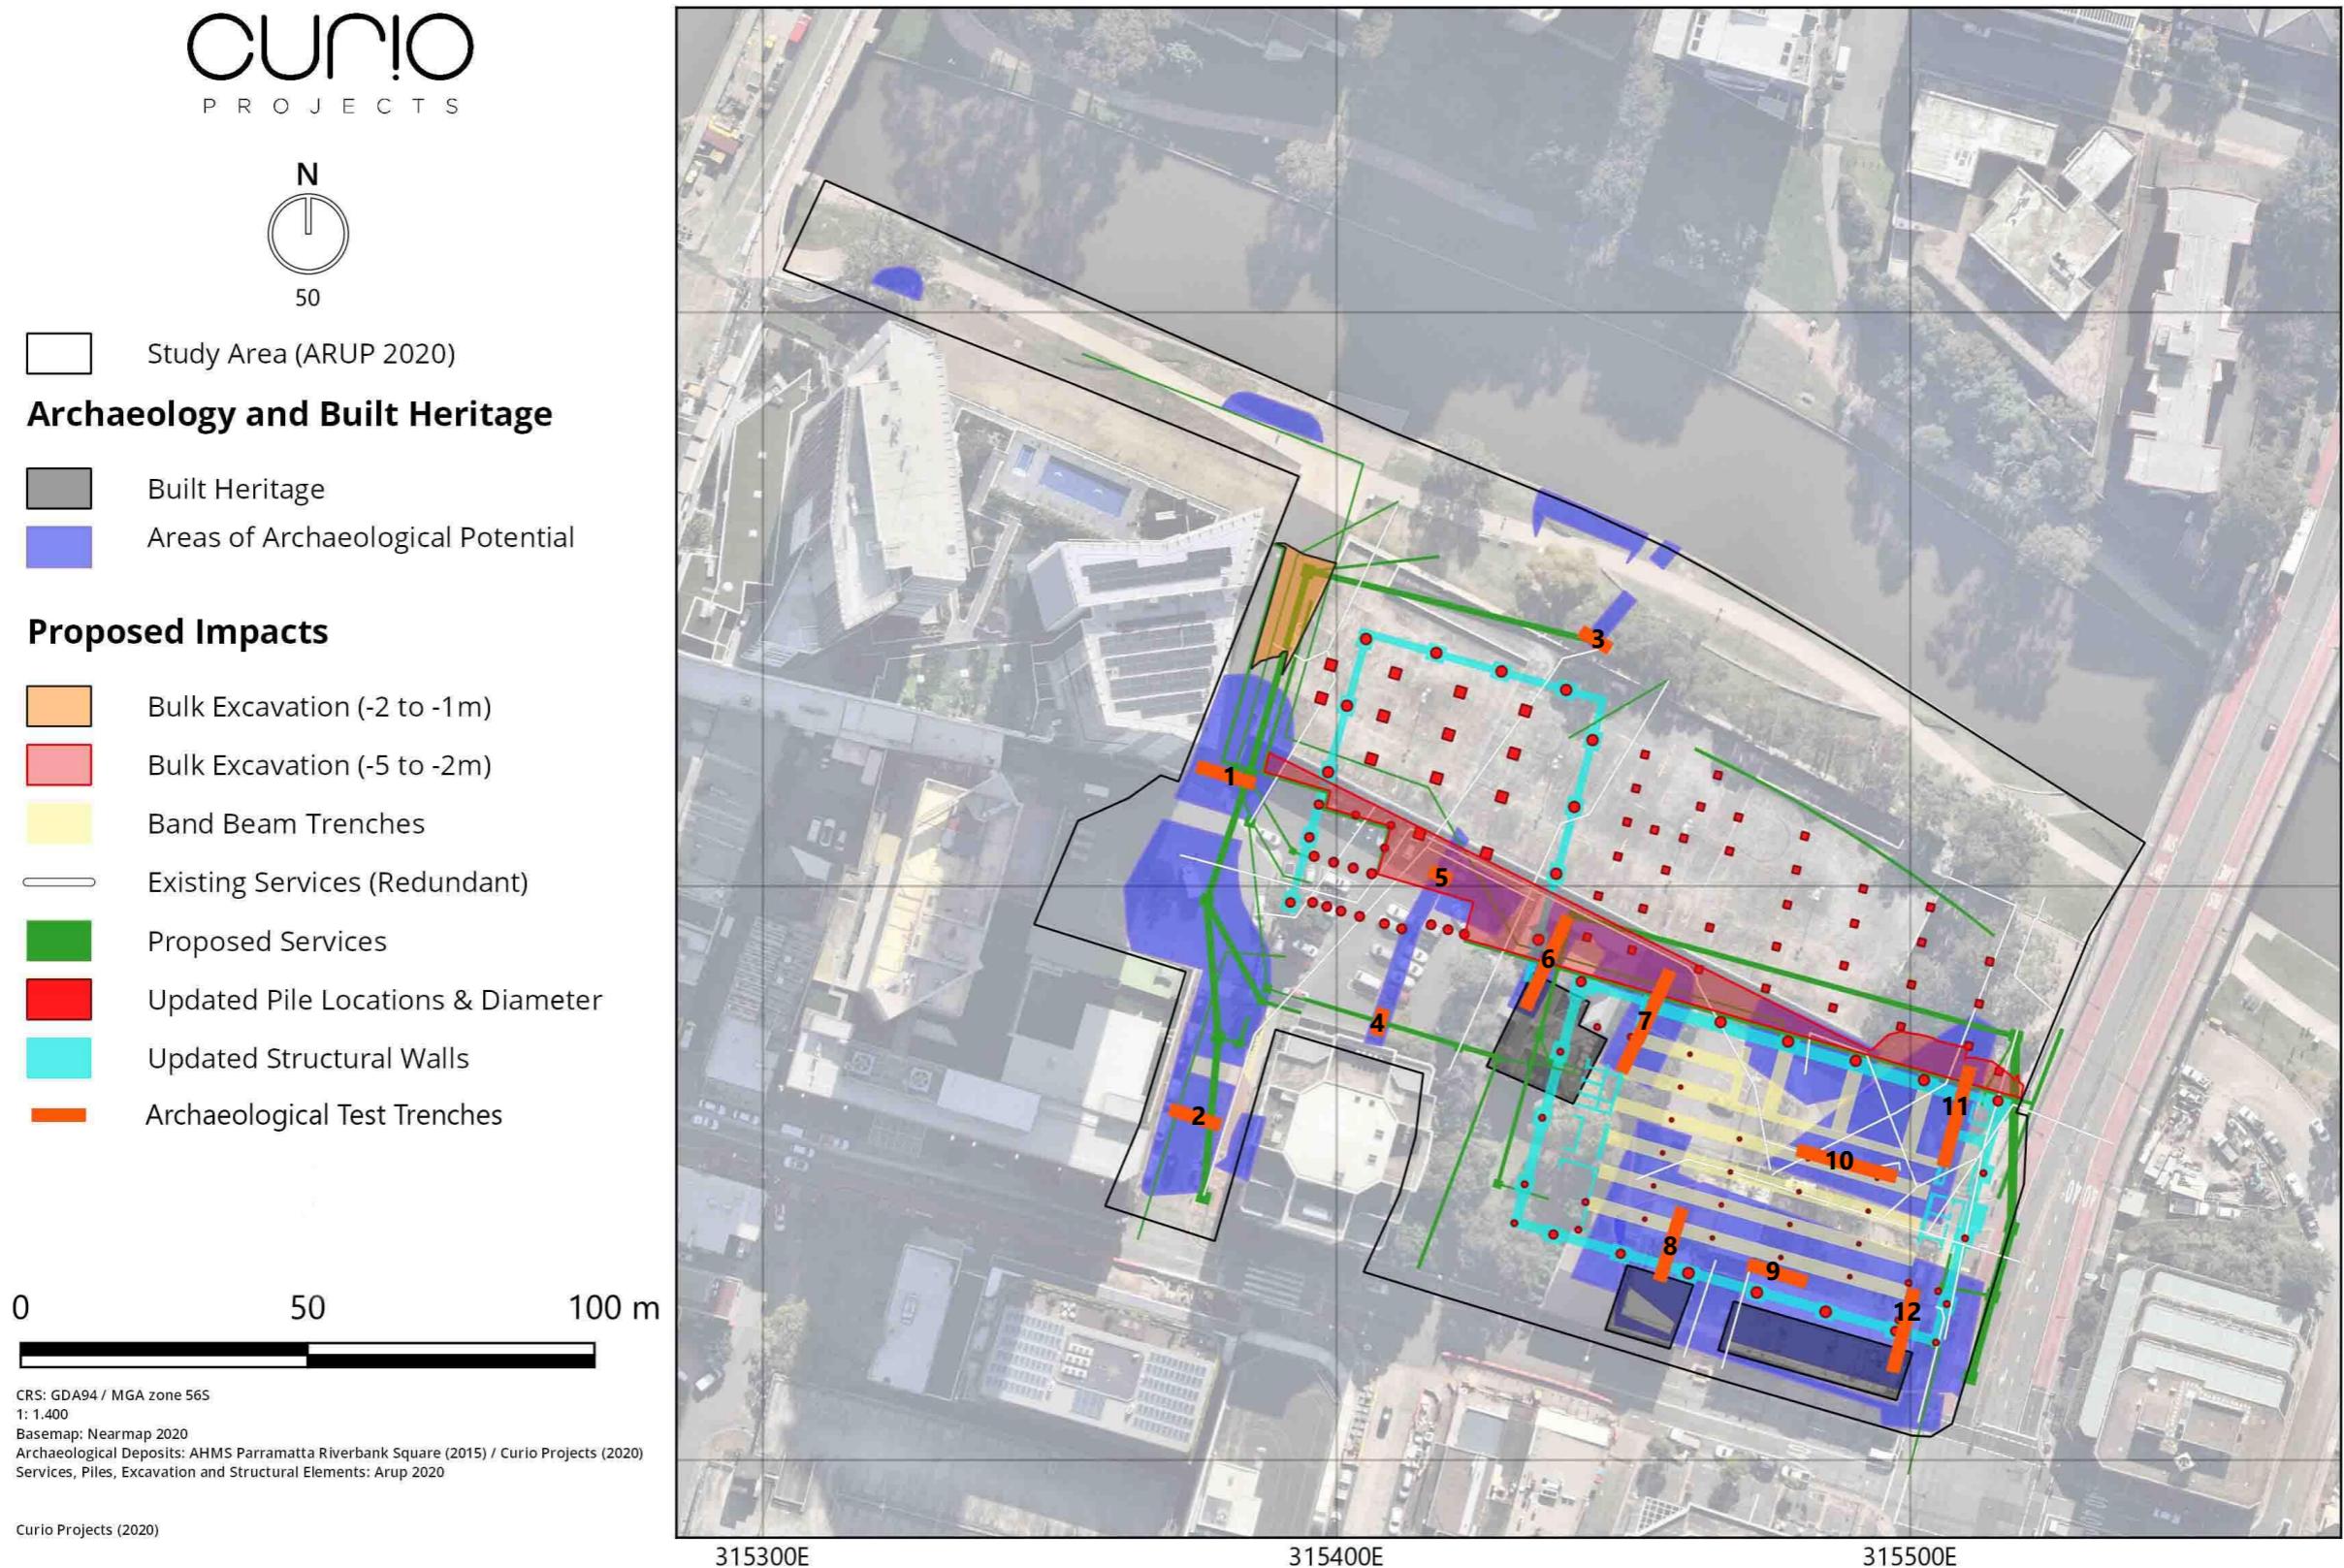
Figure 4-1 Proposed Historical Archaeological Test Trenches. Test trenches not to scale. (Source: Curio ARD 2020)

It is proposed that an initial program of the excavation of test trenches across the study area of be undertaken to investigate the potential for archaeological remains of features and deposits of the occupation of the study area (see Figure 4-1). Should the test trenches indicate that no significant archaeological deposits or features remain on study area then the archaeologist will record the exposed deposits to indicate the nature of the remains beneath the existing floor and complete a short report to meet the relevant condition(s) of the Excavation Permit. No further archaeological involvement is proposed based on the conclusion of this short report that no 'relics' are present.

The 12 test trenches set out below have been sited to investigate the presence of specific built elements and interior spaces that may contain significant deposits. They will also provide a snapshot of the general level of survival of archaeological relics across the entire study area.

- Trench 1 (dimensions 10 metre x 2 metre) has been sited to investigate the potential for potential archaeological remains along the course of the major service lines in the north-west of the impact zone;

- Trench 2 (dimensions 10 metre x 2 metre) has been sited to investigate the potential for potential archaeological remains associated with late 19<sup>th</sup> century occupation on the Phillip Street frontage;

- Trench 3 (dimensions 5 metre x 2 metre) has been sited to investigate the location of a brick barrel drain running to the river on the northern side of the study area;

- Trench 4 (dimensions 5 metre x 2 metre) has been sited to investigate the location of a brick barrel drain running to the river on the southern side of the study area;

- Trench 5 (dimensions 5 metre x 2 metre) has been sited to investigate the location of a brick barrel drain running to the river in the centre of the study area;

- Trench 6 (dimensions 15 metre x 2 metre) has been sited to investigate the potential for State Significant archaeological remains through the site of 'Willowgrove';

- Trench 7 (dimensions 15 metre x 2 metre) has been sited to investigate the potential for State Significant archaeological remains through the site of 'Willowgrove';

- Trench 8 (dimensions 10 metre x 2 metre) has been sited to investigate the potential for State Significant archaeological remains north of Phillip Street;

- Trench 9 (dimensions 10metre x 2 metre) has been sited to investigate the potential for State Significant archaeological remains to the rear of St George's terrace;

- Trench 10 (dimensions 15 metre x 2 metre) has been sited to investigate the potential for State Significant archaeological remains to the north of St George's terrace;

- Trench 11 (dimensions 15 metre x 2 metre) has been sited to investigate the potential for State Significant archaeological remains to the west of Wilde Avenue;

- Trench 12 (dimensions 15 metre x 2 metre) has been sited to investigate the potential for State Significant archaeological remains on the south eastern corner of the study area.
