## Remedial Action Plan

21 Muir Road, Chullora

Project No.: 0574561

# Stage 2 Contamination Assessment

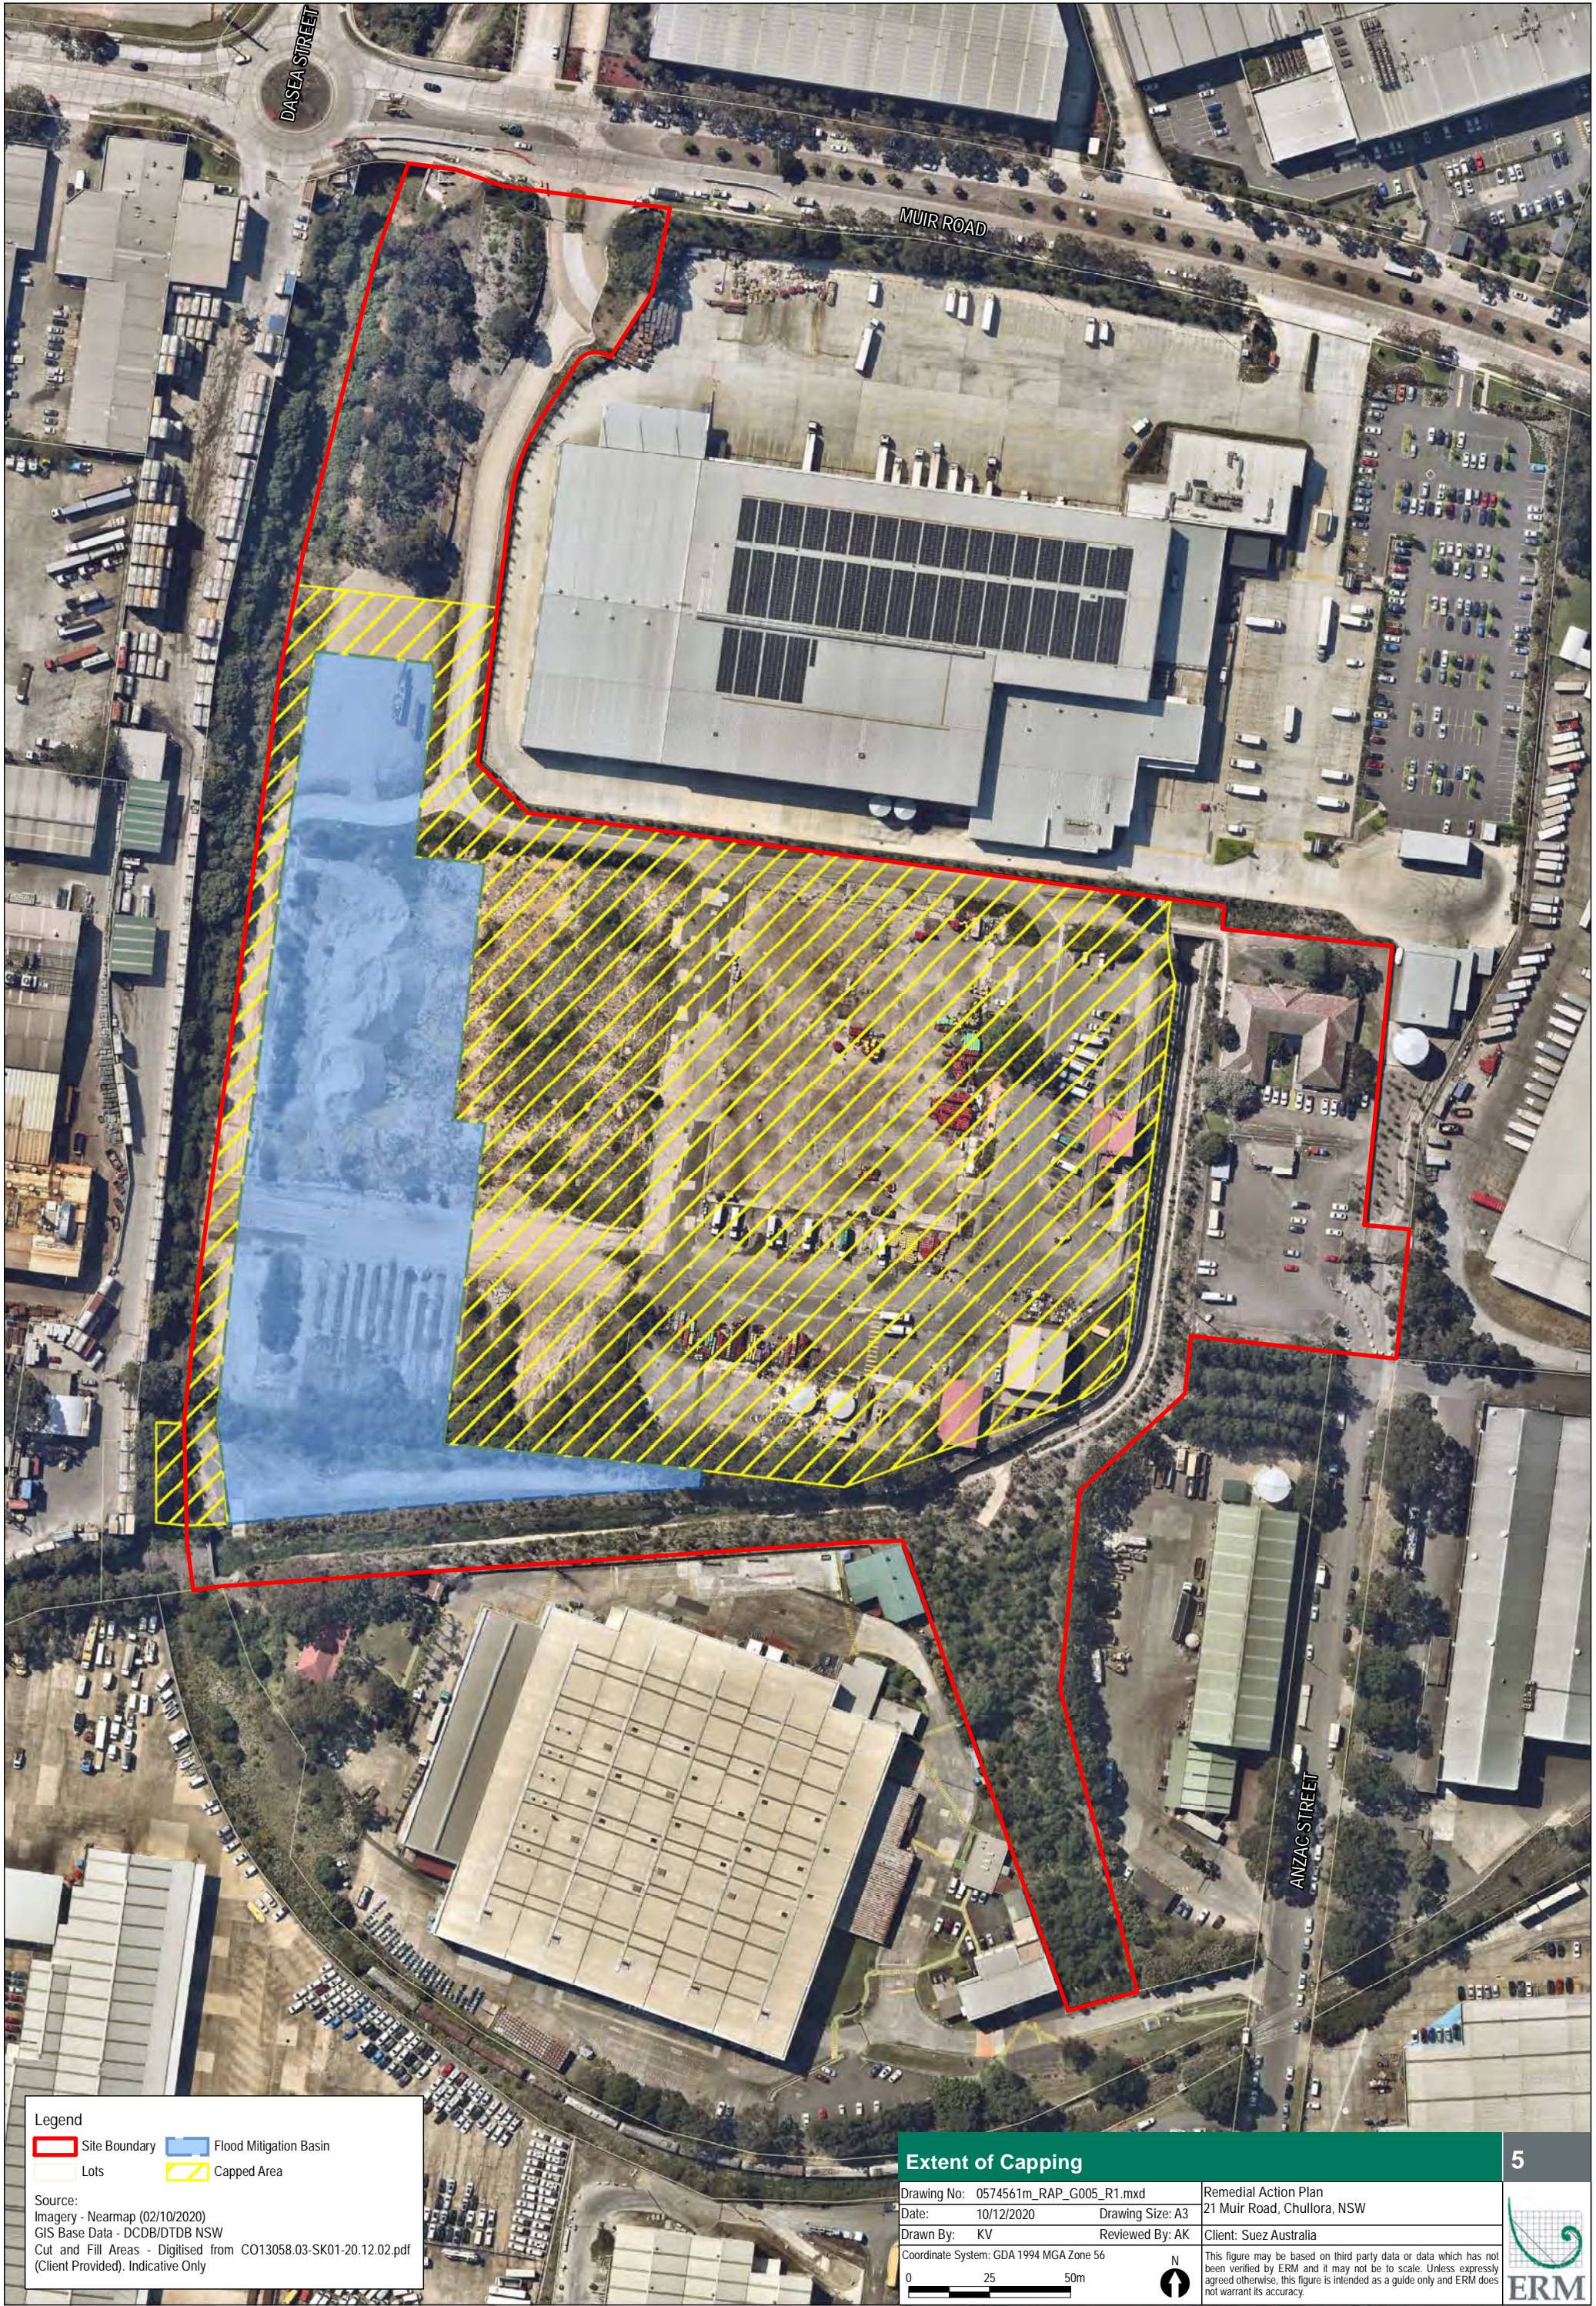
- Legend
- Site Boundary
  - Flood Mitigation Basin
  - Lots
  - Capped Area

Source:  
Imagery - Nearmap (02/10/2020)  
GIS Base Data - DCDB/DTDB NSW  
Cut and Fill Areas - Digitised from CO13058.03-SK01-20.12.02.pdf  
(Client Provided). Indicative Only
