Preliminary Remedial Action Plan

Harbourside Shopping Centre Darling Drive, Darling Harbour, Sydney

Prepared for Mirvac Projects Pty Ltd

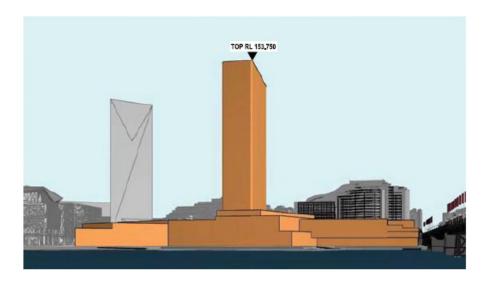
Figure 2 Amended Concept Proposal

The extent of the basement will remain the same but will extend over three levels, providing a minor increase of car parking spaces. As above, this is based on the 'Indicative Design' only.
