Hydro Aluminium Kurri Kurri – Remedial Action Works Plan, Clay Borrow Pit

AUTOMOTIVE WASTE REMOVAL VALIDATION

Hydro Aluminium Kurri Kurri Pty Ltd

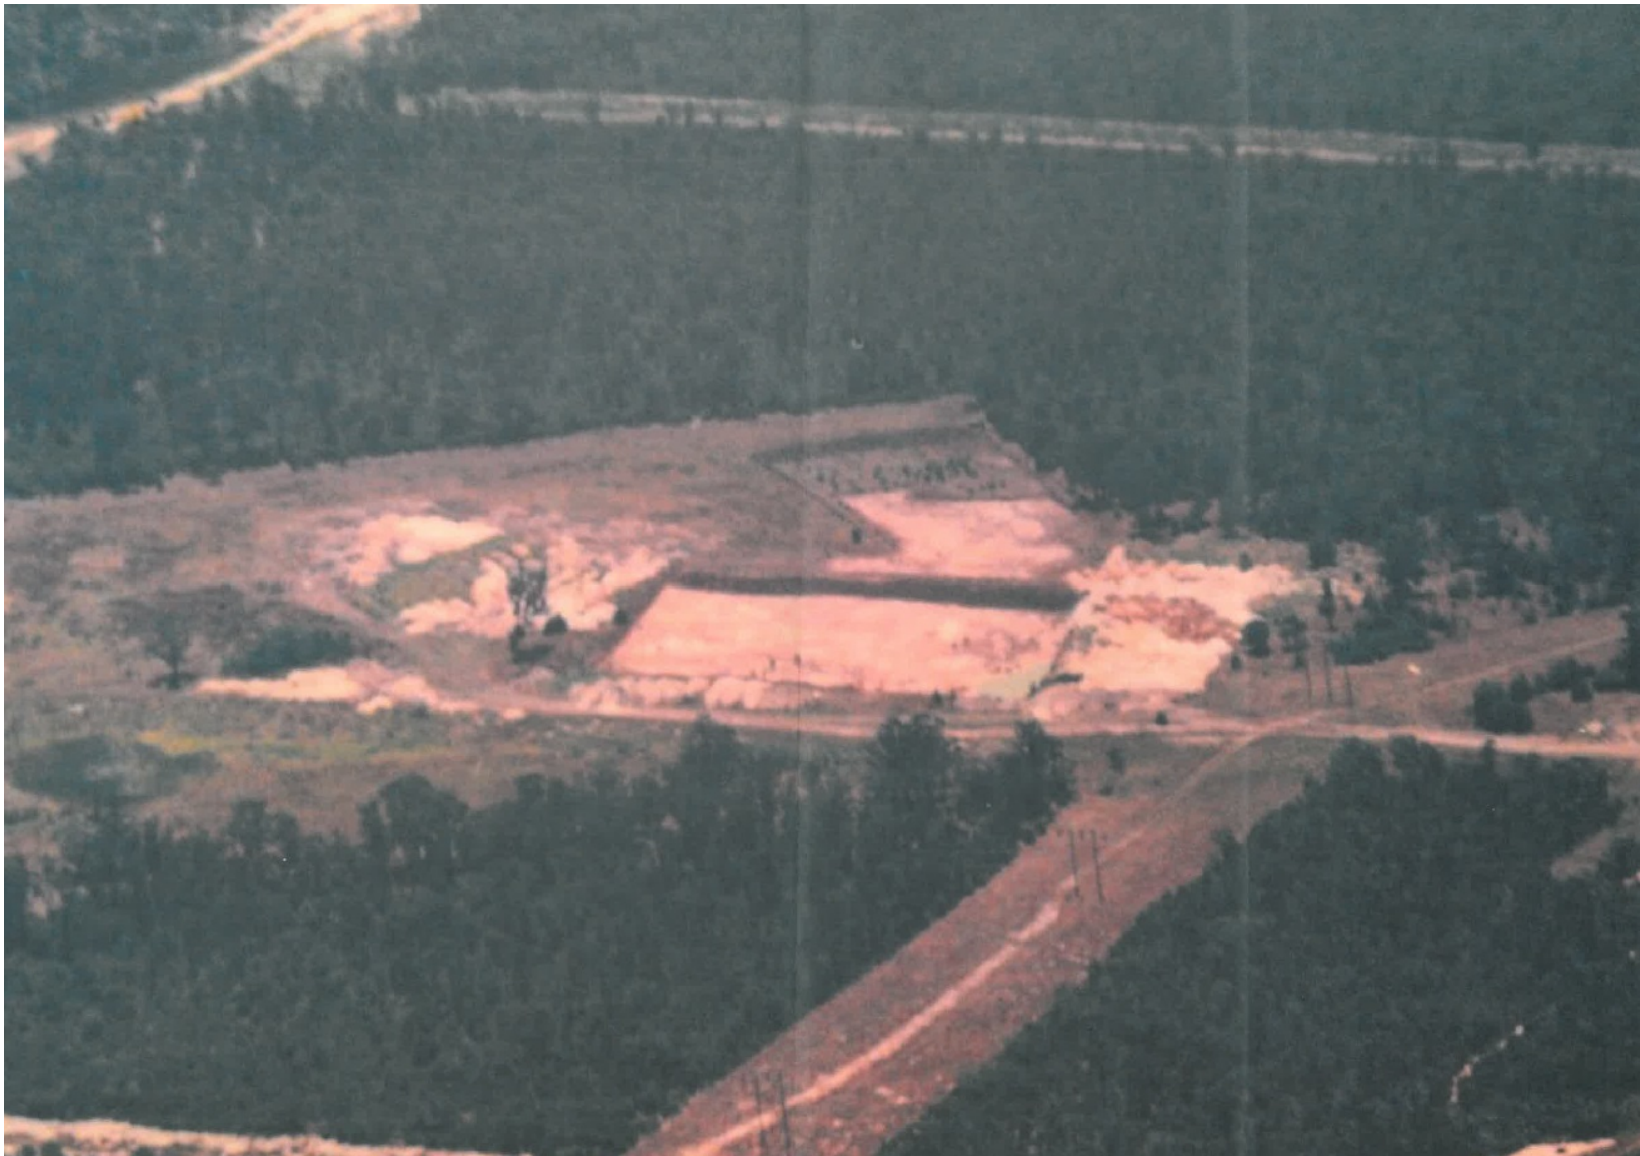
Historical Aerial Photo – Removal of clay around 1994

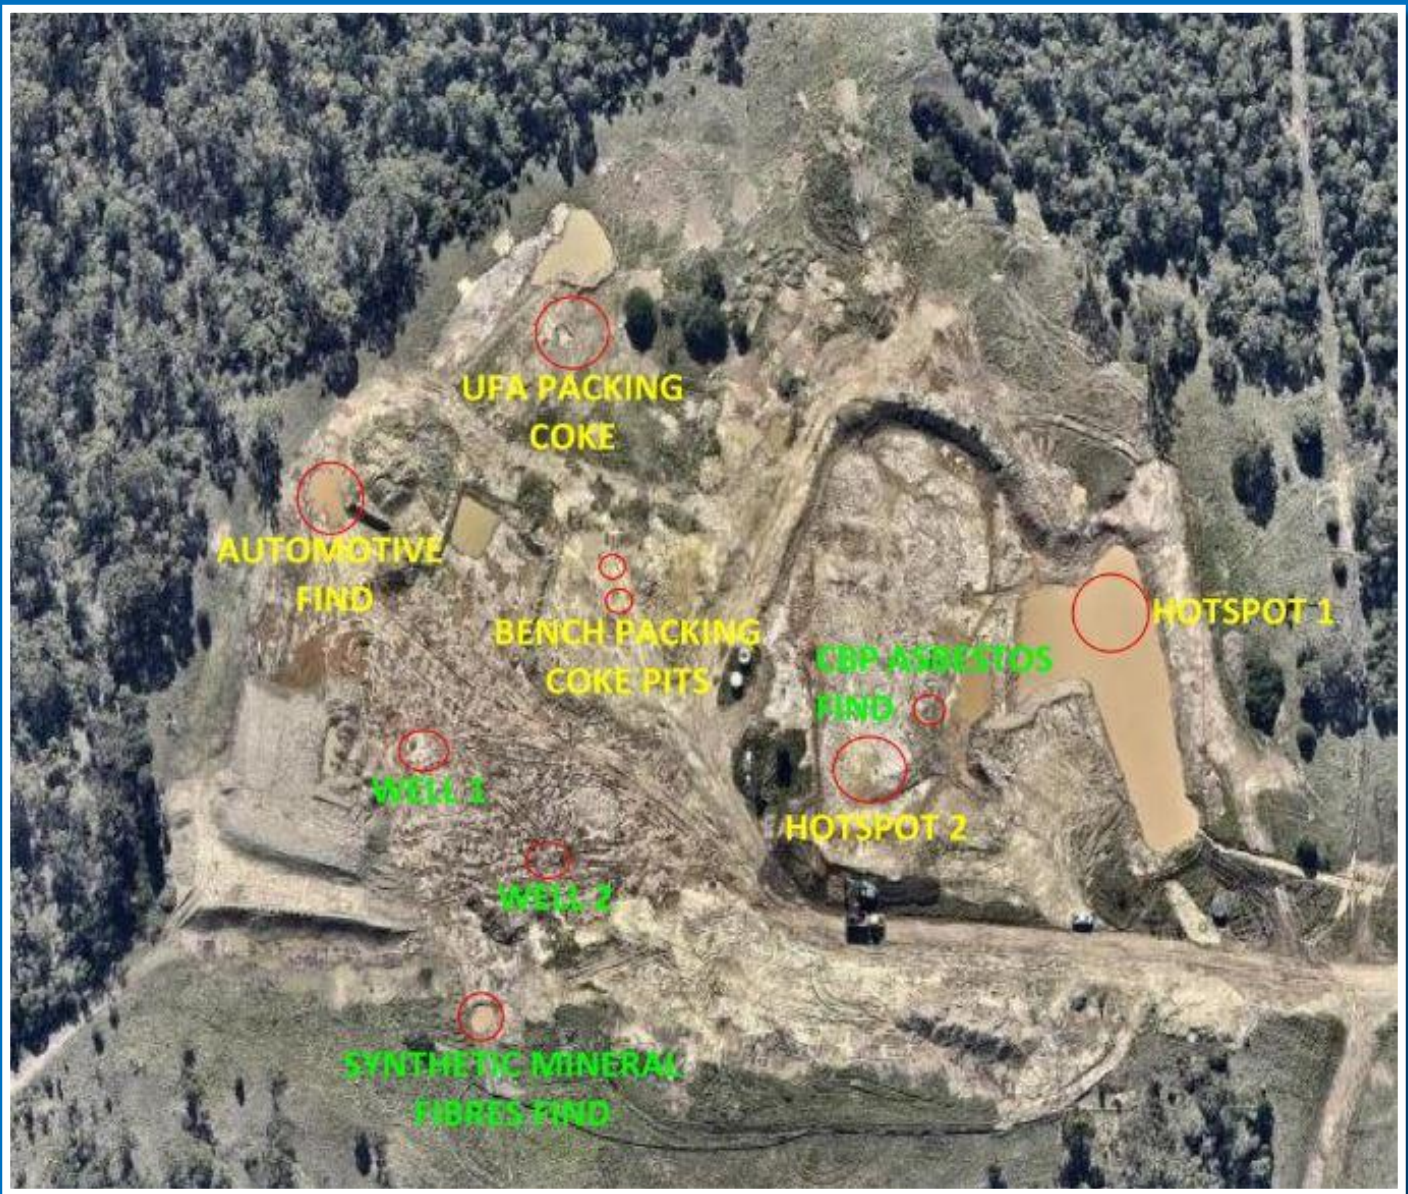
- A total of eight areas containing Potential Contaminants of Concern (PCoC's) required backfilling during works to facilitate the remediation of the Clay Borrow Pit area at Hydro Aluminium Kurri Kurri.
- The following gallery demonstrates the clean base and walls of these particular hotspot areas.
- All other areas identified as hotspots within the validation report were excavated to, and remain as, a natural clay base.
- The following map highlights areas that previously contained chemical contamination in yellow and asbestos contamination in green.

CBP Hotspot Areas Map

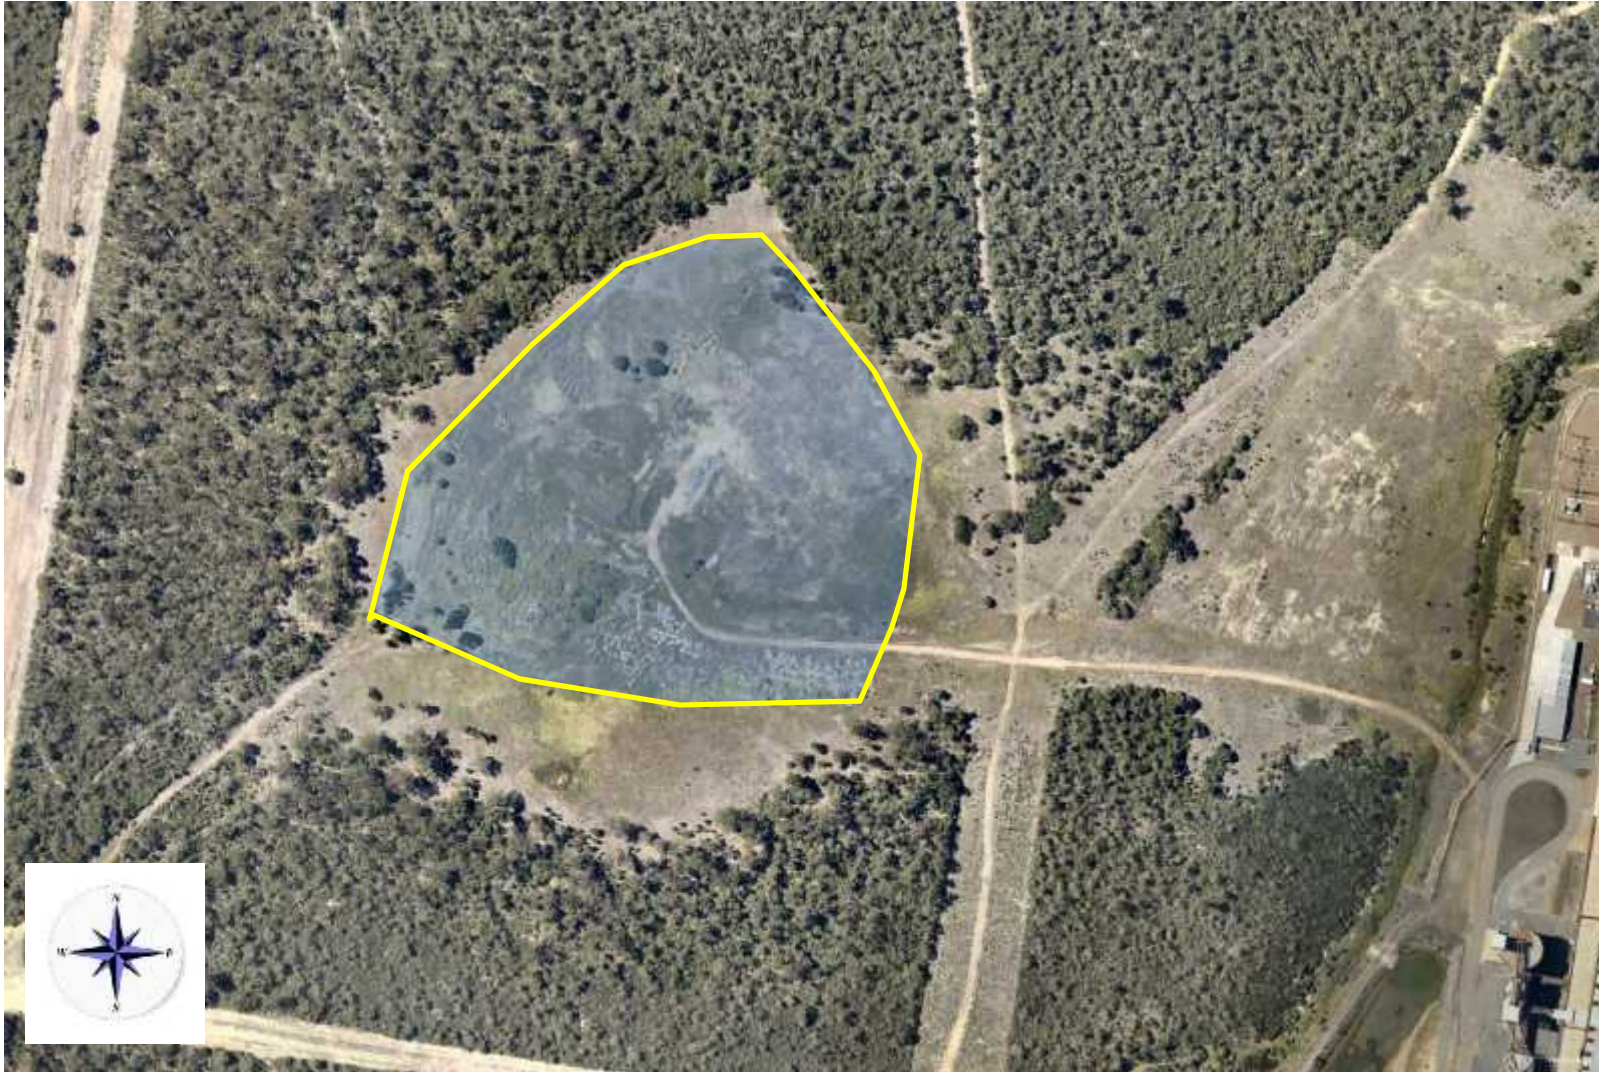
Figure 2

Site Layout with Sampling Locations
