Metro Corridor Impact Statement

**Iglu 80-88 Regent Street,
Redfern**

Prepared for Iglu Pty Ltd / 23 January 2019

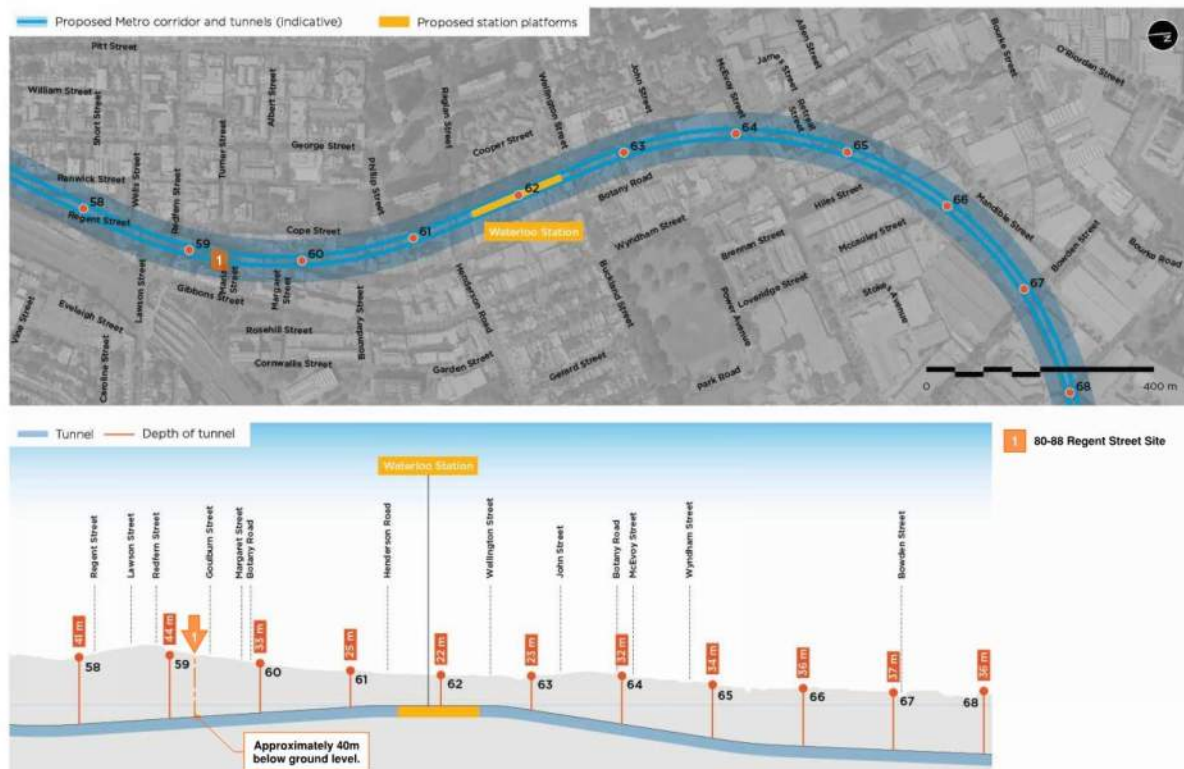
Figure 2: Excerpt from Chatswood to Sydenham Environmental Impact Statement Summary May-June 2016 Showing Site Location Adjacent to Tunnel Corridor

The proposed Metro corridor and tunnels in Figure 2 below, shows the approximate alignment with respect to the site. The tunnels and corridor run beneath the entirety of the site in an east-west direction and are anticipated to be approximately 40 m below existing ground level at the development location.

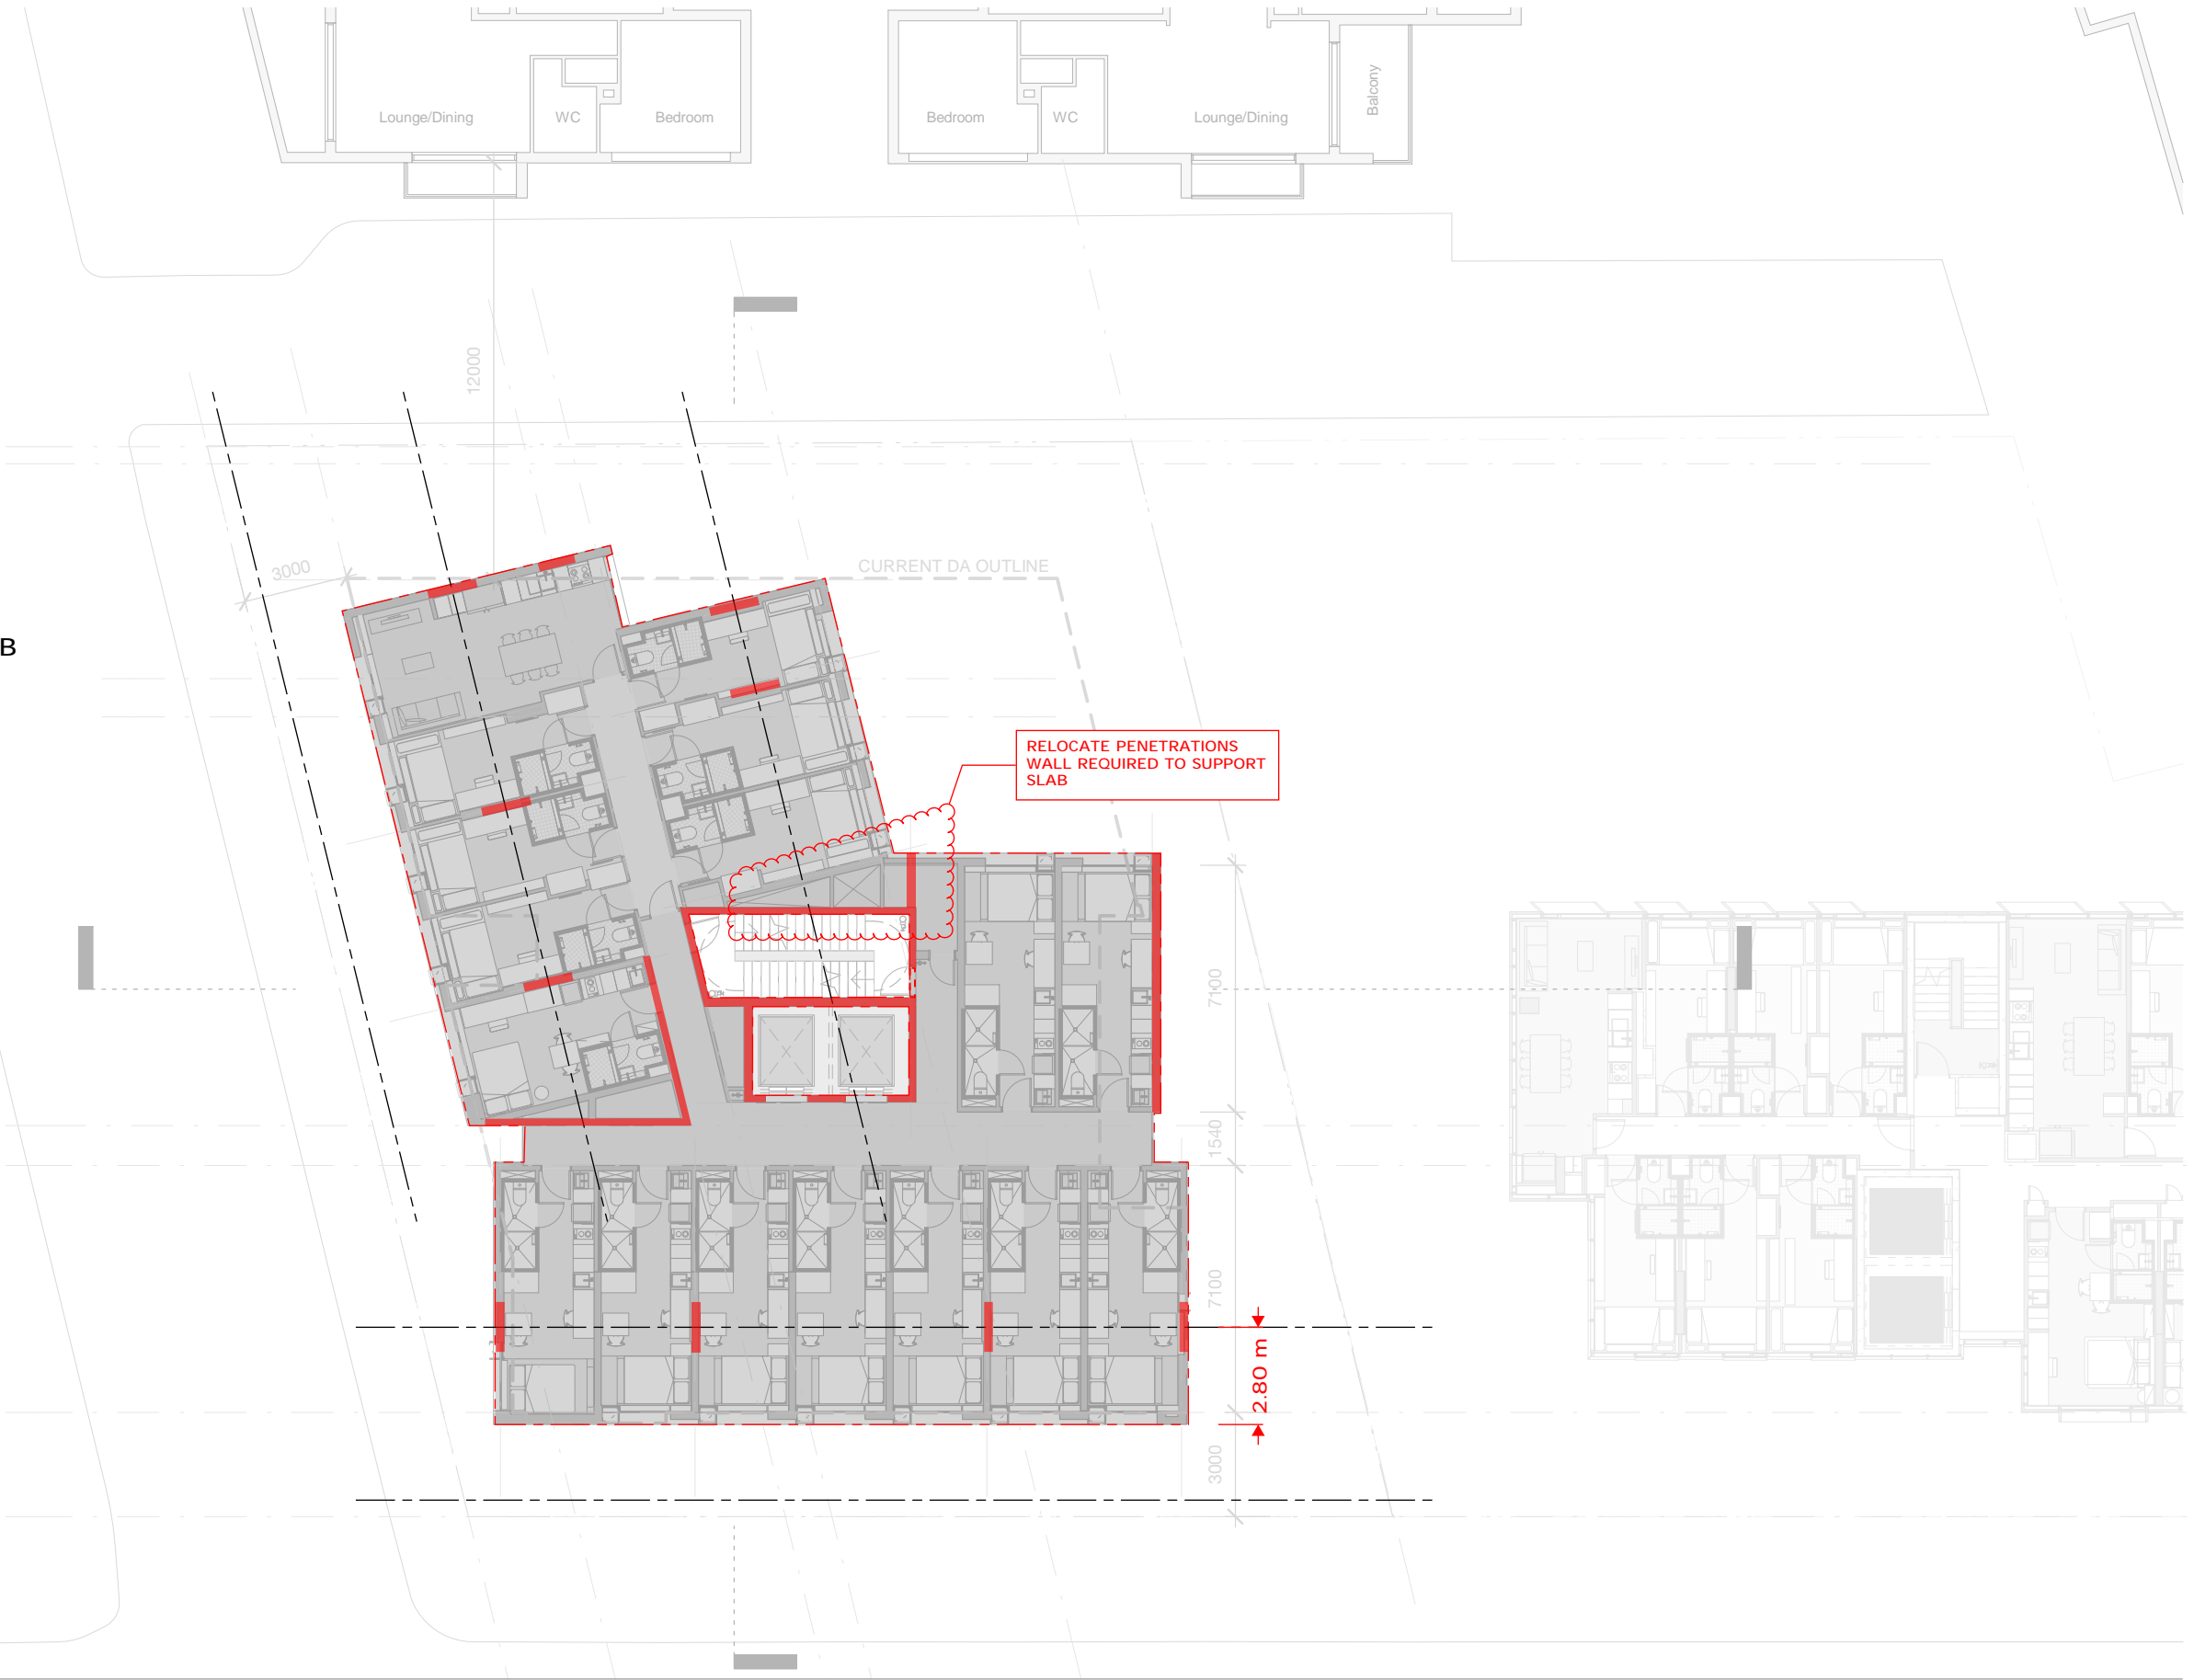
Floorplate Level 06, 11

LEVEL 06, 11 FLOOR PLAN

- BLUE HATCH - ELEMENT BELOW SLAB
- RED HATCH - ELEMENT ABOVE SLAB

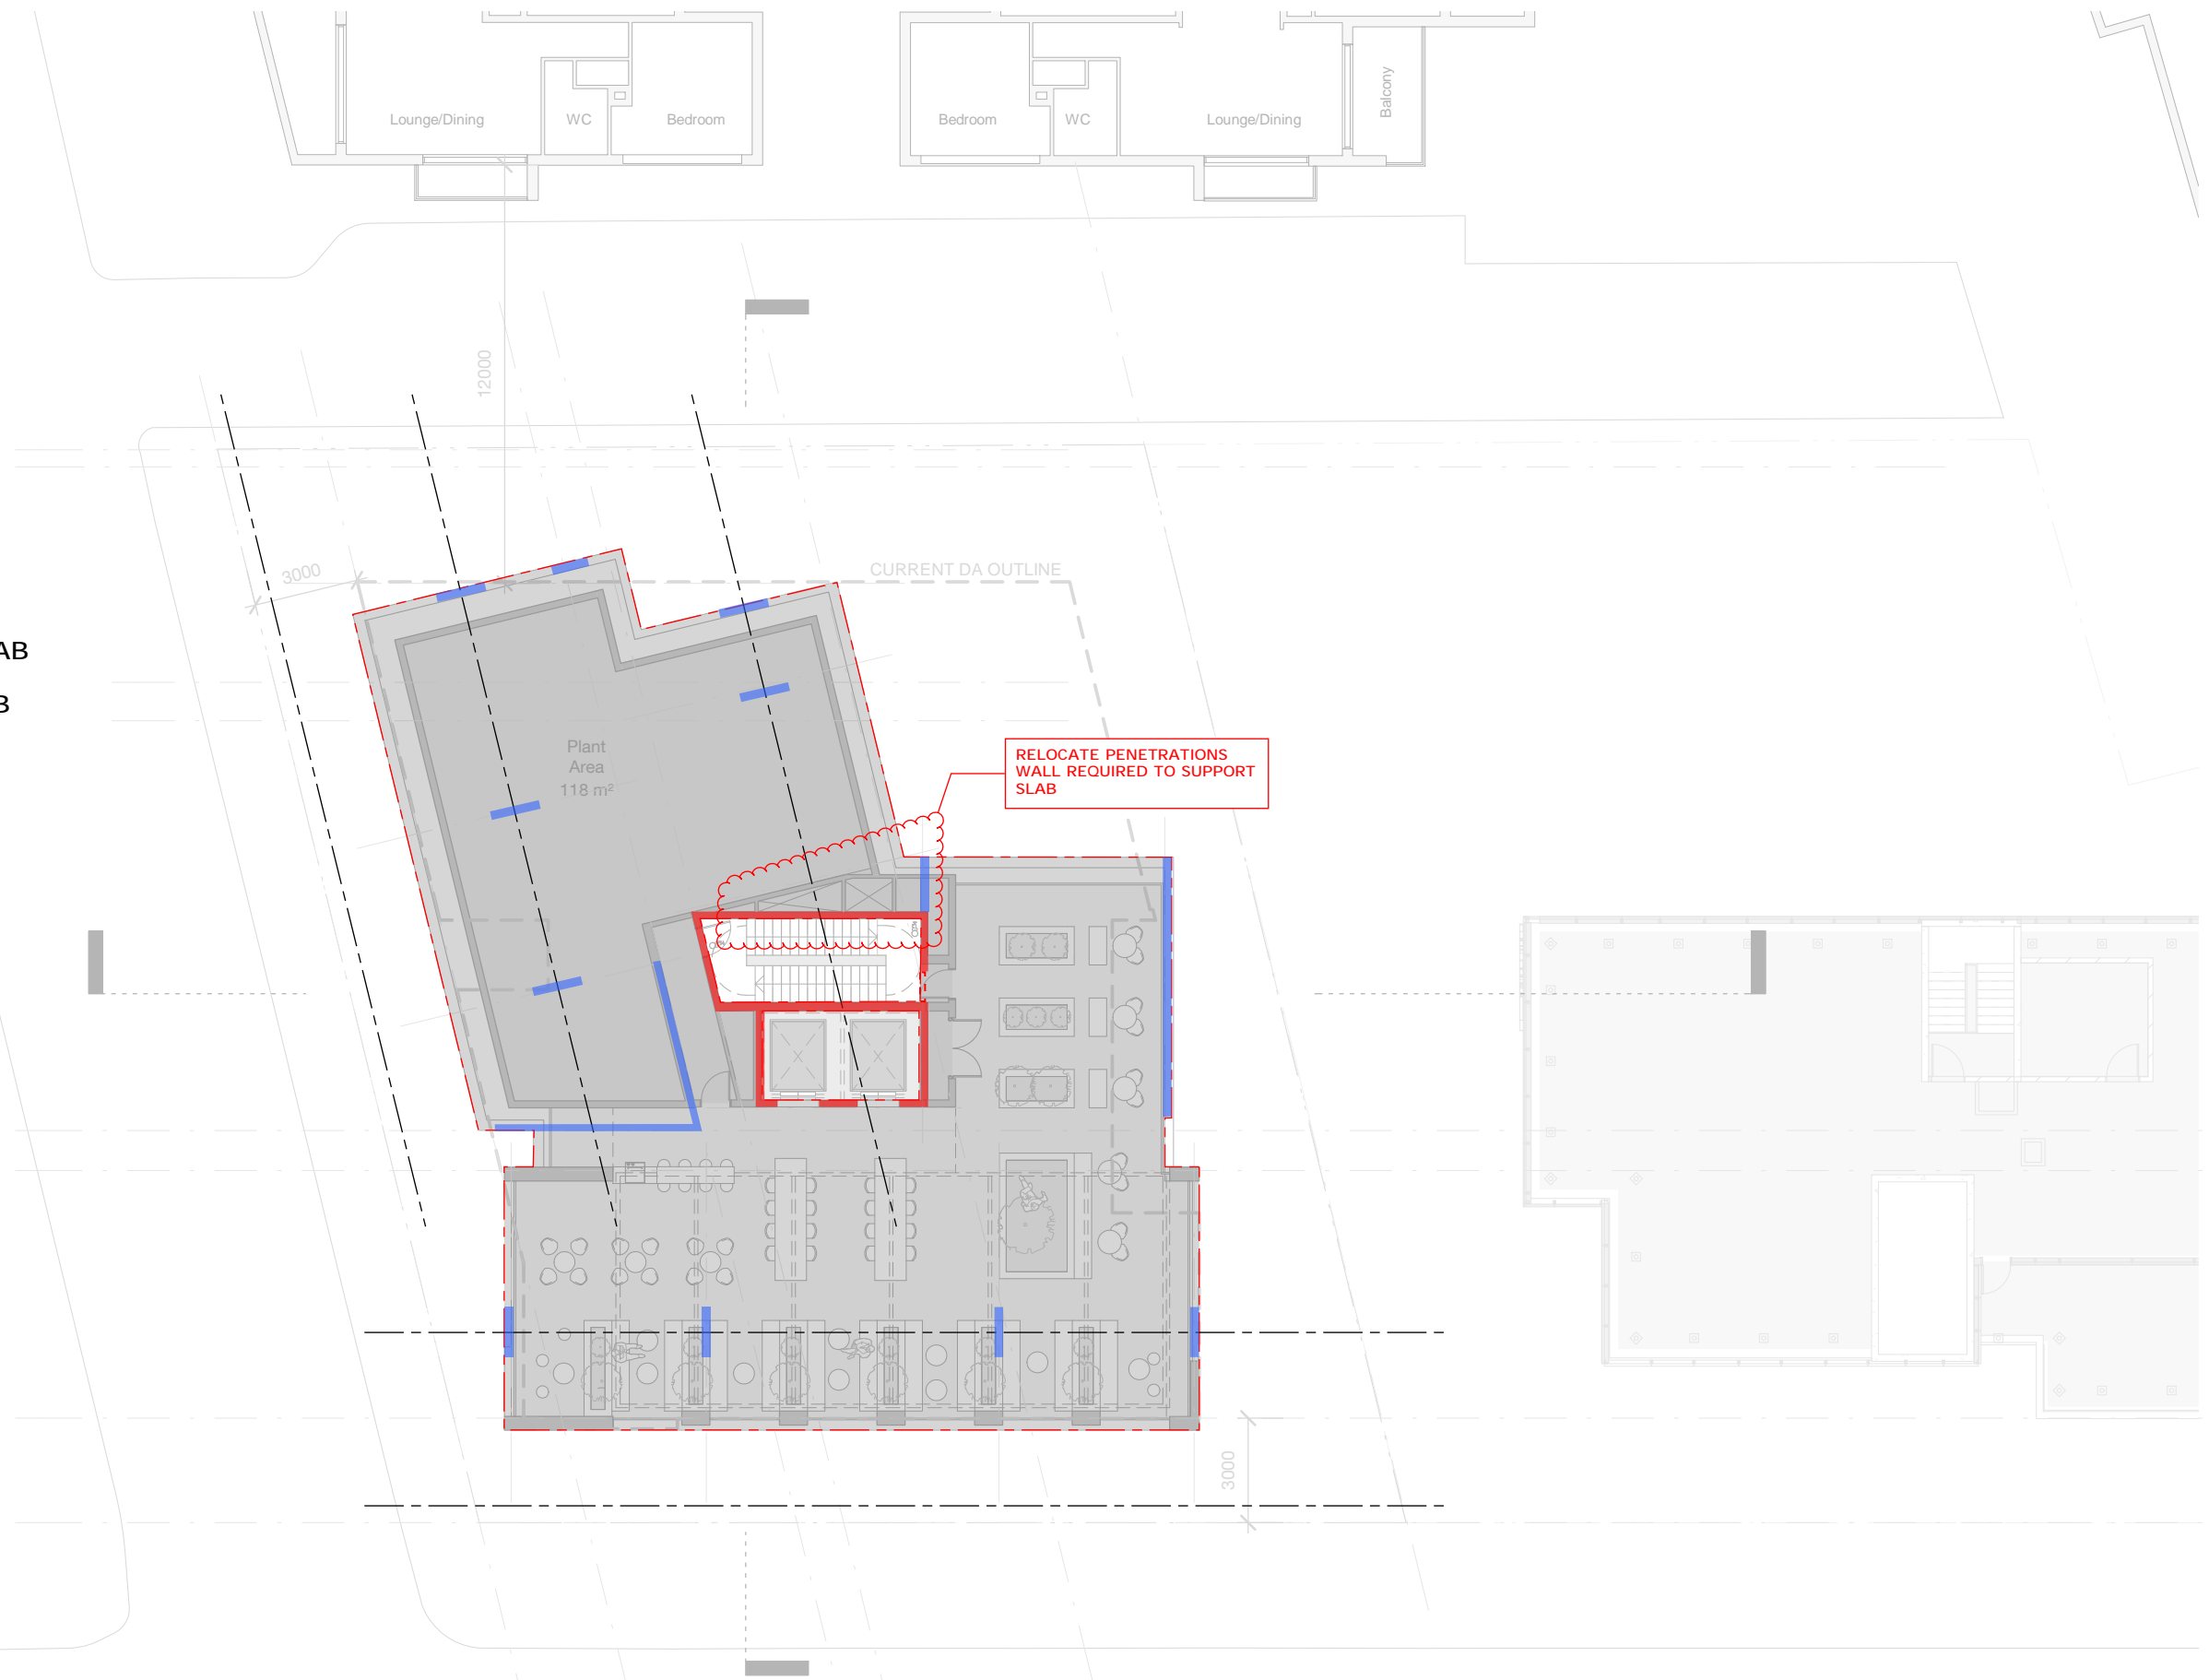
Roof Terrace level

RED HATCH - ELEMENT ABOVE SLAB

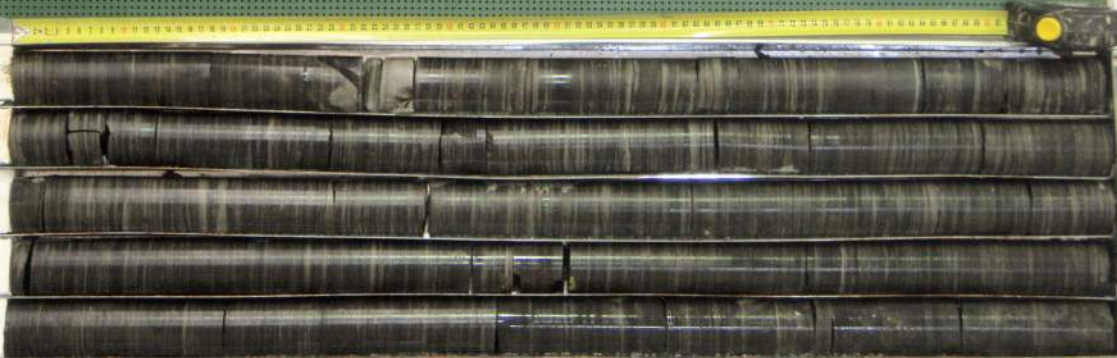
Project: 157 Redfern St., Redfern
Project No: 17055/5911B
Client: DelCorp Pty Limited
Date Cored: 18/02/09
Borehole No: 5
Depth (m): 18.00 - 20.00 End
Box 3 of 3

The subsurface conditions encountered are recorded on the borehole logs given in Appendix A. Photographs of the rock core retrieved are given in Appendix A together with a description of the terms used on the logs. Notes relating to geotechnical reports are also attached.
