Hydrogeological Assessment and Management Plan:

Proposed Sand Mine at 3631, 3679 & 3721 Nelson Bay, Bobs Farm, NSW

P1303897JR08V02

November 2020

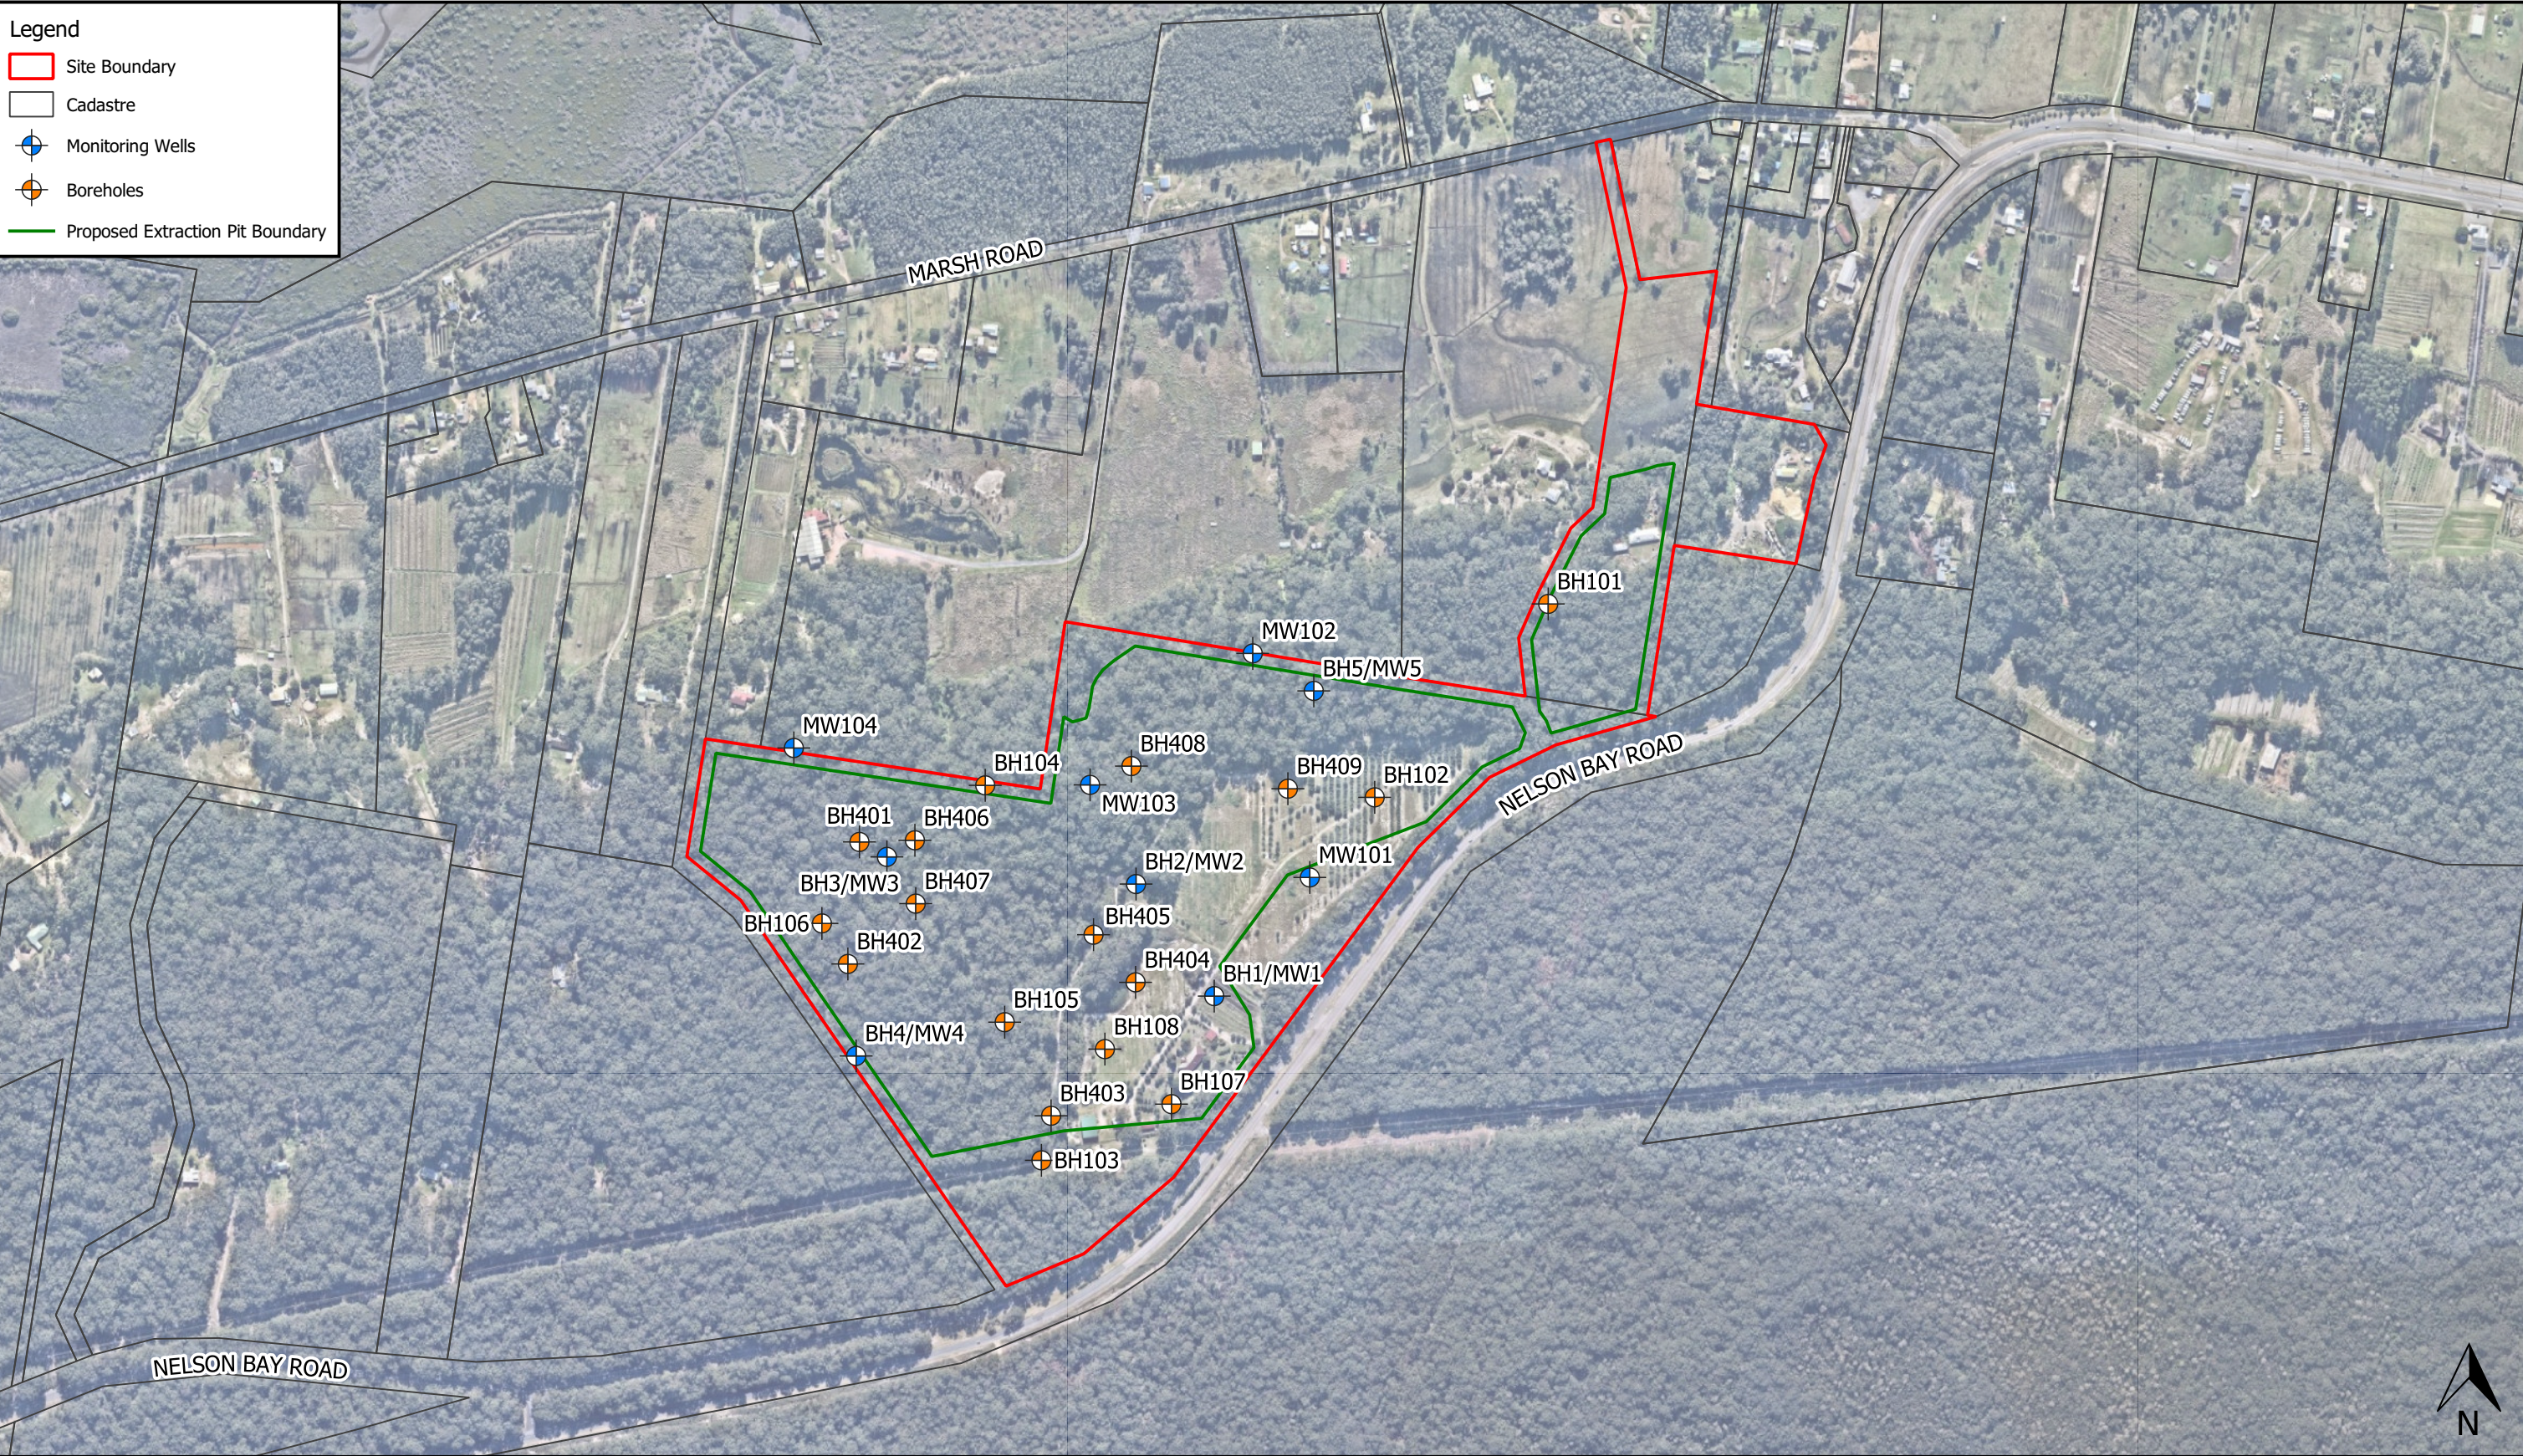
Map Title / Figure:
Hydrogeological Testing Plan

- Site Boundary
- Cadastre
- Monitoring Wells
- Boreholes
- Proposed Extraction Pit Boundary

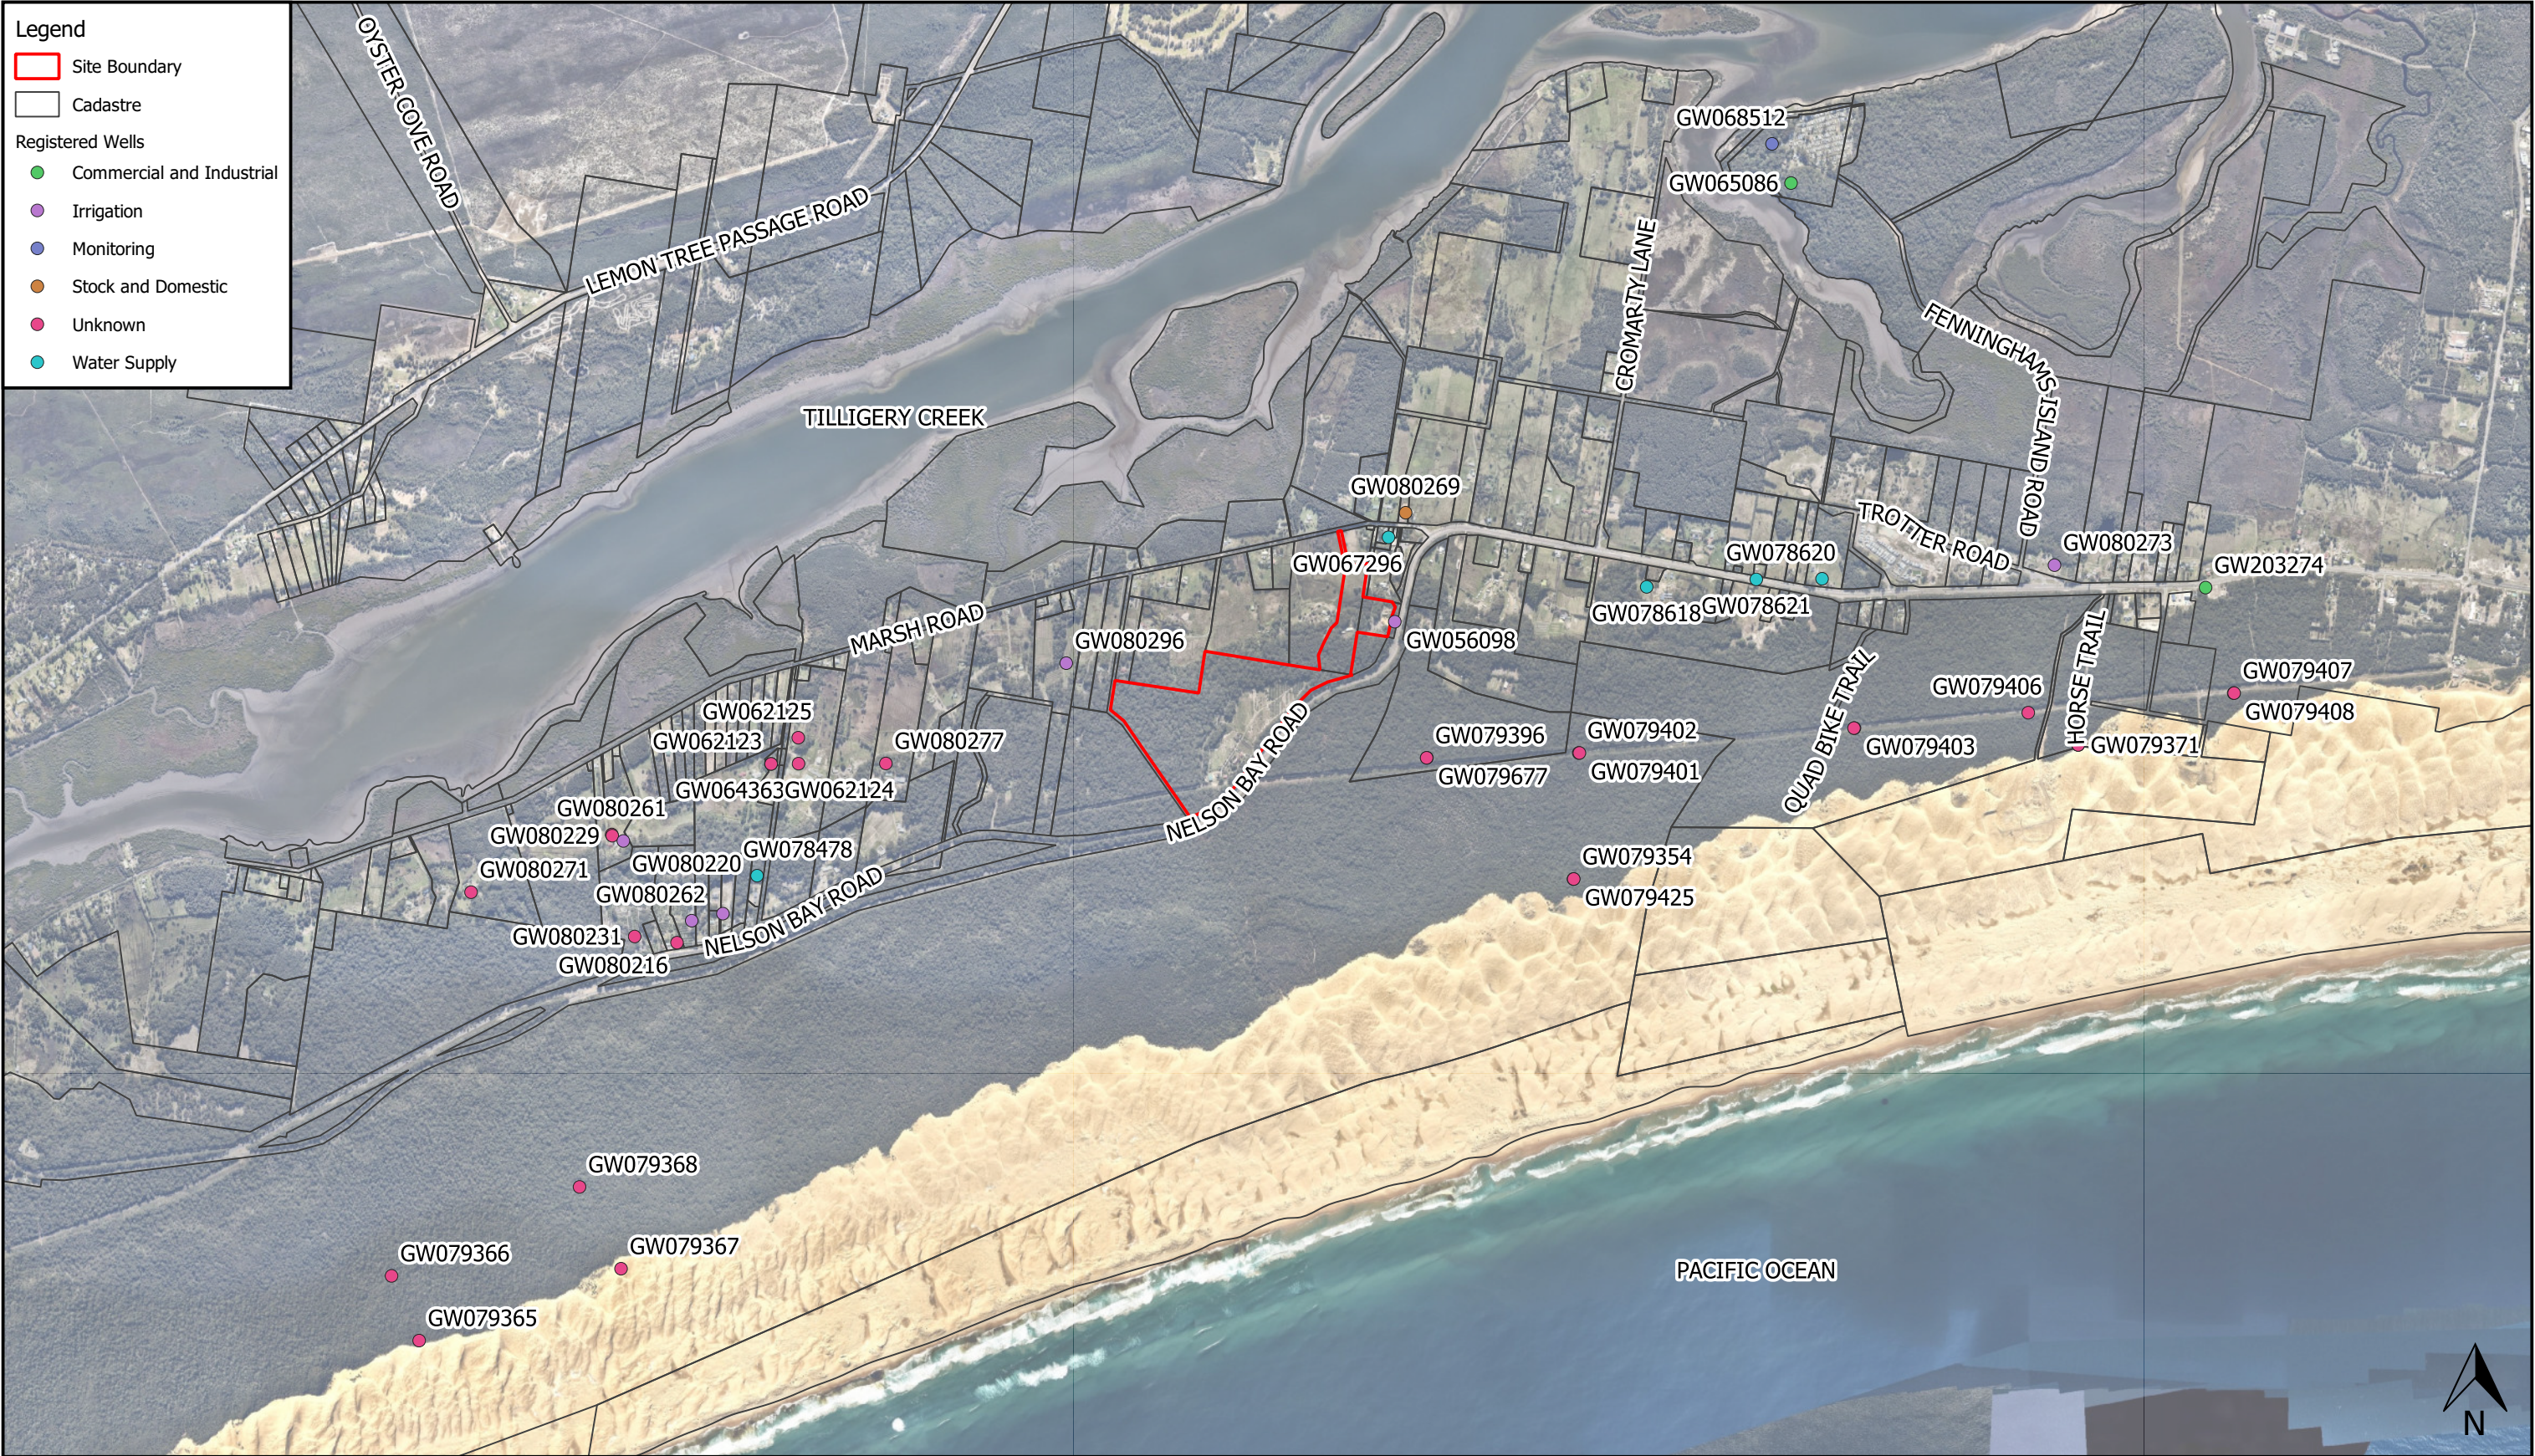
Map	Map 03
Site	3631, 3679 & 3721 Nelson Bay Rd, Bobs Farm, NSW
Project	Proposed Sand Mine
Sub-Project	Hydrogeological Assessment & Management Plan
Client	Ammos Resource Management P/L
Date	05/11/2020

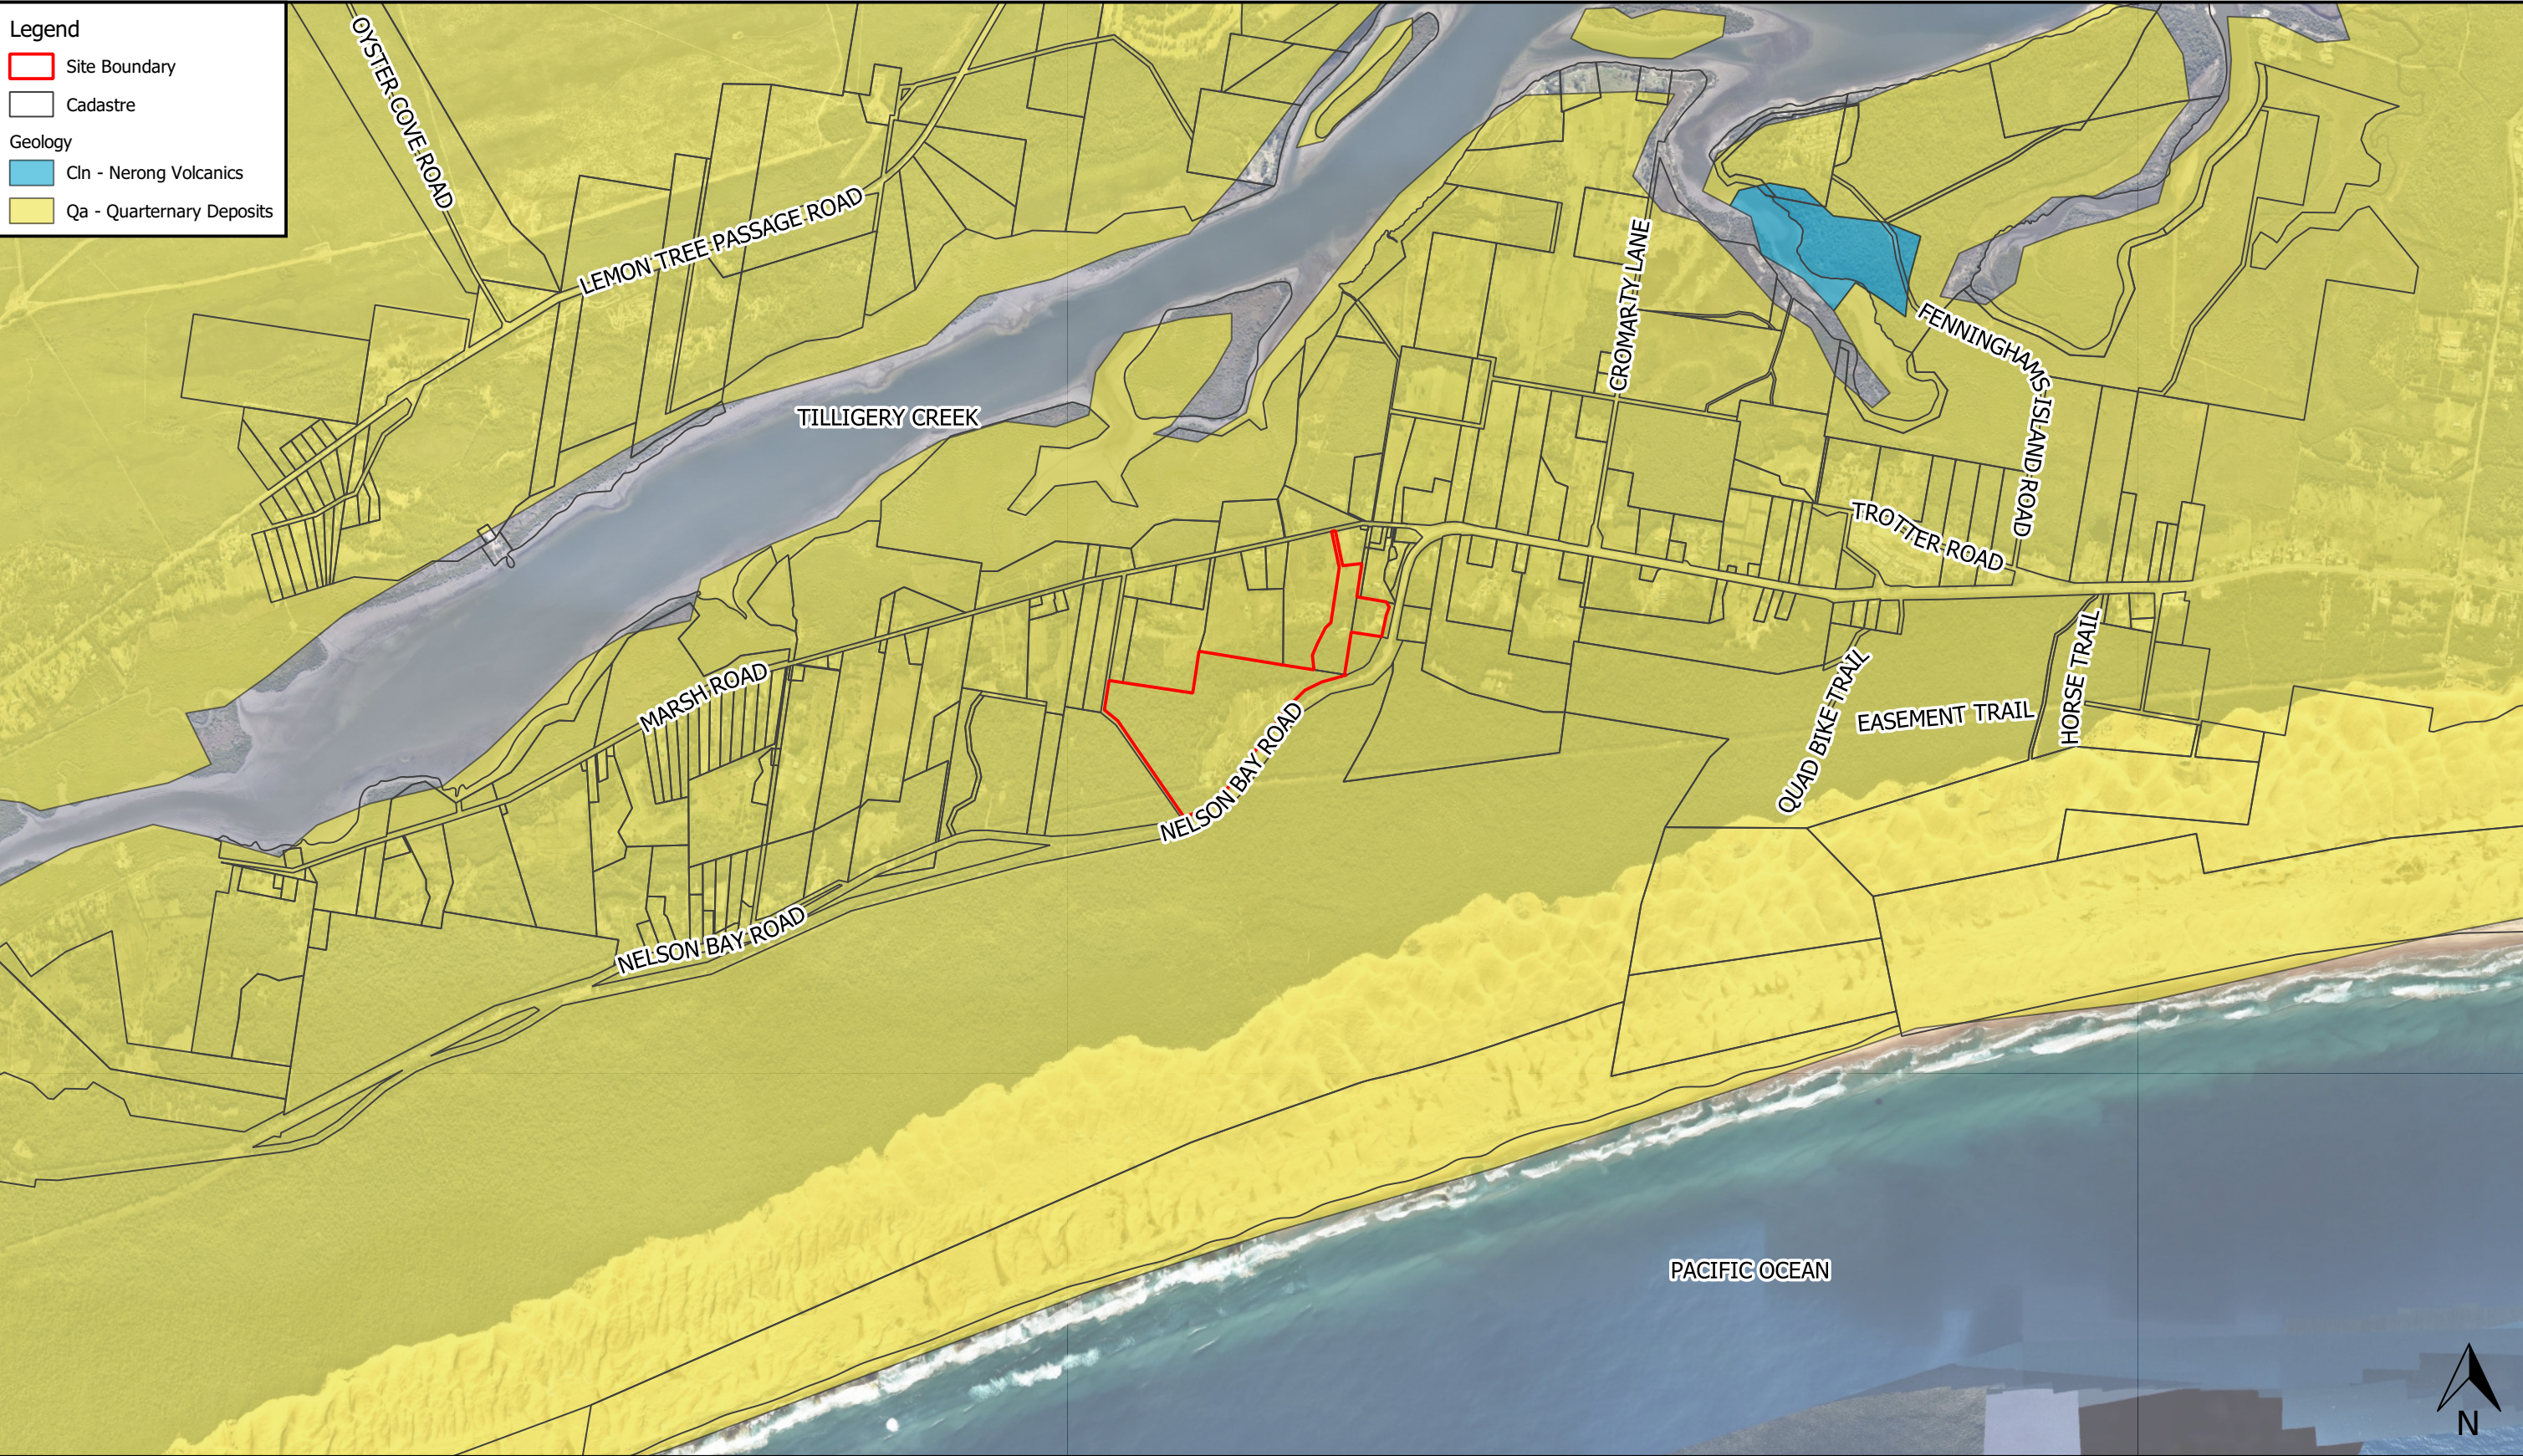
Registered Groundwater Wells

Notes:
- Aerial from Nearmap (2020).
- Registered well locations from BoM Groundwater Explorer (2020).
- Cadastre from site survey (Tattersall Lander, 2013) and NSW DFSI (2019).

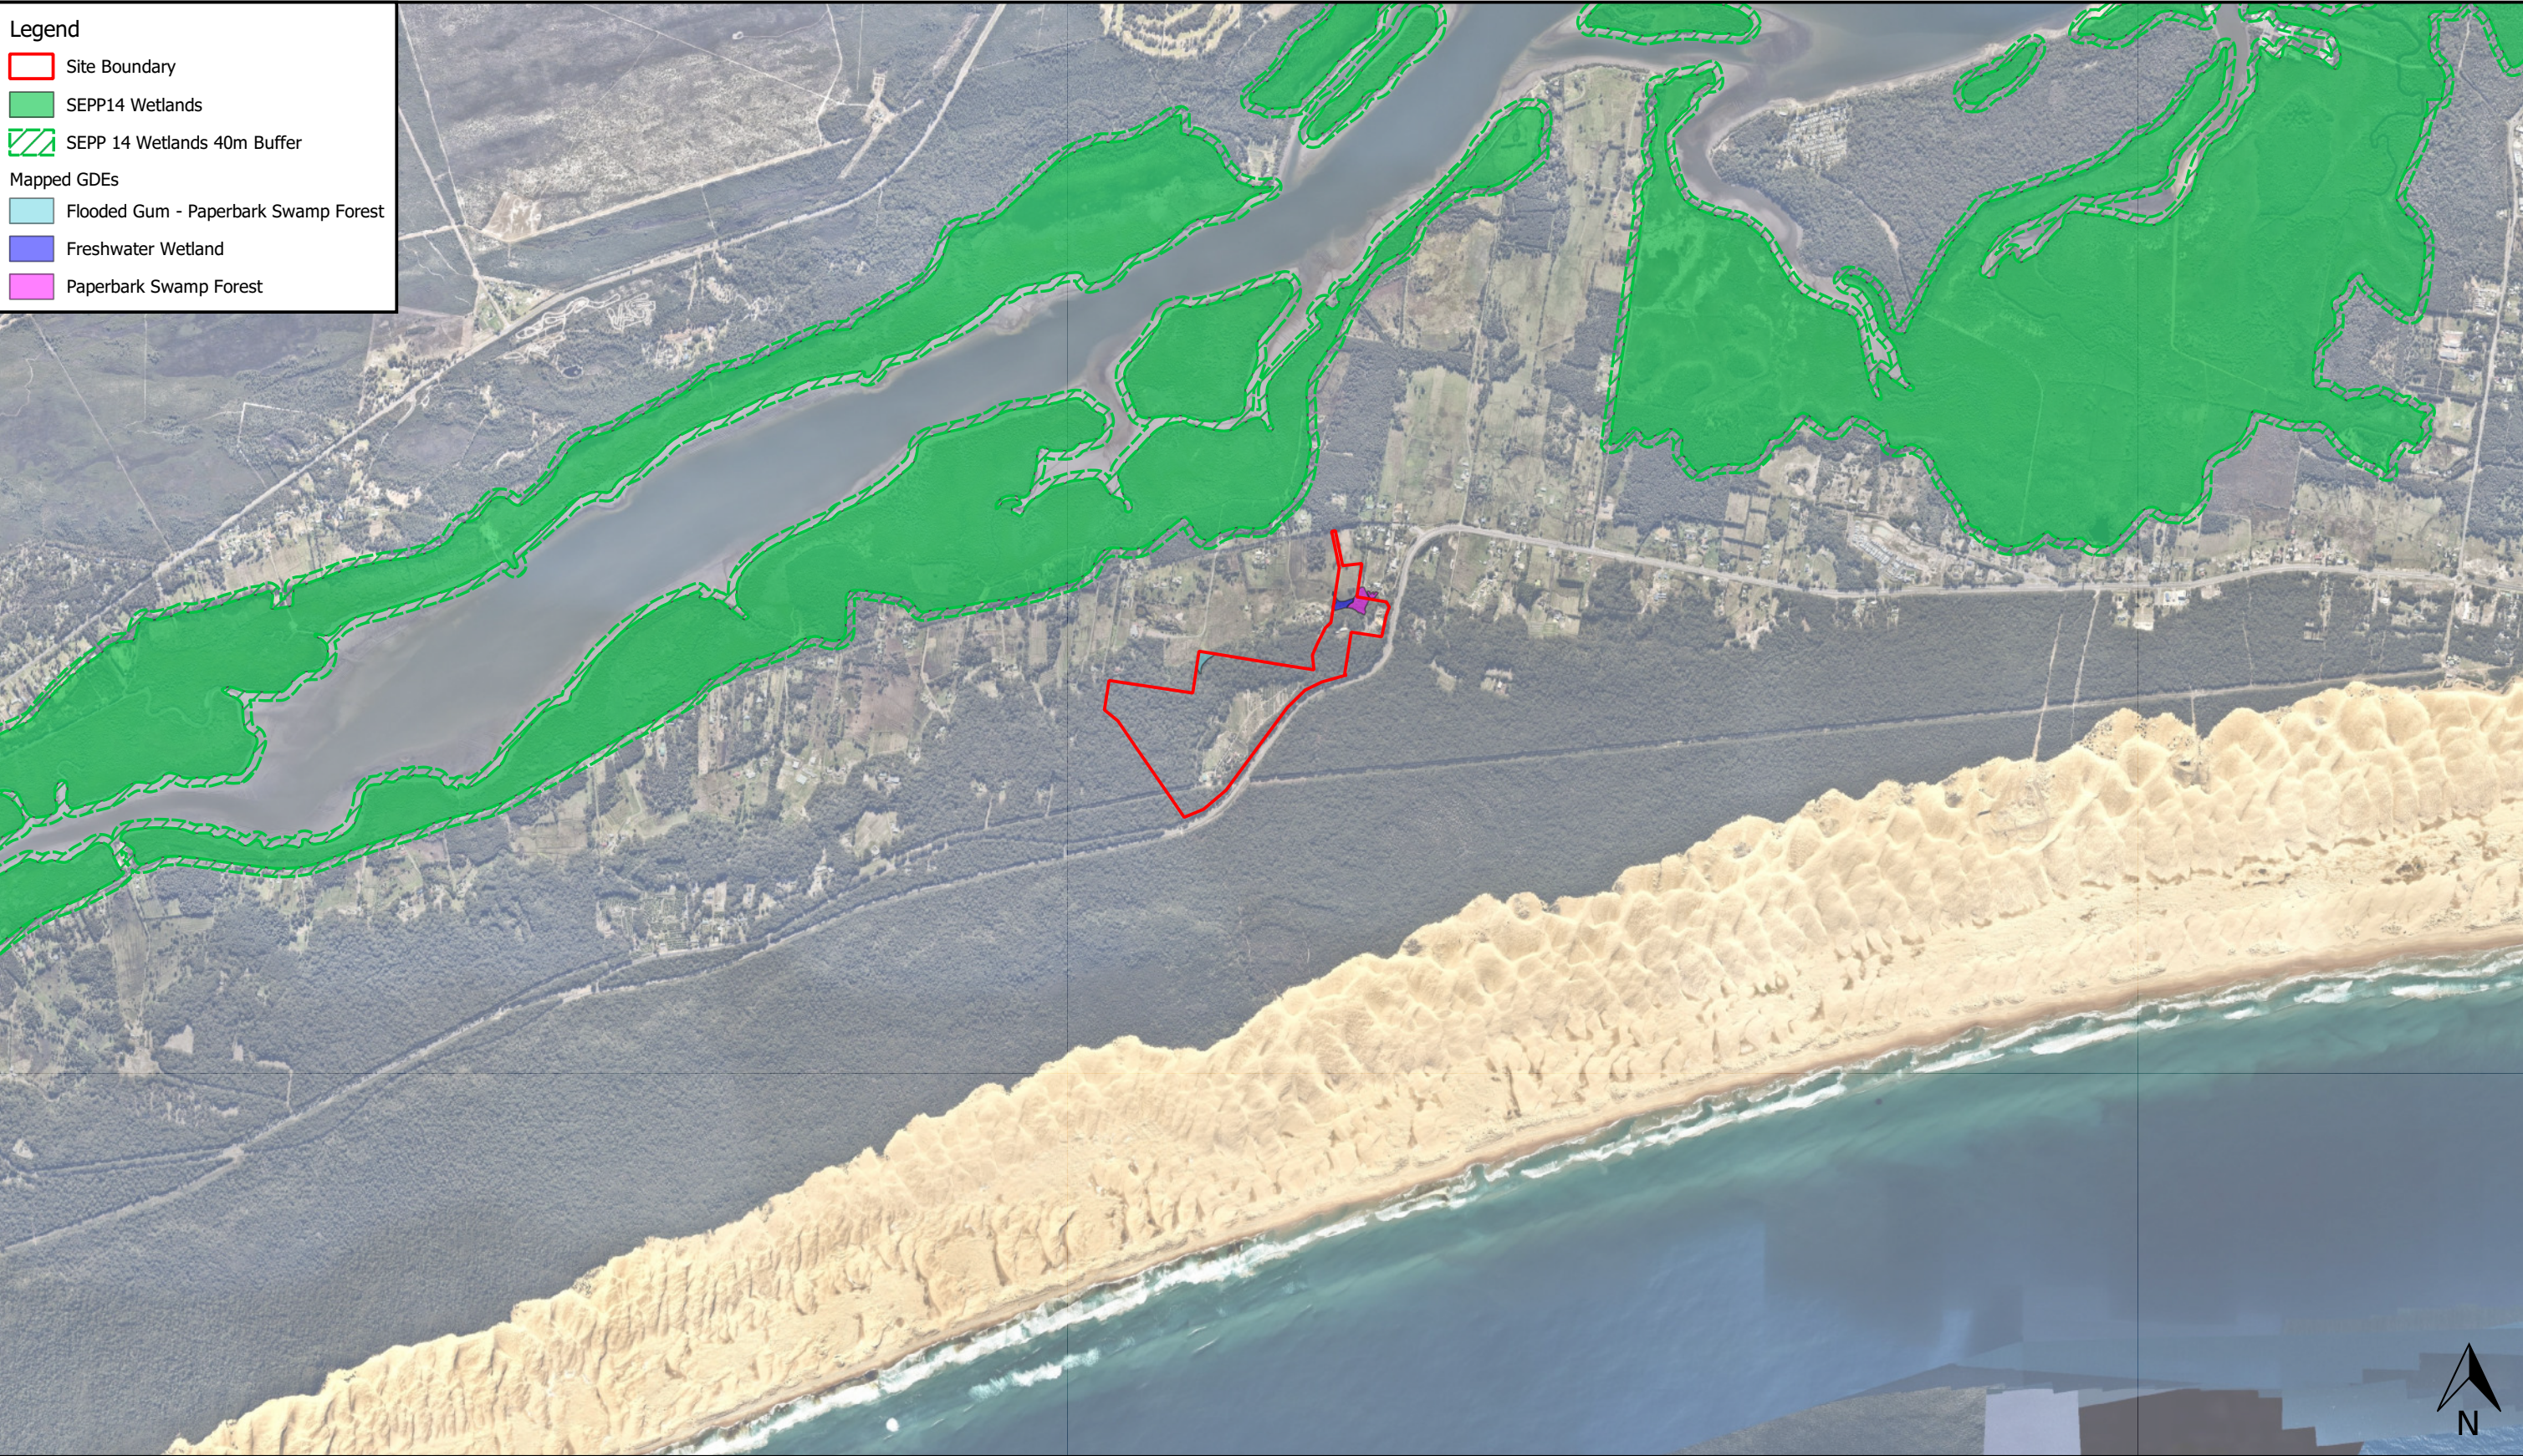
Map Title / Figure:
Soil Landscapes

Notes:
 - Aerial from Nearmap (2020).
 - Soil landscapes from NSW DPIE (2019).
 - Cadastre from site survey (Tattersall Lander, 2013) and NSW DFSI (2019).

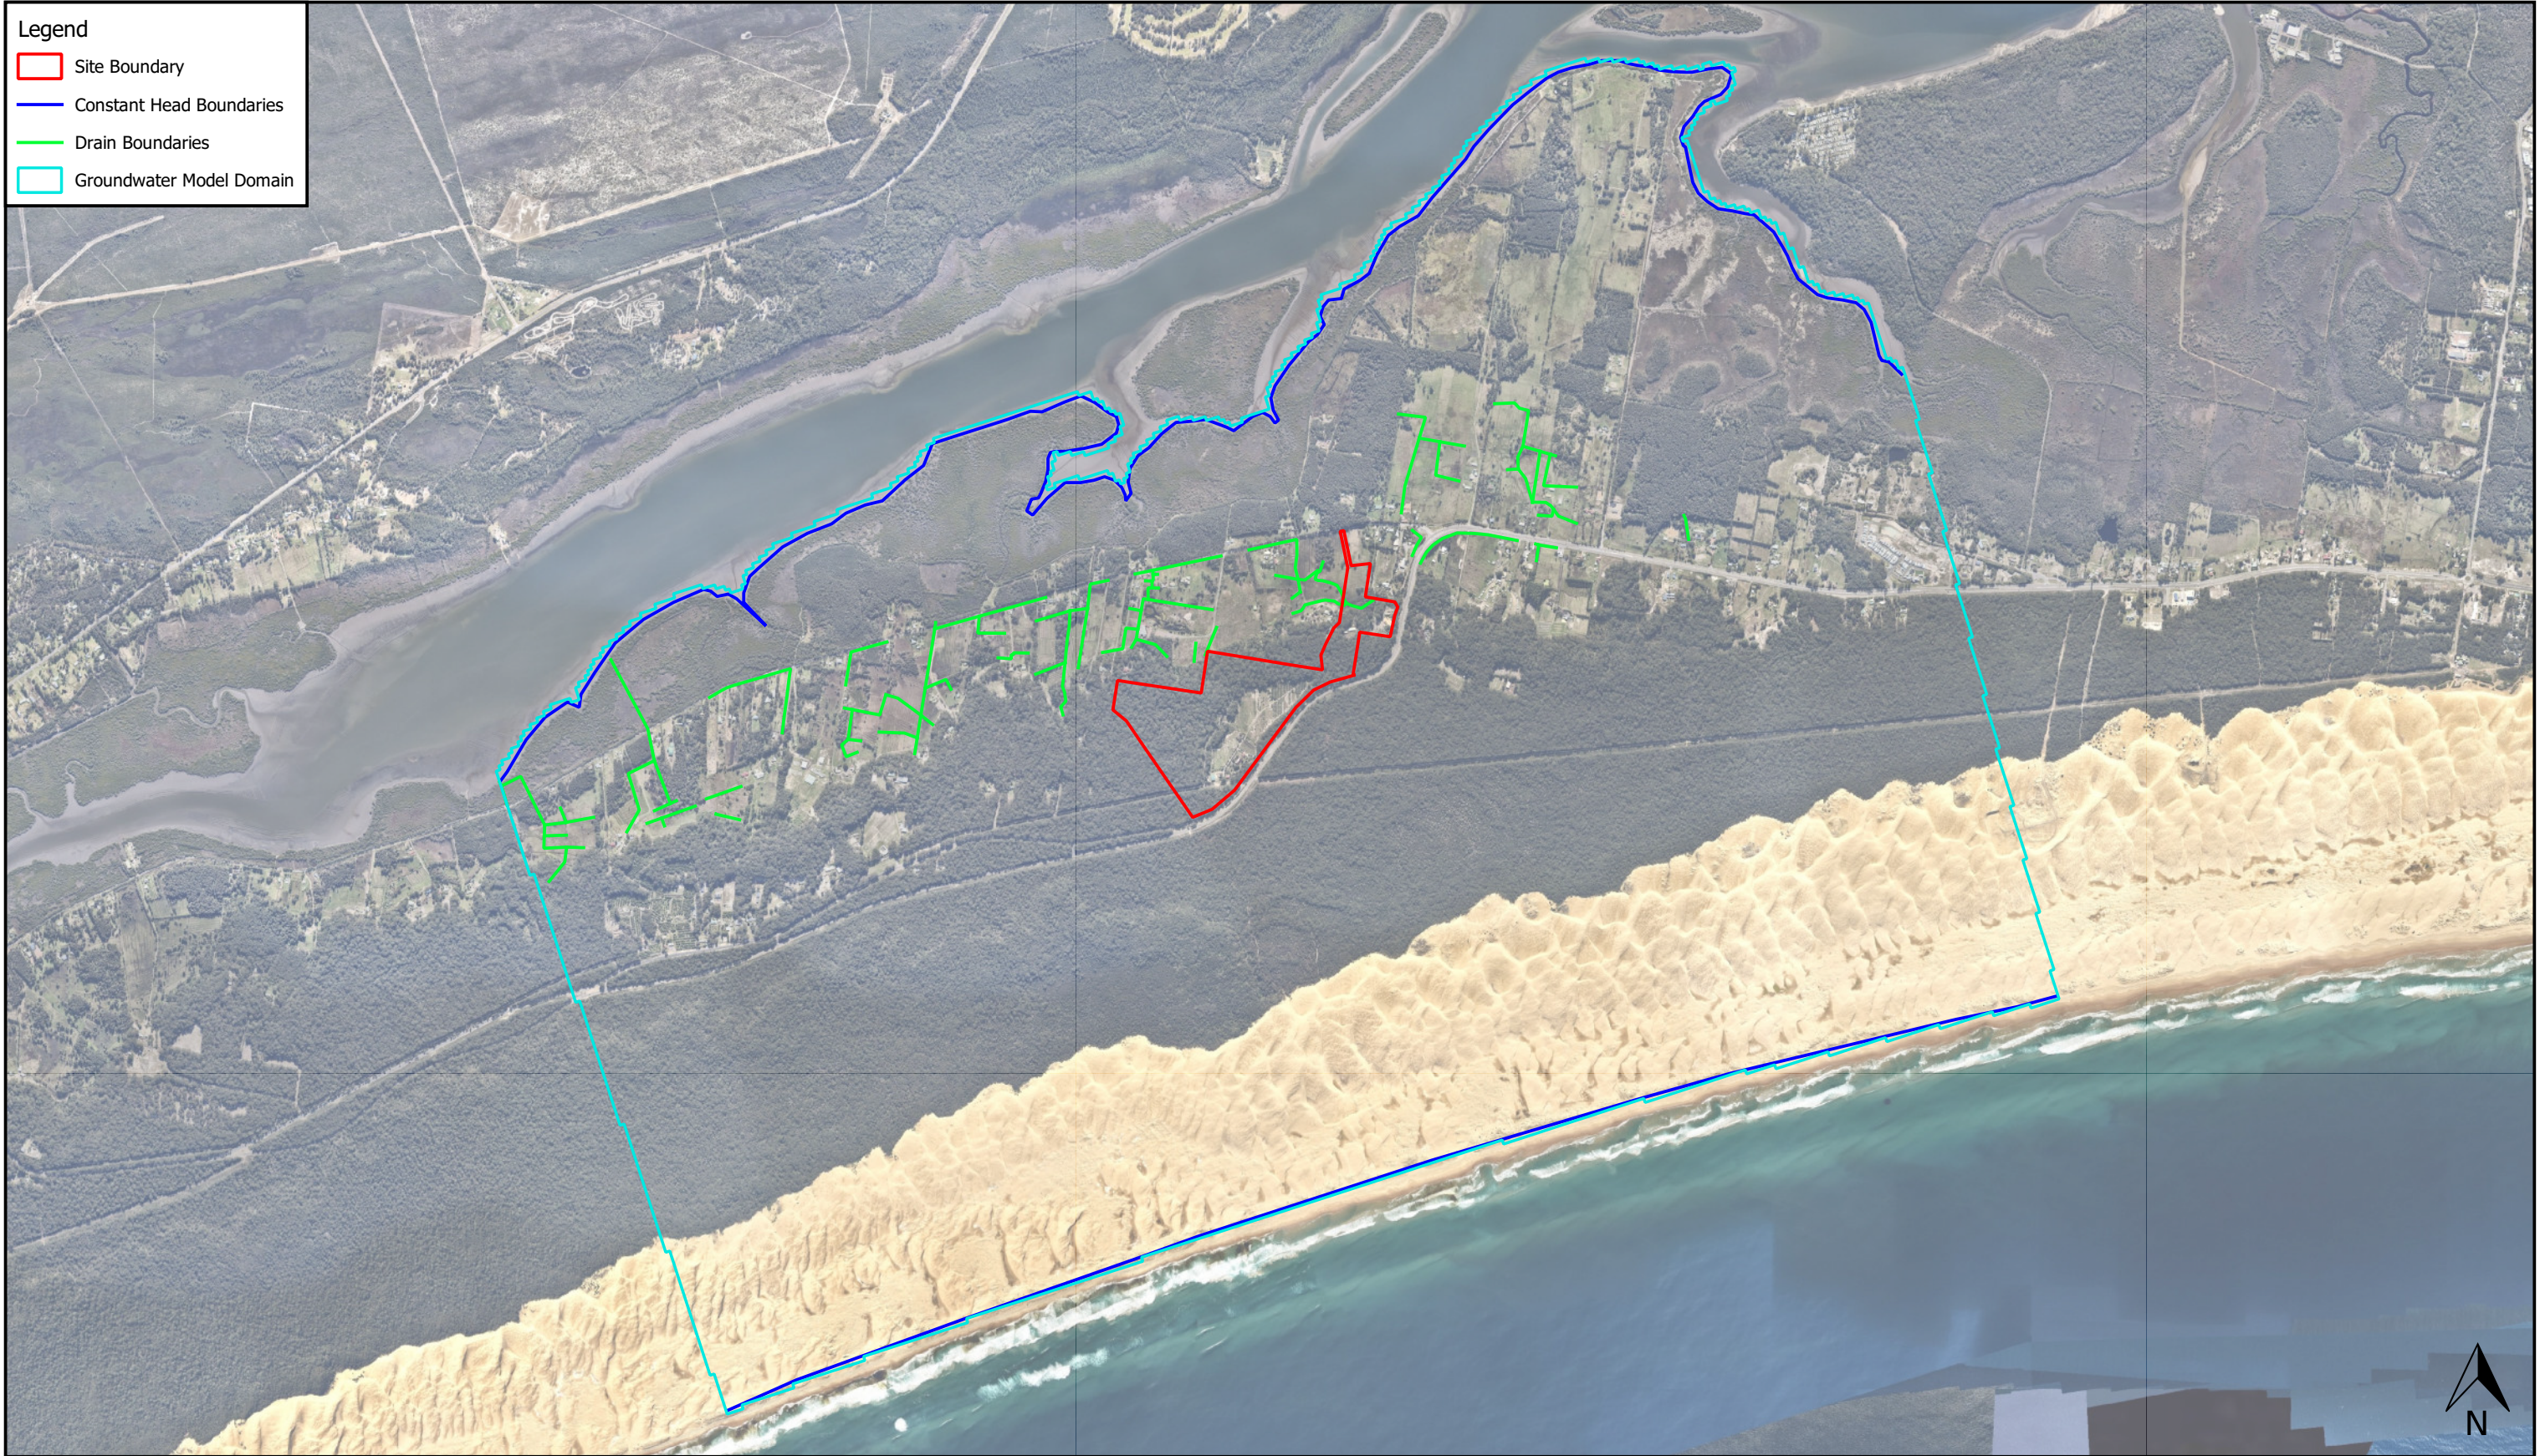
Map Title / Figure:
Mapped Groundwater Dependant Ecosystems and SEPP 14 Wetlands

Map	Map 07
Site	3631, 3679 & 3721 Nelson Bay Rd, Bobs Farm, NSW
Project	Proposed Sand Mine
Sub-Project	Hydrogeological Assessment & Management Plan
Client	Ammos Resource Management P/L
Date	05/11/2020

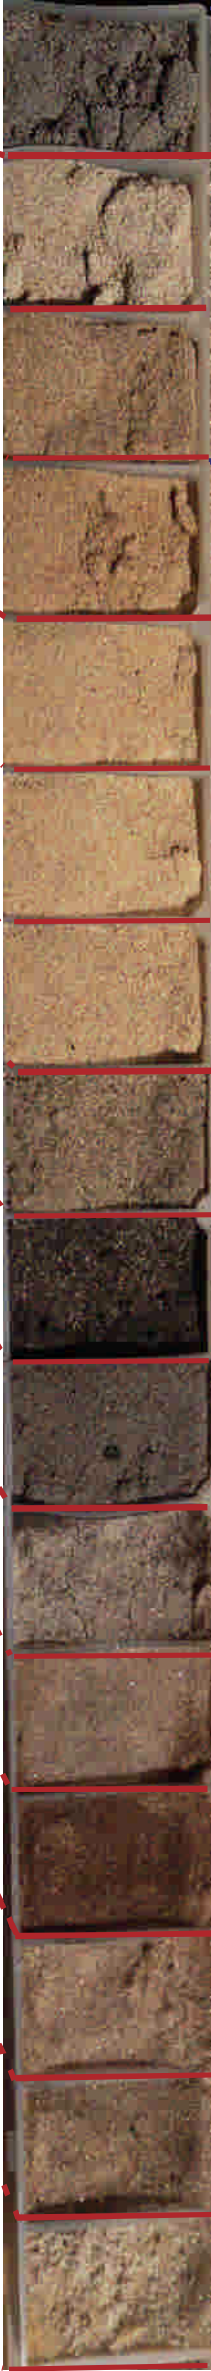
Description	Depth	Graphic Log	Heavy Mineral	Remarks
Ground Surface	0			
SAND - Koala grey, mg, sandy loam soil.				GR 406260; 6373082 r19.4
SAND - Tan, mg				
	1			
	2			
SAND- Rafia, mg, minor buff mottles	3			
	4			
	5			
SAND - Oyster / black, mg				
SAND - Black, silty high organcs?	6			
SAND - Driftwood, mg				
Water Table 7.3m	7			
	8			
SAND - Tan, mg				
	9			
SAND - Buff, mg				
SAND - Driftwood, mcg	10			
	11			
SAND- Cloud grey, mcg, 2-4% black speck				
	12			
	13			
	14			
	15			
	16			
	17			
	18			
	19			
	20			
	21			
	22			
	23			
	24			
	25

BH4-BL-B
1.5 to 5.8m

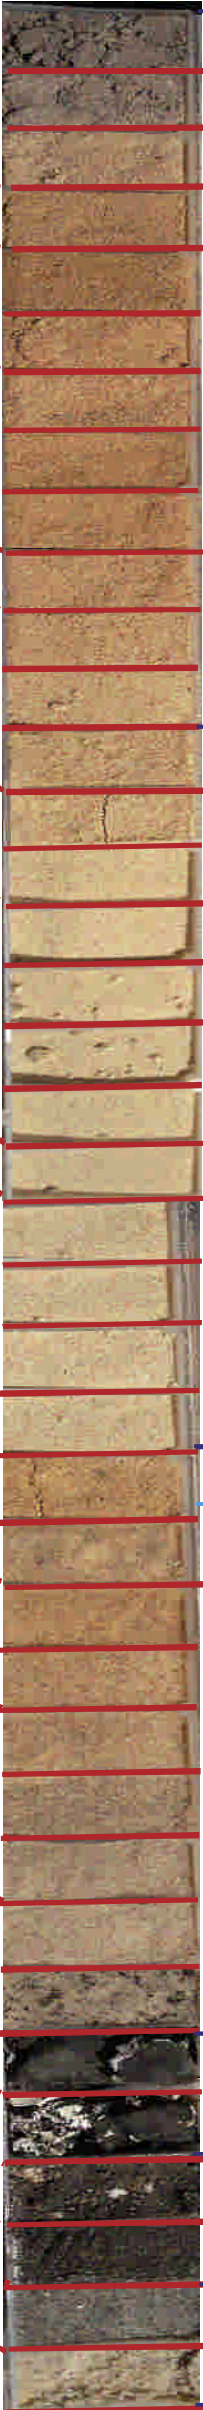
Description	Depth	Graphic Log	Heavy Mineral	Remarks
Ground Surface	0			GR 406803; 6373515; rl 18.2
SAND - Koala grey, darker at top, mg organic at top and silty at base.	0.5			
SAND - Tan / buff, mg, silty in part	1			
SAND - Buff, mg	2			
	3			
	4			
	5			
SAND - Raffia, mg, no silt	6			
	7			
	8			
	9			
	10			
SAND - Raffia, mg, no silt	11			
	12			
	13			
	14			
SAND -Pale Ochre, mc	15			
Water Table 15.4m	16			
	17			
SAND-Cloud grey, minor pale ochre, mcg	18			
	19			
SAND-Cloud grey, with 5-10% black fleck	20			
CLAY - Black, shell common	21			
	22			
SAND - Lead grey, shells	23			
SAND-Light grey, 1-2% black speck minor shell grit, mcg	24			
	25			
	26			
	27

BH5-BL-B
5.5 to 14.5m
