Ammos Resource Management Pty Ltd
C/ Tattersall Lander Pty Ltd

Acid Sulfate Soil Management Plan: Proposed Sand Quarry at 3631 Nelson Bay Road, Bobs Farm, NSW

P1303897JR07V01
November 2020

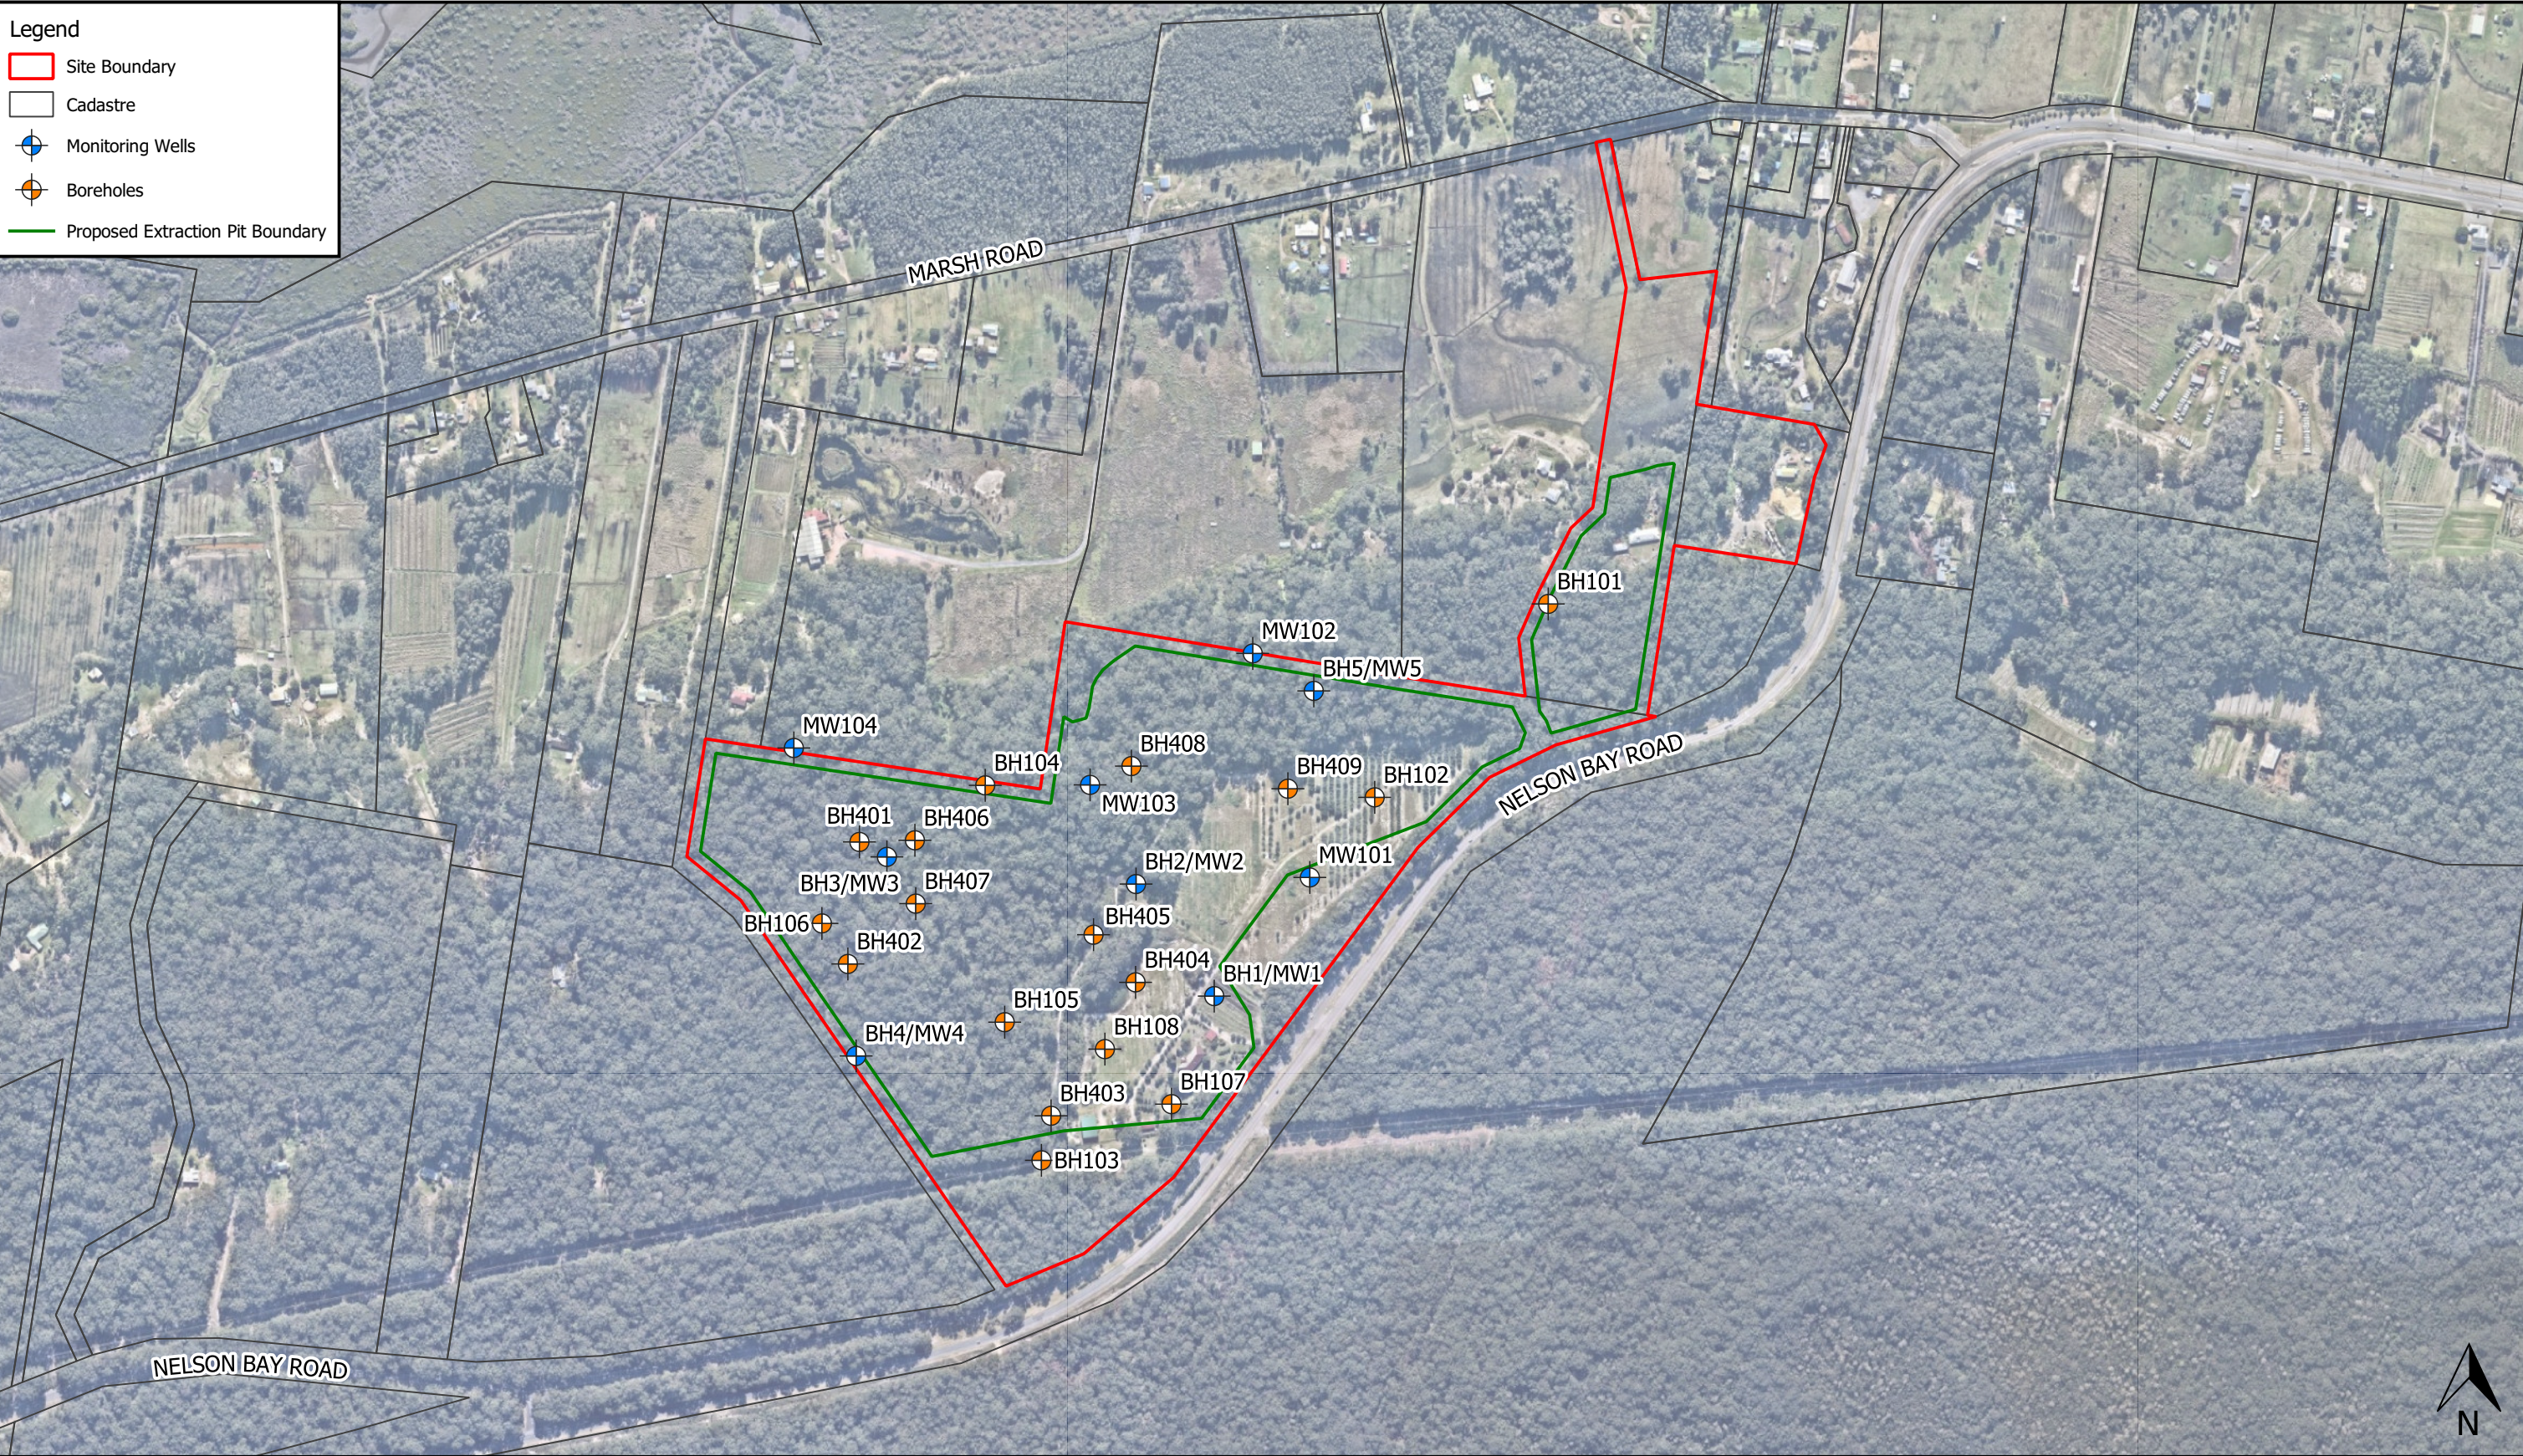
- Site Boundary
- Cadastre
- Monitoring Wells
- Boreholes
- Proposed Extraction Pit Boundary

The approach for managing PASS in each layer of excavated soils is summarised in Table 3 and identified in Figure 2, Attachment A. The approach has been separated into identified soil layers as noted in the ASS report (MA, 2020).
