WILPINJONG COAL PROJECT

Aquatic Ecosystem Assessment

APPENDIX HD
WILPINJONG COAL PROJECT
AQUATIC ECOSYSTEM ASSESSMENT

PREPARED BY
BIO-ANALYSIS: Marine, Estuarine & Freshwater Ecology

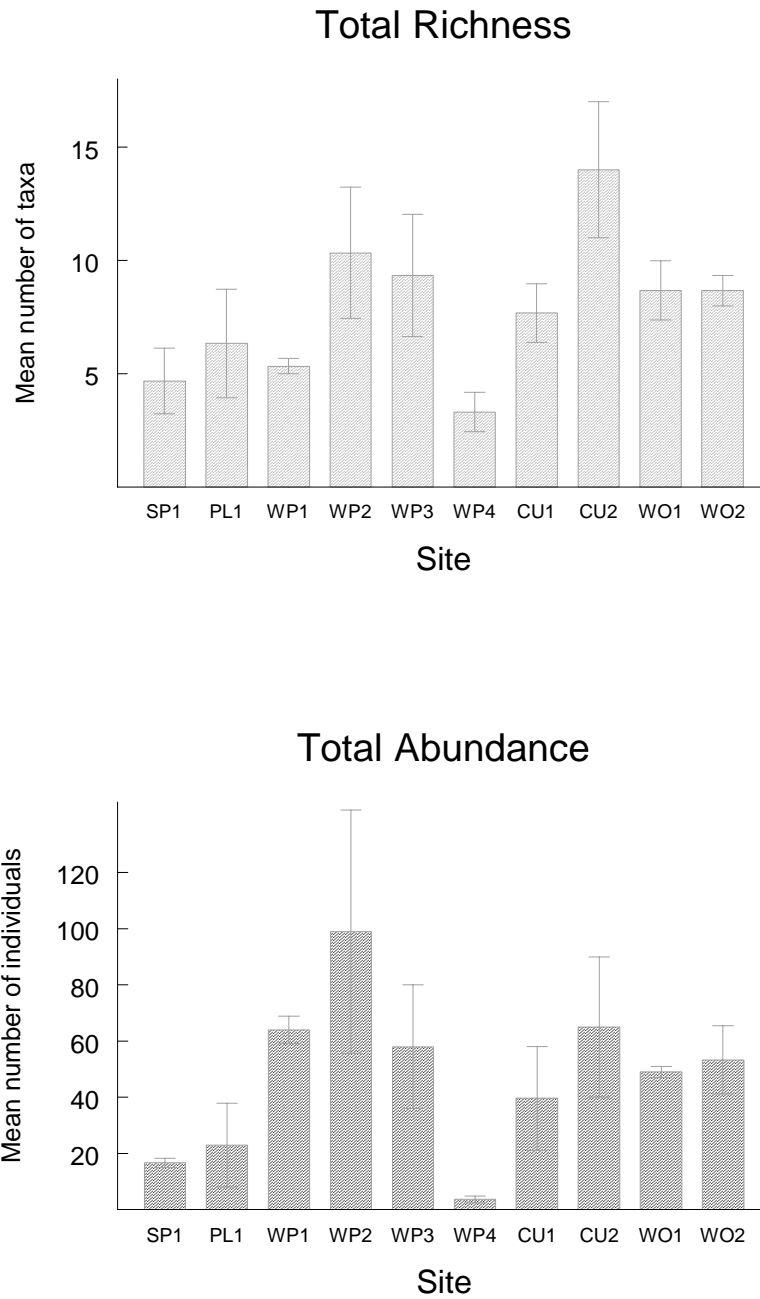
Figure HD-6 Mean (\pm SE) richness and abundance of macroinvertebrates at each site ($n = 3$); SP – Spring Creek, PL - Planters Creek, WP - Wilpinjong Creek, CU - Cumbo Creek, WO - Wollar Creek

There were significant differences in the richness and abundance of macroinvertebrates between sites (Table HD-1; Figure HD-6). Wilpinjong Creek sites 2 and 3, Cumbo Creek sites 1 and 2 and Wollar Creek sites 1 and 2 had greater mean taxa richness than the sites in Spring Creek, Planters Creek and at sites 1 and 4 in Wilpinjong Creek (Figure HD-6). A similar pattern was also found in the mean abundance of macroinvertebrates, with the exception of site 1 in Wilpinjong Creek where abundance levels were higher (Figure HD-6). In general, there was relatively smaller mean richness and abundance of macroinvertebrates at sites that were considered to be highly disturbed.

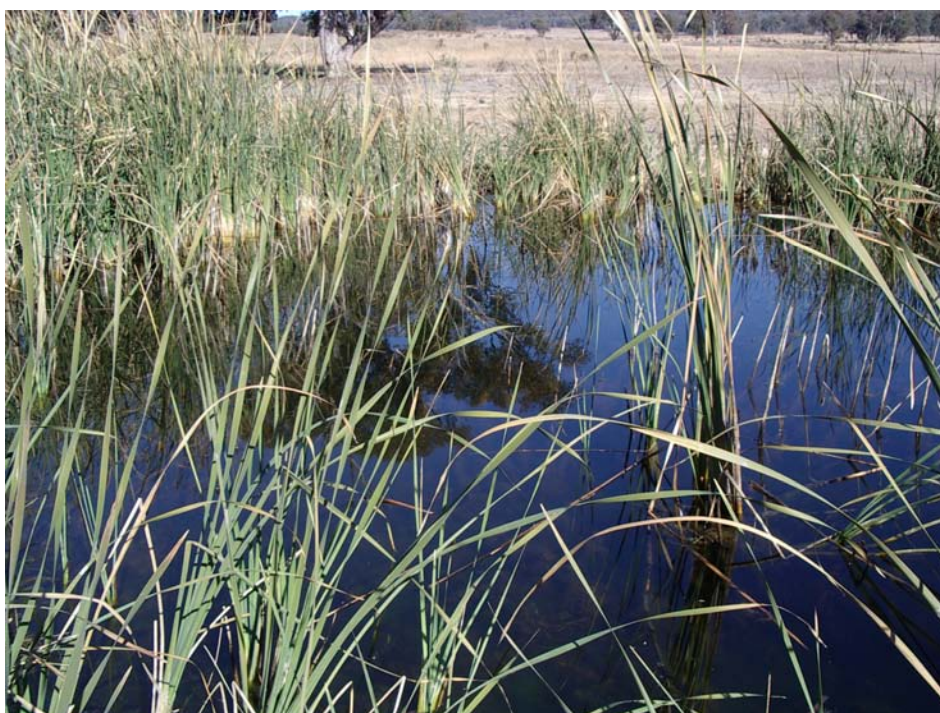
Planters Creek is restricted to a series of five small farm dams which have restricted the natural flow regime. Planters Creek is a natural drainage line that generally only contains water after significant rainfall events. The dry conditions experienced over the months prior to the survey and grazing had reduced or eliminated semi-aquatic plants from the overland flow-path, however there were some scattered *Juncus* spp. and *Carex* sp. recorded (Plate HD-3). Aquatic macrophytes were generally restricted to a single dam, situated approximately 50 m to the south of the Ulan-Wollar Road (Figure HD-3). *Typha orientalis*, *Potamogeton ochreatus* and *Ottelia ovalifolia* were found in this dam (Plate HD-4). Planters Creek was given a poor rating for aquatic habitat.

Plate HD-4 Dam on Planters Creek dominated by *Typha orientalis*

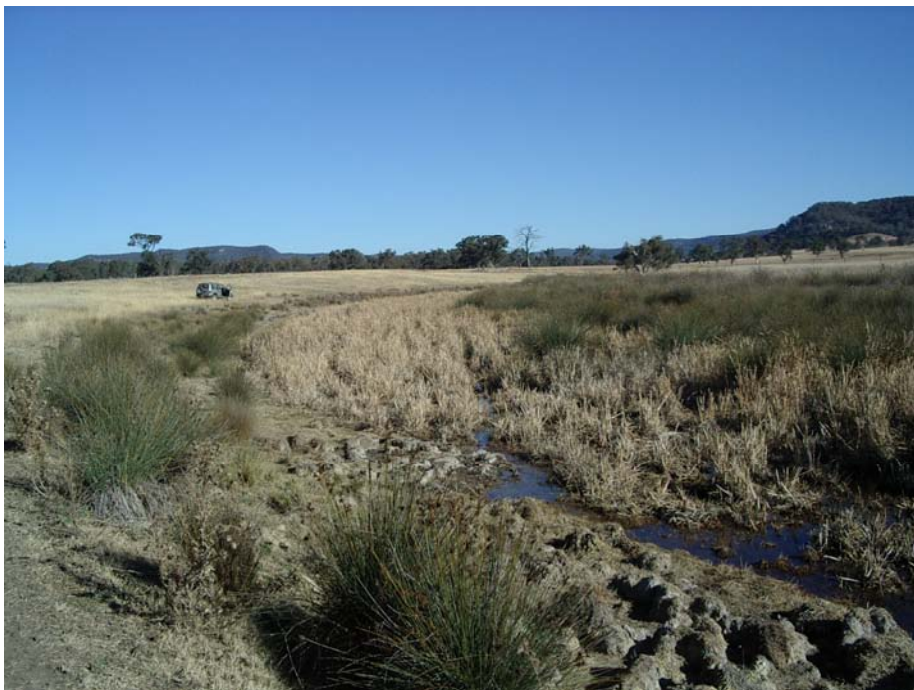
Cumbo Creek has been heavily modified by land clearing and grazing and there is very little riparian vegetation along the creek. Aquatic macrophytes include *Typha domingensis*, *Typha orientalis*, *Phragmites australis* and *Aster subulatus*. The upper parts of the creek drain through some extensive low-lying marshes, which provide some ecological function to the creek system (Plate HD-7). The banks of the creek are not very high and are gently sloped. There was evidence of erosion caused by cattle on both the streambanks and in the streambed itself (Plate HD-8). Cumbo Creek is heavily infested in places with the introduced emergent species *Juncus acutus* (Plate HD-9) which forms monospecific stands at the expense of native species. This species has become a widespread invasive problem in wetlands in NSW. Cumbo Creek was given a poor to moderate rating, due to the occurrence of *Juncus acutus* and the extent of erosion and other weeds which reduce its ecological quality.

Plate HD-8 Disturbance to Cumbo Creek as a result of cattle

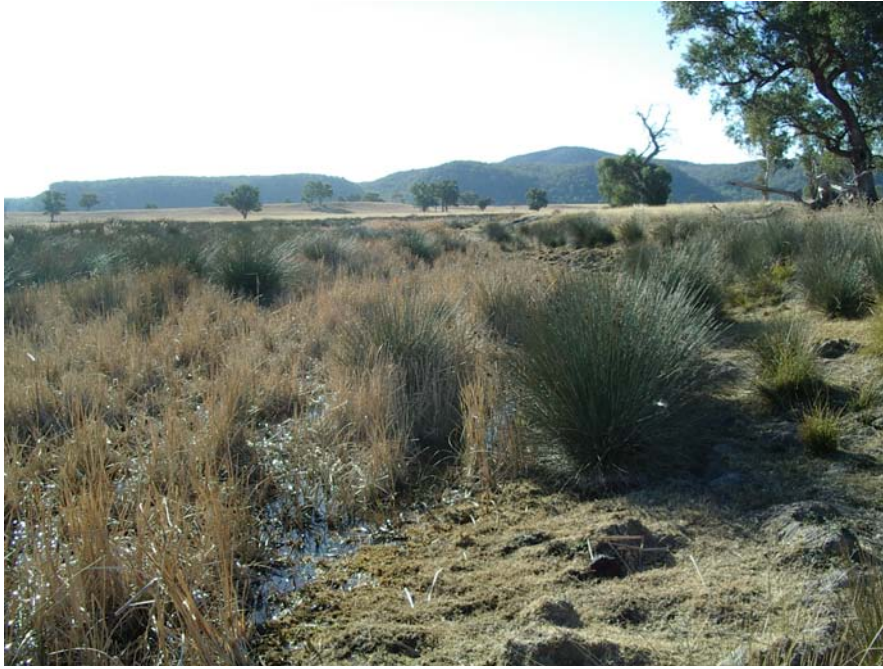
High salinity concentrations can have a deleterious effect on assemblages of macroinvertebrates, fish and aquatic plants. For example, the semi-salt tolerant exotic emergent macrophyte *Juncus acutus* was found to be widespread in Cumbo Creek where it is generally thriving under conditions of elevated salinity. The effects of increased salinity on aquatic macroinvertebrates have been well documented in the Hunter region (Chessman *et al.*, 1997). The potential reduction in salt load described above, combined with the Project creek enhancement works described in Section HD6.2, would be beneficial to the aquatic assemblages of Wilpinjong and Wollar Creeks.

Plate HD-9 The introduced species *Juncus acutus* is widespread along Cumbo Creek

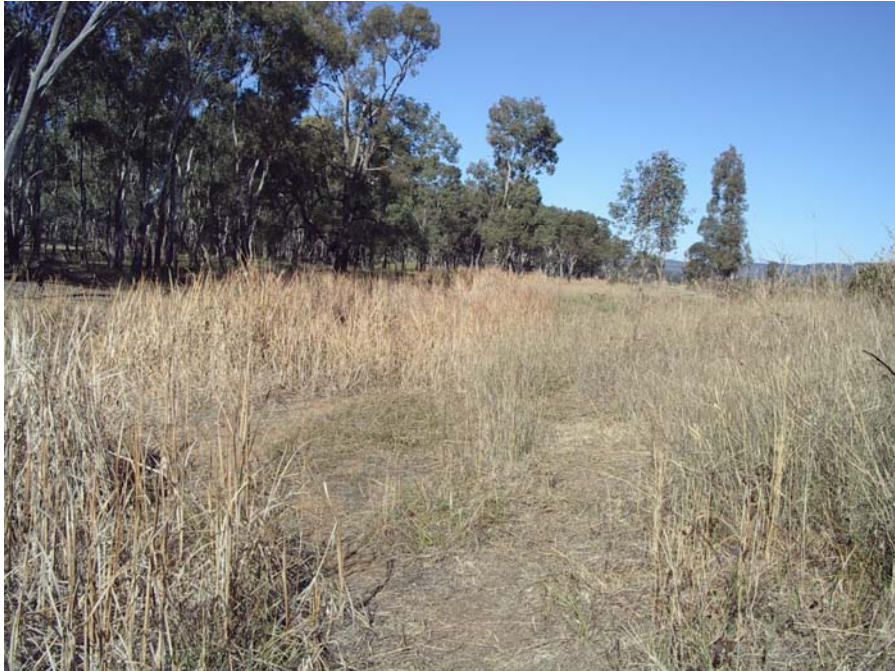
The creek bed along this section was mostly dry and composed of sandy sediments with small pebbles (Plate HD-13). A single isolated pool was found which was quite turbid due to the impacts of cattle and an algal bloom (Plate HD-14). There appeared to have been some replanting done along this section of the creek, however there was still evidence of moderate grazing by cattle. The instream macrophytes included *Typha domingensis*, *T. orientalis*, *Phragmites australis* and *Potamogeton sulcatus* (in the isolated pool) whilst the streambank plants included *Imperata cylindrical*, *Cynodon dactylon*, *Bothriochloa* sp., *Themeda australis*, *Lomandra* sp., *Austrostipa* spp., *Angophora* sp., *Eucalyptus blakelyi* and *E. moluccana*. Weeds included *Aster subulatus*, *Rubus anglocandicans*, *Verbena bonariensis* and *Cirsium vulgare*. This section of the creek was rated as moderate aquatic habitat.

Plate HD-13 Wilpinjong Creek, some evidence of grazing and dry creek beds (section 3)

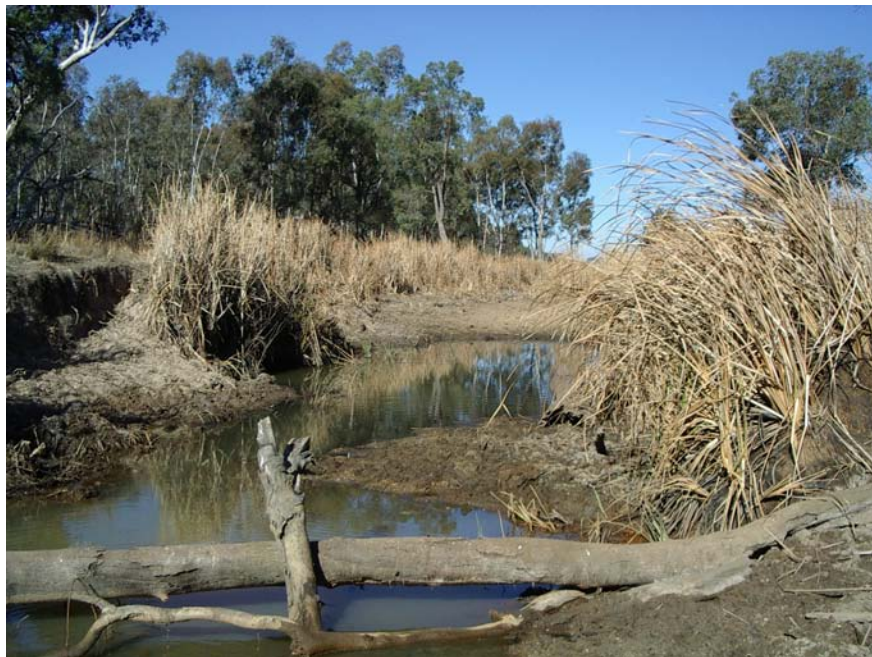
Plate HD-14 Wilpinjong Creek, small isolated pool in section 3 (site WP1)

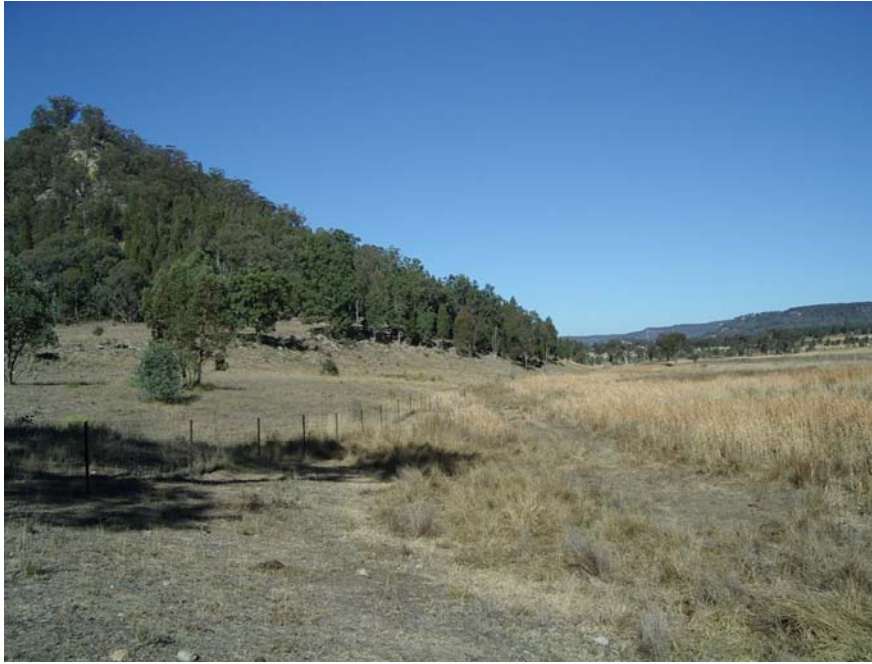
This section of the creek comprised a series of shallow channels (Plate HD-15) and marshy areas (Plate HD-16). Following significant rainfall, the marshes would support a diverse assemblage of plants and animals. The channel of the creek was generally shallow and the streambed was comprised of sandy sediments. There was some water found in scattered shallow depressions. There was evidence of erosion and moderate grazing by cattle. The instream vegetation included *Typha domingensis*, *T. orientalis*, *Phragmites australis*, *Schoenoplectus pungens* and *Paspalum distichum*. Bank and riparian vegetation included *Cynodon dactylon*, *Themeda australis*, *Lomandra* sp., *Austrostipa* spp., *Angophora* sp., *Eucalyptus blakelyi* and *E. moluccana*, whilst weeds included *Aster subulatus*, *Rubus anglocandicans*, *Verbena incompta*, *V. bonariensis*, *Carthamus lanatus* and *Cirsium vulgare*. This section of the creek was rated as moderate aquatic habitat.

Plate HD-15 Wilpinjong Creek, shallow channels and marshy areas (section 4)

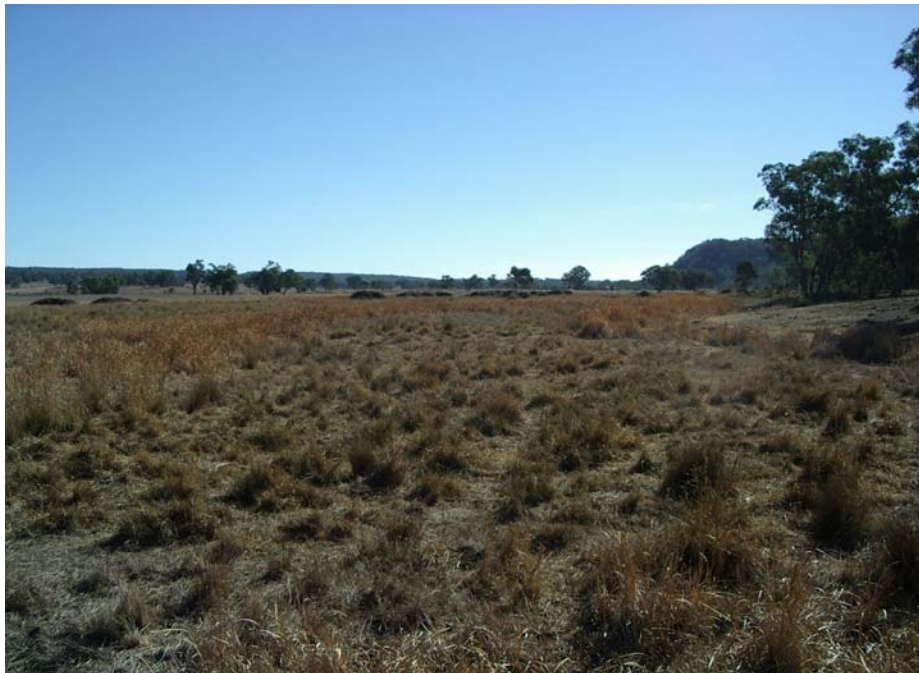
Plate HD-16 Wilpinjong Creek, large area of marsh adjacent to the creek (section 4)

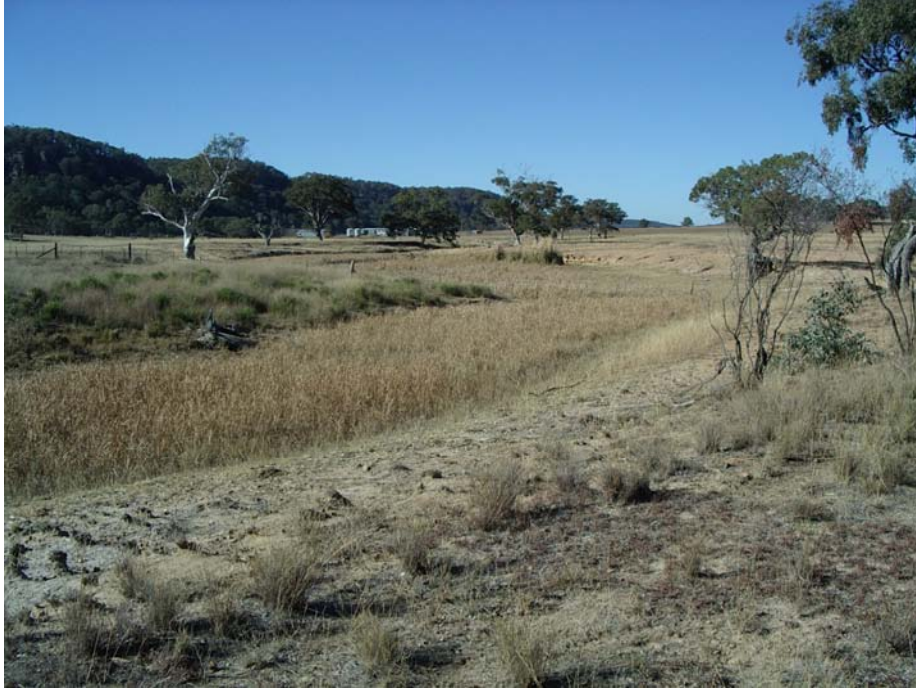
The section of creek consisted of a moderately incised channel approximately 30 to 70 m wide and 3 to 4 m deep (Plates HD-17 and 18). The creek bed consisted of sediments on shale with sandstone overlay. Scattered shallow pools were found with some flowing water. Grazing by stock was evident of both the instream and riparian vegetation. The instream vegetation included *Typha domingensis*, *T. orientalis*, *Phragmites australis* and *Schoenoplectus pungens*. Streambank and riparian plants included *Cynodon dactylon*, *Bothriochloa* sp., *Themeda australis*, *Lomandra* sp. and *Austrostipa* spp., whilst weeds included *Aster subulatus*, *Rubus anglocandicans*, *Verbena incompta*, *V. bonariensis*, *Carthamus lanatus* and *Cirsium vulgare*. This section of the creek was rated as poor aquatic habitat.

Plate HD-17 Wilpinjong Creek, upstream (section 5)

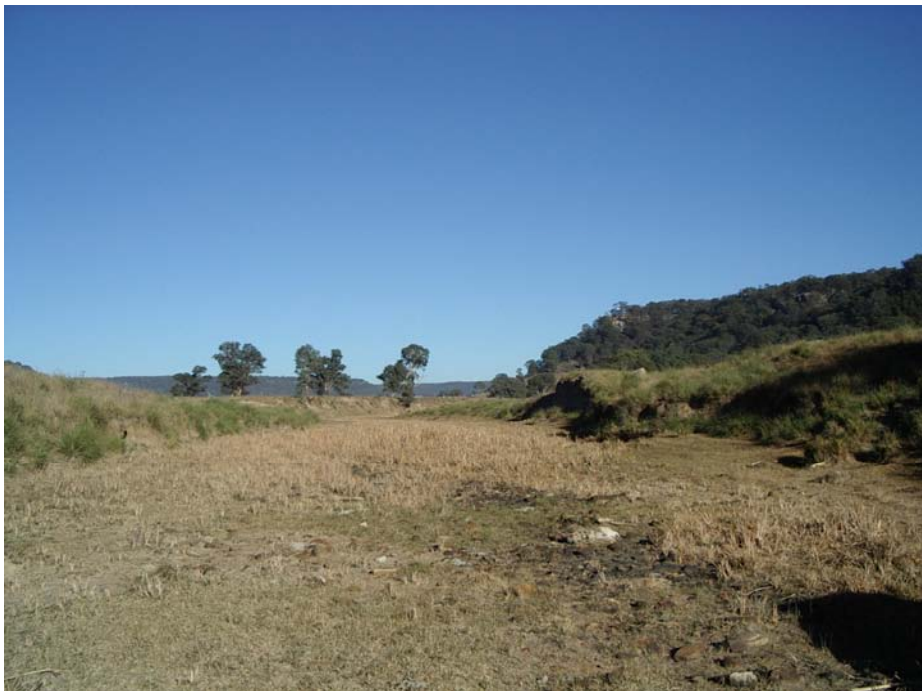
Plate HD-18 Wilpinjong Creek, downstream (section 5)

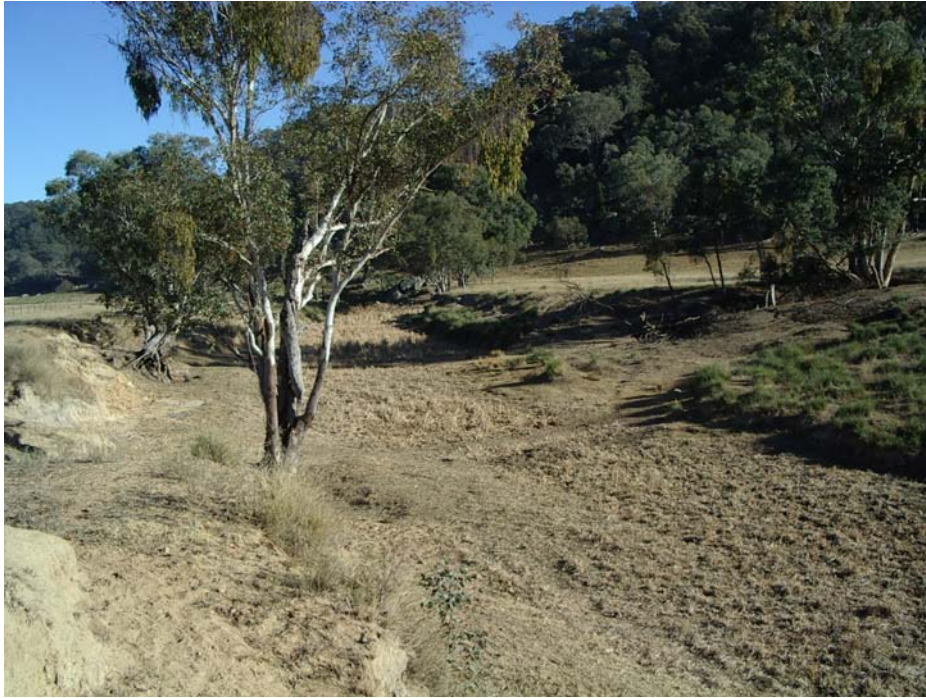
This section of the creek also consisted of scattered shallow pools with intermittently running water with deeply incised steep banks to 3 to 4 m deep (Plates HD-19 and 20). Excessive erosion was evident due to the effects of stock repeatedly grazing the instream and bank vegetation. Instream vegetation included *Typha domingensis*, *T. orientalis*, *Phragmites australis*, *Schoenoplectus pungens*, *S. validus* and *Carex appressa*. Bank and riparian vegetation included *Cynodon dactylon*, *Bothriochloa* sp., *Themeda australis*, *Lomandra* sp., *Austrostipa* spp., *Angophora* sp., *Eucalyptus blakelyi*, *Eucalyptus* sp. and *E. moluccana*. Weeds included *Alternanthera pungens*, *Xanthium spinosum*, *Aster subulatus*, *Rubus anglocandicans*, *Verbena incompta*, *V. bonariensis*, *Carthamus lanatus* and *Cirsium vulgare*. This section of the creek was rated as poor aquatic habitat.

Plate HD-19 Wilpinjong Creek, deeply incised channel with evidence of erosion (section 6)

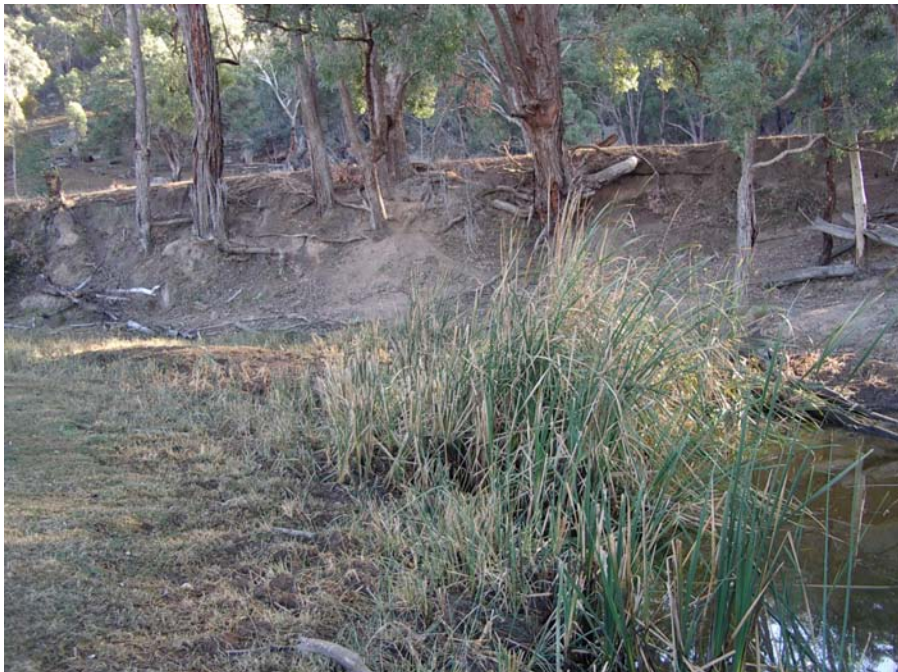
Plate HD-20 Wilpinjong Creek, large pool with *Typha* surrounding the edges (section 6 and site WP2)

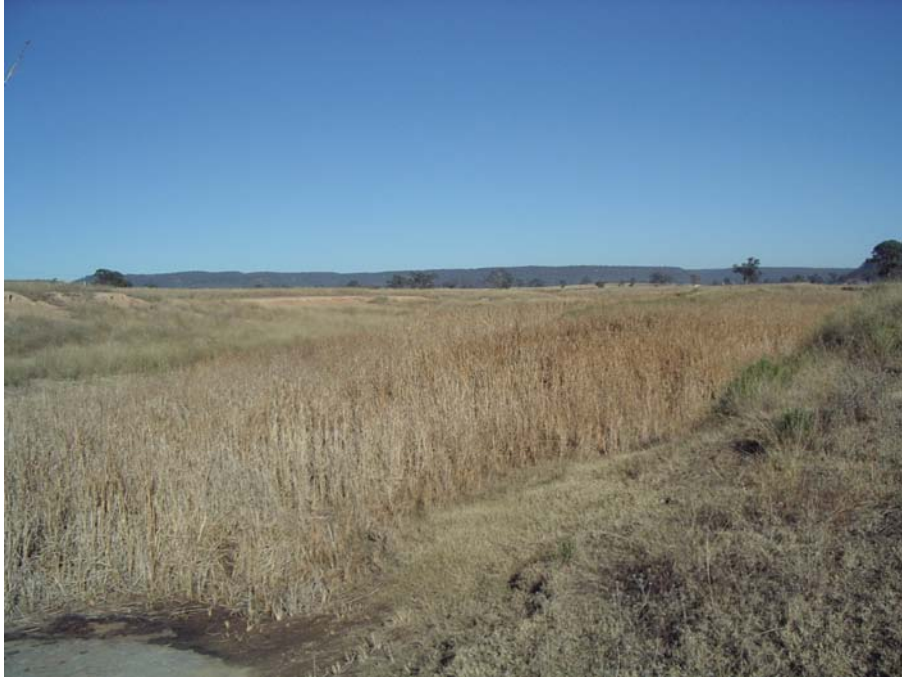
This section of creek was mostly dry with some damp soil in places (Plates HD-21). The banks were incised to a depth of 3 m. The impact of cattle grazing in this section appeared to be low. Instream vegetation included *Typha domingensis*, *T. orientalis*, *Phragmites australis*, *Schoenoplectus pungens* and *Lythrum hyssopifolia*. Bank and riparian vegetation included *Cynodon dactylon*, *Bothriochloa* sp., *Themeda australis*, *Lomandra* sp., *Austrostipa* spp., *Angophora* sp., *Eucalyptus blakelyi*, *Eucalyptus* sp. and *E. moluccana*. The weeds included *Aster subulatus*, *Rubus anglocandicans*, *Verbena incompta*, *V. bonariensis*, *Carthamus lanatus*, *Cirsium vulgare*, *Alternanthera pungens*, *Xanthium spinosum*, *Setaria gracilis* and *Malva parviflora*. This section of the creek was rated as poor aquatic habitat.

Plate HD-21 Wilpinjong Creek, dry channel with deep banks (section 7)

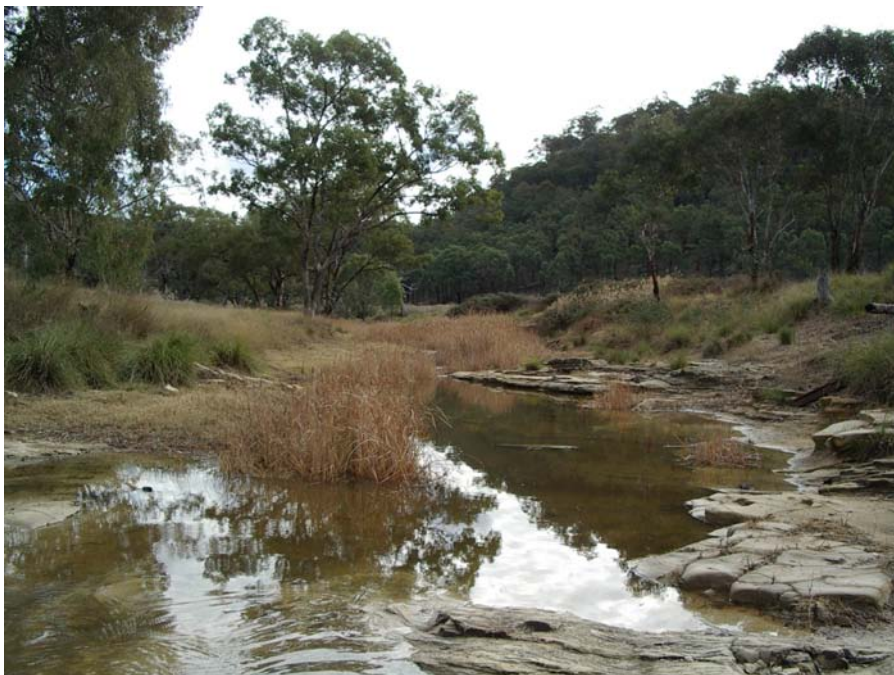
This section was separated from section 7 by a fence. The channel was incised with variably steep to occasional 50 m wide benched banks. The shale shelf has caused water to form shallow ponds (Plate HD-22). Erosion was low to moderate and the area appeared to have had restricted grazing for some time. However, twenty head of Hereford cattle were observed on this section grazing the instream and bank vegetation. The instream vegetation included *Typha domingensis*, *T. orientalis*, *Phragmites australis*, *Schoenoplectus pungens*, *Potamogeton pectinatus* and *Chara* sp. The streambank and riparian vegetation included *Cynodon dactylon*, *Bothriochloa* sp., *Themeda australis*, *Lomandra* sp., *Austrostipa* spp., *Angophora* sp., *Eucalyptus blakelyi*, *Eucalyptus* sp. and *E. moluccana*. Weeds included *Aster subulatus*, *Rubus anglocandicans*, *Verbena incompta*, *V. bonariensis*, *Carthamus lanatus* and *Cirsium vulgare*. This section of the creek was rated as moderate aquatic habitat.

Plate HD-22 Wilpinjong Creek, shallow pools formed over shale bedrock (section 8)

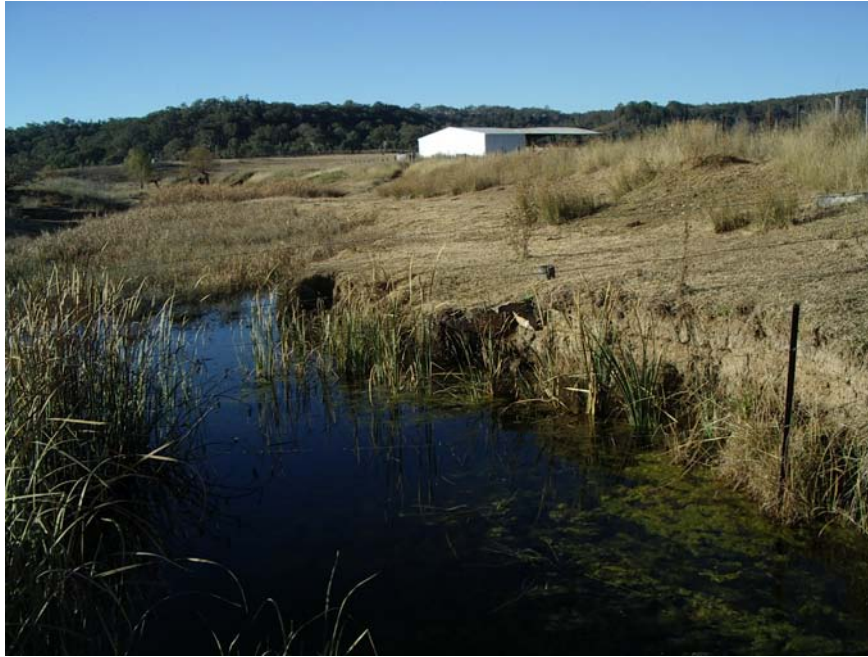
Wilpinjong Creek joins Wollar Creek before the creek enters the Goulburn River National Park (Plate HD-24). Wollar Creek is heavily modified upstream of its confluence with Wilpinjong Creek (Plate HD-25). There was significant erosion and the creek banks were heavily infested with weeds including willows. Blooms of floating algae were also observed within many places which indicated eutrophication. Instream macrophytes were dominated by *Typha domingensis*, *T. orientalis* and *Phragmites australis*. There has been some attempt to restore riparian vegetation at places along Wollar Creek as part of Natural Heritage Trust grants to local land care groups. Wollar Creek was rated as poor aquatic habitat upstream of the road crossing on Mogo Road (Plate HD-26), whilst downstream the aquatic habitat improved and was rated as moderate.

Plate HD-25 Wollar Creek, degraded habitat with floating macroalgae

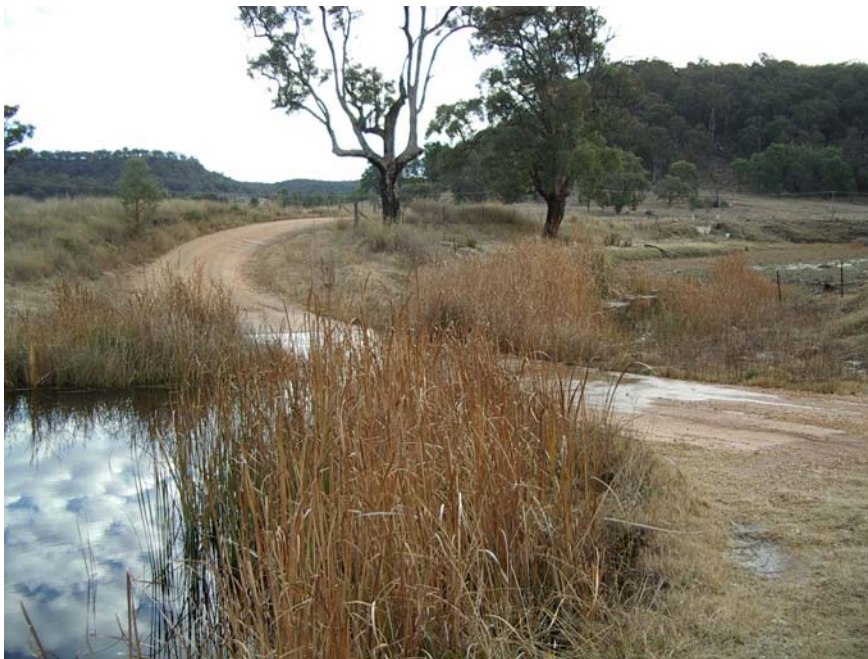
Plate HD-26 Crossing over Mogo Road on Wollar Creek (site WO2)

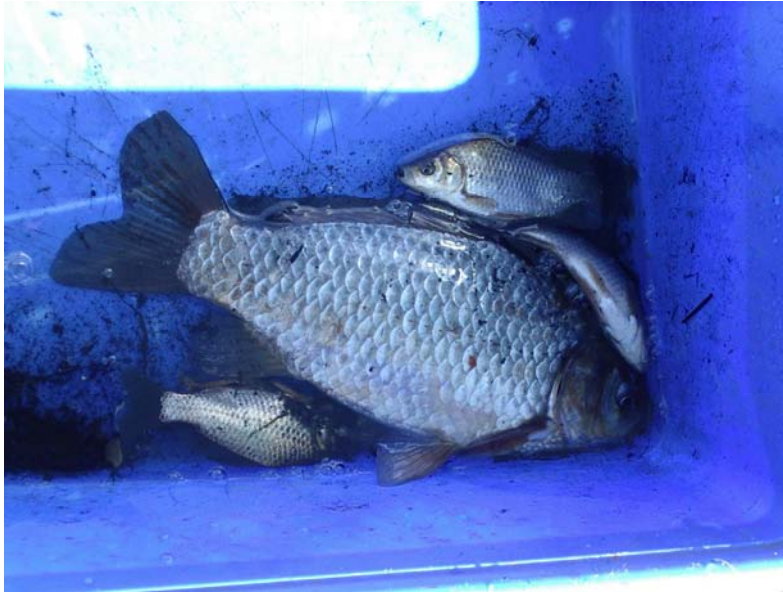
The SIMPER procedure ranked the Mosquito Fish (*G. holbrooki*) as the species that contributed most to the structure of the assemblages at sites SP1, PL1, WP1, WP3, WP4, CU1 and CU2 and the Freshwater Shrimp (*Paratya australiensis*) as the species that contributed most to the structure of the assemblages at sites WP2, WO1 and WO2 (Table HD-4). The introduced Mosquito Fish (*G. holbrooki*) was ranked the next highest contributor to the structure of the fish assemblages at sites WP2, WO1 and WO2 (Table HD-4). Long Finned Eels (*Anguila reinhardtii*) were ranked as number 2 in Spring Creek and Planters Creek and Gold Fish (*Carassius auratus*) were ranked as number 2 at site 4 on Wilpinjong Creek (Plate HD-27).

Plate HD-27 Gold Fish collected at site 1 on Wilpinjong Creek (site WP1)
