Visual impact assessment

Settlement City Shopping Centre – Port Macquarie
Environmental Assessment proposed Stage 1

SETTLEMENT CITY SHOPPING CENTRE REDEVELOPMENT, PORT MACQUARIE

VISUAL IMPACT ASSESSMENT

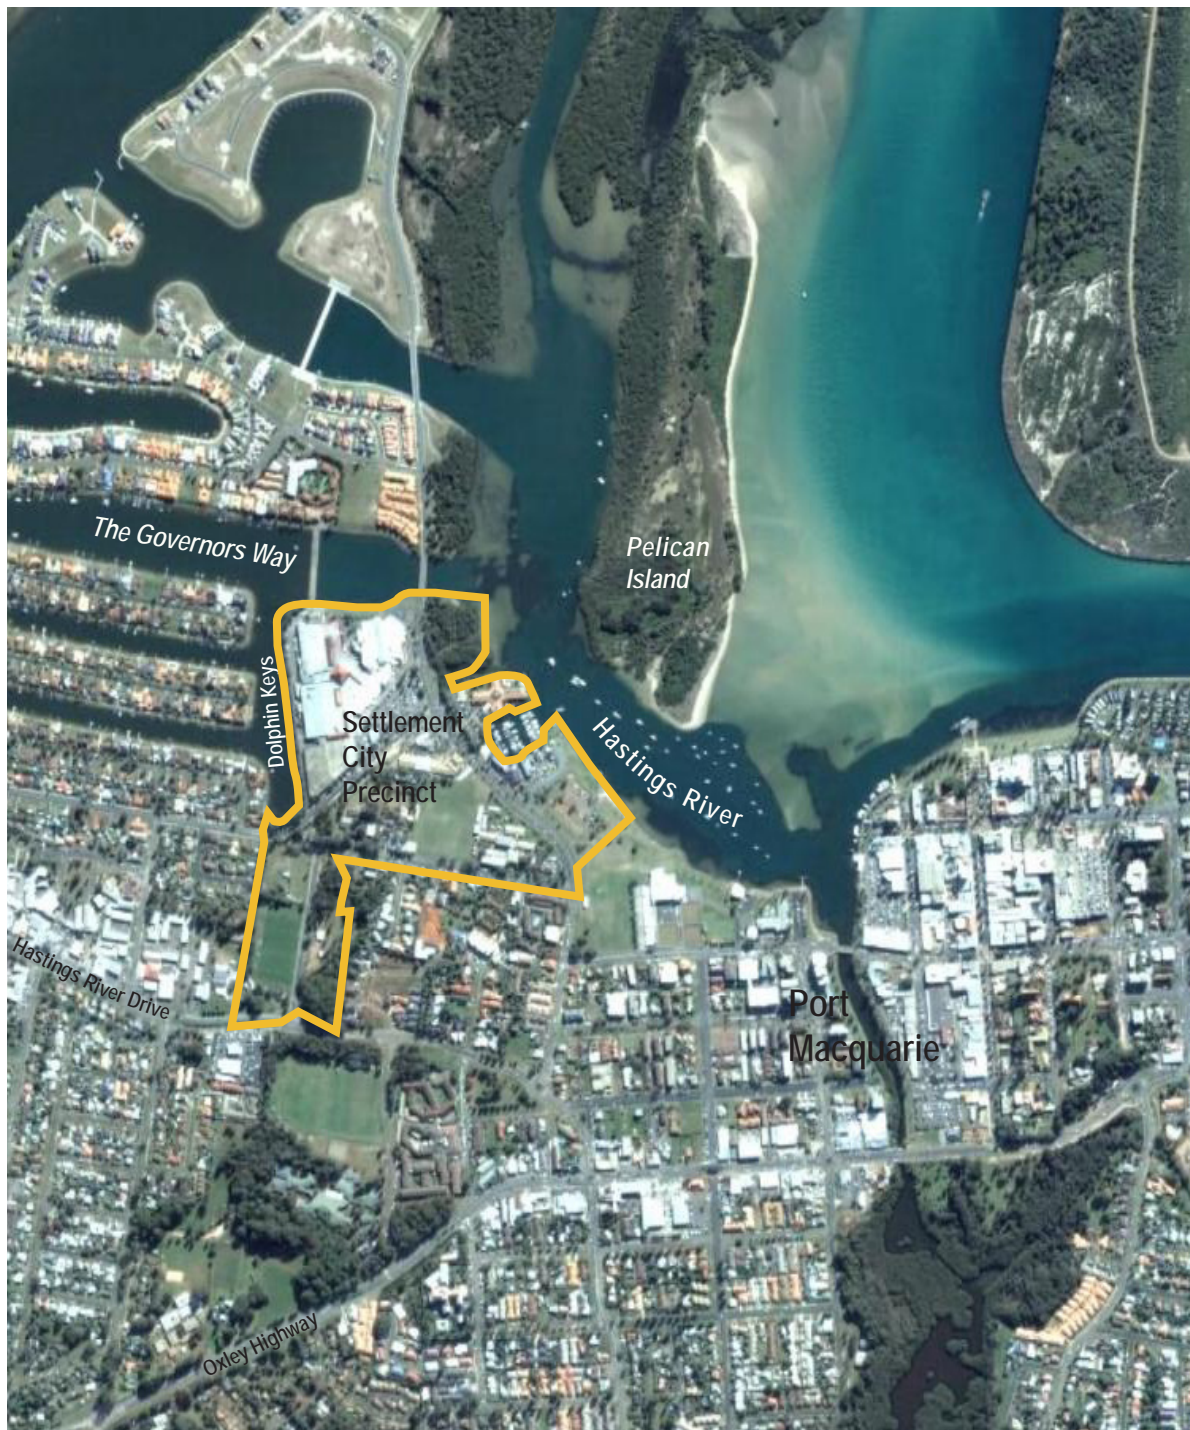
Fig 1.1

Settlement City Precinct Boundary

Settlement City, Port Macquarie • Visual Impact Assessment
LOCALITY PLAN

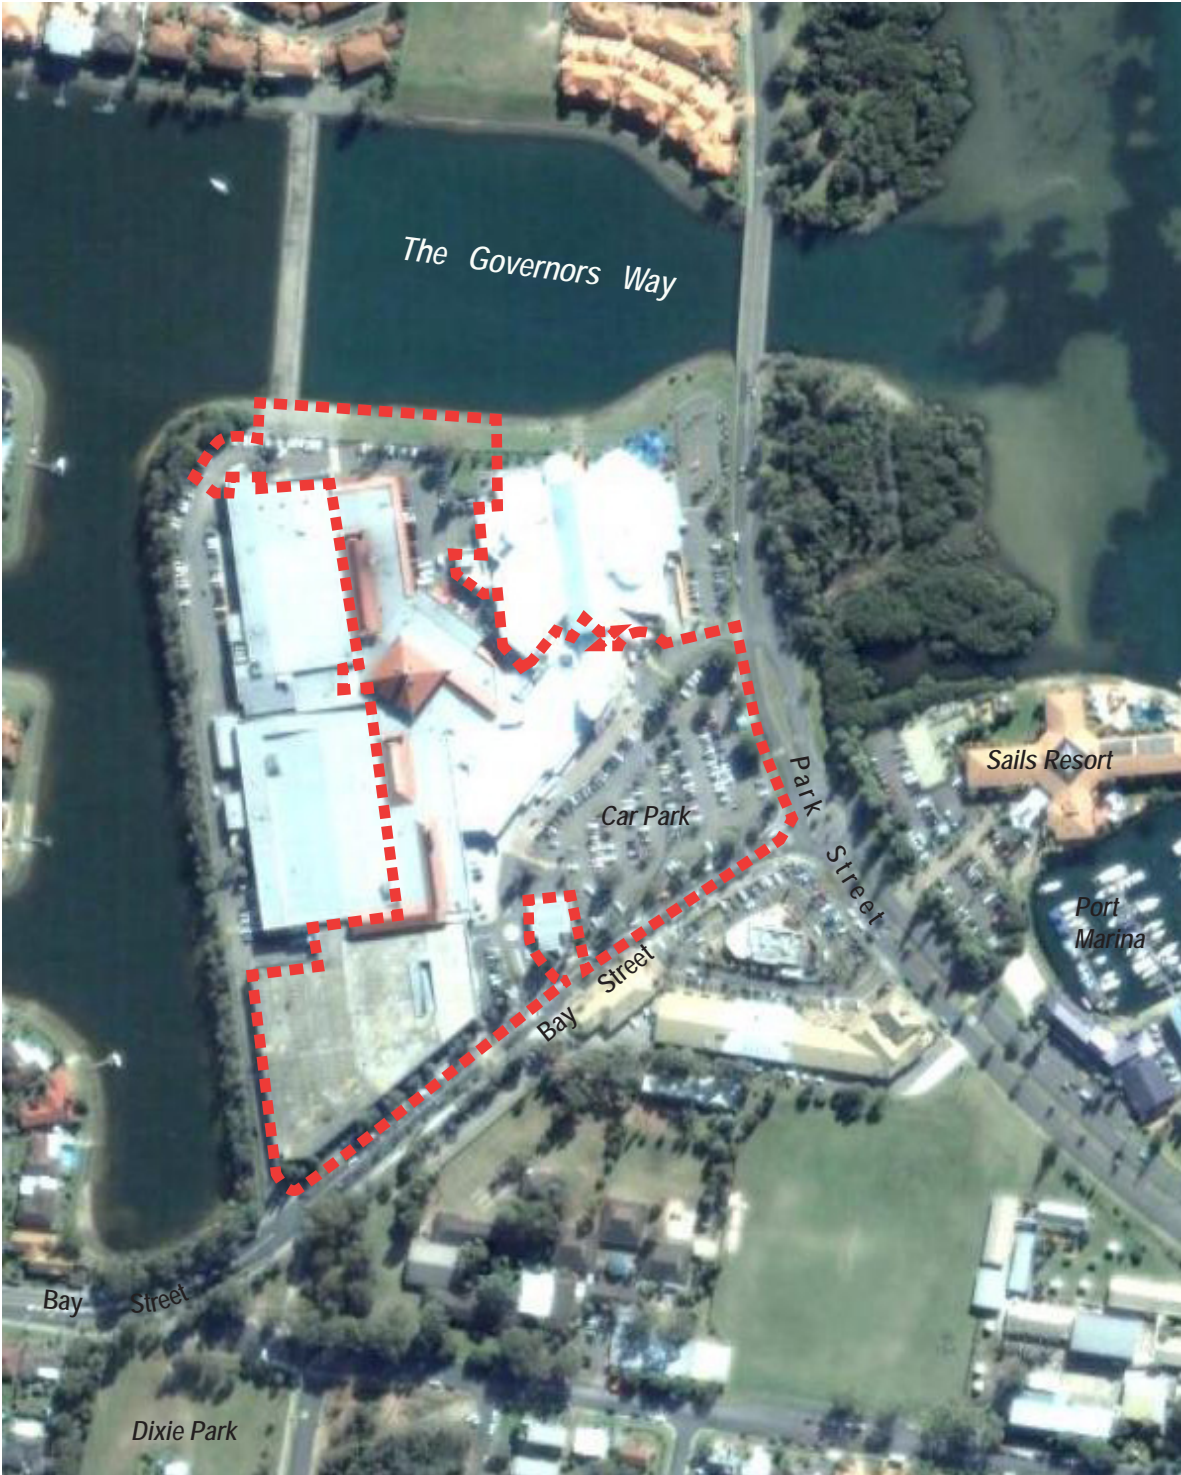
Fig 1.2

Settlement City, Port Macquarie • Visual Impact Assessment
SITE PLAN AND REDEVELOPMENT AREA

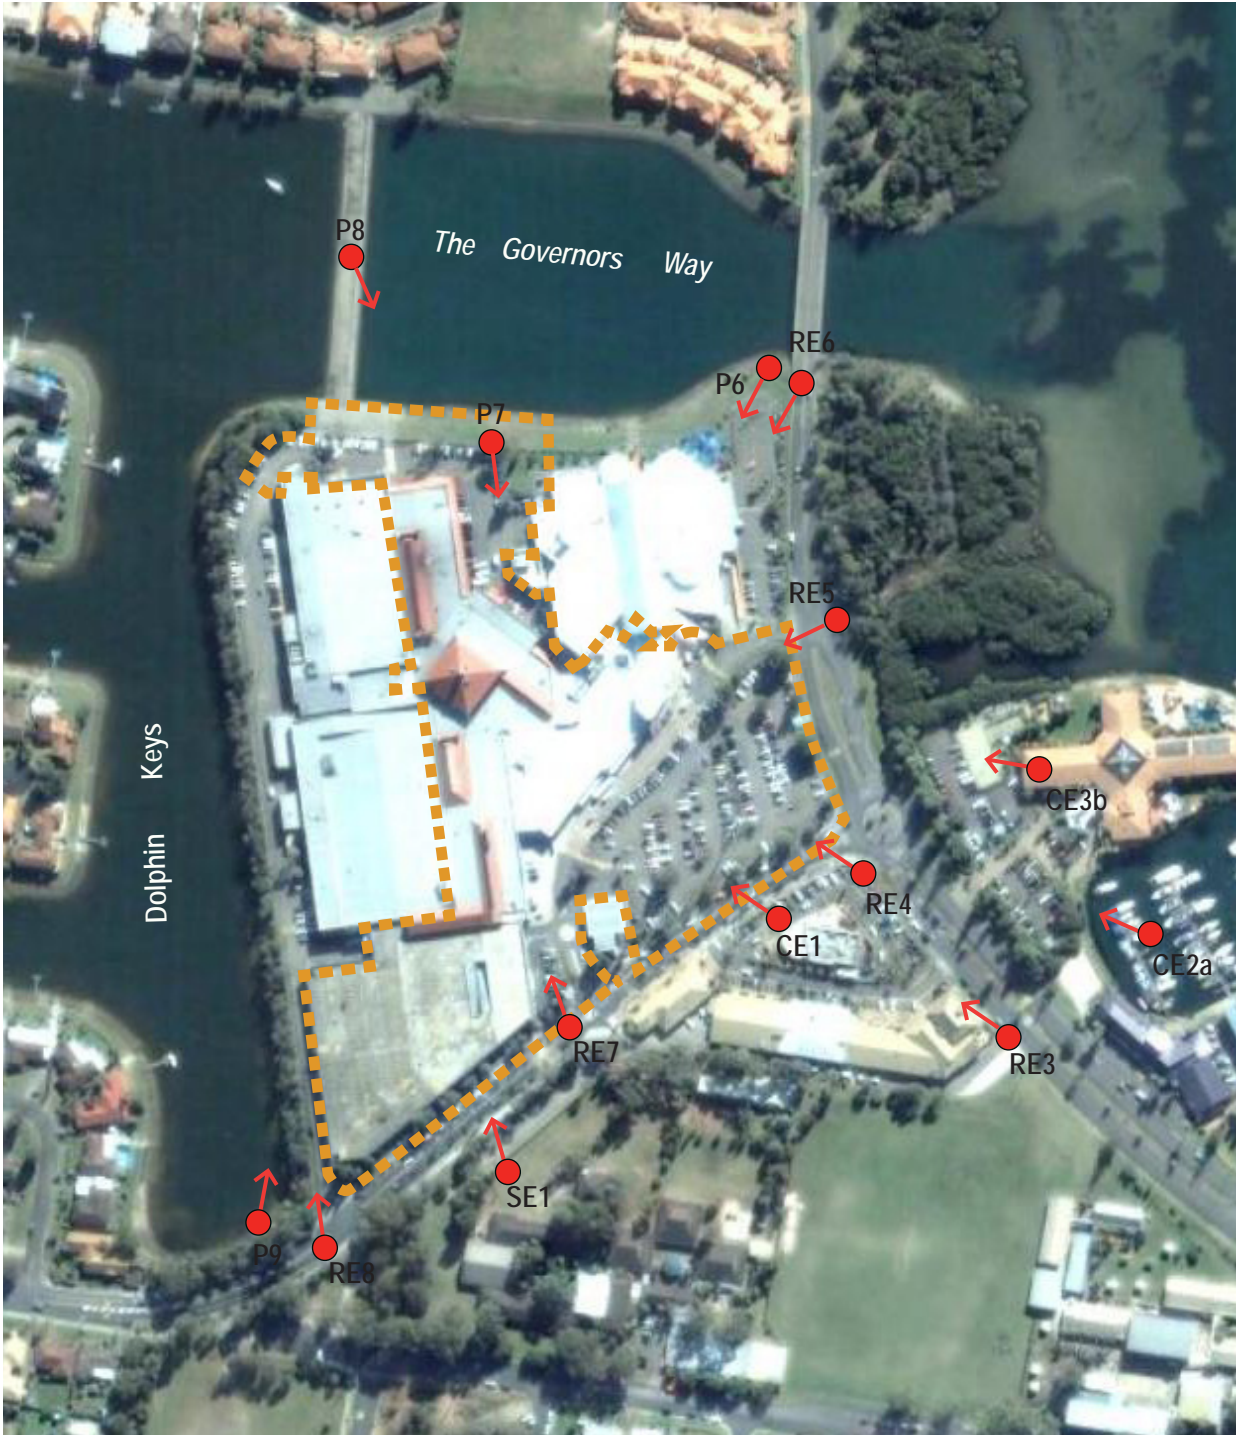
Fig 2.2

Settlement City, Port Macquarie • Visual Impact Assessment
VISUAL RECEPTOR LOCATIONS - LOCAL

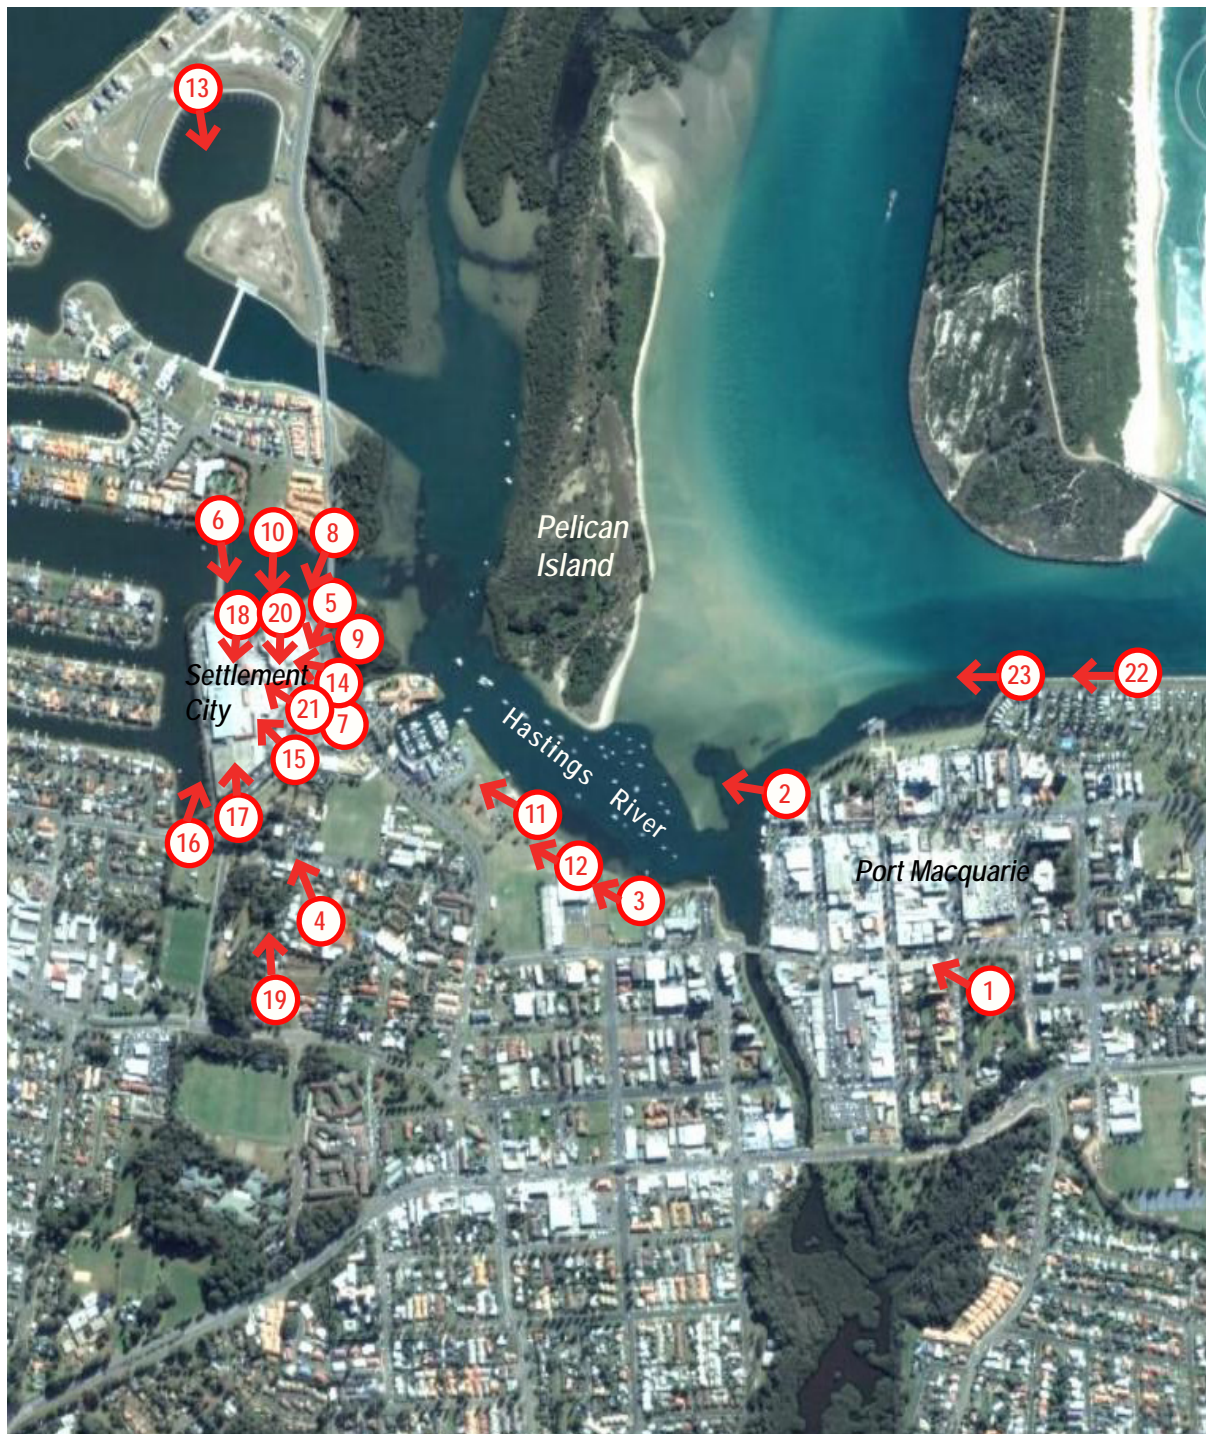
Fig 2.3

Photo Location sites
(refer to site photos)

Settlement City, Port Macquarie • Visual Impact Assessment
PHOTO LOCATIONS

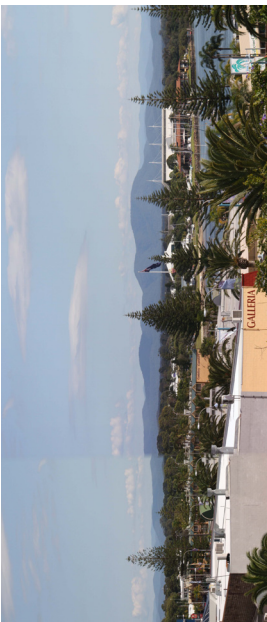
Photo 1 - View across rooftops from forecourt of St. Agnes Church. Panthers Club roof visible middle distance on the right

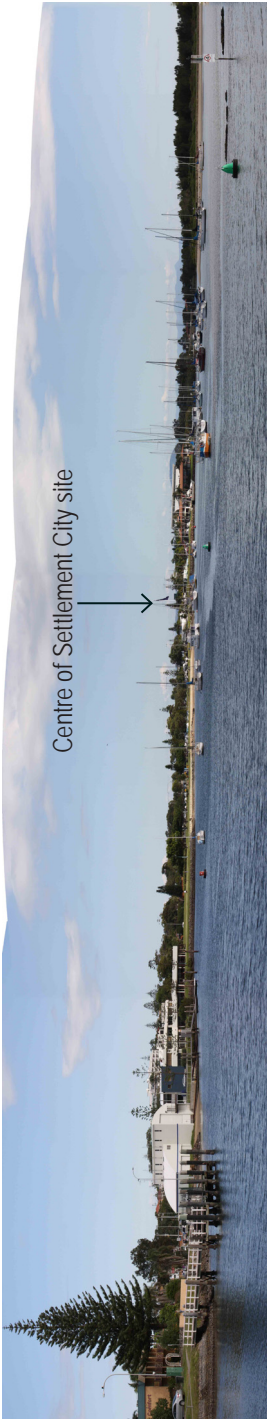
Photo 2 - View from tour boat wharf looking west towards the site

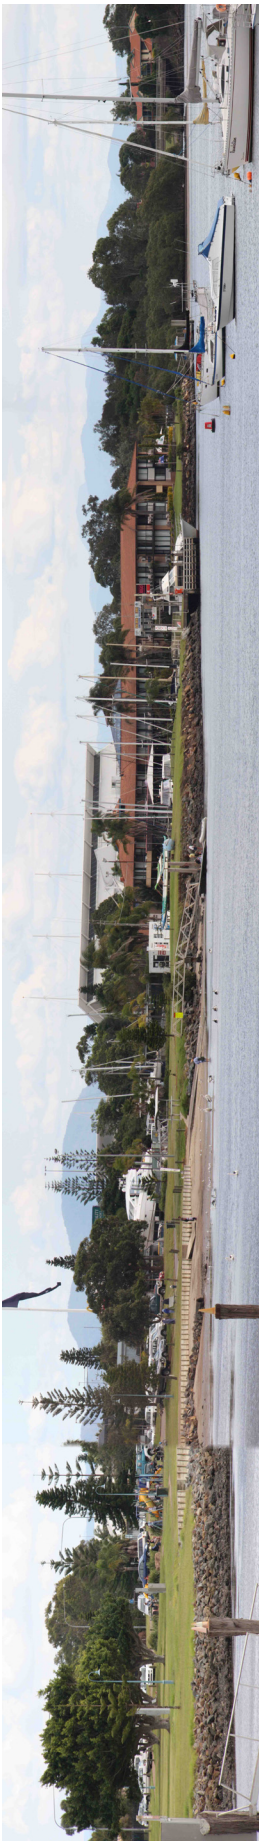
Photo 3 - Telephoto view from foreshore walk with Panthers Club roof visible in centre

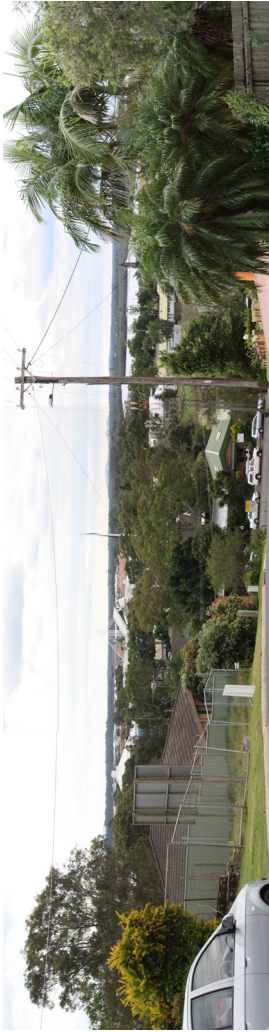
Photo 4 - View to site from top of Hastings Avenue

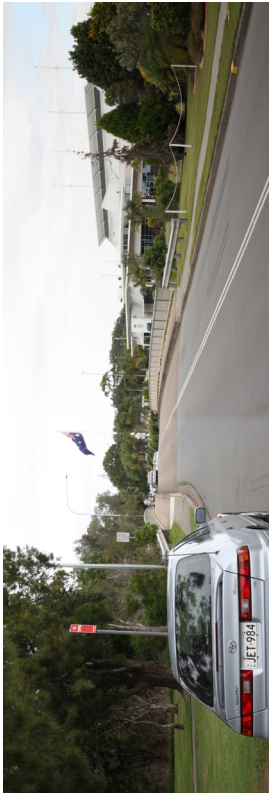
Photo 5 - View south from Park Street north of bridge

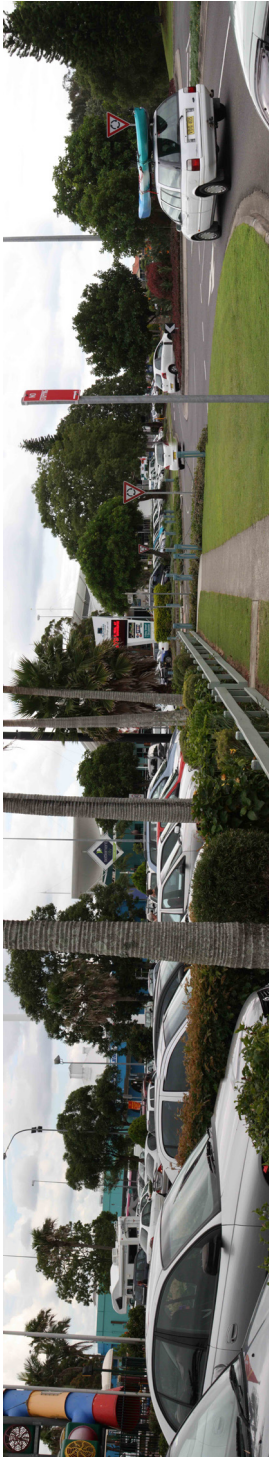
Photo 7 - View from footpath to roundabout at Park and Bay Street junctions. Note street tree planting dominates mid ground
