REMEDIAL ACTION PLAN FOR KNOWN SOIL CONTAMINATION INTERMODAL LOGISTICS CENTRE @ ENFIELD

Report Date: 23 June 2009
Project Ref: ENVIRHOD00634AA

**RE: Remediation Action Plan for Known Soil Contamination
Intermodal Logistics Centre @ Enfield**

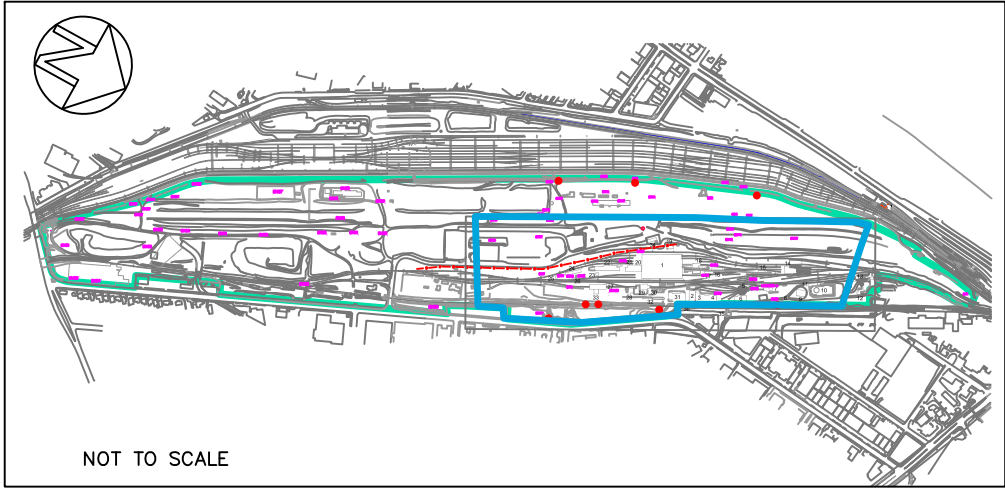
client:	SYDNEY PORTS CORPORATION	
project:	ILC ENFIELD DEMOLITION AND REMEDIATION	
title:	EXCEEDENCE LOCATIONS FOR DELEC - RAP	
project no:	ENVIRHOD00634AA-D02	figure no: FIGURE 5A

- TP TESTPIT LOCATIONS
- BD SOIL SAMPLE LOCATIONS
- BH BORE HOLE LOCATIONS
- SS SURFACE SAMPLE LOCATIONS
- RAIL TRACKS
- EXTRACT BOUNDARY
- SITE BOUNDARY
- STAINING
