REMEDIAL ACTION PLAN PREPARED BY SOPHIE WOOD

**Proposed Materials Recycling
Facility, Newbridge Road,
Moorebank, NSW**
Remedial Action Plan

Moorebank Recyclers Pty Ltd

September 2016

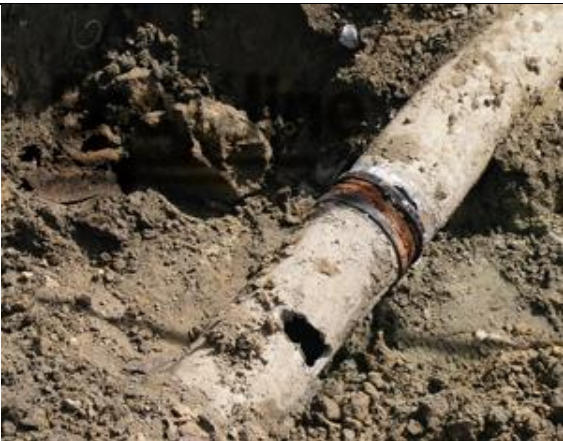
<p>Example of buried Asbestos Containing Material (ACM) pipe.</p>
Buried subsurface structures (Underground Storage Tanks (USTs), sumps, holding).	<ul style="list-style-type: none"> • Stop work; • Barricade off area and make it safe; • Report find to site foreman and the Environmental Consultant's site manager; • Do not attempt to remove find or further expose it until authorised by the Environmental Consultant's site manager; • Environmental Consultant's personnel to document nature and extent of subsurface structure; • Environmental Consultant's site manager to notify NSW Accredited Site Auditor of find and proposed strategy to manage the find; • Prior to recommencing works (and removal), Environmental Consultant's site manager to confirm any requirements for controls, appropriate PPE, monitoring, safety measures and material handling requirements; and • Refer to AS 4976 – 2008, NSW EPA UPSS Regulations/ Technical Notes and WorkCover Factsheets

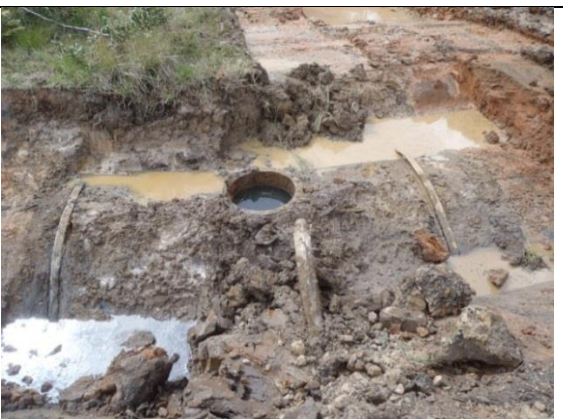
<p>Example of an Underground Storage Tank (UST)</p>
