DM & RD DOSSOR

PROPOSED RESIDENTIAL SUBDIVISION

1 Survey Street, Lennox Head, NSW

SLOPE STABILITY ASSESSMENT

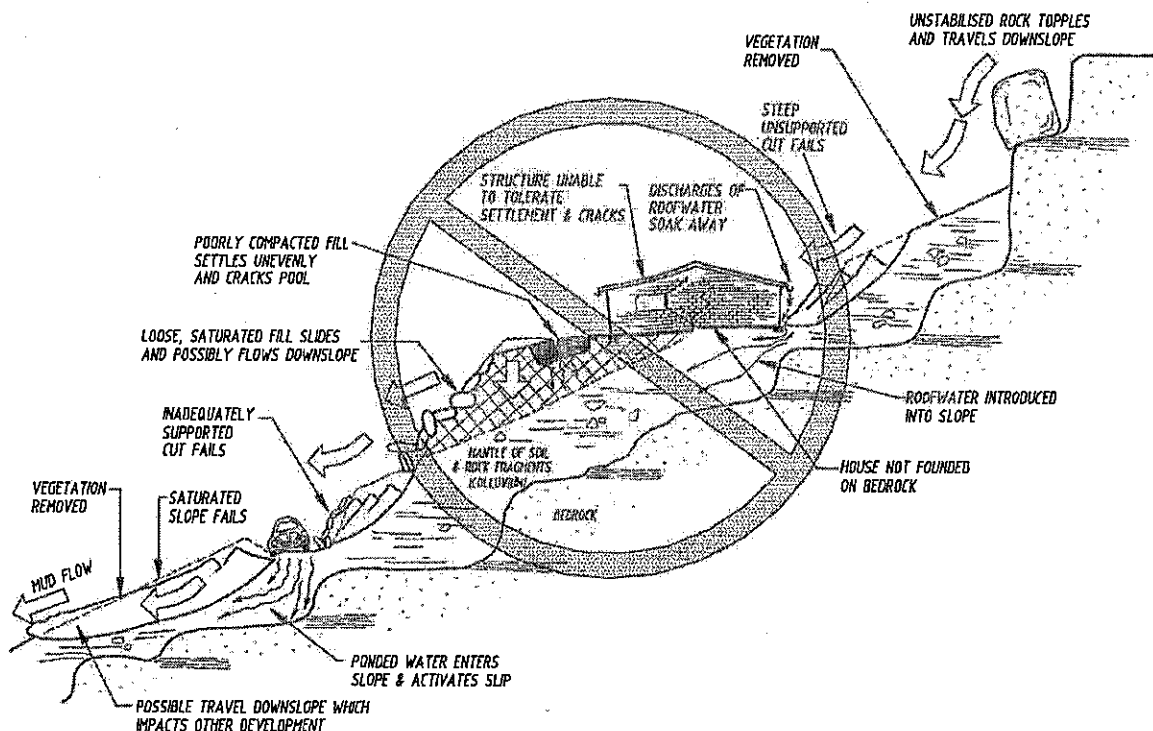
FIGURE 4: ILLUSTRATIONS OF GOOD AND POOR HILLSIDE PRACTICE

EXAMPLES OF GOOD HILLSIDE PRACTICE

EXAMPLES OF POOR HILLSIDE PRACTICE

This figure is an extract from LANDSLIDE RISK MANAGEMENT CONCEPTS AND GUIDELINES as presented in *Australian Geomechanics*, Vol 35, No 1, 2000 which discusses the matter more fully.

- The design and construction of all developments should be carried out in accordance with good hillside practice as shown on Figure 3 and Figure 4, and the relevant recommendations for development presented in this report.
