Mangoola Open Cut

2019
Annual
Review

1 January 2019 to 31 December 2019

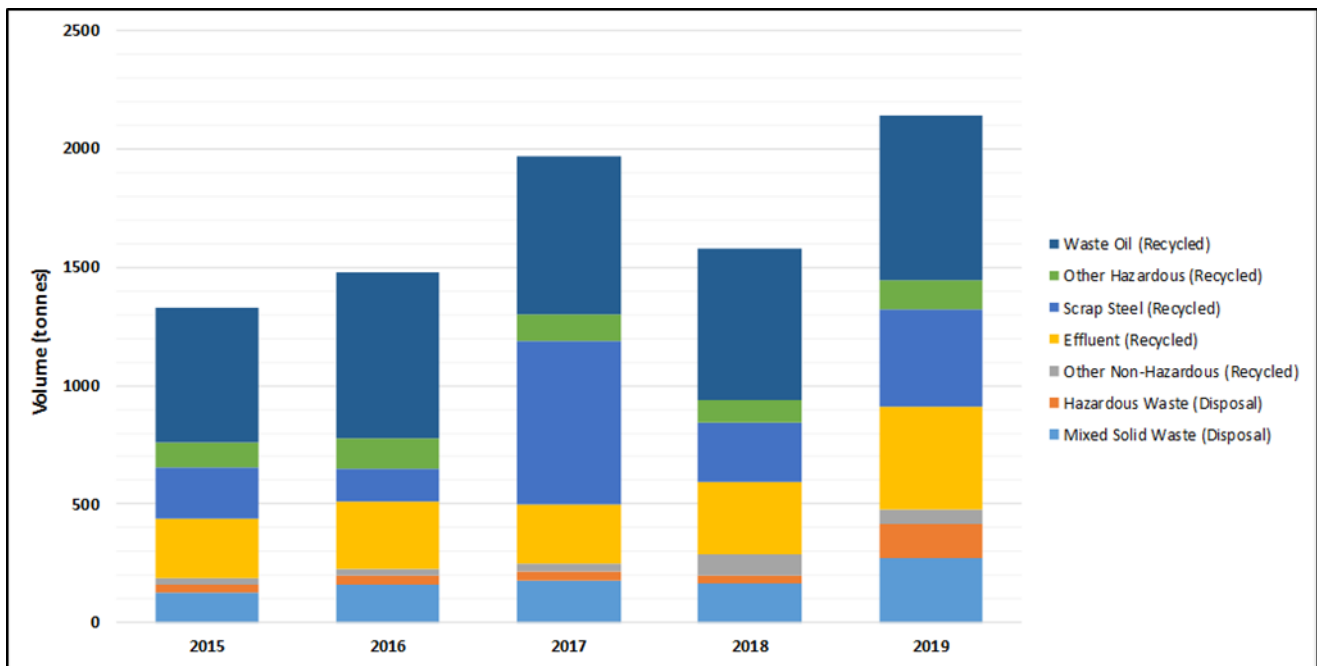
Figure 3 2014-2019 Waste Streams Generated

The major waste streams during the reporting period were waste oil (696 tonnes), scrap steel (404 tonnes), mixed solid waste (234 tonnes), asbestos (100 tonnes), concrete (157 tonnes) and effluent (432 tonnes).

A summary of waste disposal from 2015 to 2019 is presented in **Figure 3**.

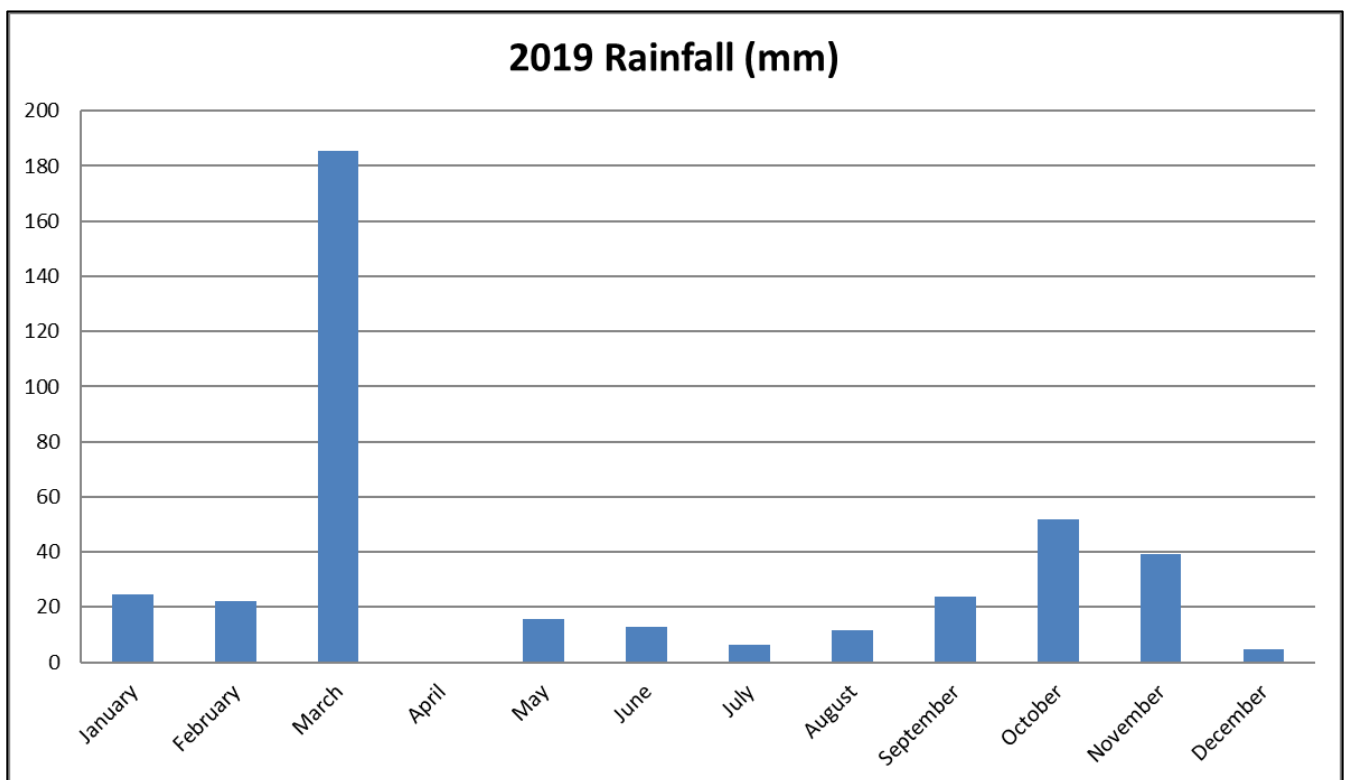
Figure 4 WSN 2019 Rainfall Data

In general, 2019 was another dry year as drought conditions continued across NSW. Total annual rainfall for 2019 was 399 mm, which was comparable to 2018 rainfall (366 mm), however much less than 2016 (632mm). As shown in **Figure 4**, annual rainfall at WSN was lowest in April and highest in March 2019. Long term rainfall data is presented in **Appendix B**, which shows that rainfall at the site has been low since March 2017. This is also supported by **Figure 5**, a map produced by the Bureau of Meteorology (BOM) which shows rainfall deficiencies from 1 January 2019 to 31 December 2019.

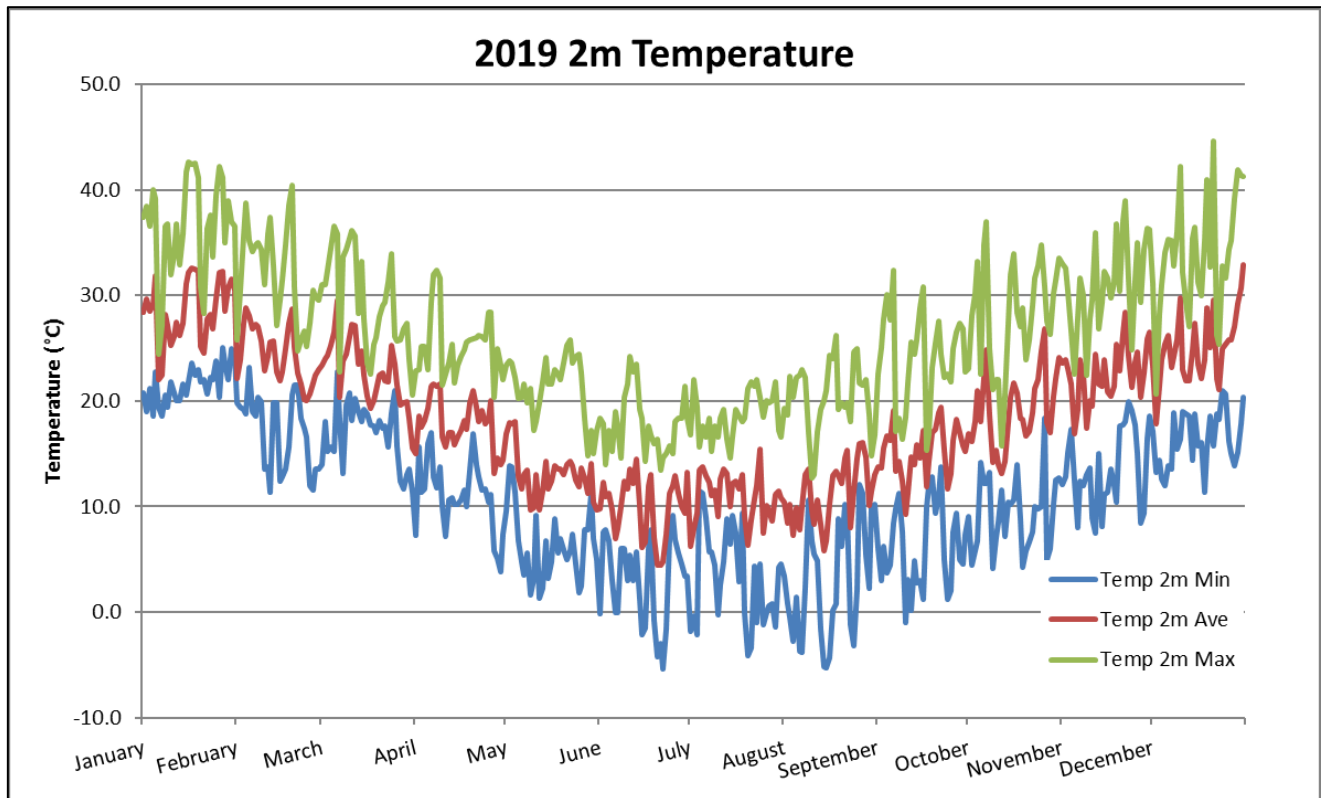
Figure 6 WSN 2019 2m Temperature Data

As shown in **Figure 6**, the daily minimum and maximum 2 m temperatures ranged from -5.4°C to 44.6°C respectively, with an average daily maximum of 26.4°C, which is warmer than the 2018 daily average of 25.5°C. Average humidity during 2018 ranged from 12.9% to 94.4%.

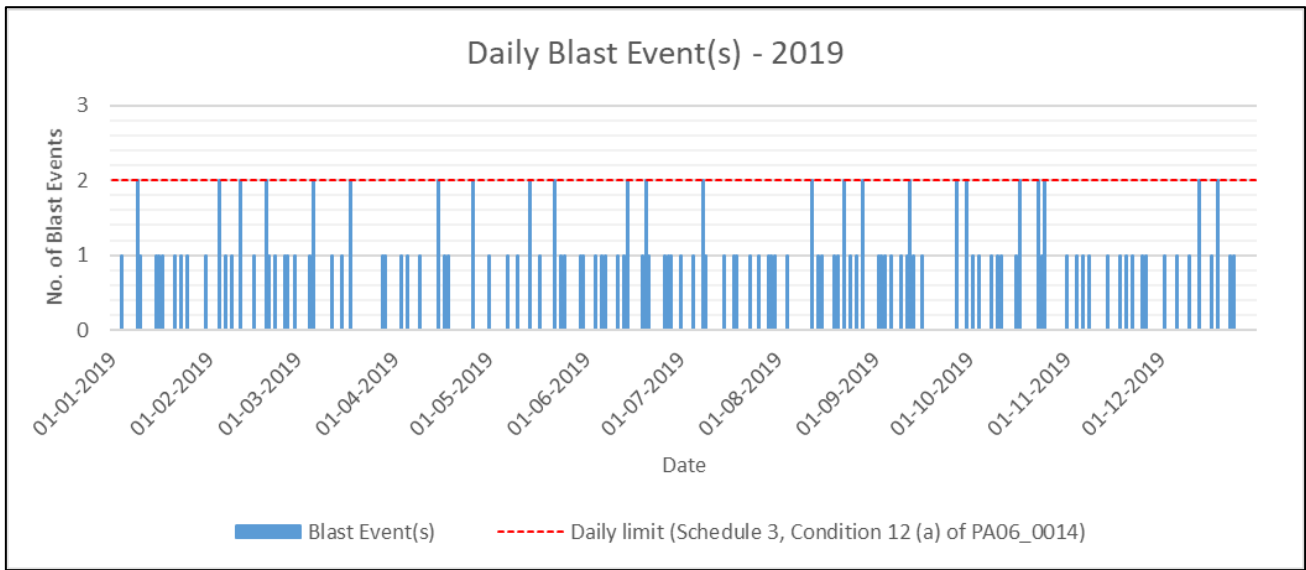
Figure 9 Daily Blast Events

During the reporting period there was an average of 2.7 blast events per week which is compliant with Schedule 3, Condition 12(b) of PA 06_0014, which allows a maximum of 6 blasts per week, averaged over a calendar year. A total of 142 blast events occurred during the reporting period and no more than 2 blast events per day which is compliant with Schedule 3, Condition 12(a) of PA 06_0014 (see **Figure 9**).

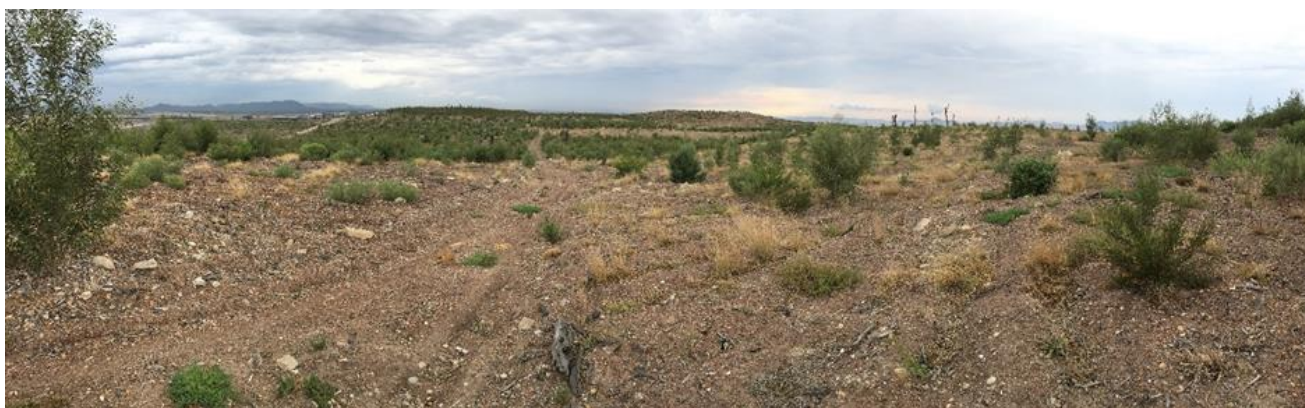
Photo 1 South Pit Rehabilitation Woodland Area Seeded 2017

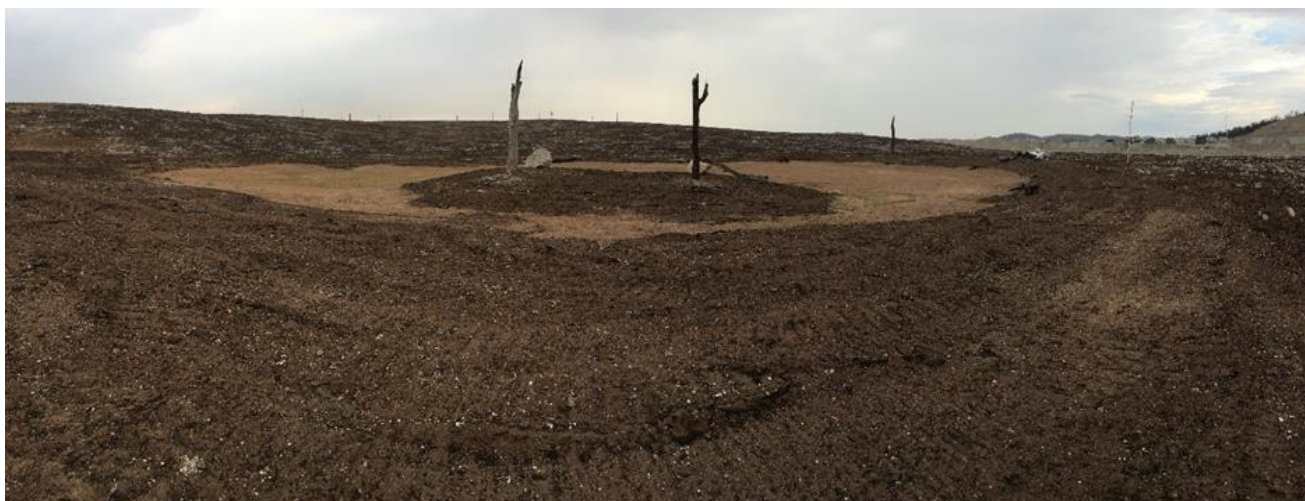
Photo 2 Main Pit Central Rehabilitation Frog Pond Constructed 2019

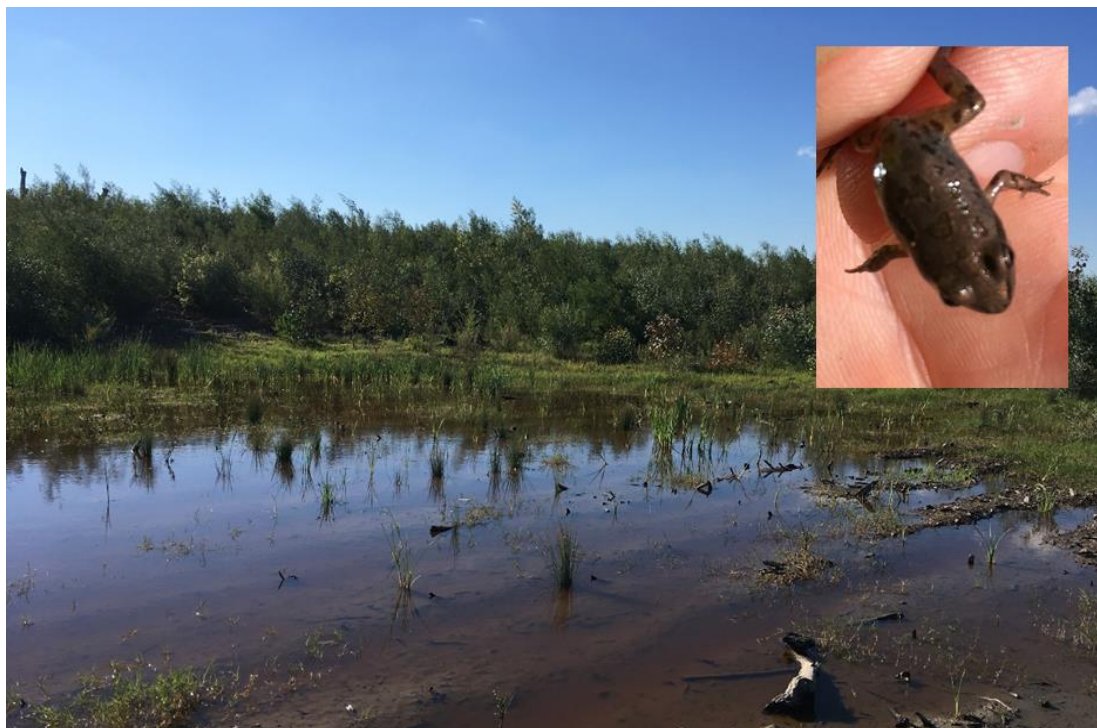
Photo 3 South Pit Rehabilitation Wetland Area with *Limnodynastes tasmaniensis* after March 2019 Rainfall

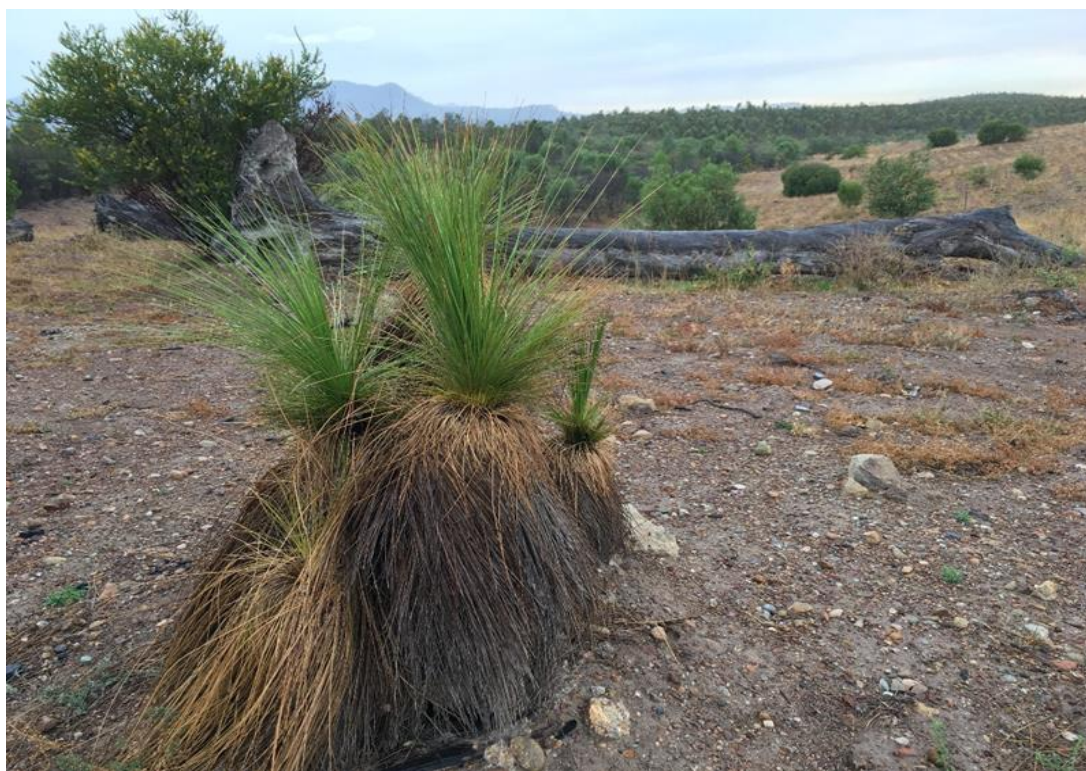
Photo 4 North Pit Rehabilitation Area Translocated *Xanthorrhoea's*

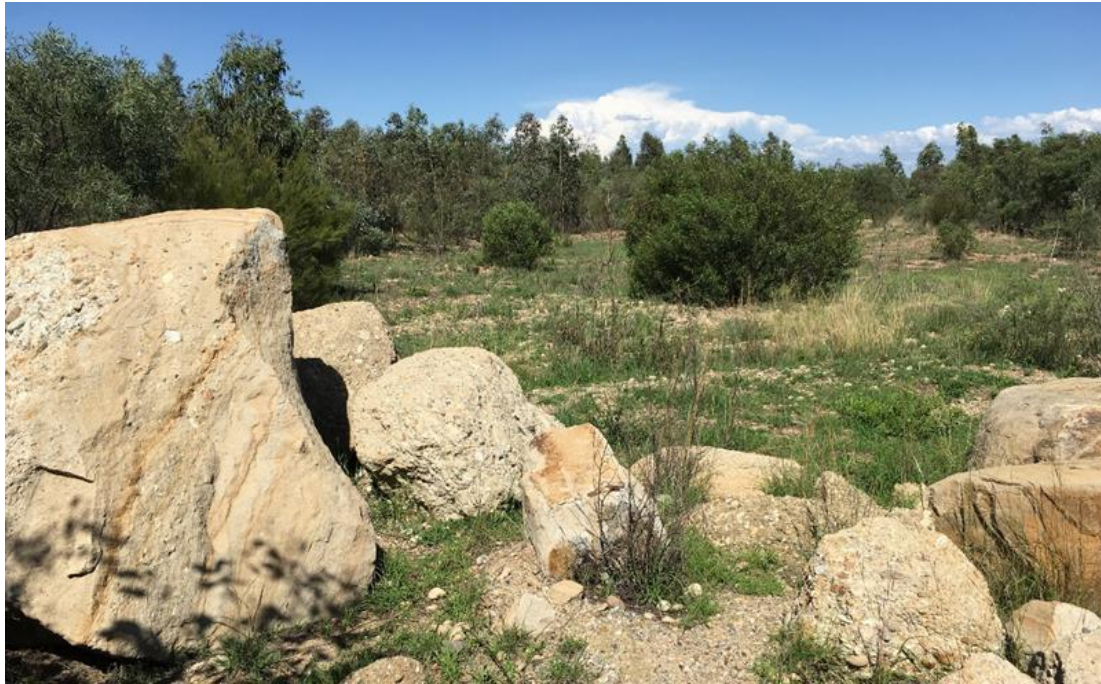
Photo 5 2014 Rehabilitation of Woodland and Grassland Area with Rock Habitat

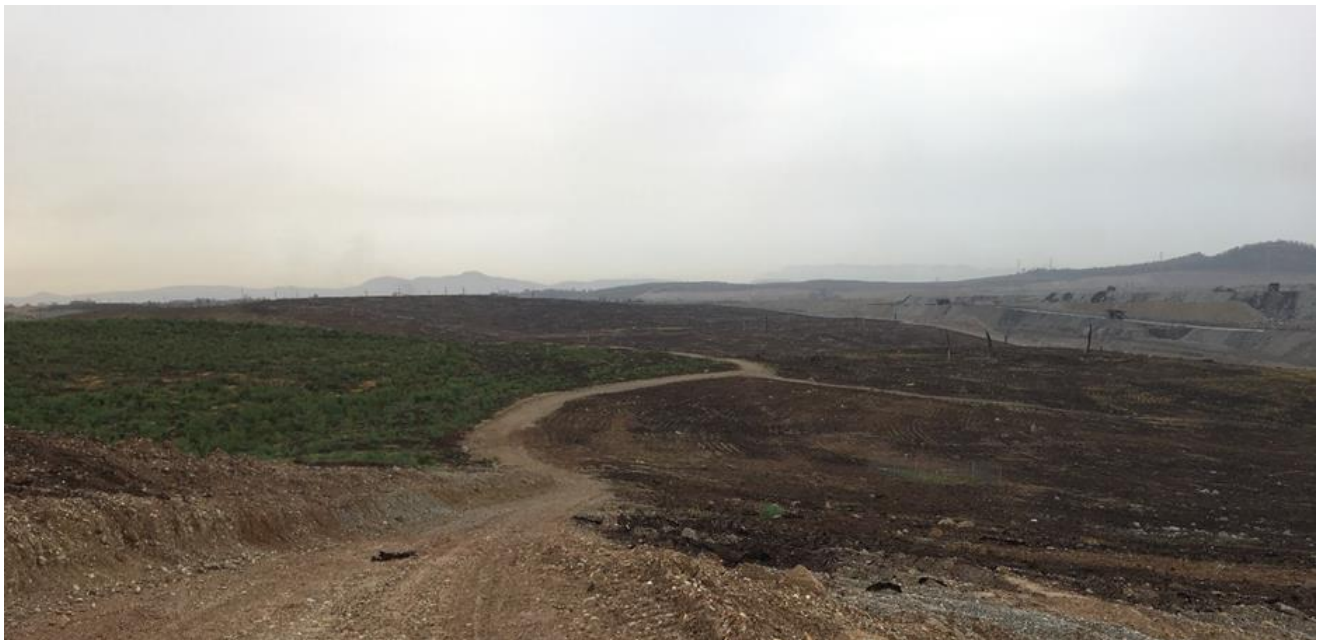
Photo 6 Progressive Rehabilitation in Main Pit Central – Left Side of Track Seeded 2018, Right Side of Track Seeded 2019

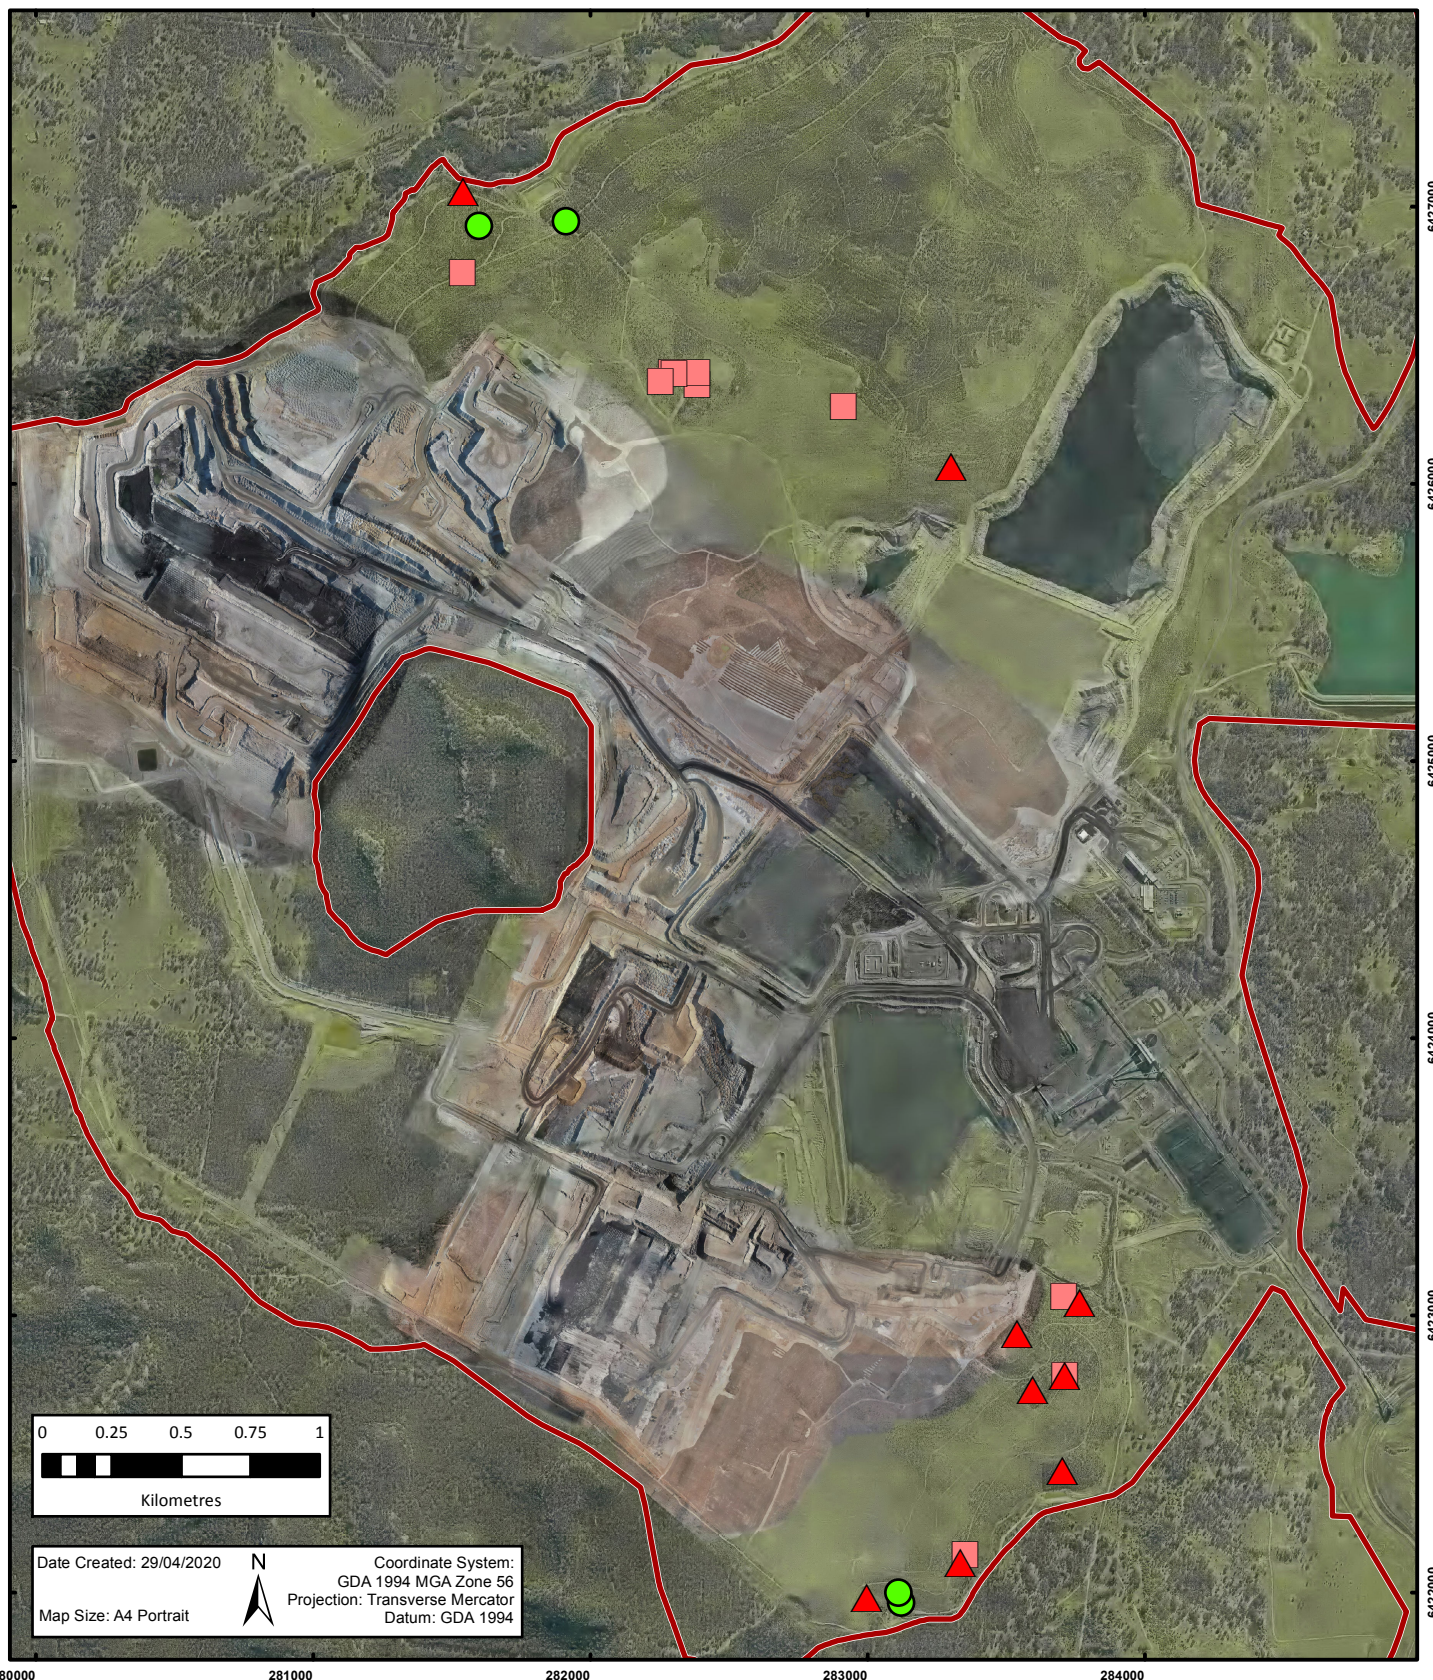
Figure 14 - MOP rehabilitation TARP areas 2019

Weed Presence	Twelve months following revegetation, >10% but <25% cover of undesirable species present. (Weeds in northern and southern rehabilitation areas).	Continue the ongoing site weed management program with a focus on the specific areas identified in the annual rehabilitation walkover report to ensure newly identified weed outbreaks are controlled.
		Twelve months following revegetation, >10% but <25% cover of undesirable species present. (Identification of native species inconsistent with the desired vegetation communities in the northern and southern rehabilitation areas).	Weed management contractor to continue to remove introduced species from the site during weed control activities.

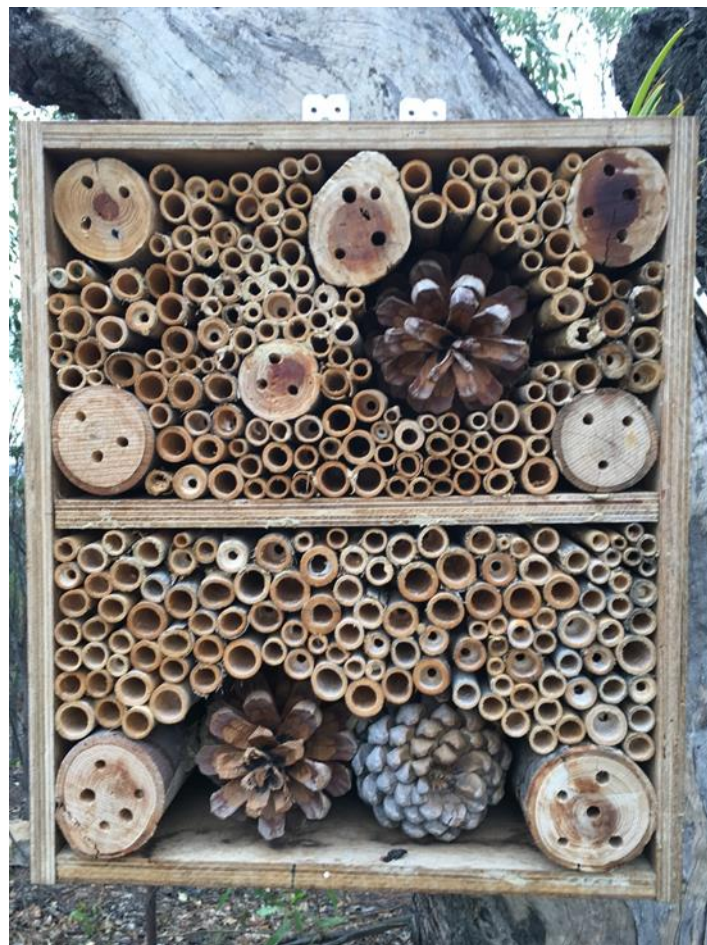
Invertebrate habitat “bee and bug hotels” were introduced into the rehabilitation during 2019 (refer **Photo 7**). These will be monitored over time to assess usage by pollinators and if successful will be installed in other areas of rehabilitation across the site.

Photo 7 One of Ten Invertebrate Habitat Boxes installed into the Rehabilitation during 2019.

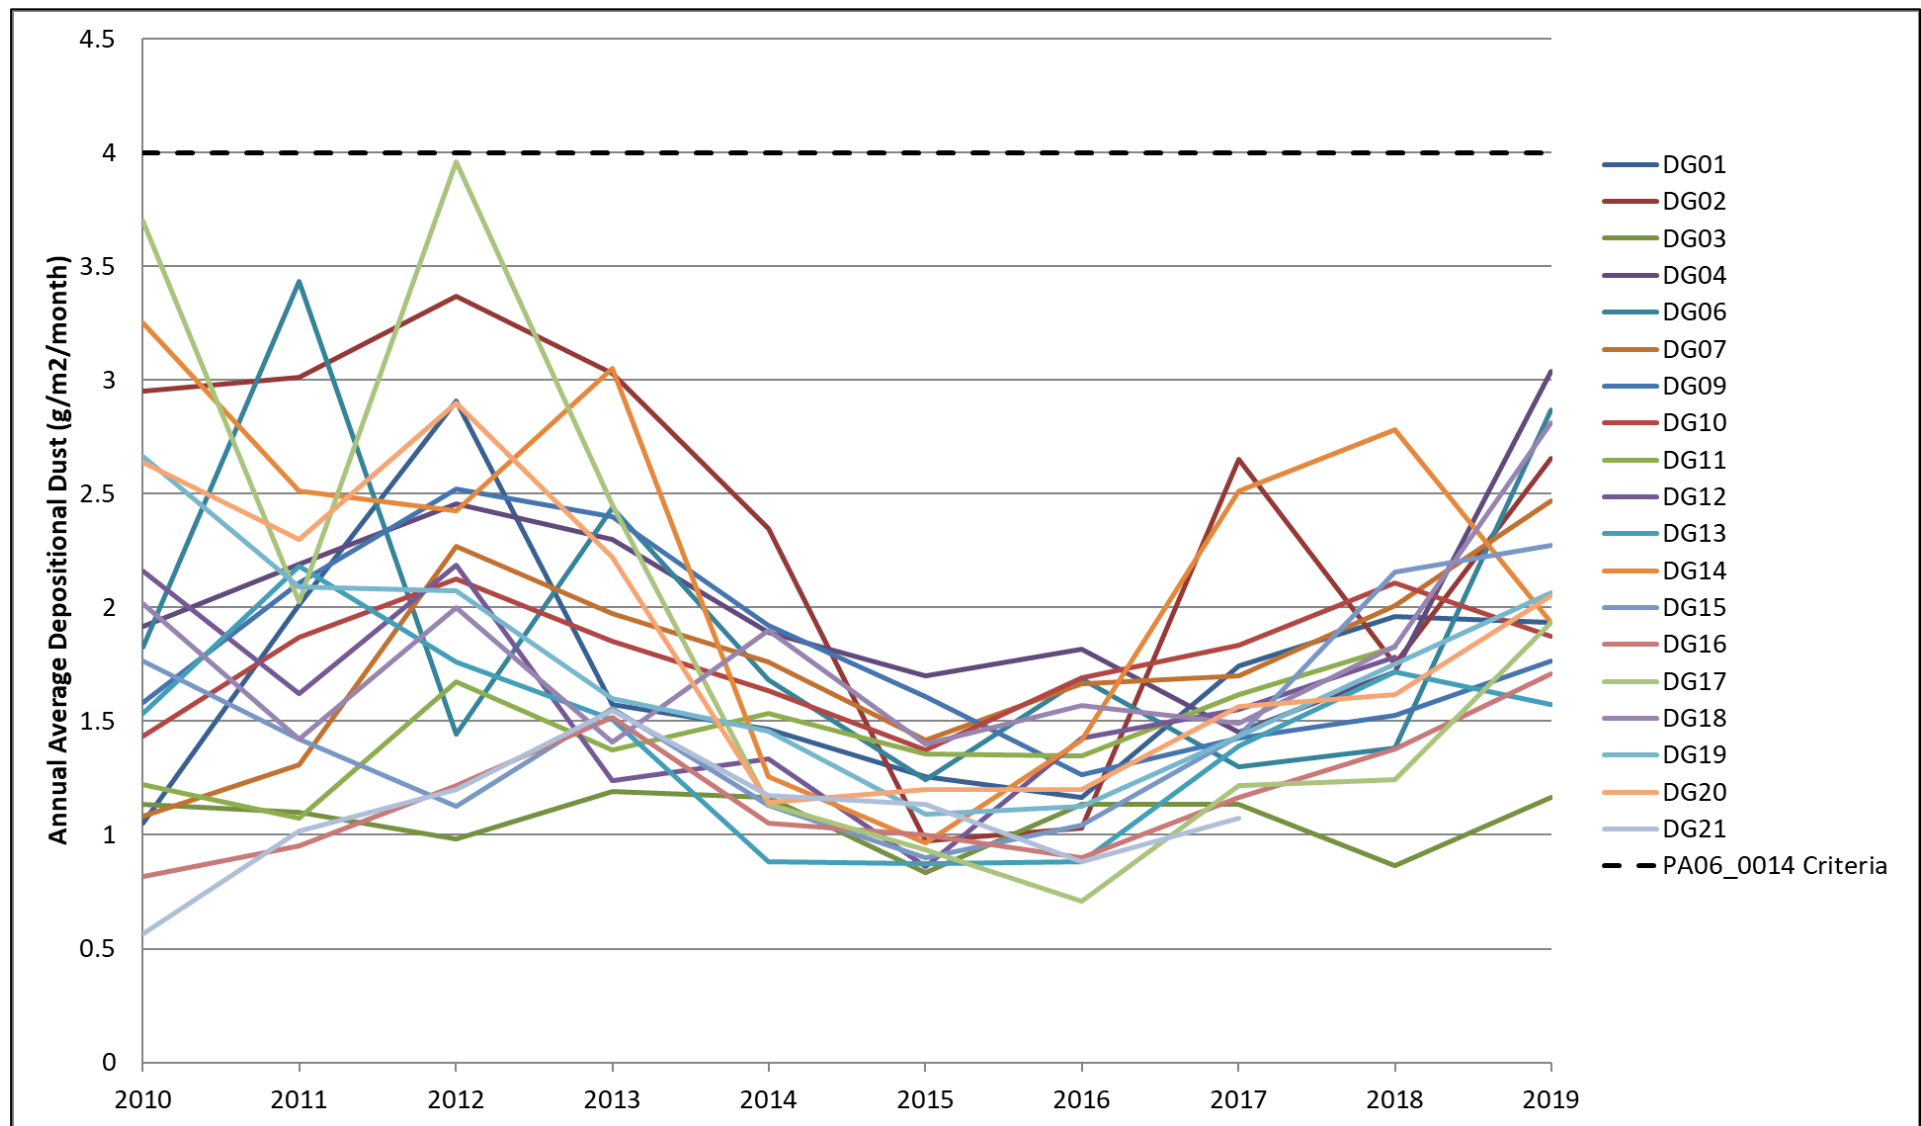
Figure 19 Long Term Annual Average Depositional Dust Monitoring Results – 2010 to 2019

A long term trend analysis of air quality monitoring results at Mangoola has been undertaken using data from July 2010 to December 2019 to identify any trends in the monitoring data over the life of the project. These graphs are presented in **Appendix C**. Depositional dust monitoring results have been variable since mining operations commenced in 2010, however results generally peaked in 2012 and declined to the lowest results during 2015-2016. Results have been generally increasing during 2017-2019 which correlates with low rainfall and the ongoing drought conditions (refer **Appendix B**).
