Mangoola Open Cut

2020 Annual Review

1 January 2020 to 31 December 2020

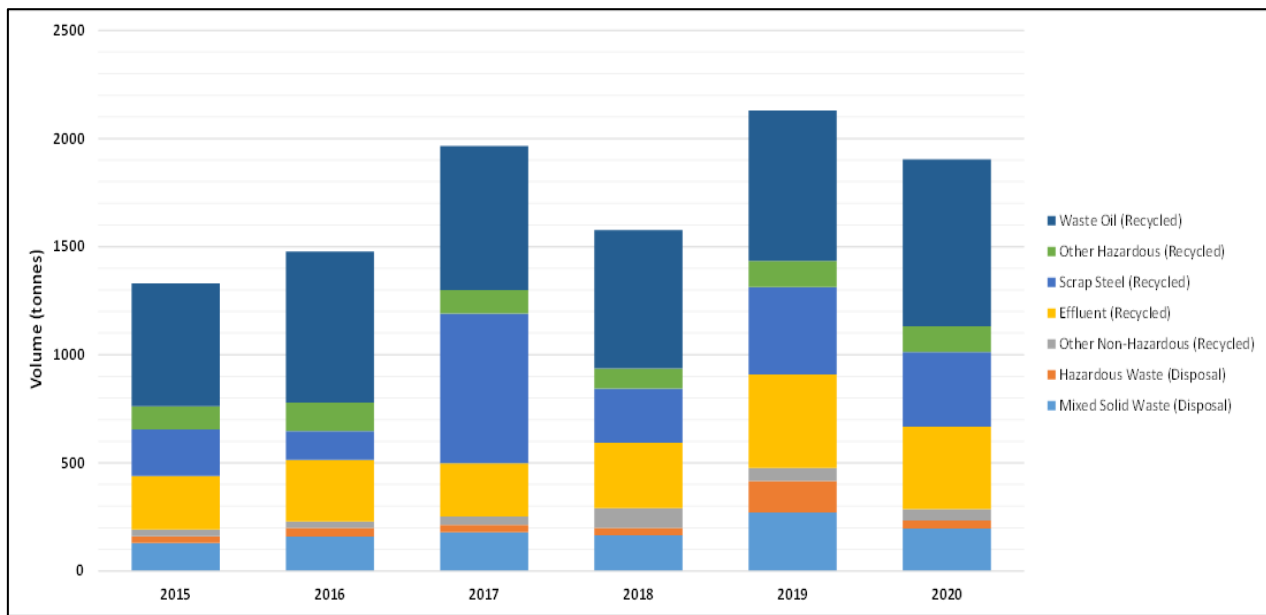
Figure 3 2015-2020 Waste Streams Generated

The major waste streams during the reporting period were waste oil (772 tonnes), scrap steel (346 tonnes), mixed solid waste (196 tonnes) and effluent (382 tonnes).

A summary of waste disposal from 2015 to 2020 is presented in **Figure 3**.

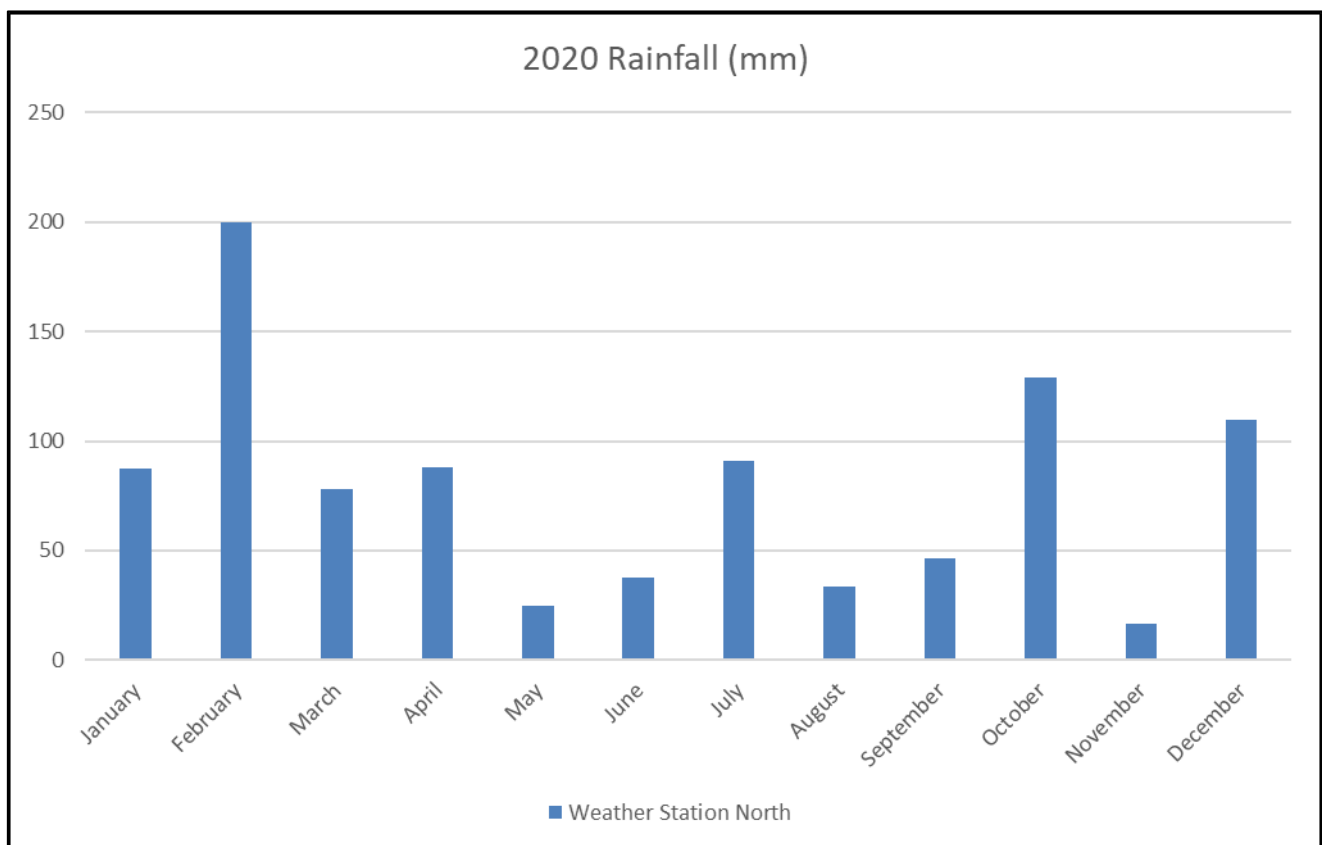
Figure 4 WSN 2020 Rainfall Data

2020 was a substantially wetter year with drought conditions broken across much of NSW, as can be seen in **Figure 5**, a map produced by the Bureau of Meteorology (BOM) which shows national rainfall deficiencies from 1 January 2020 to 31 December 2020. Total annual rainfall for 2020 was 941 mm, which was more than double the rainfall in 2019 (399 mm). As shown in **Figure 4**, annual rainfall at WSN was lowest in November and highest in February 2020. Long term rainfall data is presented in **Appendix B**, which shows that rainfall at the site was the highest during 2020 since reporting began in 2010.

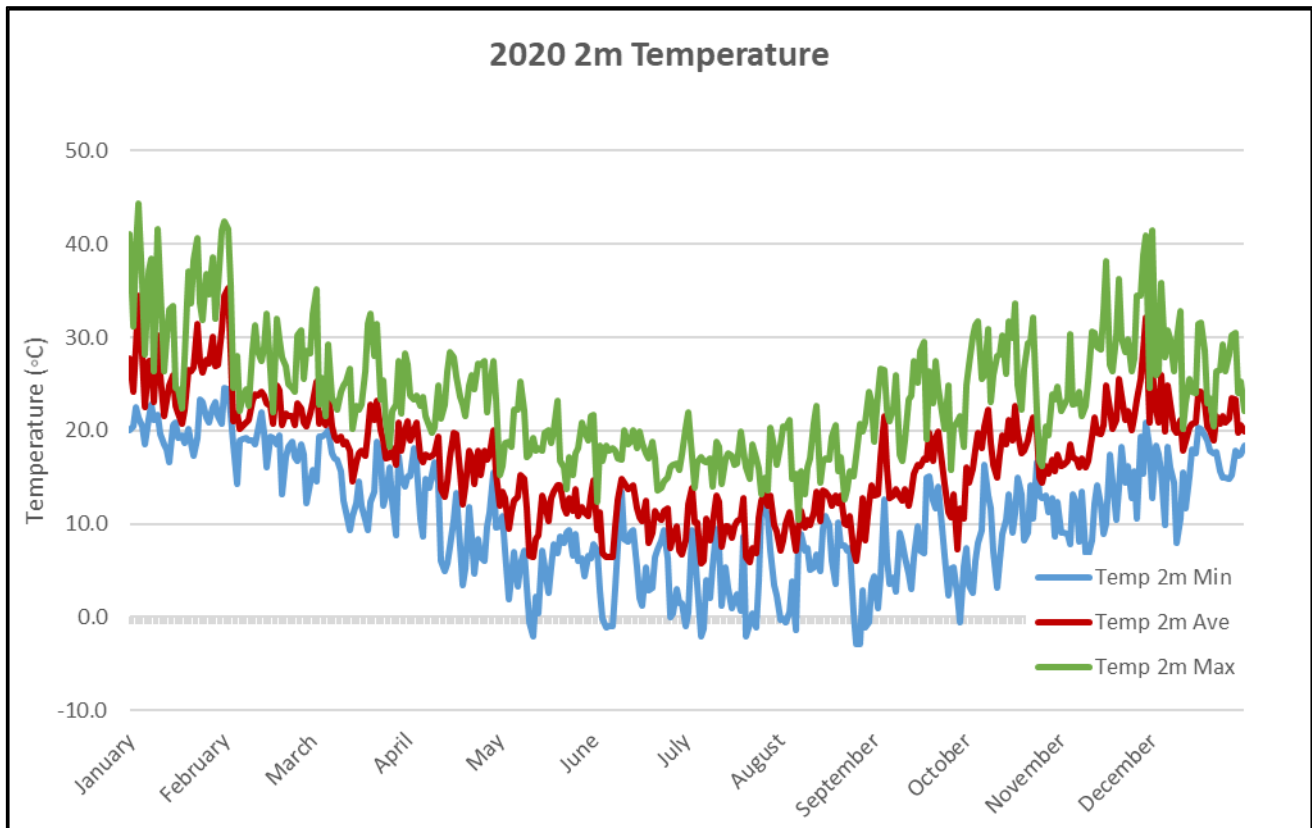
Figure 6 WSN 2020 2m Temperature Data

As shown in **Figure 6**, the daily minimum and maximum 2 metre (m) above surface level temperatures ranged from -2.9°C to 44.4°C respectively, with an average daily maximum of 24.0°C, which is cooler than the 2019 daily average of 26.4°C. Humidity during 2020 ranged from 10.9% to 98.4%.

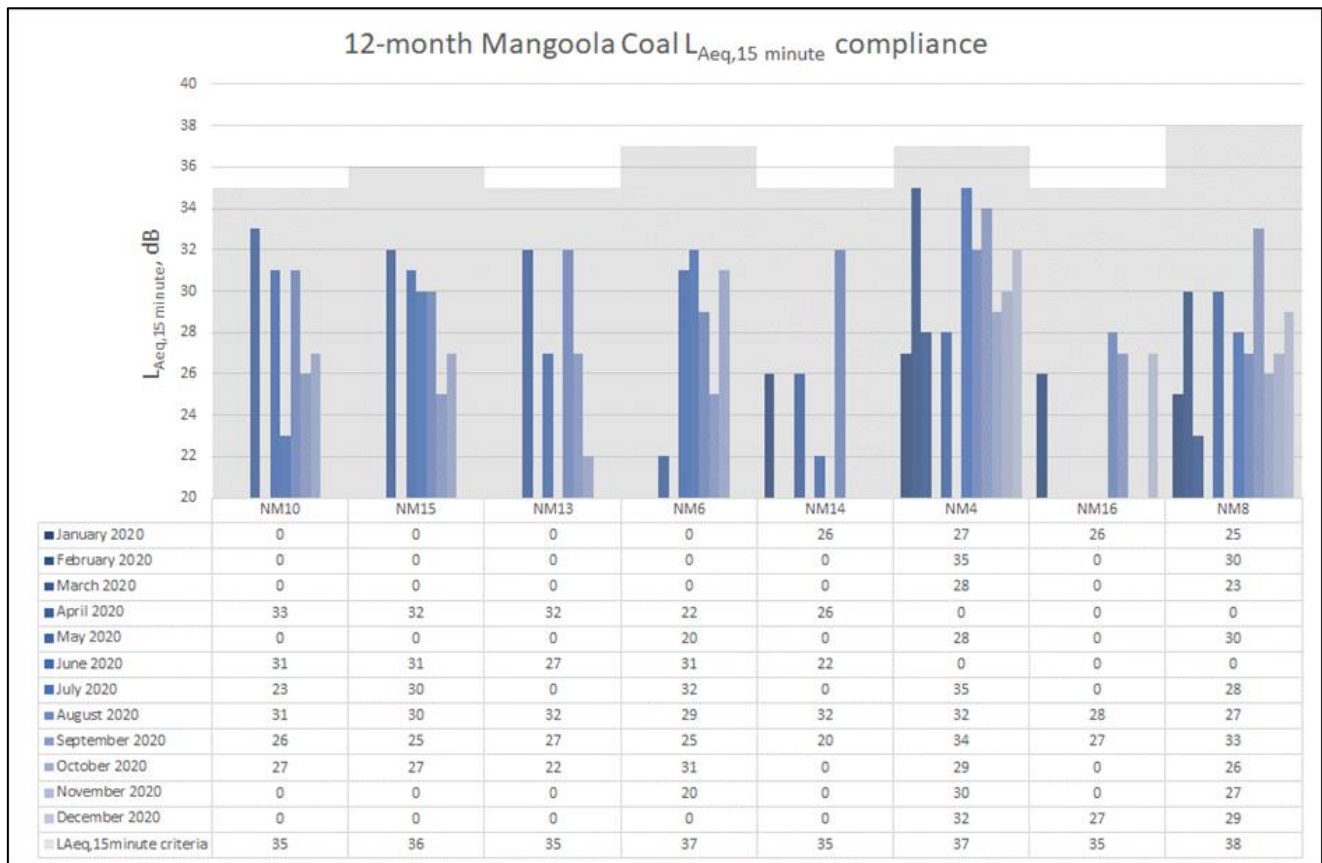
Figure 9 Annual Review Attended Noise Monitoring Compliance Results ($L_{Aeq}(15\text{minute})$)

As shown in **Table 19**, the 2020 noise levels recorded at Mangoola were compared against the Year 5 noise predictions presented in the 2013 Noise and Vibration Assessment (EMM 2013) and the PA 06_0014 criteria for $L_{Aeq}(15\text{minute})$. On three monitoring occasions (where meteorological conditions met consent condition parameters for noise limits to apply), results were recorded above the Year 5 $L_{Aeq}(15\text{minute})$ EIS predictions however, these levels were well below criteria. The remaining results were lower than the predicted levels where noise limits were applicable due to suitable meteorological conditions.

'0' indicates that the Mangoola Coal noise contribution was determined to be 20 dB or less.

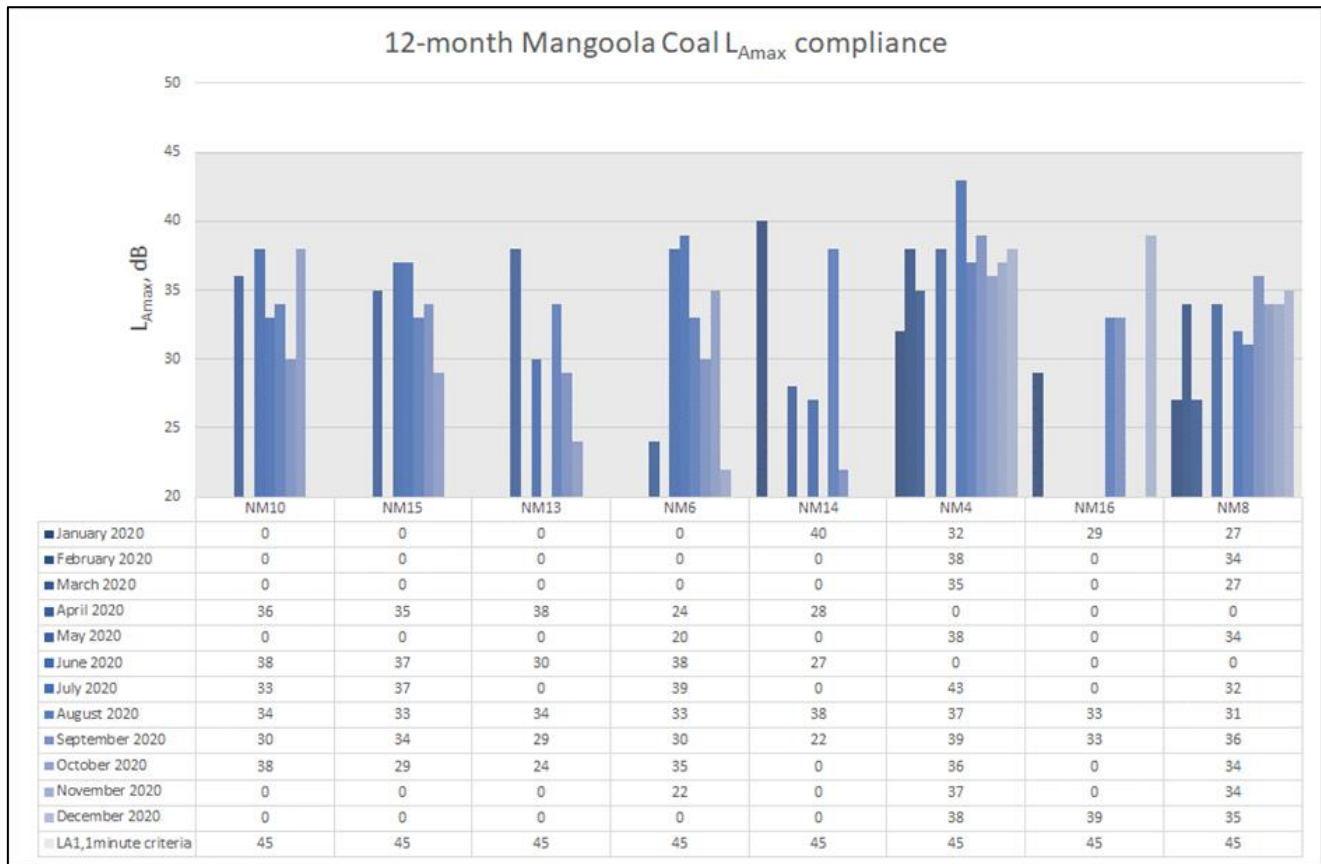
Figure 10 Annual Review Attended Noise Monitoring Compliance Results (L_{Amax})

Table 20 compares 2020 L_{Amax} noise levels against 2013 Noise and Vibration Assessment Year 5 noise predictions and approval criteria. Three monitoring locations (NM13, NM14 and NM16) recorded one result above the Year 5 L_{Amax} predictions, two monitoring locations (NM10 and NM15) recorded two results above the Year 5 L_{Amax} predictions and one monitoring location (NM8) recorded six results above the Year 5 L_{Amax} predictions. All other measured L_{Amax} noise levels were below the predicted levels. The main reason for the difference between modelled noise emissions and those measured is likely due to differences in the modelling assumptions compared to the actual operational or weather scenarios. This includes features such as mine topography as well as the locations and sound power levels of plant and equipment. Importantly, measured Mangoola noise emissions did not exceed the $L_{Aeq}(15\text{minute})$ or L_{Amax} noise criteria during 2020. **Figure 9** and **Figure 10** compare the 2020 noise levels recorded at Mangoola with the relevant approval criteria.

'0' indicates that the Mangoola Coal noise contribution was determined to be 20 dB or less.

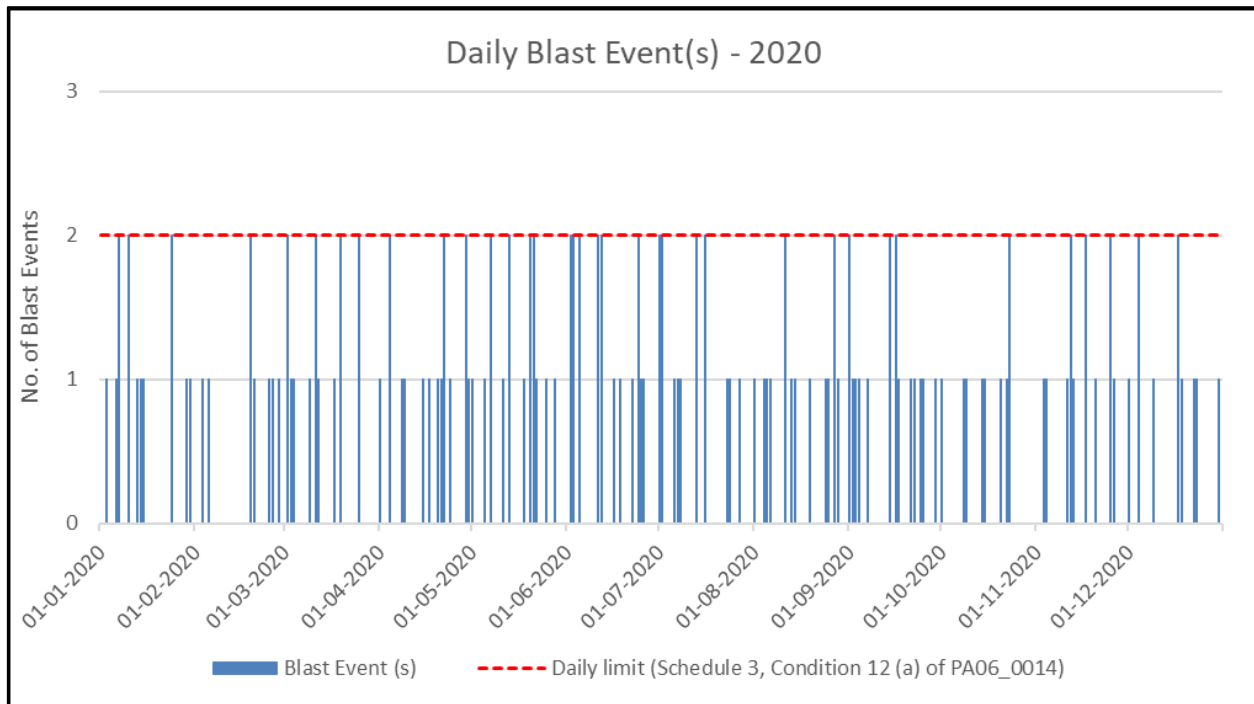
Figure 11 Daily Blast Events

During the reporting period there was an average of 3.0 blast events per week which is compliant with Schedule 3, Condition 12(b) of PA 06_0014, which allows a maximum of 6 blasts per week, averaged over a calendar year. A total of 157 blast events occurred during the reporting period and no more than 2 blast events per day which is compliant with Schedule 3, Condition 12(a) of PA 06_0014 (see **Figure 11**).

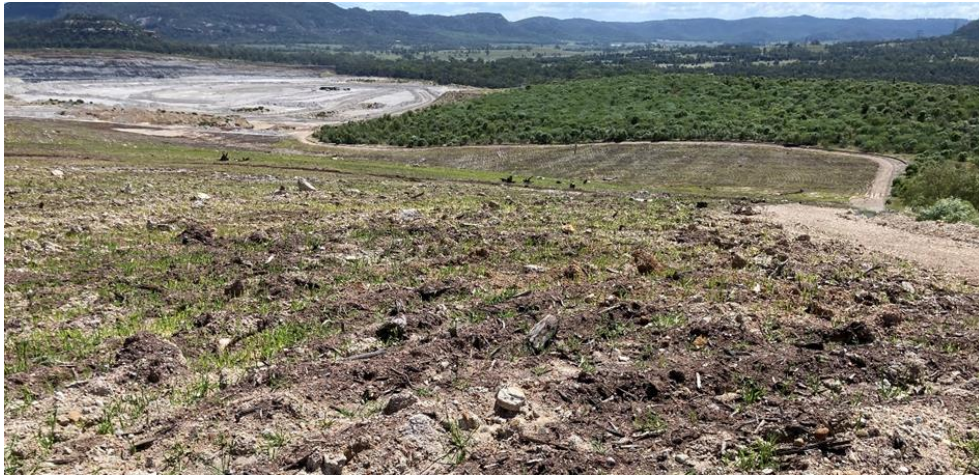
Photo 3 2020 Main Pit Rehabilitation looking toward 2016 Rehabilitation Area

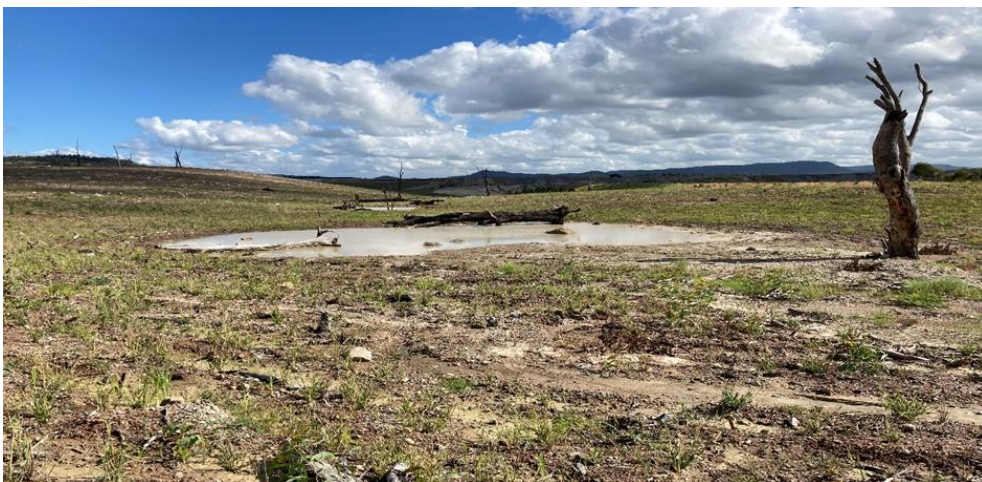
Photo 4 South Pit Rehabilitation Frog Ponds constructed 2019

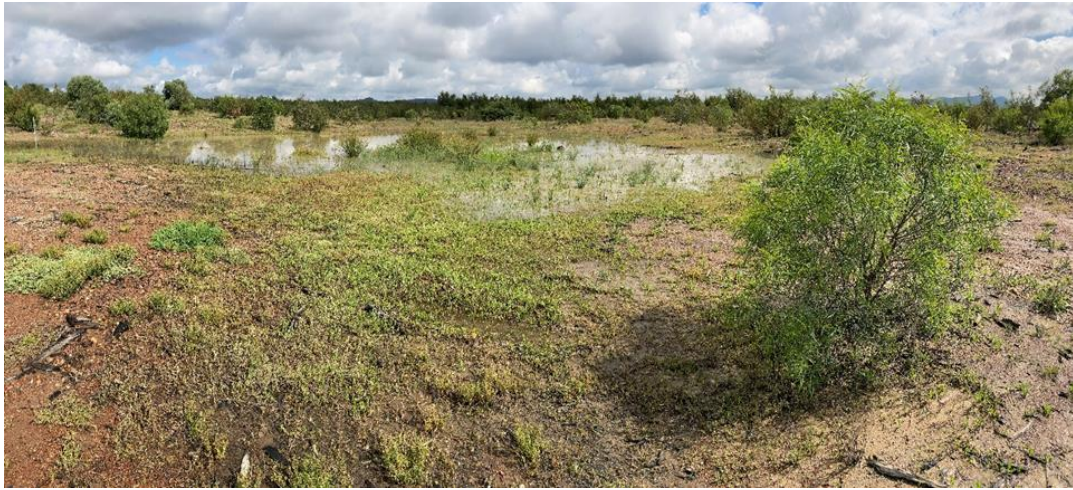
Photo 6 North Pit Rehabilitation Area Wetland

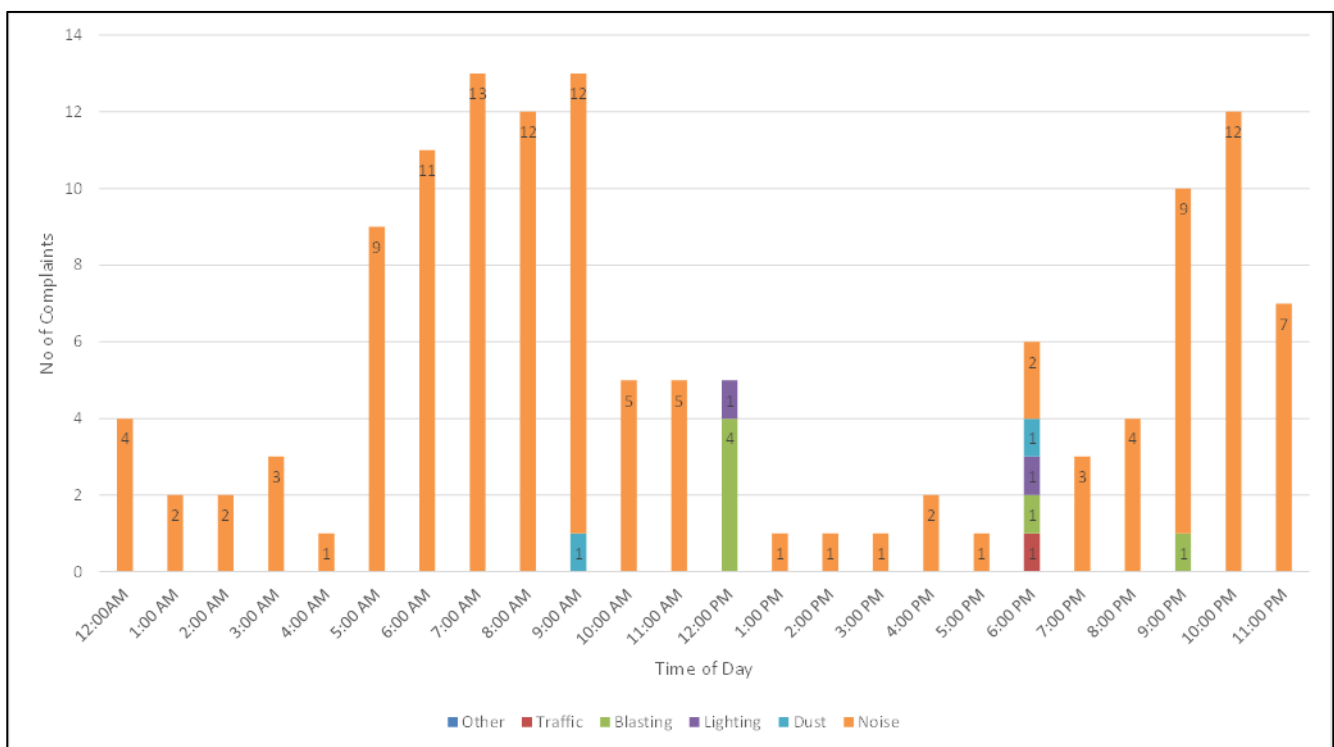
Figure 17 2020 Complaints by Time of Day

Figure 17 shows the time of day that complaints were made during 2020. Analysis of this data shows that noise complaints are generally made in the early morning and late evening, whereas blast related complaints are generally made in the middle of the day.

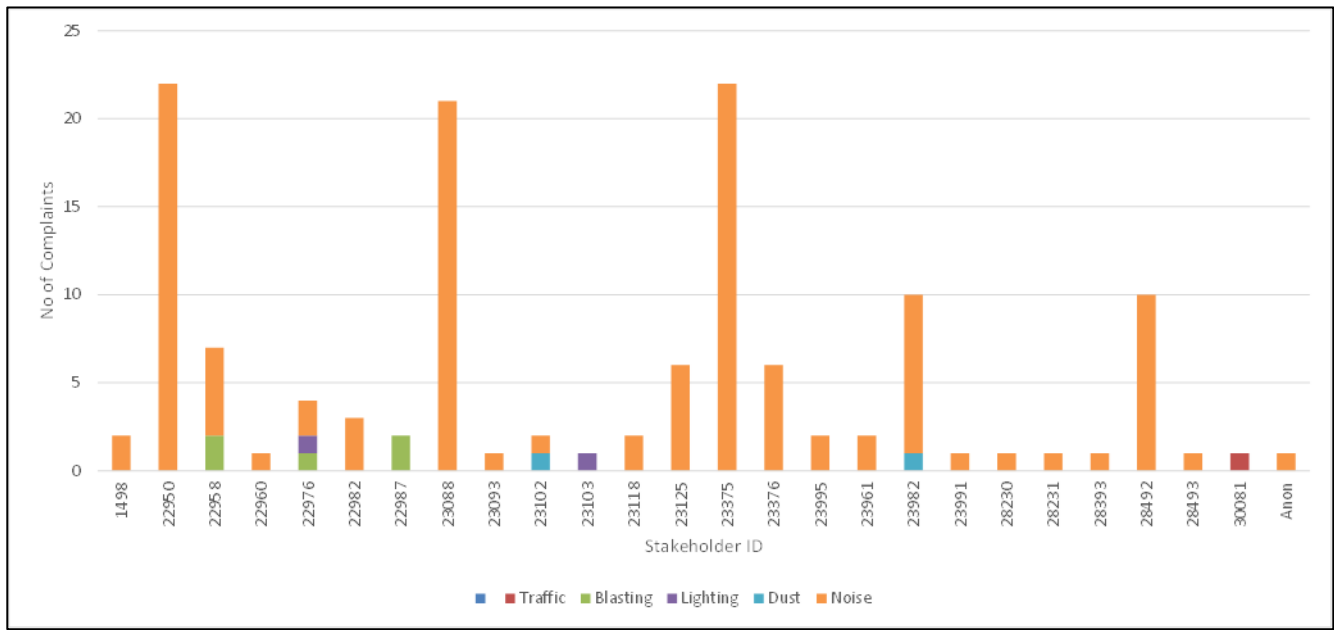
Figure 18 2020 Complaints by Complainant ID

Figure 18 shows the number of complaints made by each complainant during 2020. The 133 complaints were made by 26 individuals during 2020 and approximately a 48% of all complaints (65) were made by three complainants. These were predominantly in relation to noise.

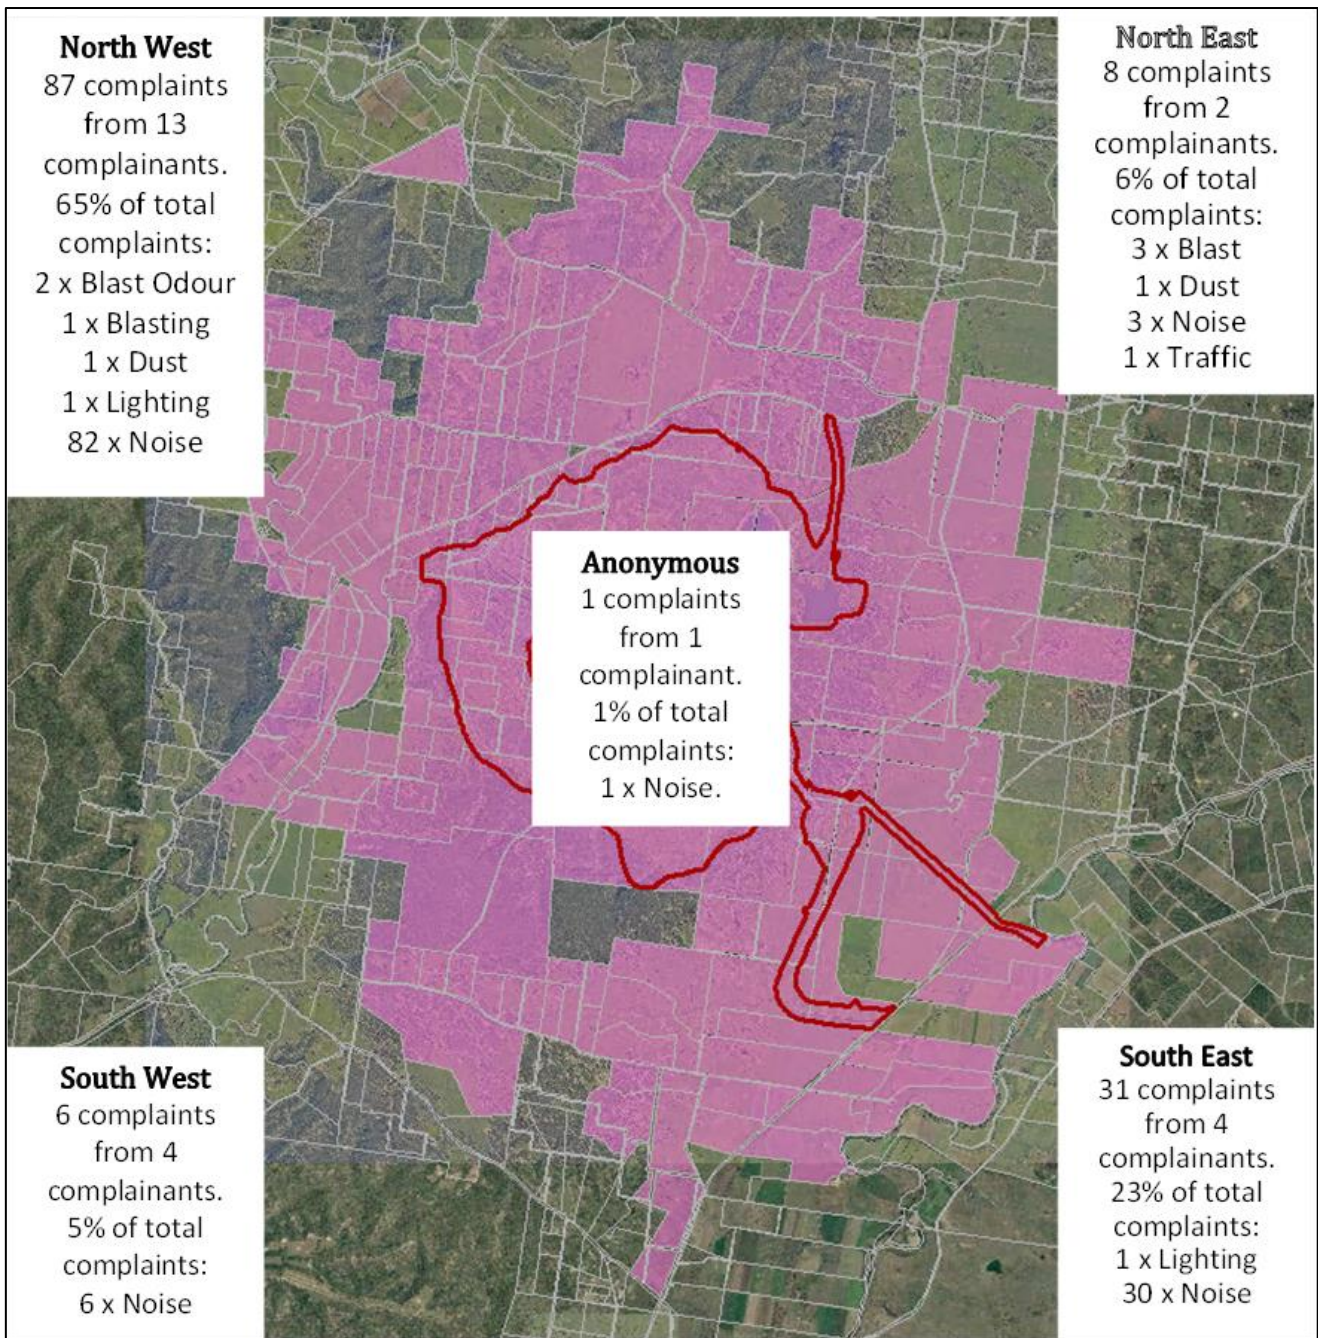
Figure 19 2020 Complaints by Location

Figure 19 shows complaint location during 2020 with the majority of complaints received from the north-west sector primarily related to noise.

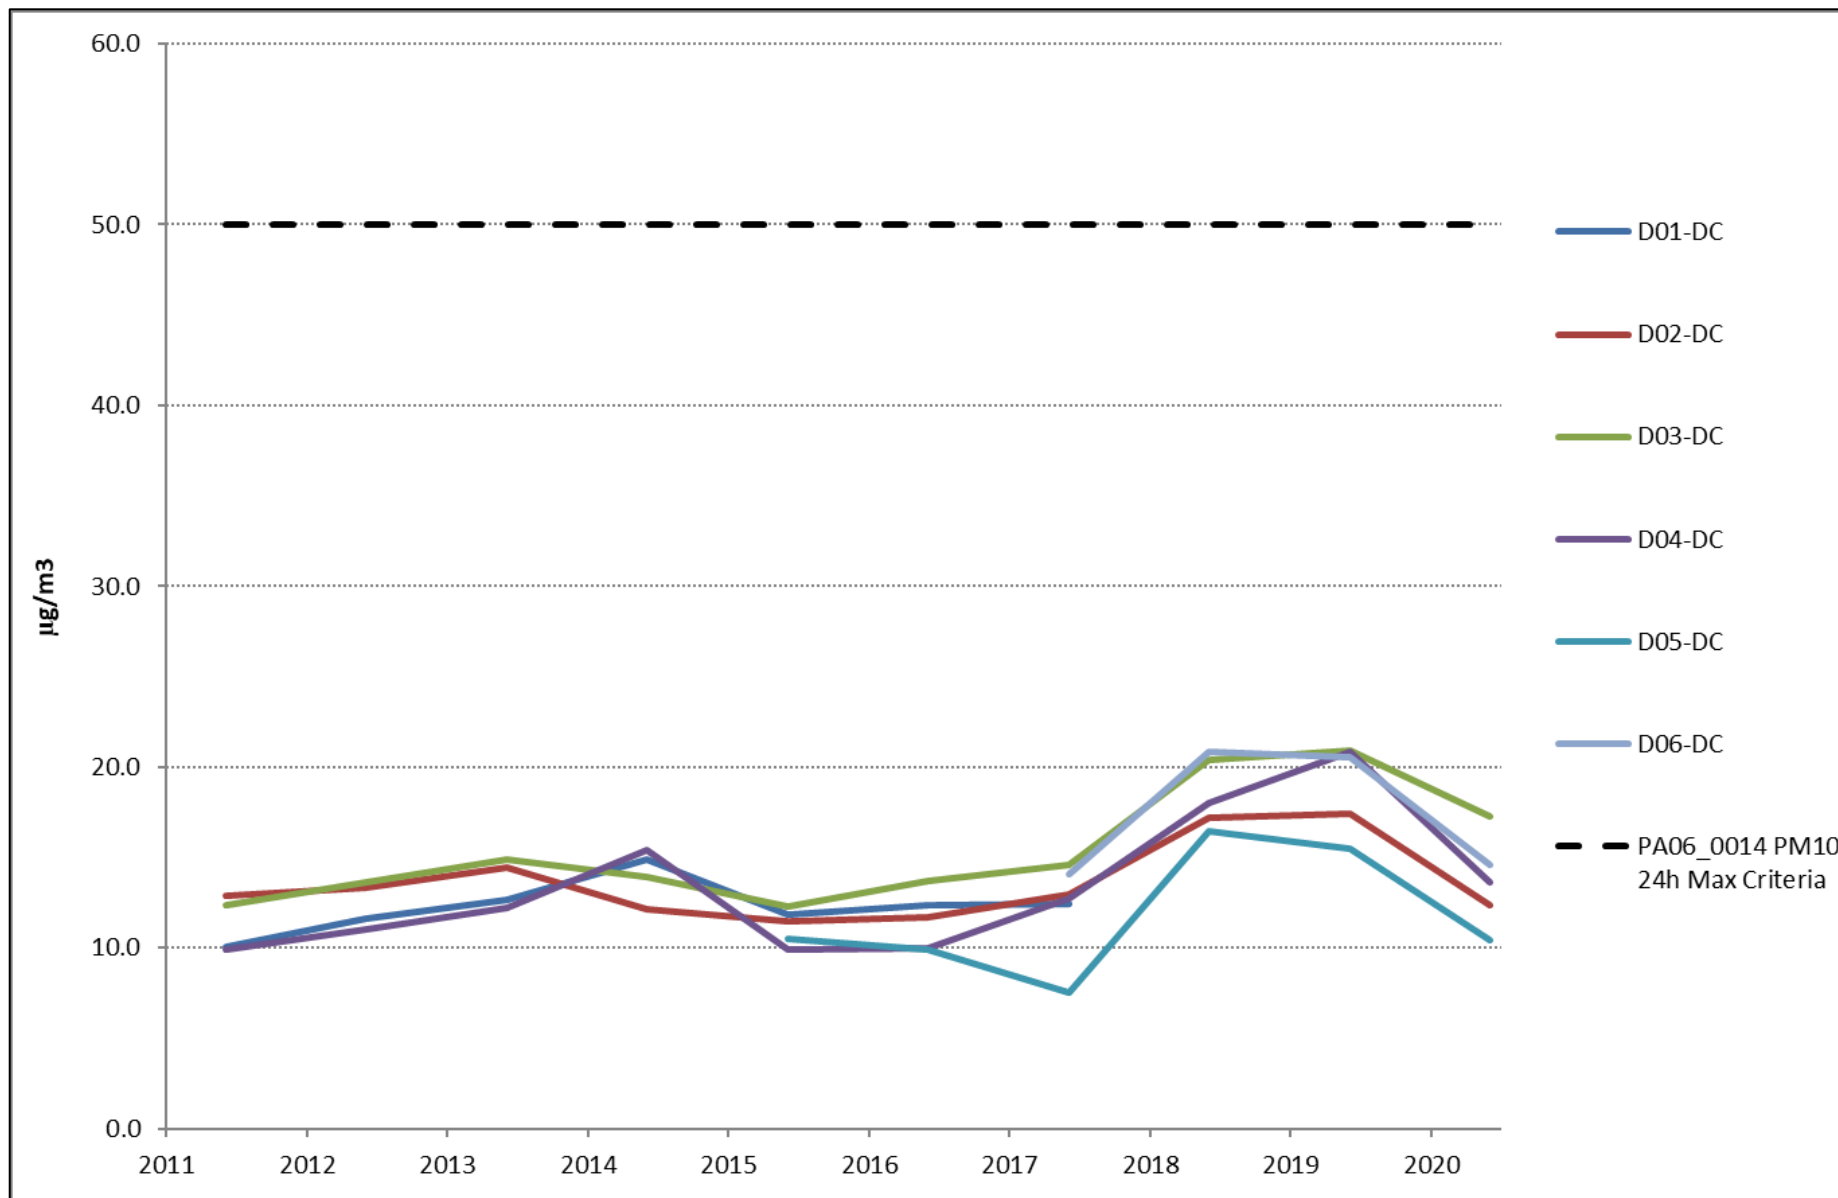
Figure 22 Long Term Annual Average PM₁₀ TEOM Monitoring Results – 2011 to 2020

The 24hr maximum TEOM data show seasonal peaks in the summer months. The annual average TEOM results have remained consistent with results from 2011 through to 2017 and results have been generally increasing during 2018-2019 which correlates with low rainfall and the ongoing drought conditions. Increased rain during 2020 has decreased results to be consistent with those from 2015 to 2017.
