REPORT ON 'RUSTEN HOUSE' BASIC UPGRADE PROPOSALS INTERPRETATIVE DISPLAY AND HERITAGE FABRIC

28TH April 2006

WAYNE MCPHEE & ASSOCIATES PTY LTD

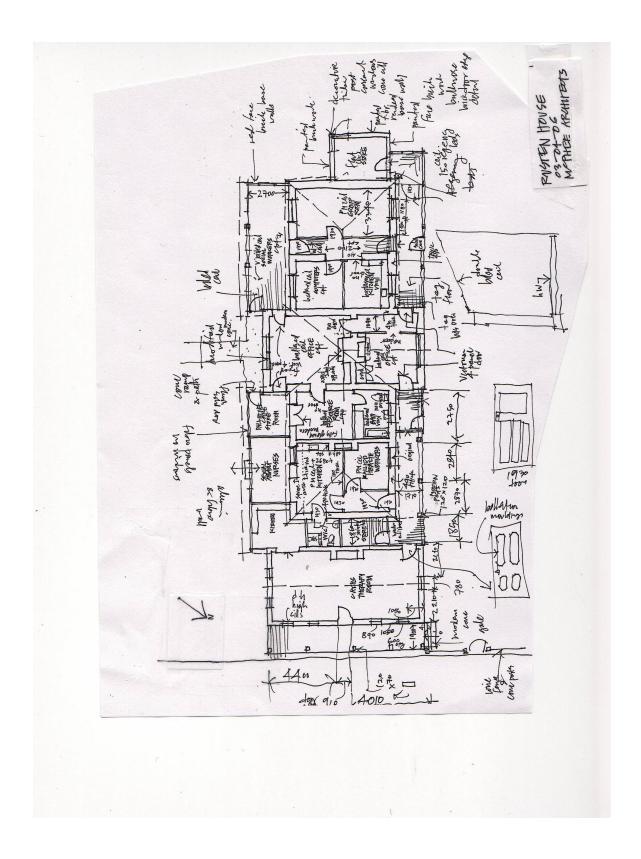
Figure 1: Repair notes, McPhee Architects, April 2006

The site was inspected on 3rd April 2006 by McPhee Architects and it was noted that 'Rusten House' is in poor to fair condition and mostly displays integrity. A number of original built elements have significantly deteriorated, such as the lifting roof iron and a collapsing verandah wall. In addition, there has been a series of external and internal changes, such as the enclosure of the verandahs by the stakeholders to adapt the building to new uses.

- Refix lifting roof iron and loose flashings on both the main and verandah roofs
- Re-paint deteriorated gable boards using paint scapes to determine original colours
- Remove surface-mounted conduits and re-route in a non-intrusive manner
- Renew loose/deteriorated bottom plate to enclosing wall, south west verandah
- Repair and renew broken fibrous cement sheeting
- Refix roofing iron on the south west extension
- Remove verandah enclosures
- Renew gutter on the south east side
- Remove modern concrete landing and ramp on south eastern side of building
- Repair the eaves soffit on the south eastern side
- Renew timber plinth boards on the south eastern side

- Renew stain finish on the timber floor in the enclosed north western verandah
- Repair roof leak, re-paint ceiling in the south western extension to match existing
- Renew internal paintwork using paint scapes to determine original colours
- Replace three internal doors to match existing
- Unblock and make good fireplaces
- Replace doors from the cupboards either side of the fireplaces.

- Re-paint deteriorated walls, windows, doors and verandah structure using paint scapes to determine colours
- Renew flyscreen to the north eastern door
- Replace sections of missing timber door mouldings on south western facing door
- Refix roof iron
- Remove modern gas fire to fireplace and make good
- Repair wall cracks internally using non-shrink grout and make good
- Remove surface-mounted conduits generally
- Remove modern lighting and replace with in-context luminaries.
