## **The Glades Estate Lots 1 & 2 DP 725785 Pacific Highway, Moonee**

### **Environmental Assessment**

GEOTECHNICAL ASSESSMENT

CH1173/1-AM

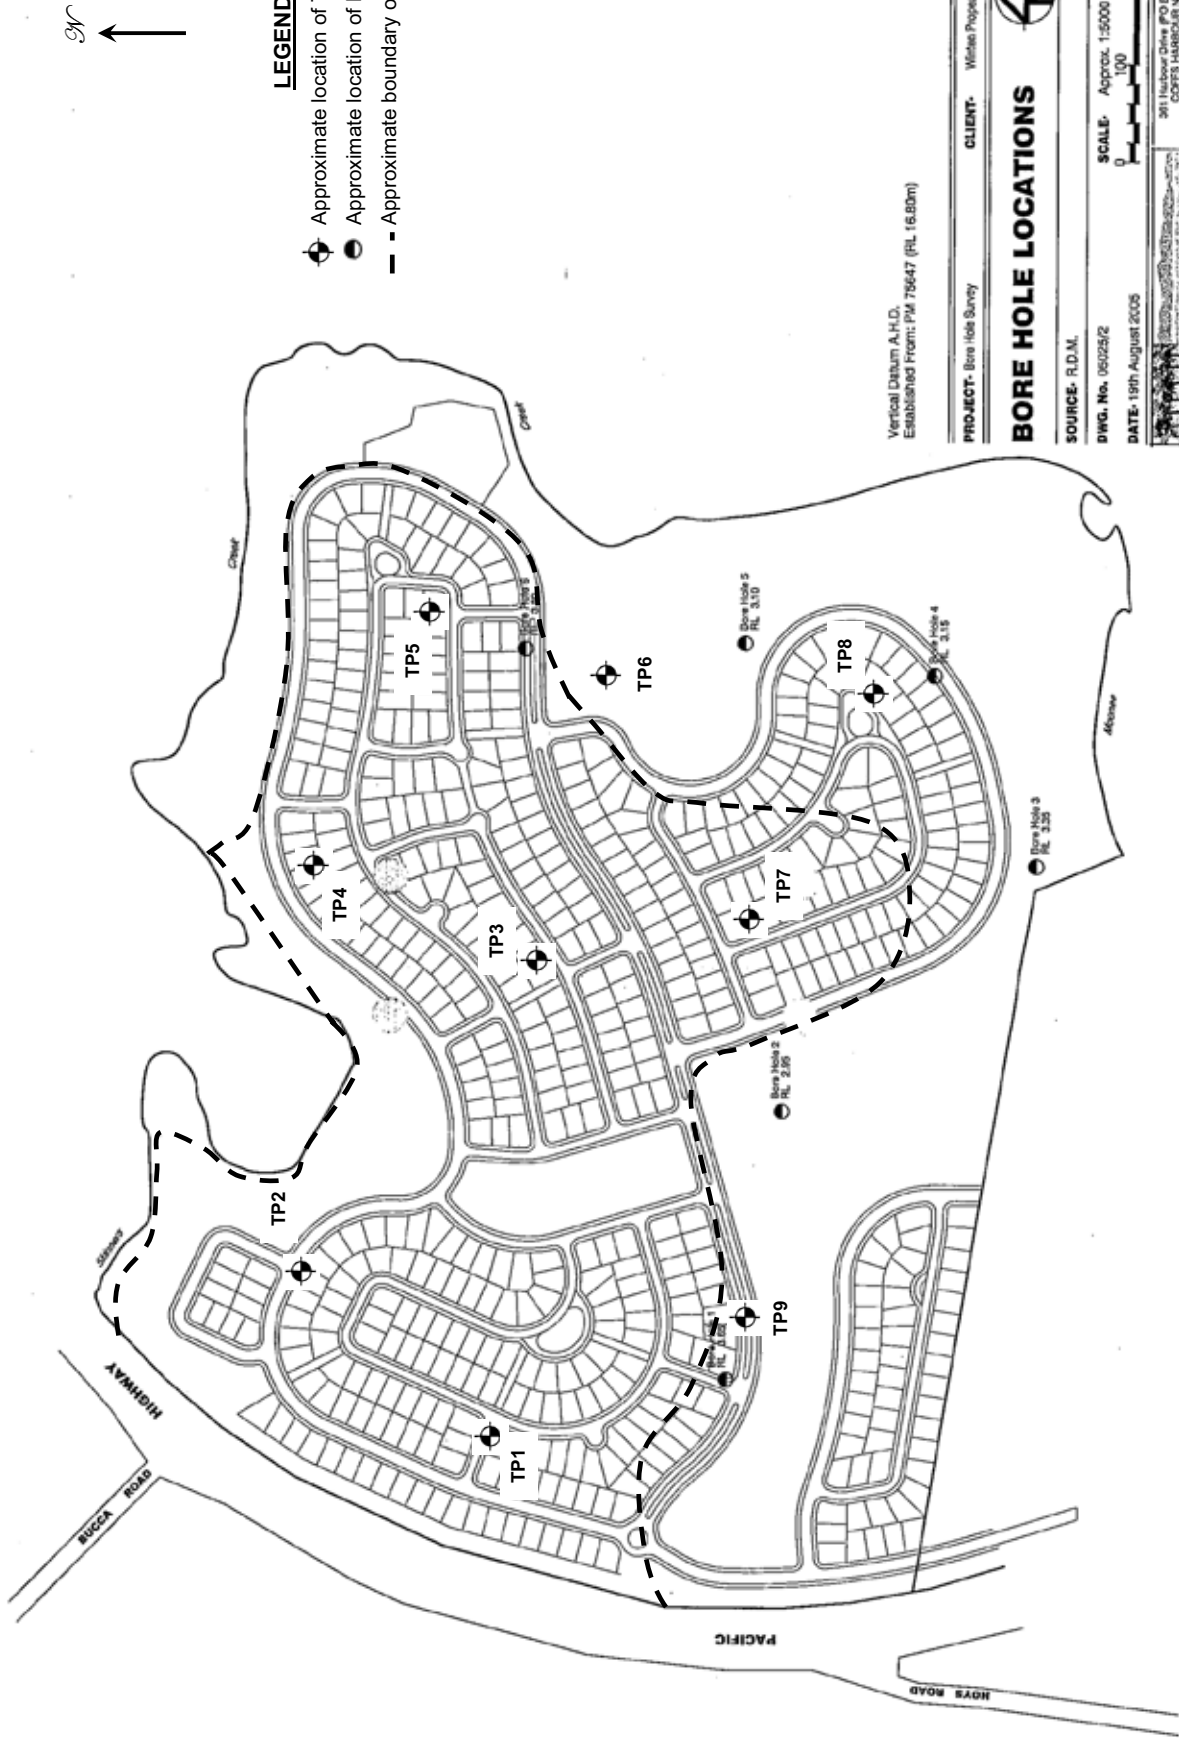
revision	description	drawn	approved	date	SK			client:	project:	title:	project no:	figure no:
					drawn	approved	SK					
	Site Plan - Original	ELC	DB	25/10/2005			AH	Resource Design & Management	Proposed Subdivision, Pacific Highway, North Moonee Beach			
	Site Plan - Rev 1	SK	AH	11/10/2007			11 Oct 2007					
							1:5500			Site Plan		
							A3				CH1173/1-AM	FIGURE 1

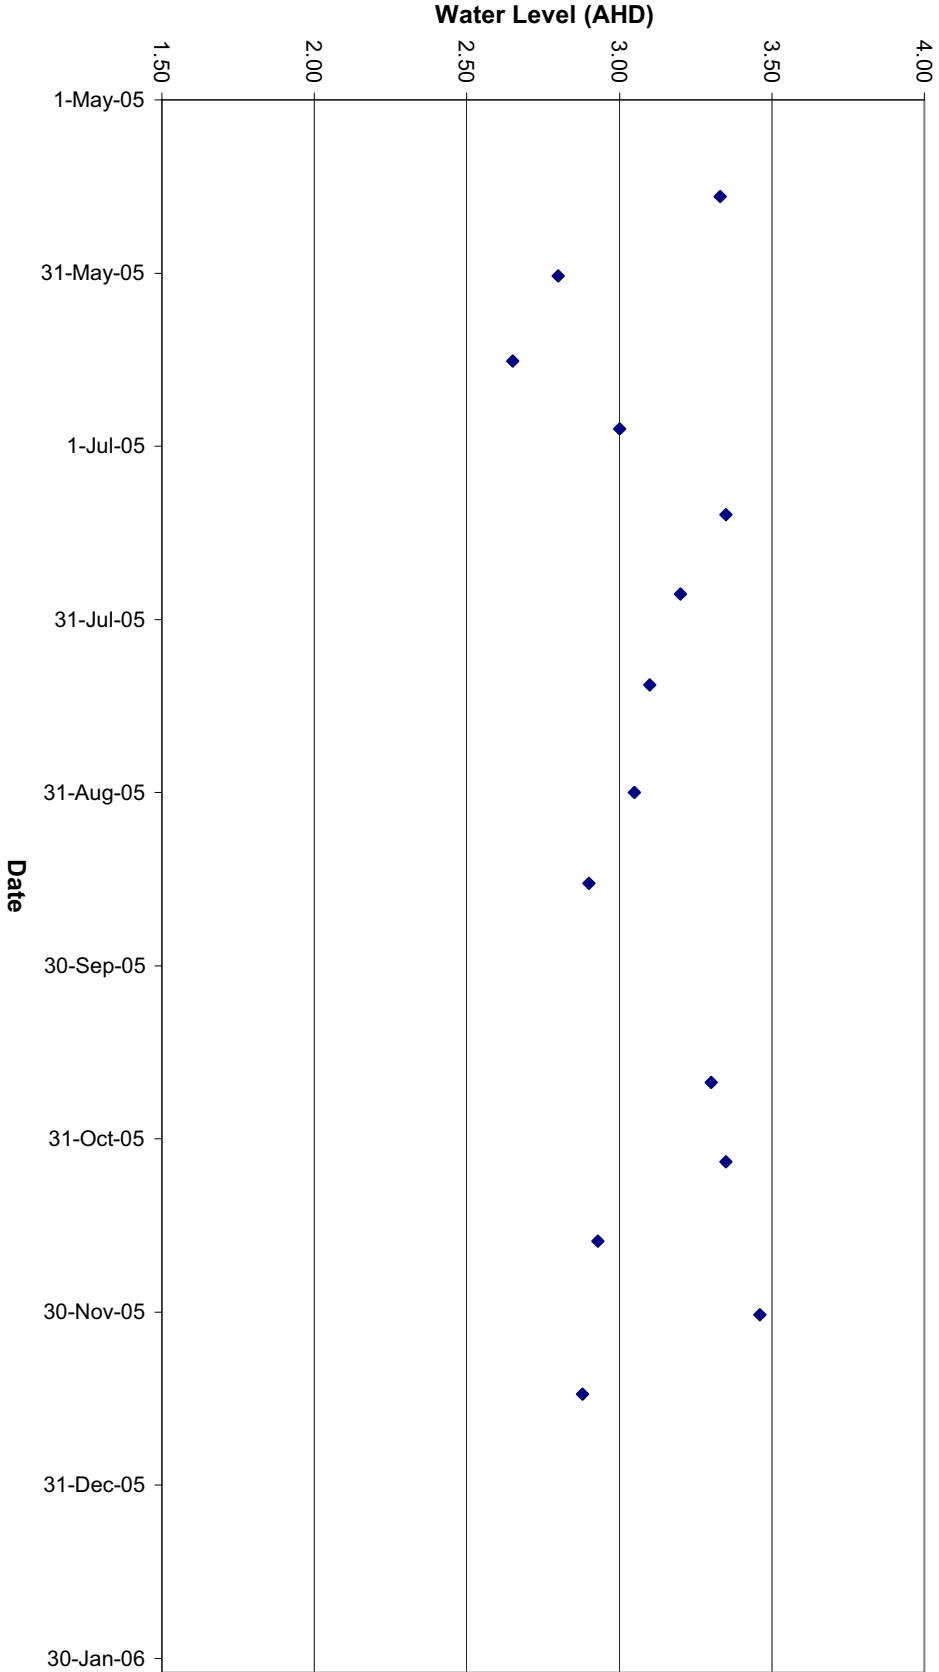
<b>Coffey Geosciences Pty Ltd</b>		ACN 056 336 516	Geotechnical   Resources   Environmental   Technical   Project Management	
Drawn	ELC	<b>RESOURCE DESIGN &amp; MANAGEMENT</b>  <b>PROPOSED SUBDIVISION</b>  <b>PACIFIC HIGHWAY, NORTH MOONEE BEACH</b>  <b>PLOT FOR BH1</b>		
Approved				
Date	16/12/05			
Scale	NTS			
		Drawing no:	<b>BH1</b>	
		Job no:		
			<b>CH1173/1</b>

Six groundwater wells (BH1 to BH6) were installed in the Zone 2 area on 5 April 2004. Loggers were installed in these boreholes to record water level every three hours over a twelve month period. These loggers were found to be vandalised or removed from the site on the 27 May 2004. Water levels were measured on the 6 April 2004 and 27 May 2004.

The client decided not to replace the loggers, and instead water levels have been measured by direct measurement on a regular basis from May 2005 to date to assess trends in groundwater levels at the site. This monitoring will continue until twelve months of data has been collected.

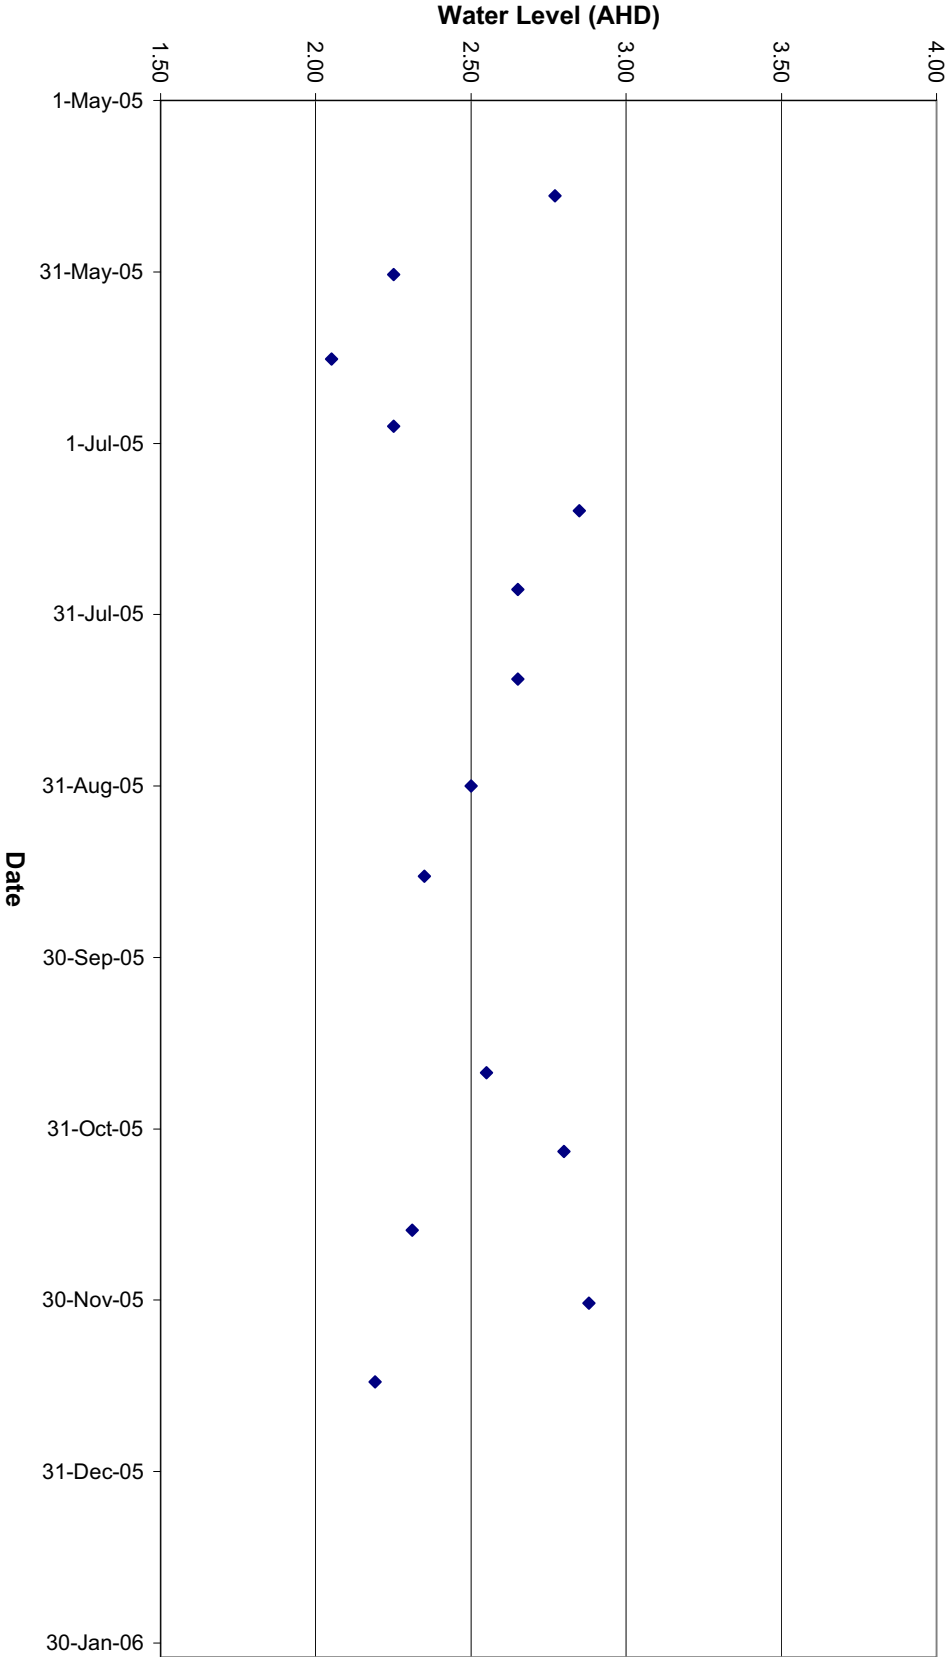
<b>Coffey Geosciences Pty Ltd</b>		ACN 056 336 516	Geotechnical   Resources   Environmental   Technical   Project Management	
Drawn	ELC	<b>RESOURCE DESIGN &amp; MANAGEMENT</b> <b>PROPOSED SUBDIVISION</b> <b>PACIFIC HIGHWAY, NORTH MOONEE BEACH</b> <b>PLOT FOR BH2</b>		
Approved				
Date	16/12/05			
Scale	NTS			
		Drawing no:	BH2	
		Job no:	CH1173/1

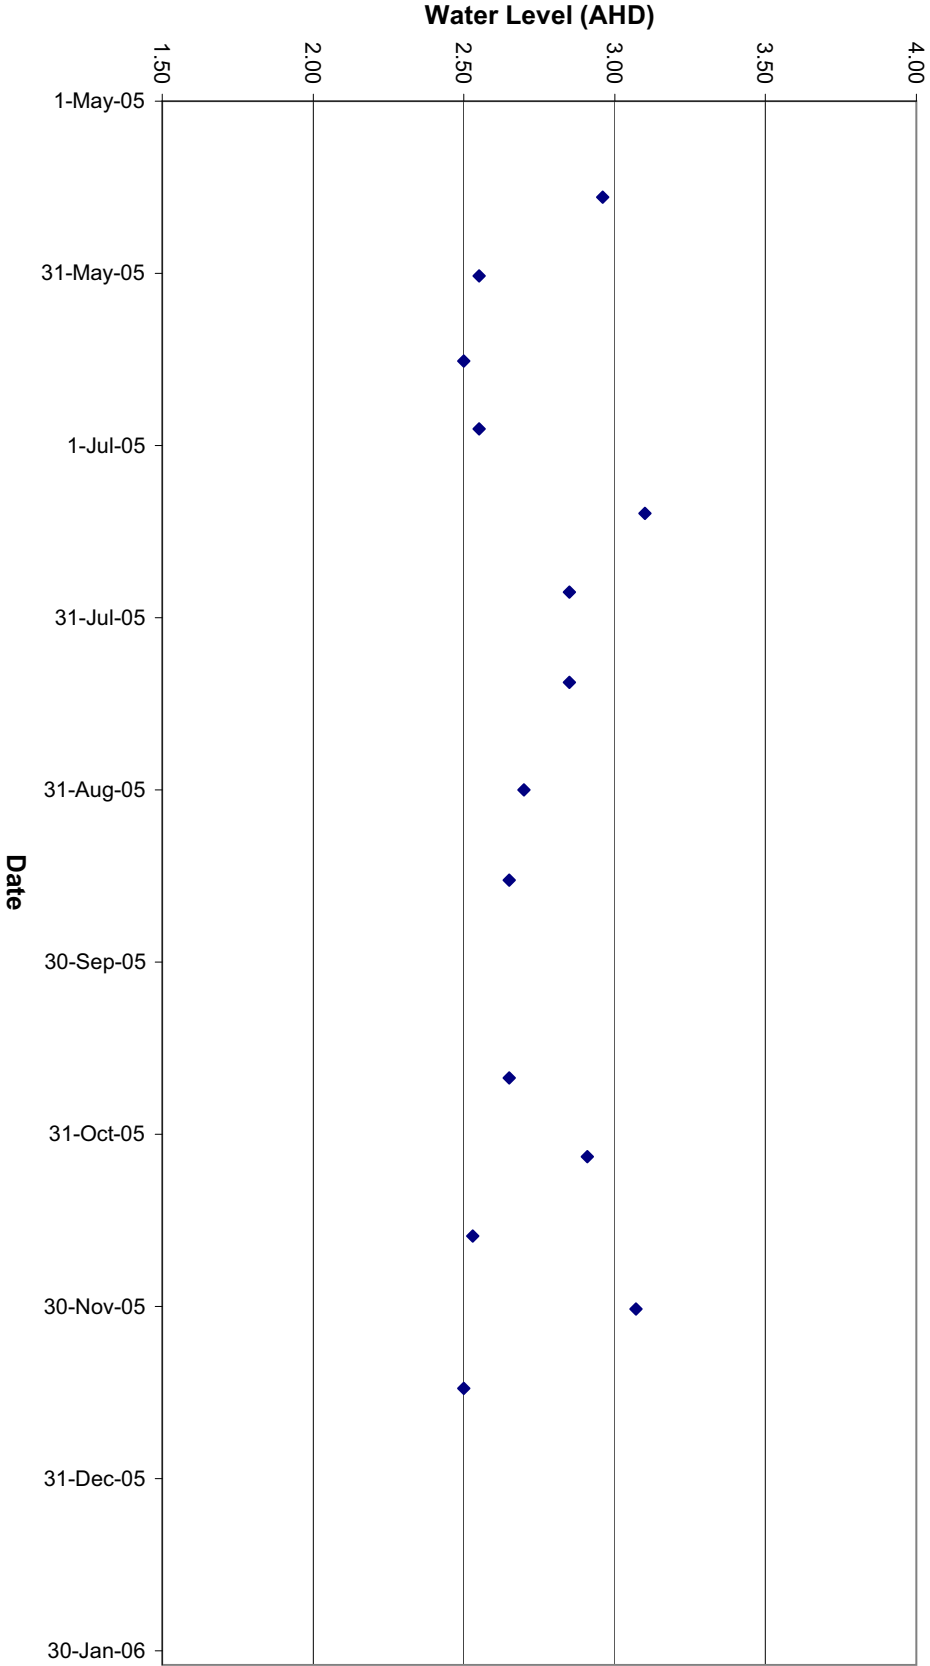
<b>Coffey Geosciences Pty Ltd</b>		ACN 056 336 516	Geotechnical   Resources   Environmental   Technical   Project Management	
Drawn	ELC	<b>RESOURCE DESIGN &amp; MANAGEMENT</b> <b>PROPOSED SUBDIVISION</b> <b>PACIFIC HIGHWAY, NORTH MOONEE BEACH</b> <b>PLOT FOR BH3</b>		
Approved				
Date	16/12/05			
Scale	NTS			
		Drawing no:	BH3	
		Job no:	CH1173/1

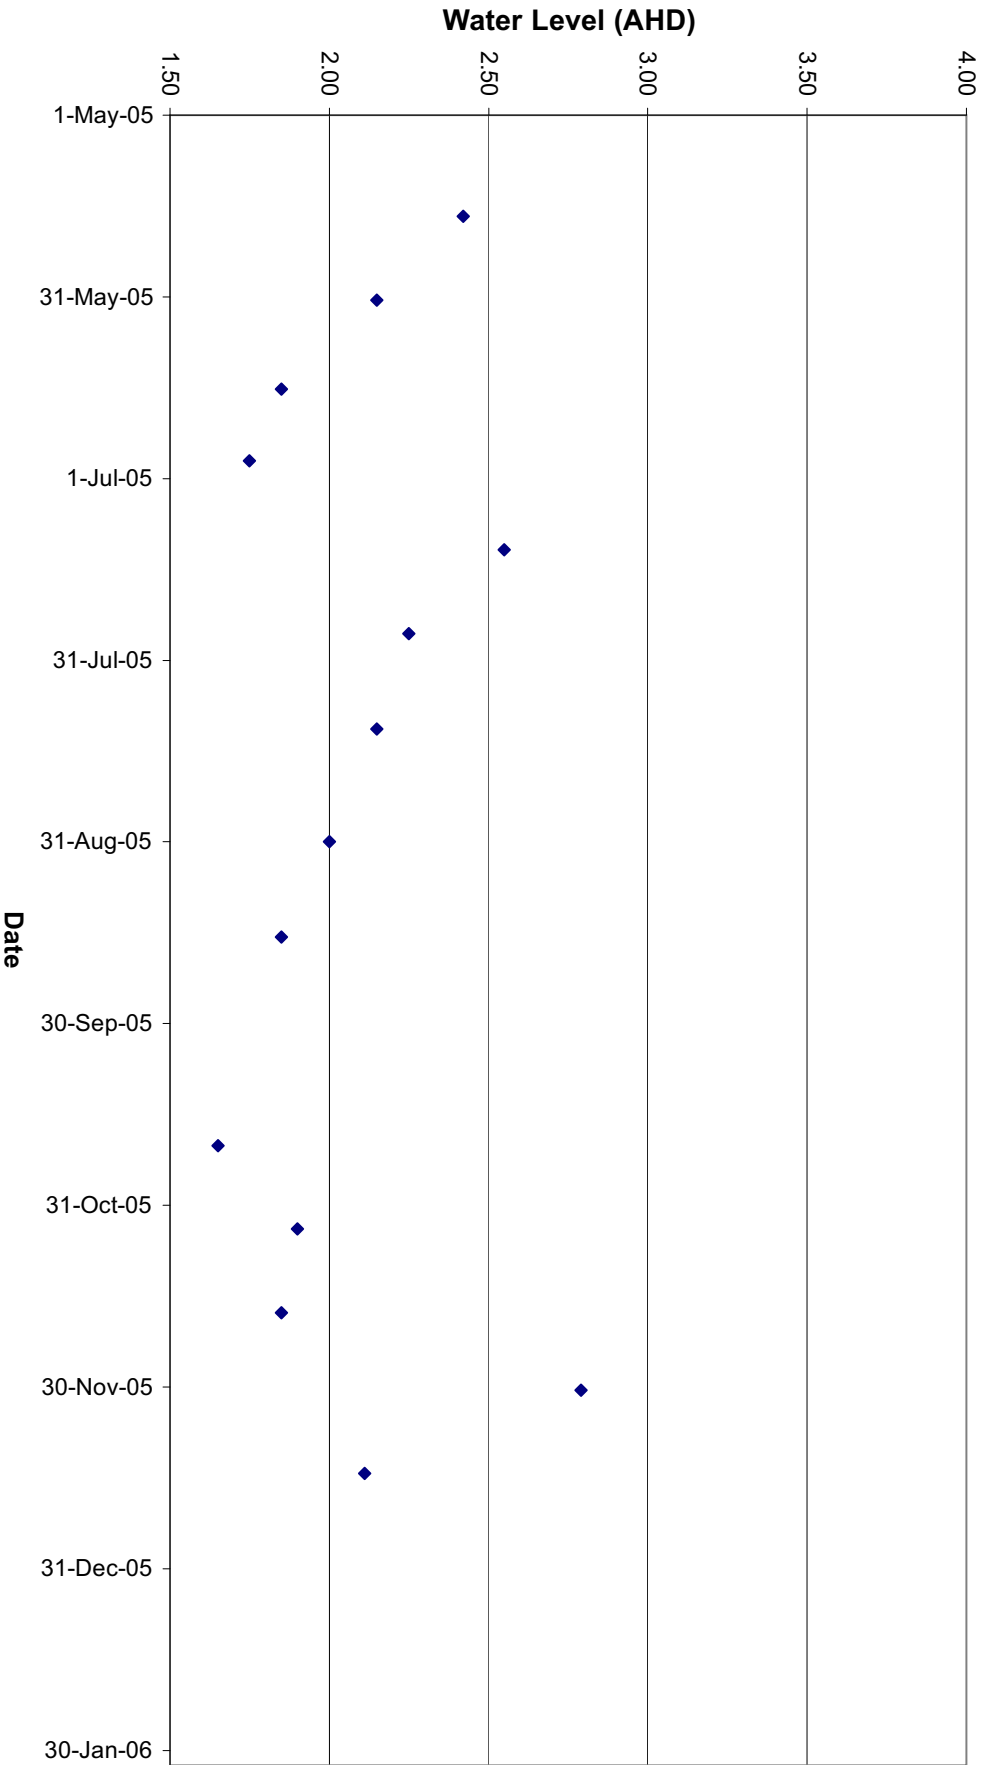
<b>Coffey Geosciences Pty Ltd</b>		ACN 056 336 516	Geotechnical   Resources   Environmental   Technical   Project Management	
Drawn	ELC	<b>RESOURCE DESIGN &amp; MANAGEMENT</b> <b>PROPOSED SUBDIVISION</b> <b>PACIFIC HIGHWAY, NORTH MOONEE BEACH</b> <b>PLOT FOR BH4</b>		
Approved				
Date	16/12/05			
Scale	NTS			
		Drawing no:	BH4	
		Job no:	CH1173/1

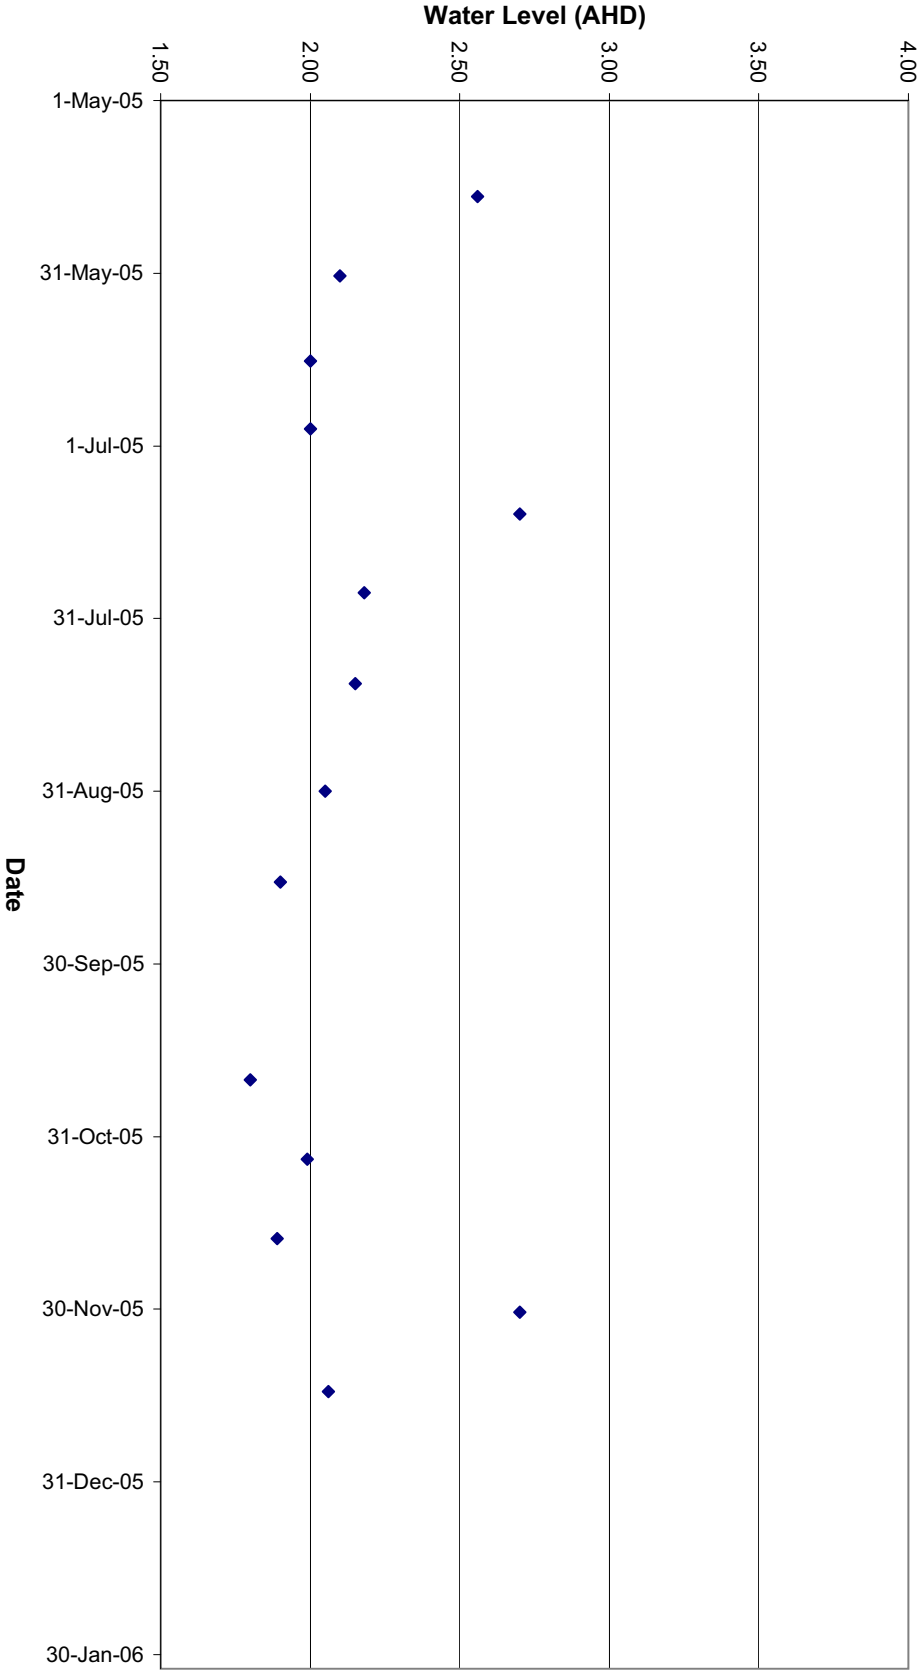
<b>Coffey Geosciences Pty Ltd</b>		ACN 056 336 516	Geotechnical   Resources   Environmental   Technical   Project Management	
Drawn	ELC	<b>RESOURCE DESIGN &amp; MANAGEMENT</b> <b>PROPOSED SUBDIVISION</b> <b>PACIFIC HIGHWAY, NORTH MOONEE BEACH</b> <b>PLOT FOR BH5</b>		
Approved				
Date	16/12/05			
Scale	NTS			
		Drawing no:	BH5	
		Job no:	CH1173/1

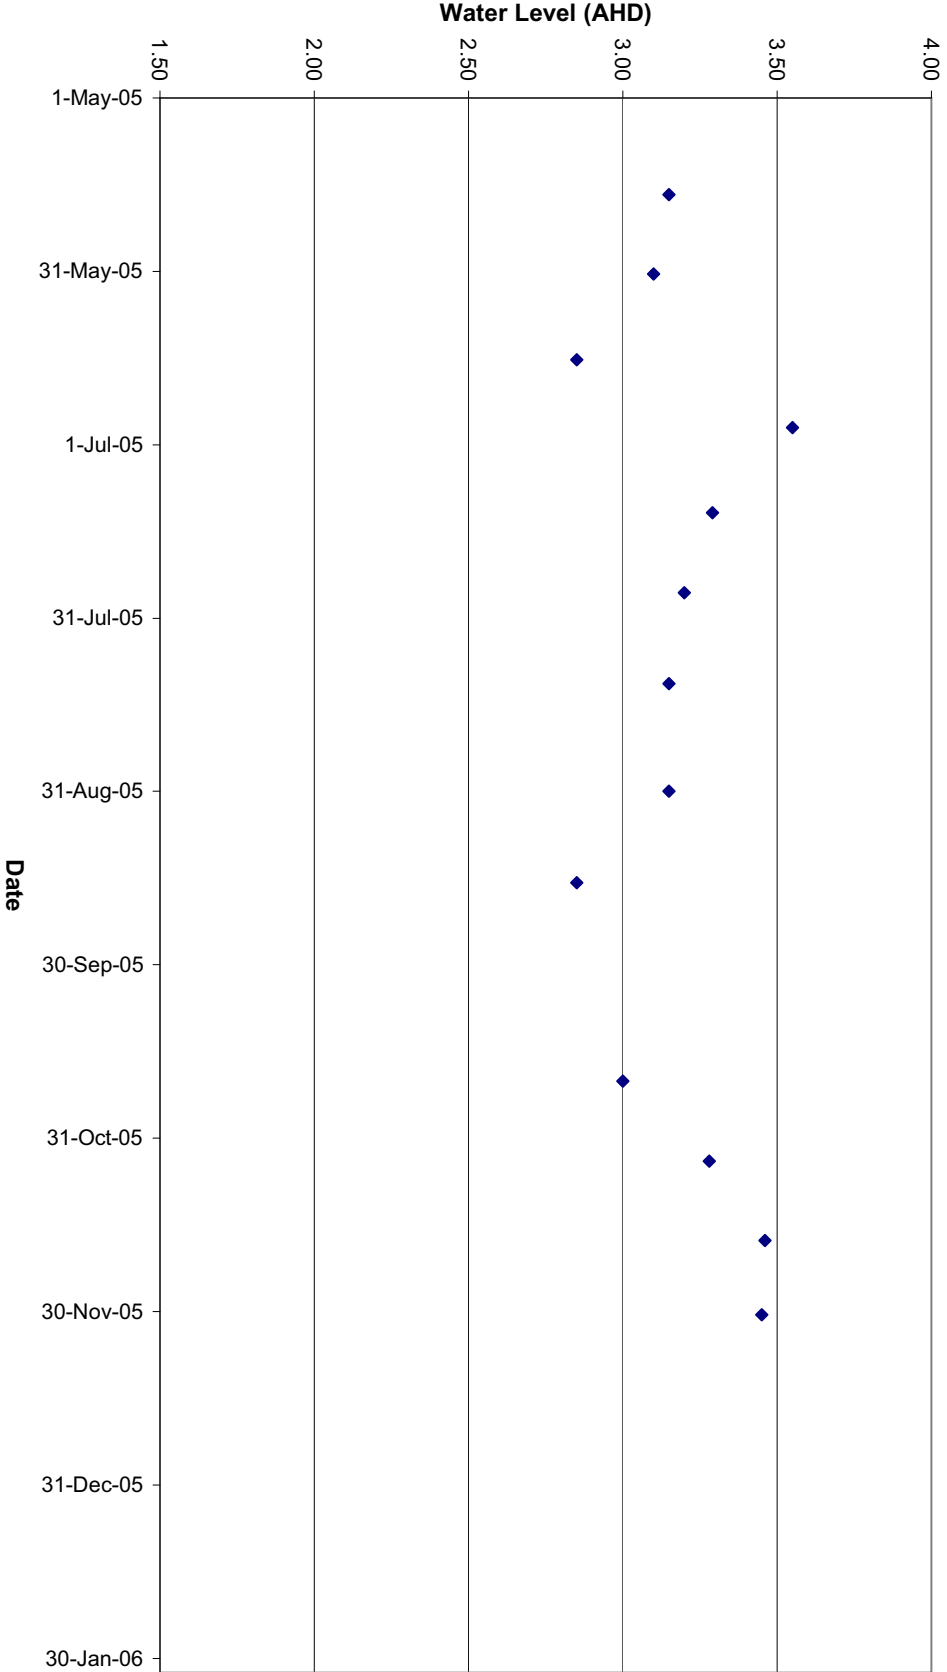
<b>Coffey Geosciences Pty Ltd</b>		ACN 056 336 516	Geotechnical   Resources   Environmental   Technical   Project Management	
Drawn	ELC	<b>RESOURCE DESIGN &amp; MANAGEMENT</b> <b>PROPOSED SUBDIVISION</b> <b>PACIFIC HIGHWAY, NORTH MOONEE BEACH</b> <b>PLOT FOR BH6</b>		
Approved				
Date	16/12/05			
Scale	NTS			
		Drawing no:	BH6	
		Job no:	CH1173/1

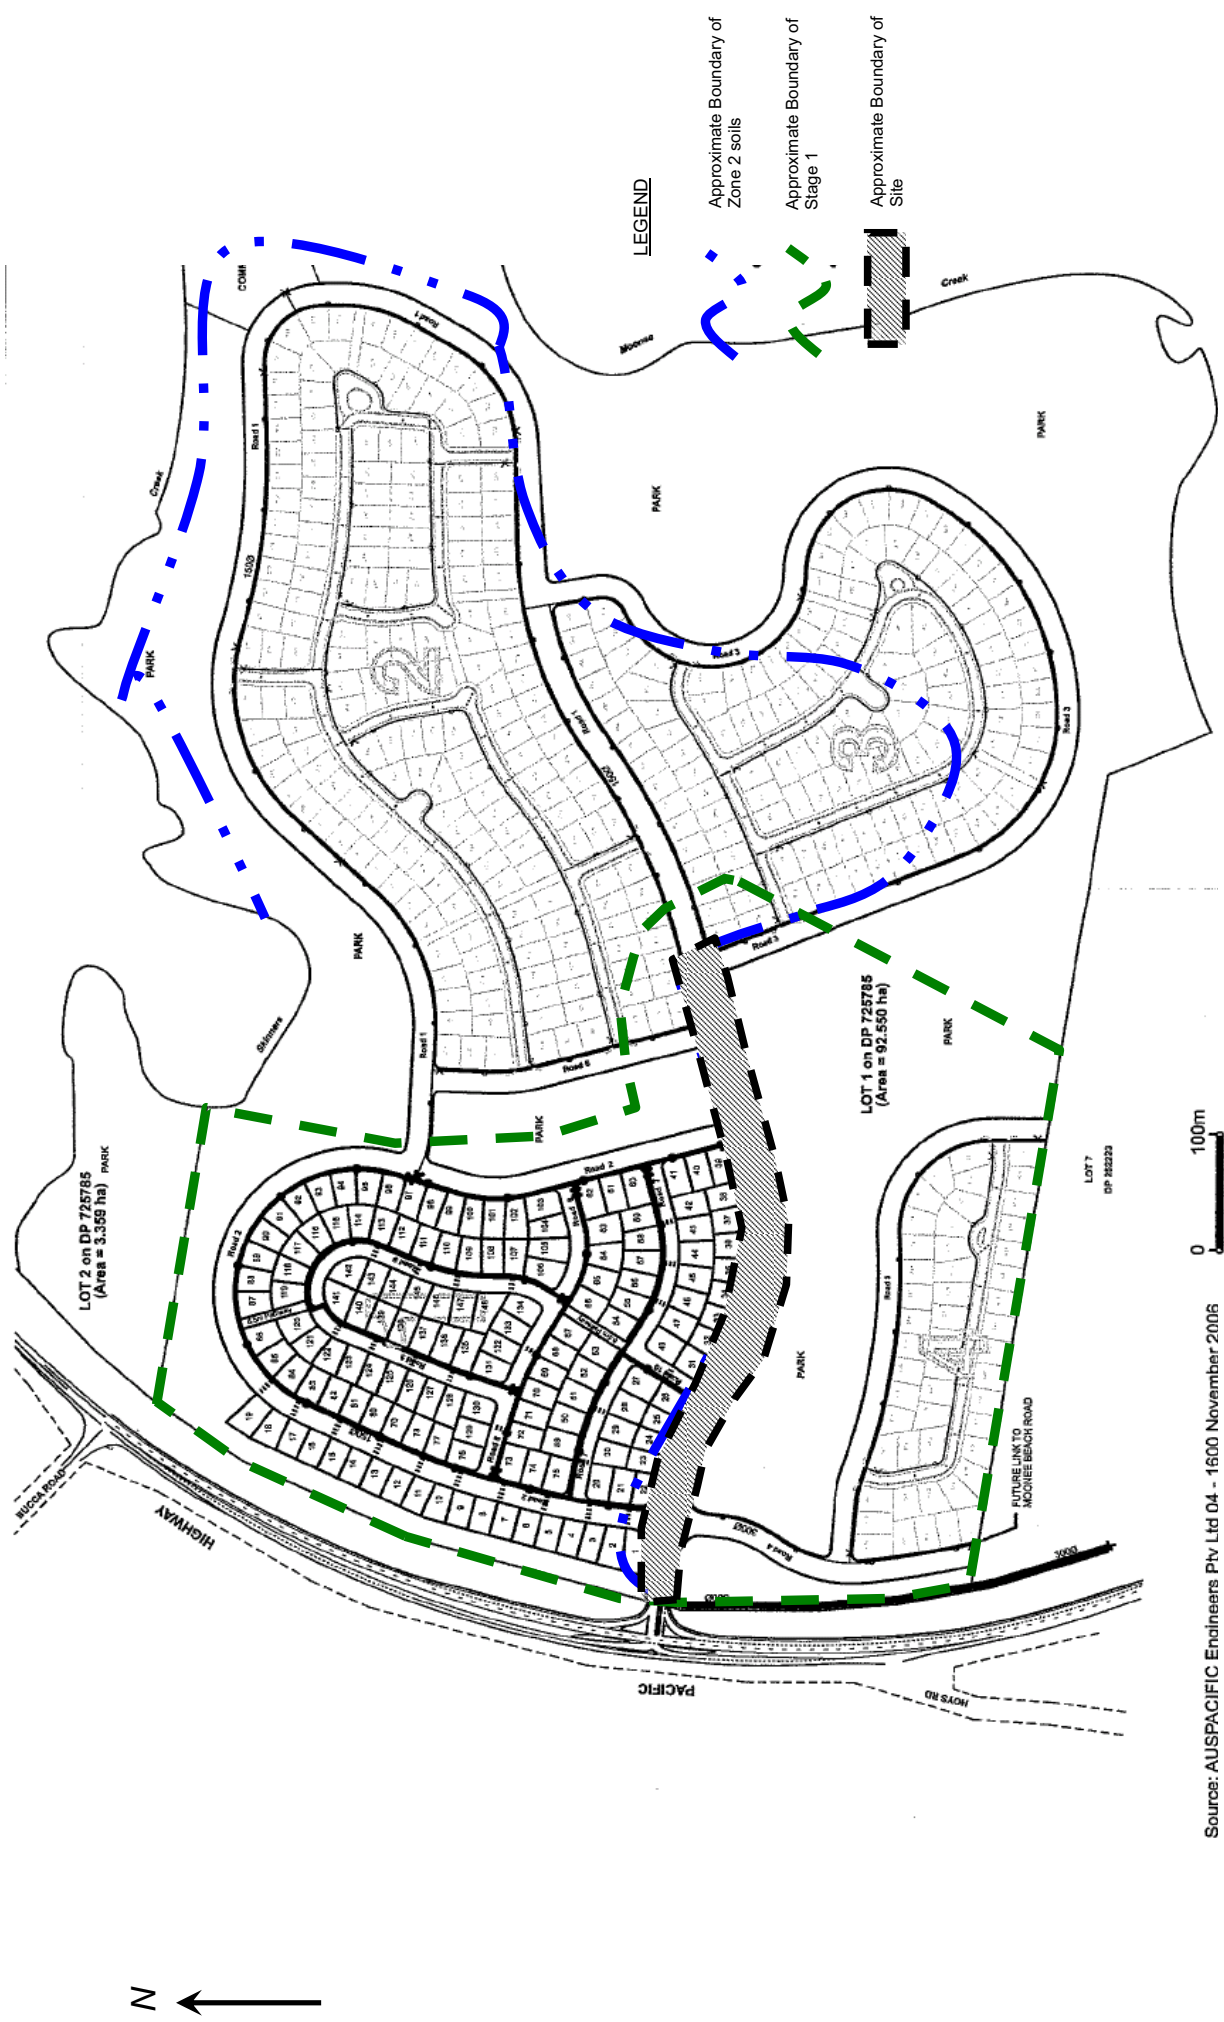
Approximate  
location of test pits
